Stone deterioratins in Mardin Madrasas: The case of Şehidiye and Kasımiye Madrasas

Biçen Çelik, A., Ay, İ., Ergin, Ş., & Dal, M. (2024). Stone deterioratins in Mardin Madrasas: The case of Şehidiye and Kasımiye Madrasas. *Cultural Heritage and Science*, 5 (1), 38-51

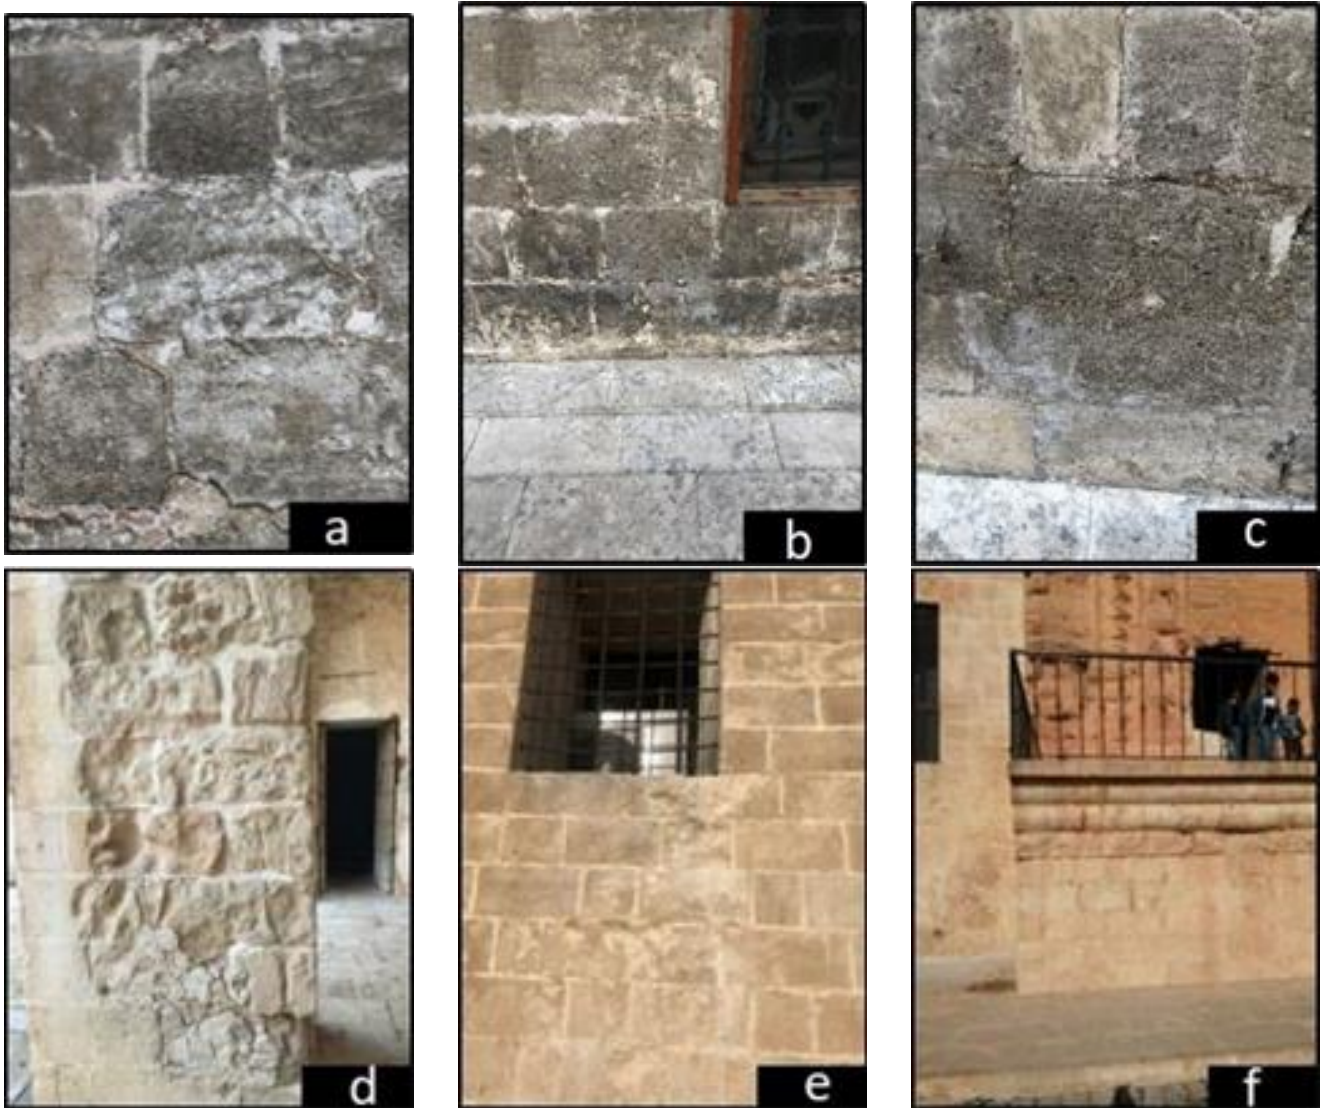
In both Şehidiye and Kasımiye madrasahs, joint discharges, hairline crack formation, fragment loss and surface abrasion are observed as physical deterioration types. Due to the climatic conditions prevailing in the city and the effect of time, the mortars binding the stone structures together have lost their effectiveness and the joints between the stones have become empty. Due to the climatic conditions of the city of Mardin, capillary cracks are frequently observed in historical stone structures, which are cultural heritage, as a result of exposure to thermal shock, and crack formation due to weather events such as precipitation and the properties of the stone. Surface abrasions on stone structures are observed as a result of the wind-carrying dust particles. It can be said that the natural conditions and the orientation parameters of the buildings are also effective in the similar types of physical deterioration seen in Şehidiye and Hatuniye madrasas. The physical deterioration observed in the structures is shown in Figure 5. Capillary cracks (Figure 5a), joint discharges (Figure 5b and 5c), fragment losses (Figure 5d) and surface abrasions (Figure 5e and 5f) are observed.

Figure 5. Physical deterioration observed in Şehidiye and Kasımiye madrasas.

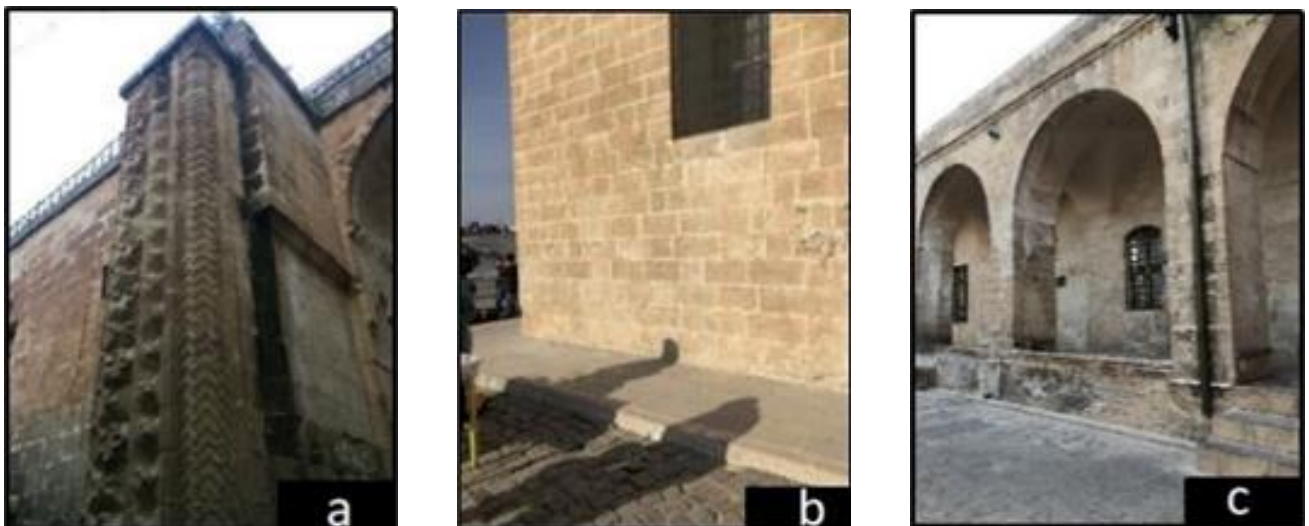
The limestone used as the main construction material in the Şehidiye and Kasımiye madrasas has been subjected to chemical deterioration as a result of internal and external factors over time. Changes such as discoloration, salinization and bacterial growth observed on the stone surfaces are examples of chemical

degradation. The chemical deterioration of the Şehidiye and Kasımiye madrasas is shown in Figure 6. Color changes (Figure 6a), salinization (Figure 6b) and bacterial growth (Figure 6c).

Figure 6. Chemical deterioration observed in Şehidiye and Kasımiye madrasas.

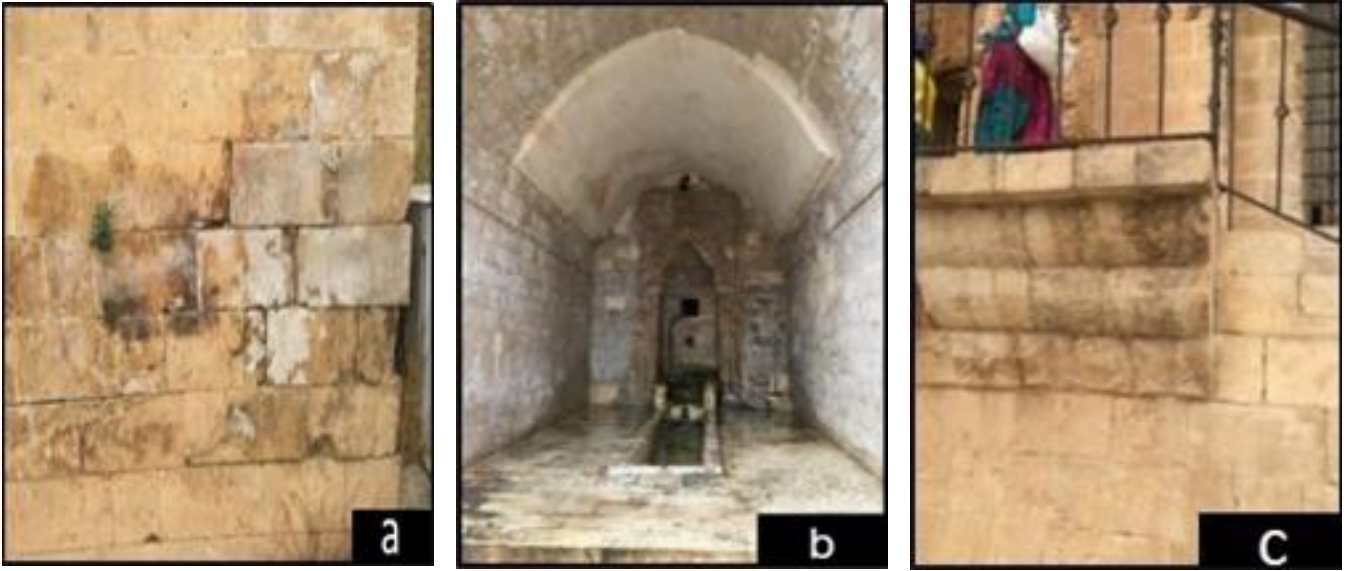
The biodegradation observed in Şehidiye and Kasımiye madrasas are shown in Figure 7. Plant, algae and bacterial growths were observed as biodegradation in Şehidiye and Kasımiye madrasas. The growth of roots due to plant growth in the structures causes the formation of joint gaps, widening of cracks and fragmentation on the stone surfaces. Plant growth, which is a type of biological degradation, accelerates the processes of physical degradation such as joint voiding, crack formation and surface detachment [54]. In addition to plant growth, moss and bacterial growths are found in Şehidiye and Kasımiye madrasas. Moss formations are more common in areas where stone surfaces come into contact with water [55]. Plant growth (Figure 7a), moss growth (Figure 7b) and bacterial growth (Figure 7c) observed in the madrasas are shown.

Figure 7. Biological deterioration observed in Şehidiye and Kasımiye madrasas.

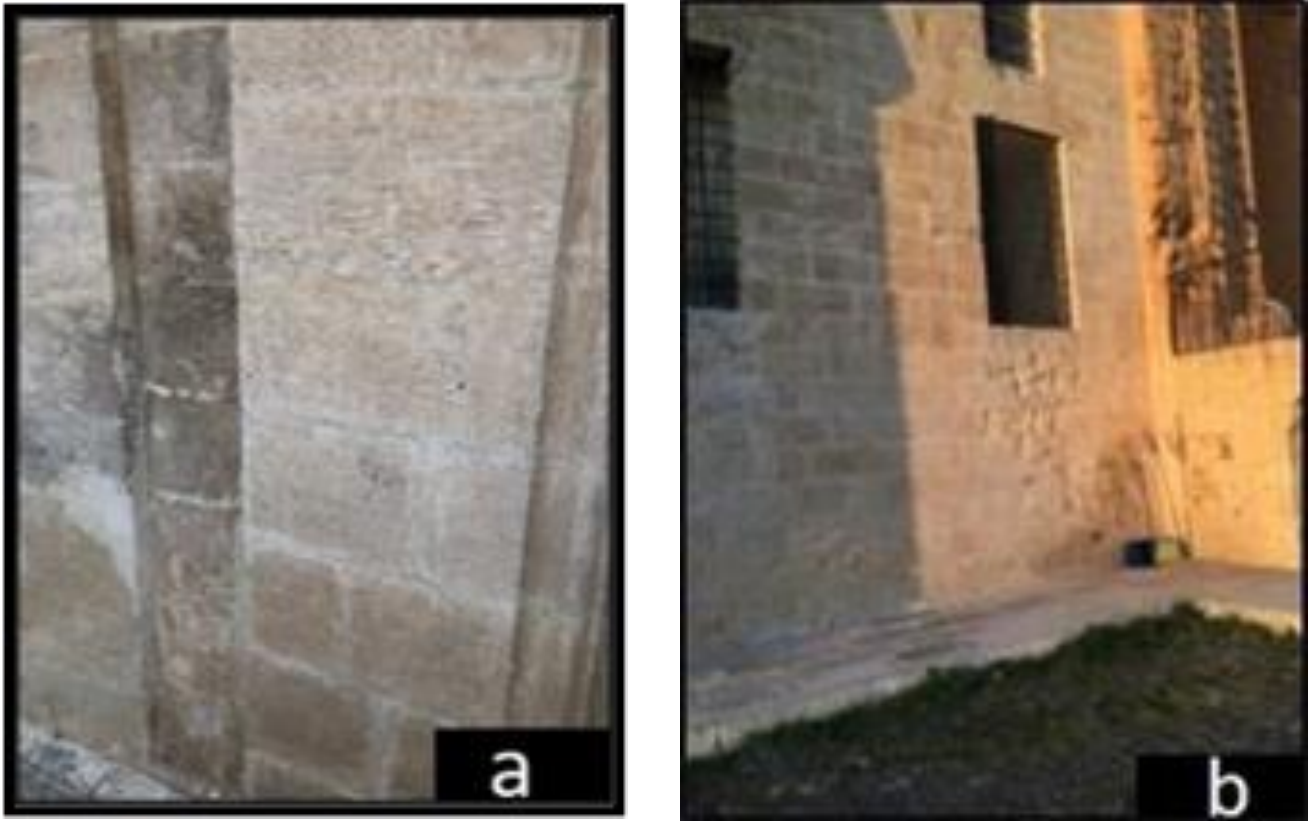
Anthropogenic degradation, which occurs as a result of the damage and harm caused by people consciously or unconsciously to cultural heritage buildings, was observed in Şehidiye and Kasımiye madrasas. In both buildings, anthropogenic deterioration is observed on the stone surfaces as a result of the use of sharp tools. Figure 8 shows the deterioration caused by the use of sharp tools.

Figure 8. Anthropogenic deterioration observed in Şehidiye and Kasımiye madrasas.

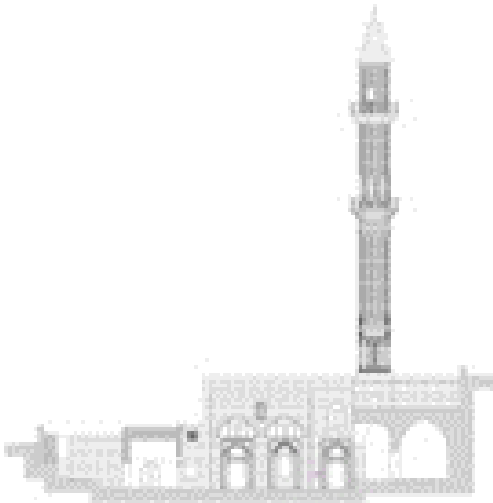
Table 8. Analysis of anthropogenic deterioration in Şehidiye Madrasah by mapping method.

Anthropogenic Deterioration Type	Facade Deterioration Ratio	Ratio (%)
North Facing Courtyard Facade Sharp Instrument Use

0.1

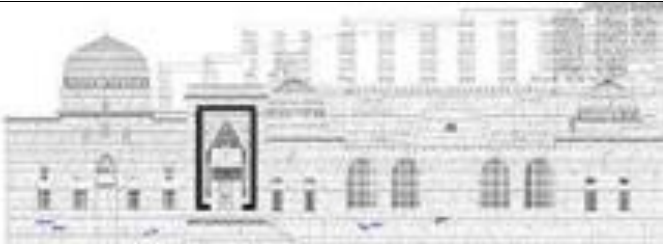
Table 9. Analysis of anthropogenic deterioration in Kasimiye Madrasah by mapping method.

Anthropogenic Deterioration Type		Facade Deterioration Ratio	Ratio (%)
South Facade	Sharp Instrument Use

0.4
South Facing Courtyard Facade	Sharp Instrument Use

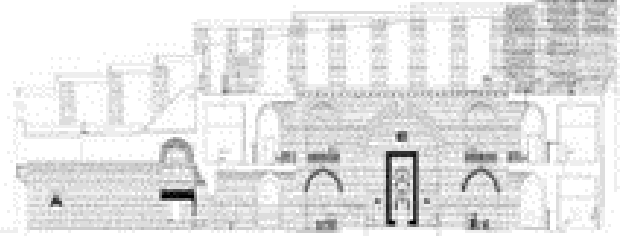
0.9
West Facing Courtyard Facade	Sharp Instrument Use
