## Evaluation of Earthquake-Related Damages on the Reinforced Concrete Buildings due to the February 6, 2023, Kahramanmaraş-Türkiye Earthquakes

Zeliha TONYALI<sup>ID</sup>, Adnan KIRAL\*<sup>ID</sup>

\*Recep Tayyip Erdogan University, The Faculty of Engineering and Architecture, Department of Civil Engineering, 53100 Rize, Türkiye

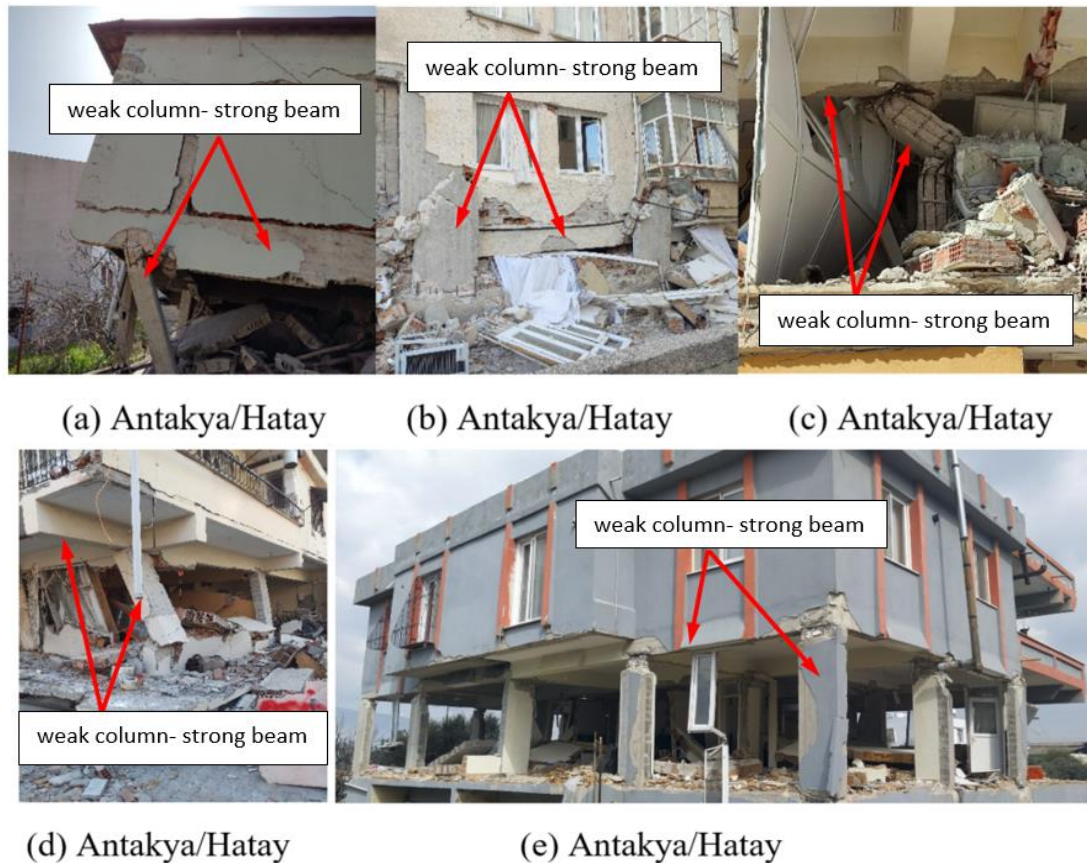
beams while the columns are flexible and weak. Flexible columns thus collapse before the beams. When an earthquake hits, the strong beams in this type of design behave elastically, whereas the weak columns suffer brittle failures due to compression crushing or shear failure. Buildings' full and partial collapse during the February 6, 2023, Kahramanmaraş-Türkiye earthquakes, was mostly caused by the strong beam-weak column

design. The collapses of several structures that suffered from this type of design are seen in Figure 8. Current and previous seismic regulations (TBEC, 2019; TEC, 2007) mandate that total moment resistance of beams at beam-

**Figure 8.** Observed structural damages in Antakya/Hatay

column joints be at least 20% smaller than total moment resistance of columns at the same joints in order to prevent this sort of damage and brittle collapses of columns.

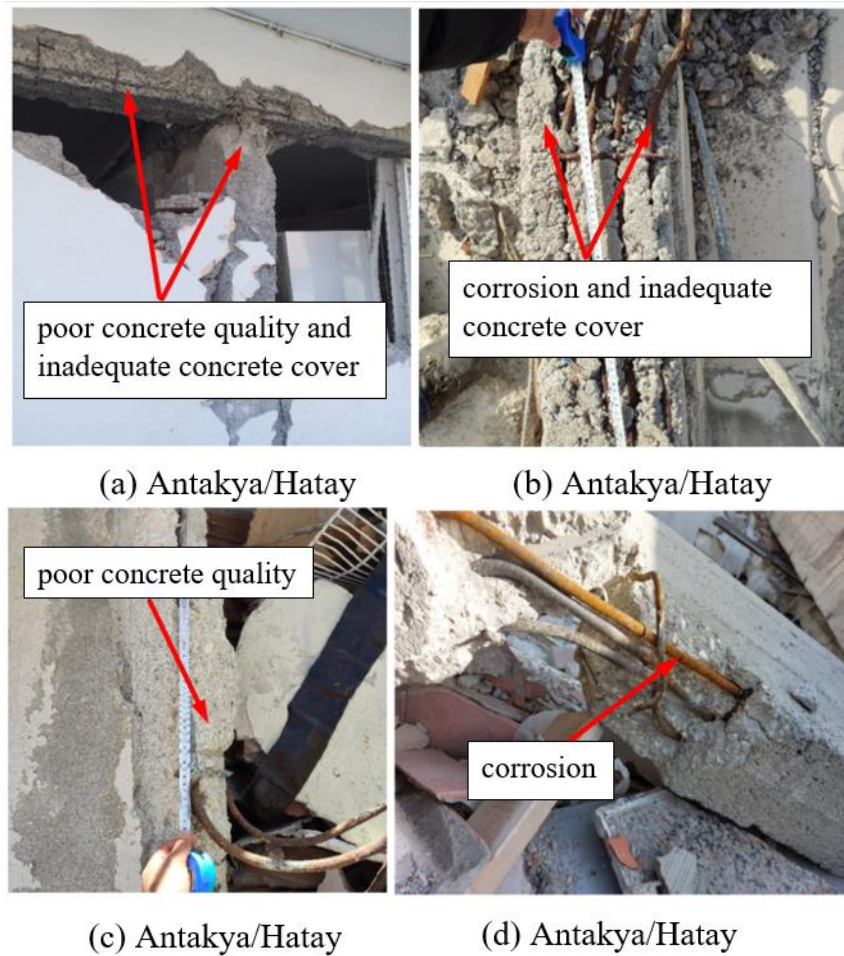
One of the key components needed for RC buildings to operate as anticipated during earthquakes is concrete compressive strength. However, it was observed through field inspections that many collapsed, or severely damaged structures did not have adequate concrete quality. Insufficient concrete cover, and corrosion of the reinforcement bars were also other types of structural material defects which were observed in the earthquake sites. The reinforcing bars' diameters decreased due to corrosion caused by insufficient concrete cover.

Following the Kocaeli earthquake in 1999, ready-mix concrete use spread across Türkiye. Concrete that was prepared by hand was commonly utilized prior to this earthquake without the use of a vibrator. This incorrect application prevented a uniform mixture of concrete and thus the anticipated compressive strength from it. According to the old seismic code TEC [14], minimum allowed compressive strength of concrete was 20MPa for all RC buildings, however the latest seismic code TBEC (2019), demands that this must be at least 25MPa. Buildings damages having poor-quality concrete and corroded reinforcement bars due to insufficient concrete cover are shown in Figure 9.

**Figure 9.** Observed structural damages in Antakya/Hatay, (a) poor concrete quality and inadequate concrete cover, (b) corrosion and inadequate concrete cover, (c) poor concrete quality, and (d) corrosion failures

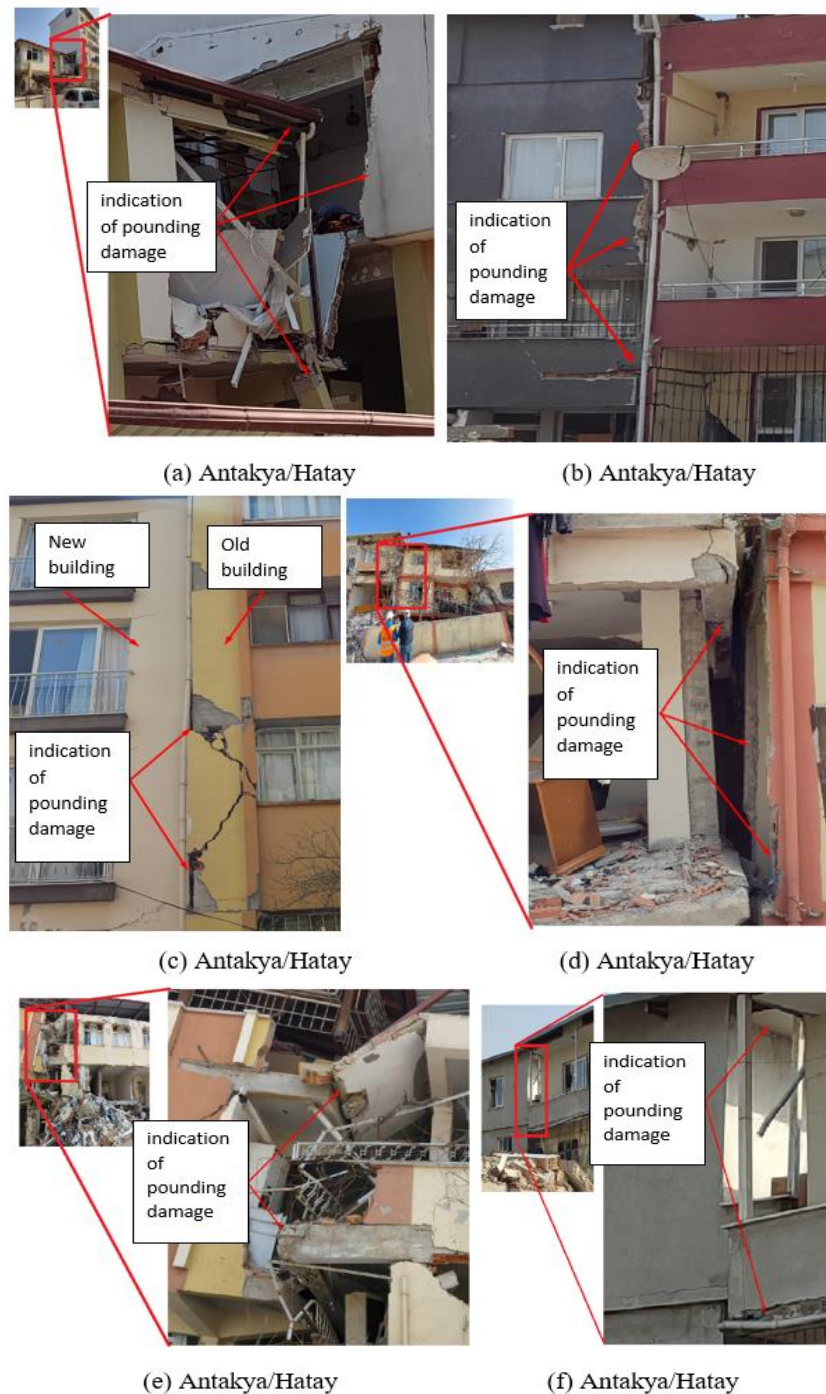
As a result of insufficient land availability in the city centers, adjacent buildings are built. As a result, one or two building facades are in touch with one another or there is a small space between them. Hence, during an earthquake, these structures crash into one another. Unaligned floor levels between adjacent structures make the situation even riskier. In cases like these the floor of one building could hit the columns of the neighboring building, causing brittle fractures. A sufficient gap between adjacent buildings is necessary to prevent such damage. It is recommended that gaps between adjacent structures be 3cm up to a height of 6m, according

to the latest seismic code TBEC (2019). For every 3m height increment, 1cm should be added gap to between adjacent buildings. In view of the requirement defined in the previous statement, gaps cannot be lower than the total of the absolute values of the average storey displacements times the coefficient ( $a$ ). The amount of gap is  $a = 0.25(\frac{R}{I})$  and  $a = 0.50(\frac{R}{I})$  if neighboring floor levels of buildings at all storeys are the same and not the same, respectively.  $I$  and  $R$  stand for the building's importance factor and the response modification factor, respectively. In Figure 10, structural damages are shown that have occurred as a result of insufficient spacing between buildings.

**Figure 10.** Observed structural damages in Antakya/Hatay. Damages due to adjacent buildings' lateral displacement. (a) A 7-story building collided with a 2-story building. (b and c) 4-story new and old buildings collided with each other. (d, e and f) 2-story old buildings collided with each other.

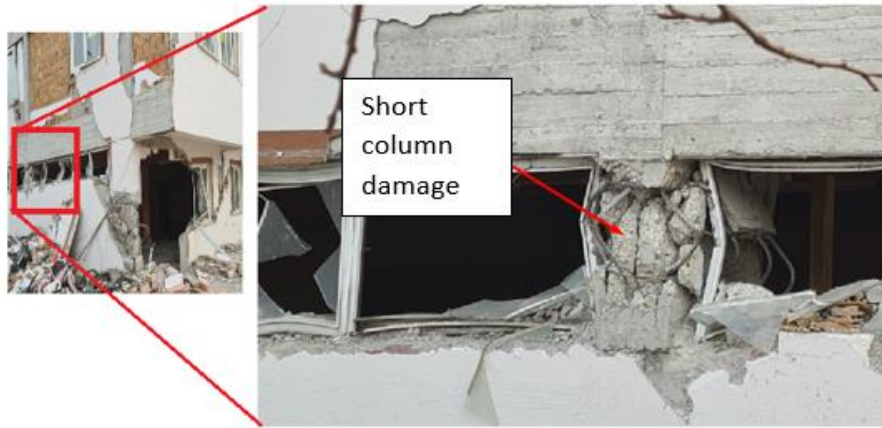
(a) City centre / Malatya

An exterior band window, which is aimed at lighting basements of buildings, leads to short columns. With this application, a column's effective length is reduced, it becomes stiffer and is subjected to considerable dynamic shear forces, leading to shear cracking, and ending in brittle

failure. This type of critical failure is shown in Figure 11. Calculating the shear force for transverse reinforcement in accordance with TBEC (2019) is given in 12, where  $M_{bottom} = 1.4M_{ra}$ ,  $M_{top} = 1.4M_{r\ddot{u}}$ ,  $V_e$  and  $l_n$  indicate calculated shear force and the length of the short column, respectively.

**Figure 11.** Observed structural damages in the earthquake region. RC building damage related to (a) shear force (or called short column damage) in City centre/Malatya, (b) Nurdağı/Gaziantep, (c) Narlıca/Hatay and (d) Narlıca/Hatay.

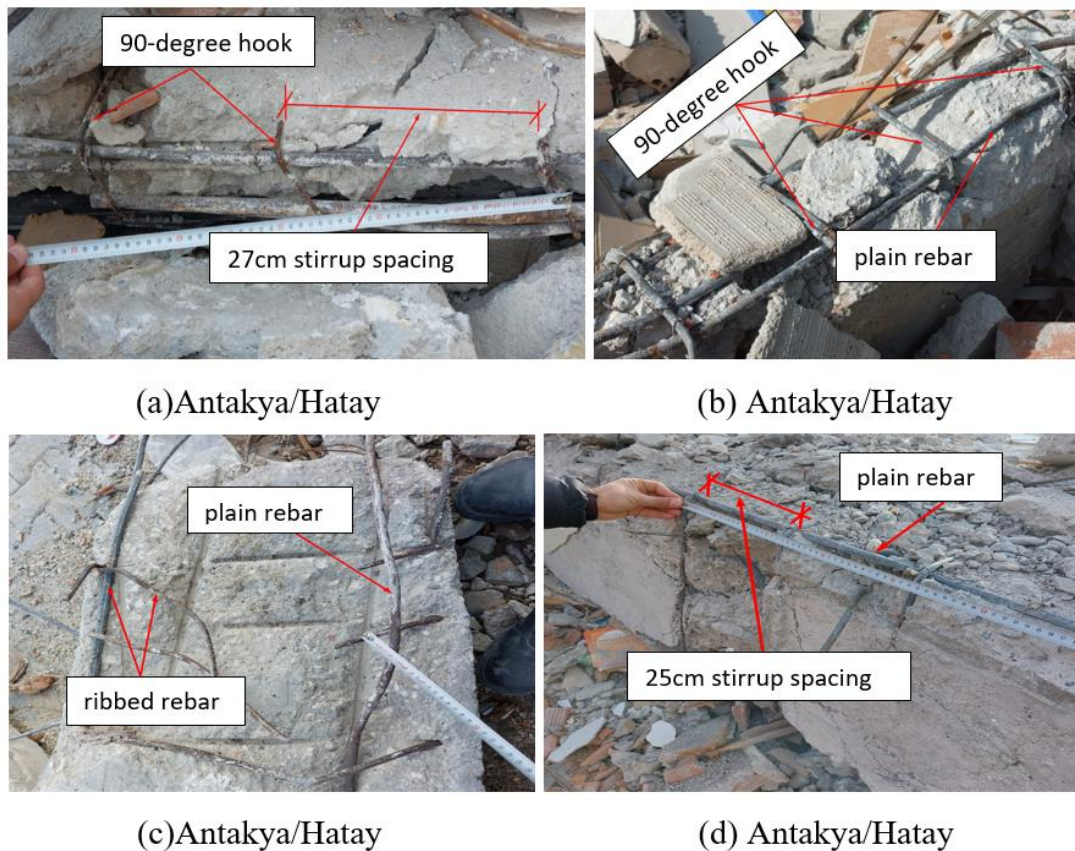
For structures to be sufficiently ductile all structural elements need to be ductile. Transverse reinforcement plays a crucial role in shear resistance as well as the flexural ductility of beams and columns. The ends of beam, column and column-beam junctions are particularly impacted by shear forces under lateral forces. From the site investigations, it was observed that the distance between the transverse reinforcement in over 90 percent of severely damaged structures was not in accordance with the regulations. This was especially the case in the plastic hinge regions of structural members where the spaces were ranging from 20cm to 35cm. The incorrect application of this construction resulted in buckling of the longitudinal reinforcement bars under compression, caused by the moment reversals during the earthquake. Finally, the

Another observed issue was bond failure, also leading to brittle failures. It is strictly recommended by the design codes that smooth reinforcement should not be used and the bars should be properly anchored. The bending degree be not less than  $135^\circ$  for seismic hooks and ties and that the reinforcement bar be not damaged while being bent. However, site investigations revealed smooth transverse reinforcement, which causes less adherence with concrete (bond-slip), and  $90^\circ$  bent seismic tie hooks on damaged buildings. Apart from these, some collapsed buildings had smooth and ribbed bars within the same column (Figure 13c).

**Figure 13.** Observed structural damages in Antakya/Hatay. RC building damage related to deficiencies in materials and workmanship. **(a)** 90-degree hook angle instead of  $135^\circ$  and 27 cm stirrup space, which is larger than the Turkish code requirement; **(b)** smooth steel bars instead of ribbed rebar; **(c)** having both plain and ribbed rebar in the same column; and **(d)** having plain rebar and inadequate stirrup space.

It was also observed that the ground floor of some buildings had smooth steel bars, whereas the upper floor had ribbed steel bars. It is considered that some floors were added to these old weak buildings after 2000 because it is the date when ribbed steel bars became common in the country. Such non-uniform material distribution in the building causes the ground floor to be the weakest point in a building, with the upper floors acting as a rigid box, which leads to concentration of damage at ground floor and a total collapse of the building. Some transverse and longitudinal bars details from the sites are given in Figure 13.

columns failed to handle axial forces and were severely damaged. As a result, transverse reinforcement details should be clearly specified in the project and must be carefully checked during construction.

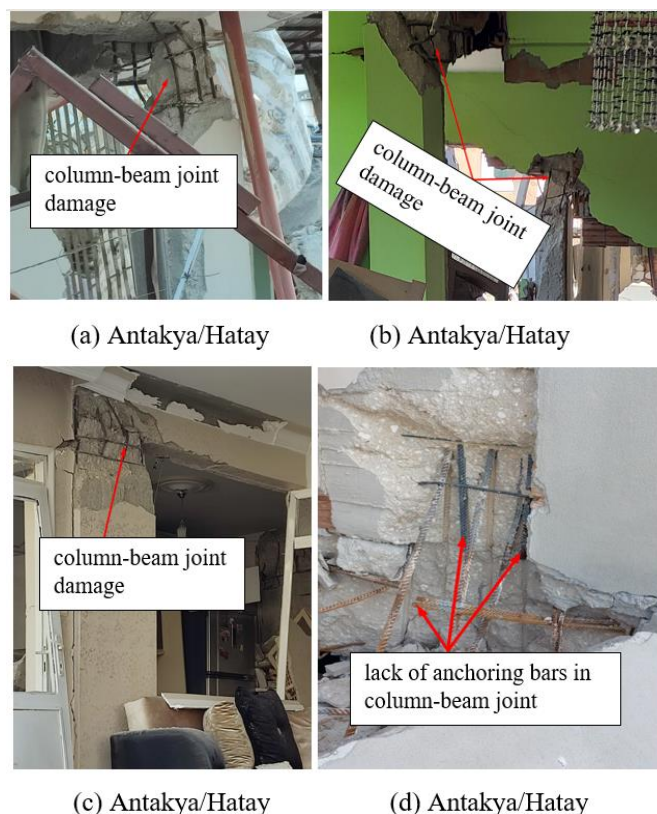
Because of improperly designed beam-column joints, buildings' structural performance significantly decreases during earthquakes. To avoid catastrophic failures following an earthquake, the joints must be kept in an elastic zone. The distribution of force and moment depends heavily on these joints. The most frequent reasons for these joints to fail are the bond and shear mechanisms. Several RC

structures suffered significant damage during the 2023 Kahramanmaraş and Hatay earthquakes because of the failures of these joints. From site observations, it was found that the major causes of these collapses were poor craftsmanship, inadequate materials, and deficient detailing at column-beam joints. Joint failure also results from a lack of anchoring bars and transverse reinforcements and seismic cross-ties for columns and beams in RC components. According to TBEC (2019), in places where lap joints will be made, special earthquake stirrups will be used along the lap joint, and the spacing of these stirrups will be a maximum of 100 mm. Besides, TBEC (2019) in RC frame systems, the total ultimate moment resistances of beams at a column-beam joint must be at least 1.2 times lower than the sum of ultimate moment resistances of columns at the same joint. This design approach facilitates beams to yield before the columns reach their ultimate strength point. Figure 14 shows structural damages related to column-beam joint failures.

**Figure 14.** Observed structural damages in Antakya/Hatay. RC building damage related to deficiencies in materials and workmanship. (a, b and c) Lack of stirrup tightening in the beam-column joint and corrosion in the rebar; and (d) lack of anchoring bars in the joint and corrosion.

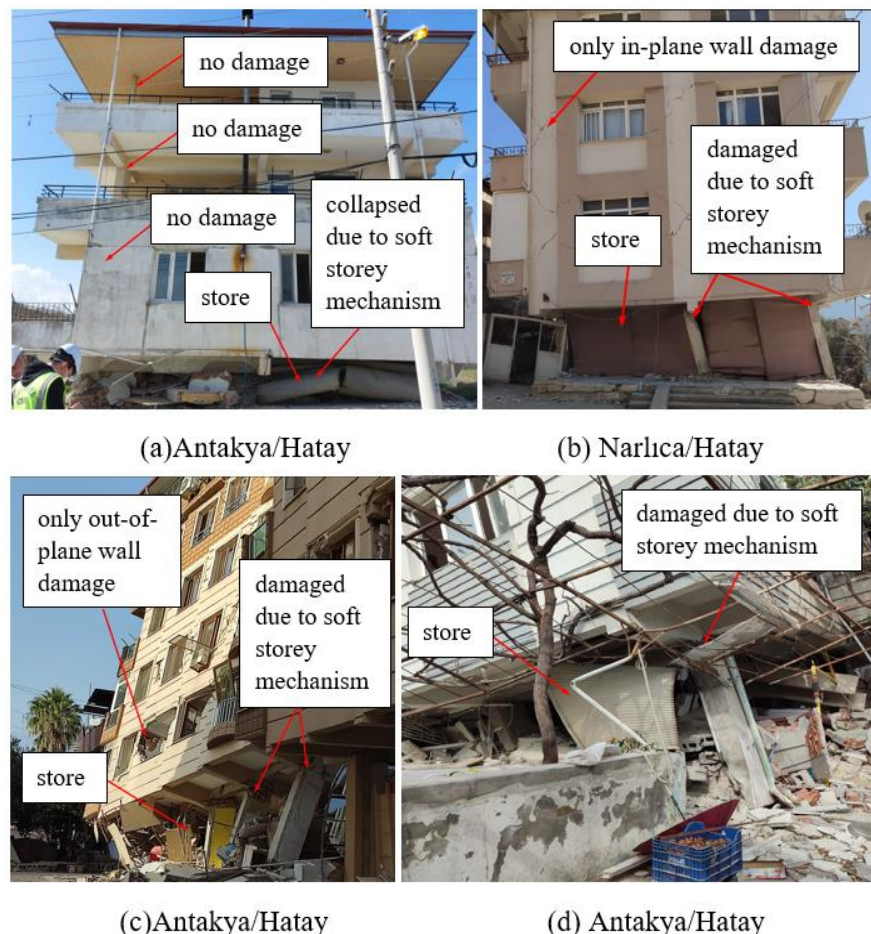
partition walls as they behave like a shear wall before getting damaged. The ground floor, where the partition walls are removed, deforms more than the above floors after such an incorrect application. The increase of the ground floor height is another factor causing soft-story mechanisms. Floor stiffness is reduced by increasing its height. During an earthquake, large displacements and thus extremely large second-order moments happen on this floor, which leads to a total collapse of the building on the top of this floor. For preventing soft story damage in buildings, ground floor drift should be limited by using RC shear walls or/and increasing column sizes. The collapses related to a soft story mechanism during the earthquakes are depicted in Figure 15.

**Figure 15.** Observed structural damages in the earthquake region. RC building damage related to the soft-story mechanism. (a) Building, located in Antakya / Hatay, collapsed on the ground floor with no damage to the upper floors; (b) Building's ground floor, located in Narlıca / Hatay, was heavily damaged, yet the upper floors had only in-plane wall damage; (c) In Antakya / Hatay, the ground floor of the building was heavily damaged, while the upper floors only suffered out-of-plane damage; and (d) The ground floor of the building, located in Antakya / Hatay, was severely damaged, while only the walls were damaged on the upper floors.

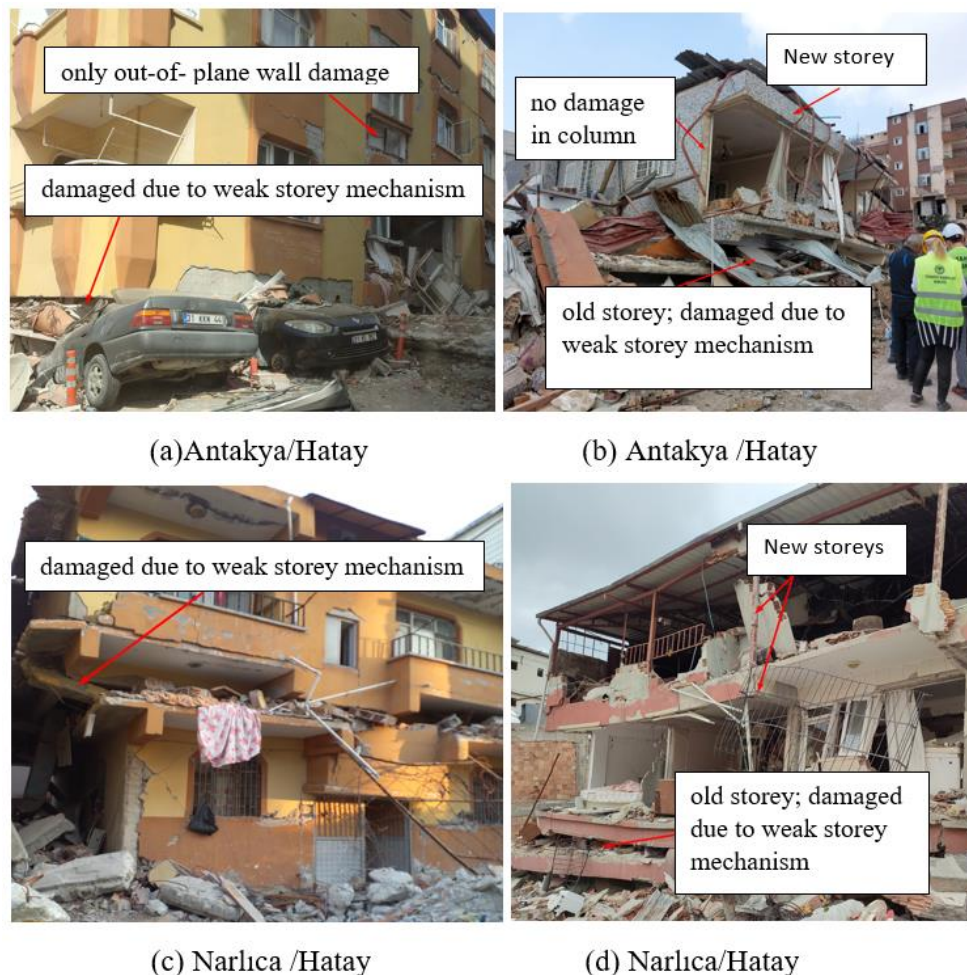
When the upper floors went up in old Turkish buildings, the dimensions of the lateral resistant elements (columns or curtain walls) decreased. Shear walls were sometimes used on only lower floors. The remaining floors of the building were completed with columns. Mezzanine floors can sometimes be removed by building owners to create larger spaces. The design of earthquake-resistant buildings is incompatible with such an approach. Due to excessive earthquake displacement demands, a floor with reduced stiffness may collapse. Also, from the site investigations of slum areas, it was observed that a constructed building was one-storey at first, but in subsequent years, two or more storeys were added to that building with higher strength

concrete, higher yielding strength of steel and larger column cross sections than the existing ground floor. Such incorrect applications lead to a weak storey on the ground floor. TBEC (2019) and TEC (2007) recommend that the effective shear area of the  $i^{\text{th}}$  storey to the effective shear area of the  $(i+1)^{\text{th}}$  story shall not be less than 0.80 in each of the orthogonal seismic directions for avoiding weak storey mechanisms in buildings. Some examples of weak storeys observed in the earthquake site are given in Figure 16. One of common observed construction misapplication in Hatay city (given in Figure 16b-d) was adding stories to old and weak ground floor. This can easily violate the ratio of 0.8 given by the latest code TBEC (2019).

**Figure 16.** Observed structural damages in the earthquake region. RC building damage related to the weak storey mechanism. **(a)** Building, located in Antakya/Hatay, collapsed on the ground floor, while the upper floors had only wall damage; **(b)** Building, located in Antakya/Hatay, collapsed on the ground floor, yet the upper floor had no damage in beam-column joints; **(c)** Building, located in Narlıca/Hatay, collapsed on the second floor; and **(d)** Building, located in Narlıca/Hatay, collapsed on the first and second floors.

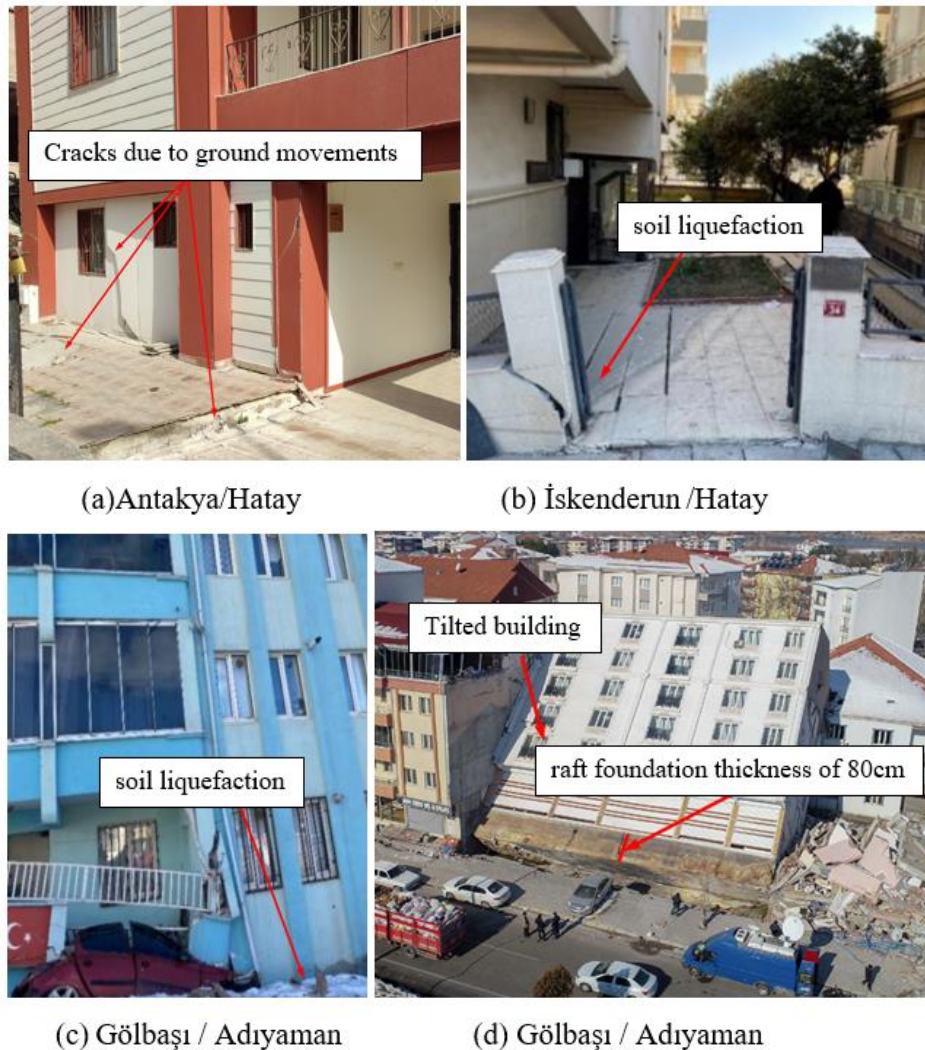
Because of seismic soil liquefaction initiation in the regions of Adıyaman-Gölbaşı, Hatay-İskenderun and Hatay-Antakya, the bearing capacity failures, and excessive settlements in the foundation of many residential buildings were observed (Figure 17). The size of the foundation settlements in the earthquake was observed to

vary from a couple of cm and up to 80cm (Cetin et al., 2023). As well as 30cm of differential settlements, from 5 to 10 degrees rotation has been also observed in buildings. Figure 17d shows a severe example of liquefaction-induced bearing capacity failure-the toppling of an apartment (which had a raft foundation thickness of 80cm) in Adıyaman-Gölbaşı.

**Figure 17.** The foundation failure in (a) Antakya-Hatay, (b) İskenderun-Hatay (Cetin et al., 2023)), (c) Gölbaşı-Adıyaman (Cetin et al., 2023)) and (d) Gölbaşı-Adıyaman (adapted from (Bilgin, 2023; Cetin et al., 2023)).

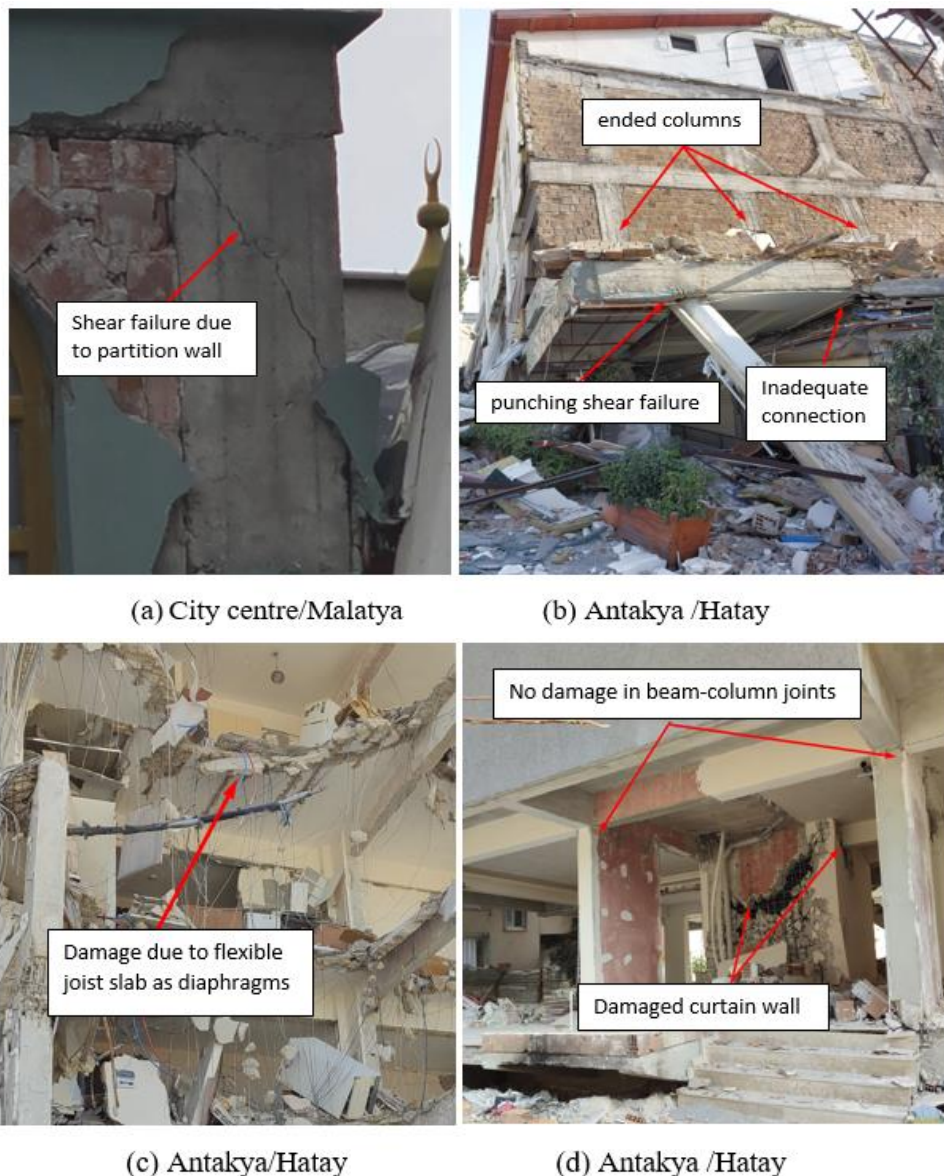
- A rigid partition wall between column and window lead to shear failure in the column (Figure 18a).
- The columns of upper floors did not end in the ground (Figure 18b). They were hanging over first floor. The column on the

ground floor failed by punching through the slab. From site observations, the author think that the above three floors were added to a single storey later without getting engineering help.

- Damage related to flexible joist slabs as a diaphragm was observed in a newly constructed multi-storey building (Figure 18c).

- Most of the buildings with a shear wall from bottom to top did not get severely damaged based on the buildings observed in the region. In these buildings, there was little or no damage to the beam-column joints (Figure 18d). This proved the impotence of shear wall construction in earthquake-prone regions.

**Figure 18.** Other types of structural damage observed on the site. (a) Shear failure in the column due to partition wall in City centre/Hatay; (b) deficiencies in construction and material in Antakya/Hatay; (c) damage due to flexible joist slab as diaphragm; (d) shear wall damage with no damage in the beam-column joint.

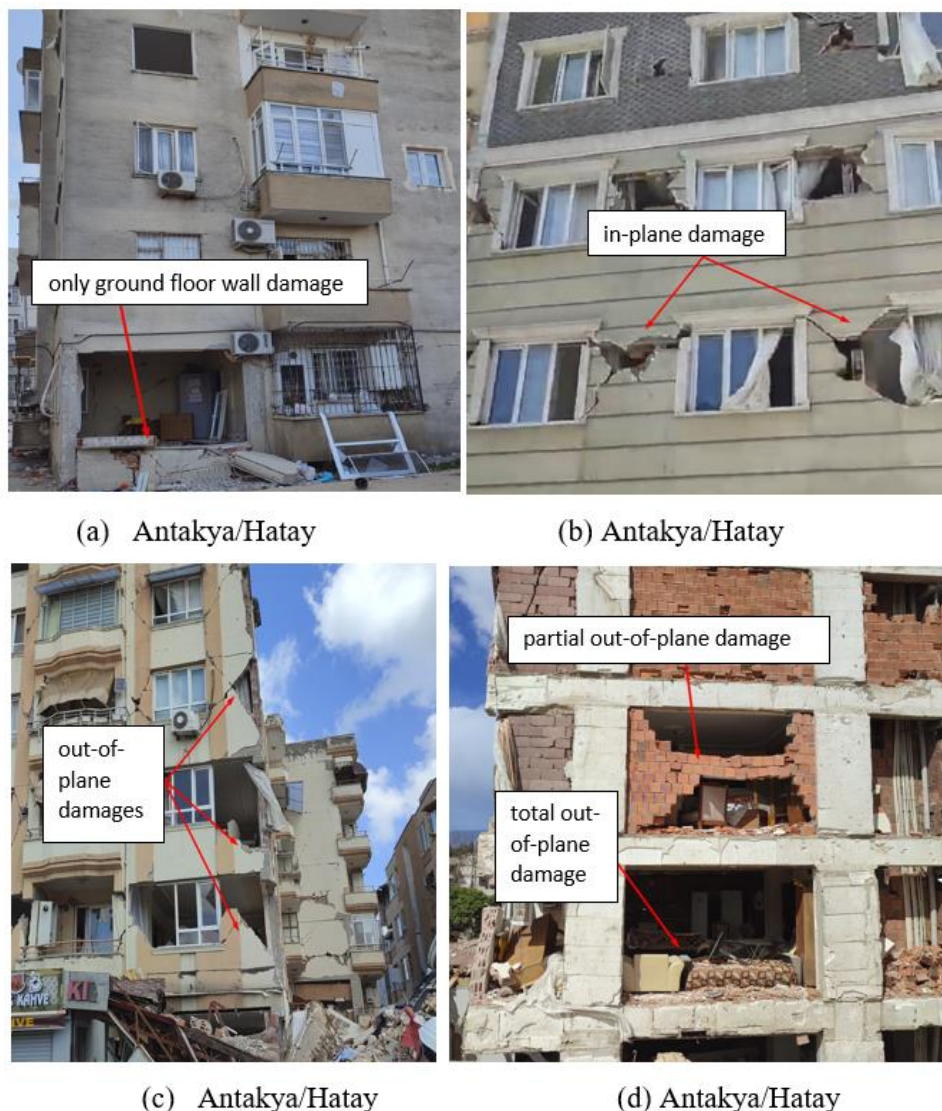
Observations in the field presented different types of infill damage. There is a complexity between in-plane and out-of-plane interactions and such complexity is fully dependent on load-transferring mechanisms in reinforced concrete elements interacting with infill walls. As a result of being subjected to the highest in-plane demand in infilled reinforced concrete buildings, ground floor walls are first expected to break (Figure 19a). Examples of shear cracks in the plane of the walls are given in Figure 19b.

**Figure 19** Figure 19c-d display examples of the total and partial out-of-plane failure mechanisms. Most wall damages observed from the site were out-of-plane due to the complexity of earthquakes (Mw7.7 and Mw7.6) which hit the region.

**Figure 19.** Infill wall damage observed in Antakya/Hatay
