Using AURAP Method in Determination of Building Earthquake Risk

Hüseyin BAYRAKTAR^{a,*},

^a Department of Building Drafting, Kaynaşlı Vocational School, Düzce University, Düzce, TURKEY

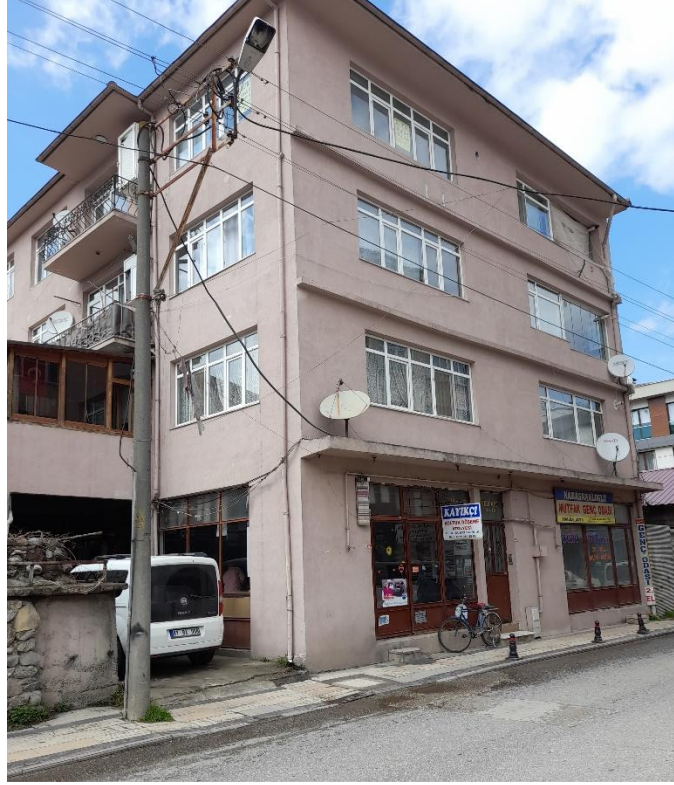
5-storey (basement+4) reinforced concrete building (Figure 3) located in Burhaniye Neighborhood of the center of Düzce was examined by AURAP method and its earthquake risk performance was determined. The building was constructed in 1979 and it was determined on site that only the basement and ground floor were retrofitted in 2001 after November 12, 1999. However, the retrofitting project of the building could not be found. A detailed retrofitting project is recommended.

Figure 3. View of the examined building from the road front

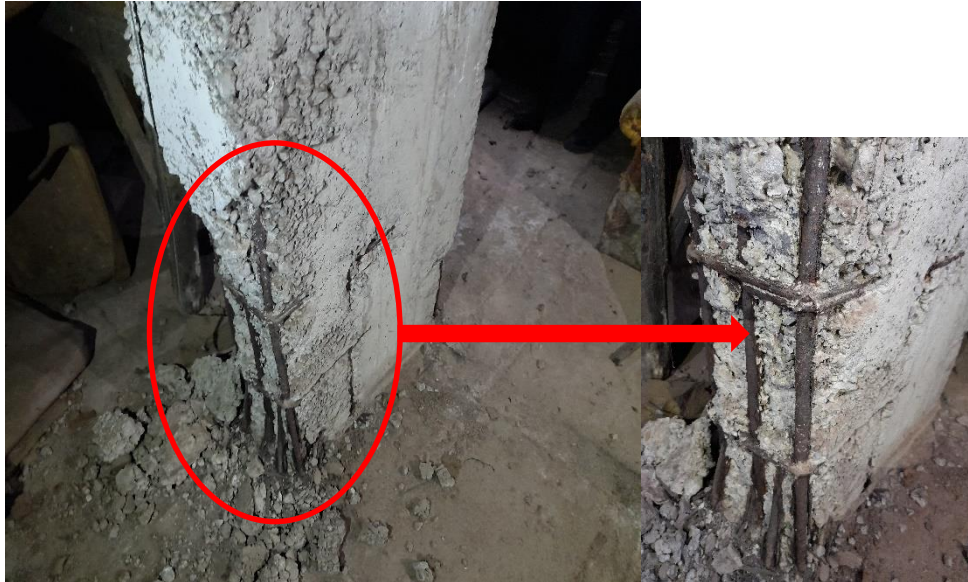
When the basement of the building was examined, it was seen that some of the columns were shelled and corroded reinforcements were revealed. It was observed that there was no tightening in the column, and the stirrup hooks wrapped the longitudinal reinforcement by turning 90 degrees. Additionally, it is considered that aggregate gradation in concrete is not appropriate (Figure 4).

Figure 4. Crust loss in the column and corrosion in the reinforcement

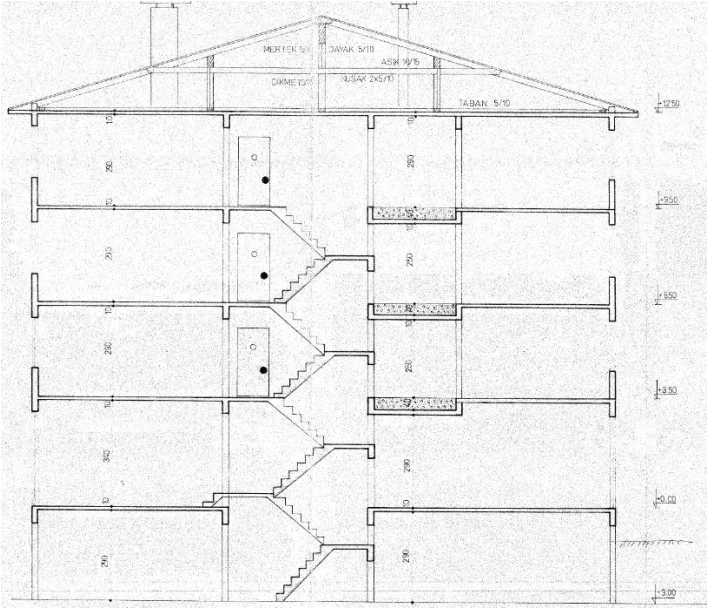
Figure 5. 5-storey building section

The building section taken from the archive file of the examined building is given in Figure 5. When the building section is examined, the ground floor is 3.40 m high and the other floors, including the basement, are 2.90 m high. Leaving the ground floor higher is planned as a workplace. The floors are beamed floors and low floors are used in wet areas. Low flooring will have a negative impact on load transfer during an earthquake, thus creating a defect in the building. The roof was made as a wooden hipped roof.

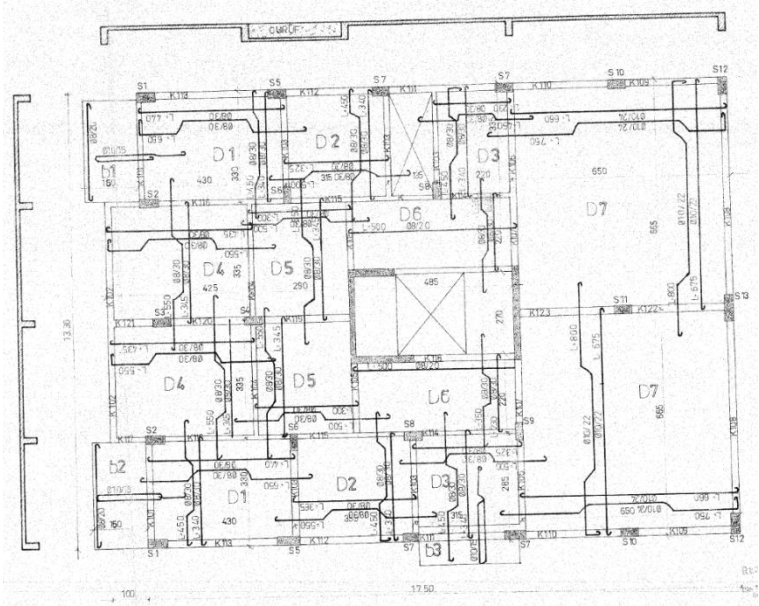
Figure 6. Formwork plan of the building under review

Figure 6 shows the formwork plan taken from the archive file of the building. When the formwork plan is examined, it is seen that flat and pleated irons are used in both directions in the slabs, and the tucked

irons pass to the other slab. It is evaluated that the diameter and distribution of the reinforcement is done regularly.

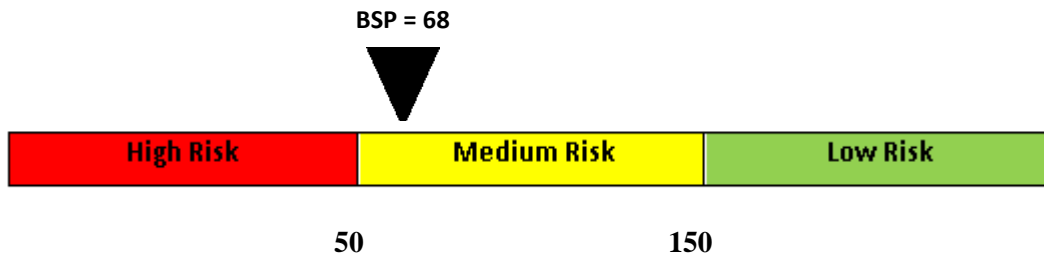
The building inspection form used in the AURAP method was filled out by obtaining the necessary information from both the outside and the inside of the building. The ground floor, which was selected as the critical floor, was surveyed and compared with the projects in the archive. The possible risk score of the building was found by taking general information about the structure, carrier system features, material information, irregularities, defects and ground information. Building Result Score (BRS); As a result of the multiplication of Relative Building Score (RBS), Structural Safety Factor (SSF) and Continuous Frame Score (CFS), the Building Result Score (BRS) was found to be 68. 68 points correspond to the medium risk level on the risk level scale (Figure 7).

Figure 7. Medium risk level determined according to Building Result Score (BSP)

In the AURAP method, if a building is found to be at medium risk level, it is recommended that "medium risk level buildings should be examined with a more detailed seismic performance evaluation method, although not as urgently as high risk buildings."
