An Examination of Serious Runway Incursion Incidents Resulting from Air Traffic Control Services

RESEARCH ARTICLE

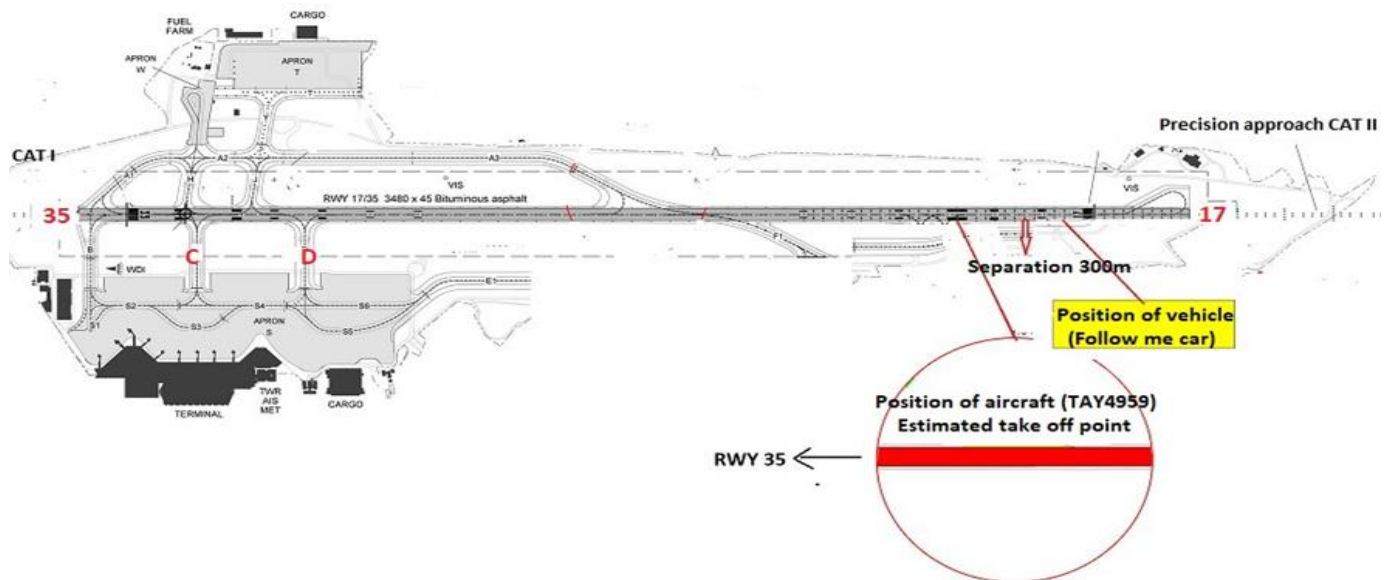
Figure 1. TAY4959, Path followed for Runway 35

On the day of the incident, follow-me vehicle made a call on the handheld radio and asked for permission from the controller to enter Runway 35 from Taxiway ‘B’ in order for inspection. In the meantime, the controller continued to work under a heavy workload because the frequency clearance for taxi, taxiing and take off were given on the same frequency due to frequency merging. 10 minutes later than the vehicle had entered runway 35 for routine controls, TAY4959 asked for clearance for taxi on runway 35 holding point and an intersection departure from taxiway D and this request was approved by the controller, and TAY4959 was given clearance to take off from Runway 35 at Intersection D. When TAY4959 was given clearance to take off from the D taxiway intersection, the follow-me vehicle had reached the end of Runway 35 and started to turn around to head south and inspect the remaining part of the runway. 15 seconds after TAY4959 had started to take off run, the driver of the follow-me vehicle informed the controller through handheld radio that he was seeing bright lights coming towards him. While the controller and the driver of the follow-me vehicle were communicating, TAY4959 took of moments before reaching the follow-me vehicle as it can be seen in Figure 1. Due to the absence of stopbar lights during the incident also reduced the situational awareness of the controller, pilot and the driver of the vehicle (GPJA, 2021).

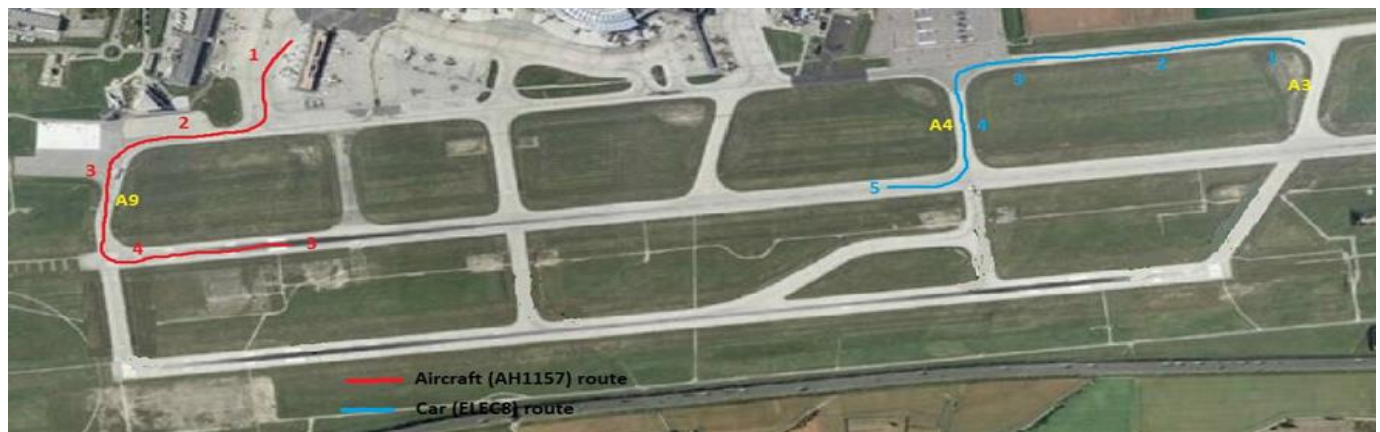
Figure 2. Lyon Saint-Exupéry Airport 17R/35L Runway and Taxiways

As the ground controller granted taxi clearance to AH1157 to Taxiway A9 CAT III holding point for Runway 35L, the ELEC8 snowplows reported that they would be clearing snow from Taxiway A4 and then intended to clear the A4 and runway intersection. When AH1157 was at A9 holding point on tower frequency, “ELEC8” contacted ground controller and stated that they would continue clearing snow from A4 taxiway and its intersection with the runway. The ground controller instructed ELEC8 to enter Runway 35L and authorized them to clear the area marked as blue zone number 5 in Figure 2. Thirty seconds after the vehicle group led by ELEC8 entered the runway, the tower controller instructed AH1157 to begin takeoff while holding at red point 4 on the runway. Five seconds after AH1157 started its takeoff roll, the tower controller noticed the vehicles at blue point 5 on the runway and urgently instructed AH1157 to abort the takeoff (BEA, 2022).

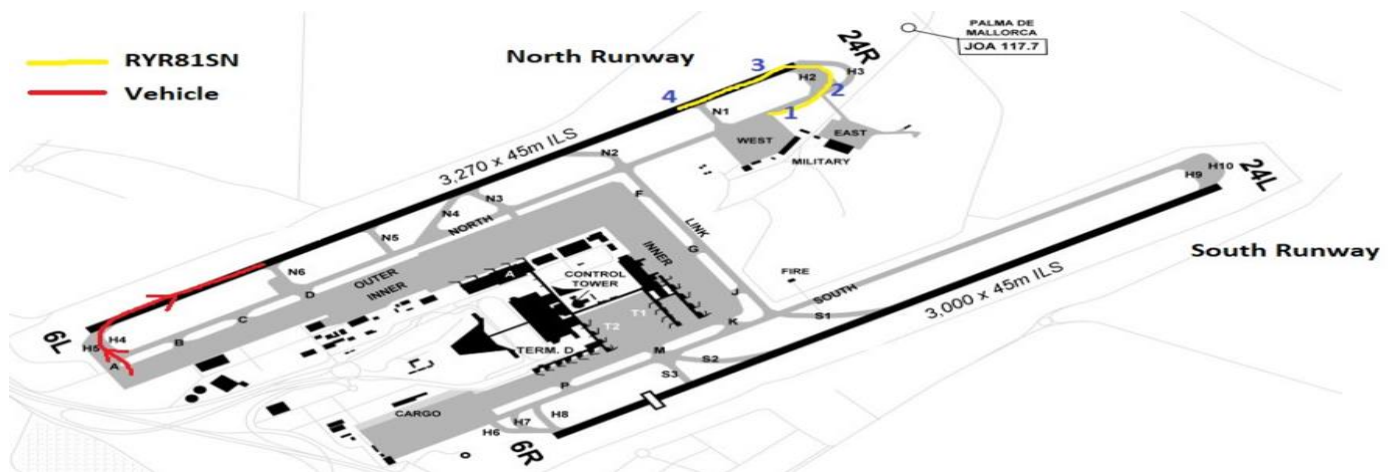
Figure 3. Palma de Mallorca Airport 06R-24L Runway and Taxiway

instead of the northern runway. Despite "clear" instruction of the controller, the follow-me vehicle informed the controller that the stopbar lights were on and needed to be turned off. Nevertheless, the controller stated that follow-me vehicle could ignore these lights and repeated the clearance to enter the runway. In the meantime, RYR81SN requested takeoff clearance, and the controller issued a takeoff clearance from runway 24R while the traffic was at position 2. Meanwhile, the Follow-me vehicle driver, who was listening to the frequency, called the tower to inform them that the vehicle was still on the runway. The controller issued an immediate stop instruction to the traffic with the callsign RYR81SN while it was at position 3. Although RYR81SN had reached takeoff speed, the aircraft responded to the call of the controller and managed to stop at position 4 (CIAIAC, 2020).

- Using north/south in order to describe the runway caused an error in the way the vehicle driver referred to the runway he intended to access. The locational error made by the vehicle driver, requesting access to a runway that couldn't be reached from H5 during their initial communication at H5, went unnoticed by the controller for this reason.

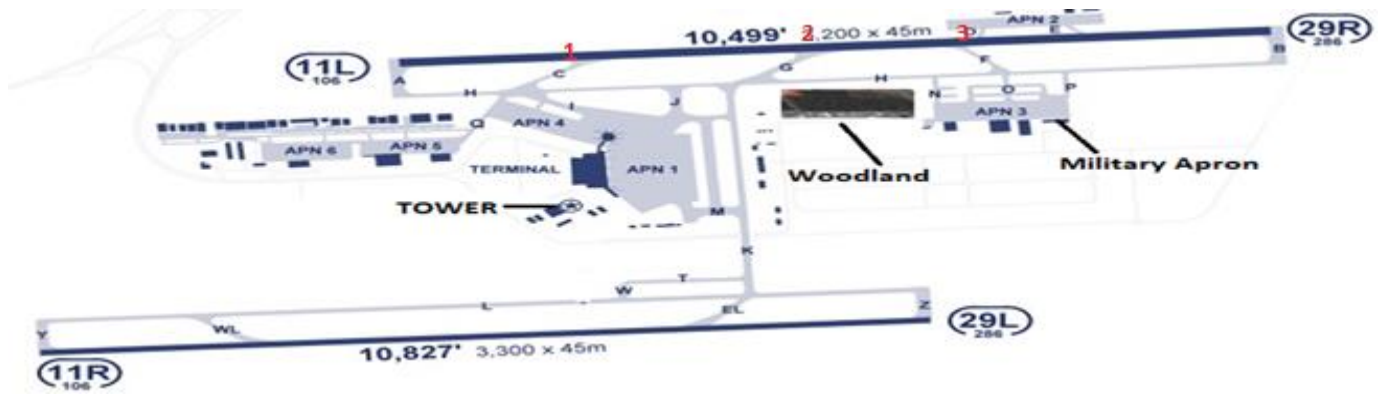
Figure 4. Brasilia Airport 11L/29R Runway and taxiways

On April 10, 2018, an incident occurred between a GOL Aviation B738 (callsign GOL2311) that had started its takeoff roll at night from Brasilia, and a Brazilian Air Force E110 (callsign FAB2345) that had just landed on the same runway and had not yet vacated it. After landing, when the FAB2345 reached taxi speed and, was at position 1 (Figure 4), indicated its intention to vacate the runway via taxiway C. However, the controller, seeing that the FAB2345 had passed taxiway C, instructed the FAB2345 traffic to vacate the runway via taxiway G and to switch to the ground control frequency. However, as it can be seen in figure 4, due to the visual similarity of the names on the signage of G and C taxiways, and the faded condition of signage of taxiway G, the FAB2345 mistook the taxiway G thinking that it is taxiway C. Consequently, at position 2, it continued to position 3 (F taxiway) thinking that the next runway exit was taxiway G and switched to ground control frequency. Since tower controller did not have a comprehensive runway view between G and F taxiways due to the woodland shown in figure 4, the controller granted takeoff clearance to GOL2311 when FAB2345 was at position 3 believing that FAB2345 had exited the runway via taxiway G (CENIPA, 2018).

- The working position of the tower controller and external environmental conditions prevented the controller from seeing the aircraft with the FAB2345 callsign, and the ground controller was unable to determine the position of FAB2345 during their initial contact on the frequency. The lack of teamwork between the tower and ground controllers, and the absence of a third controller monitoring them, were among the latent factors contributing to the incident.

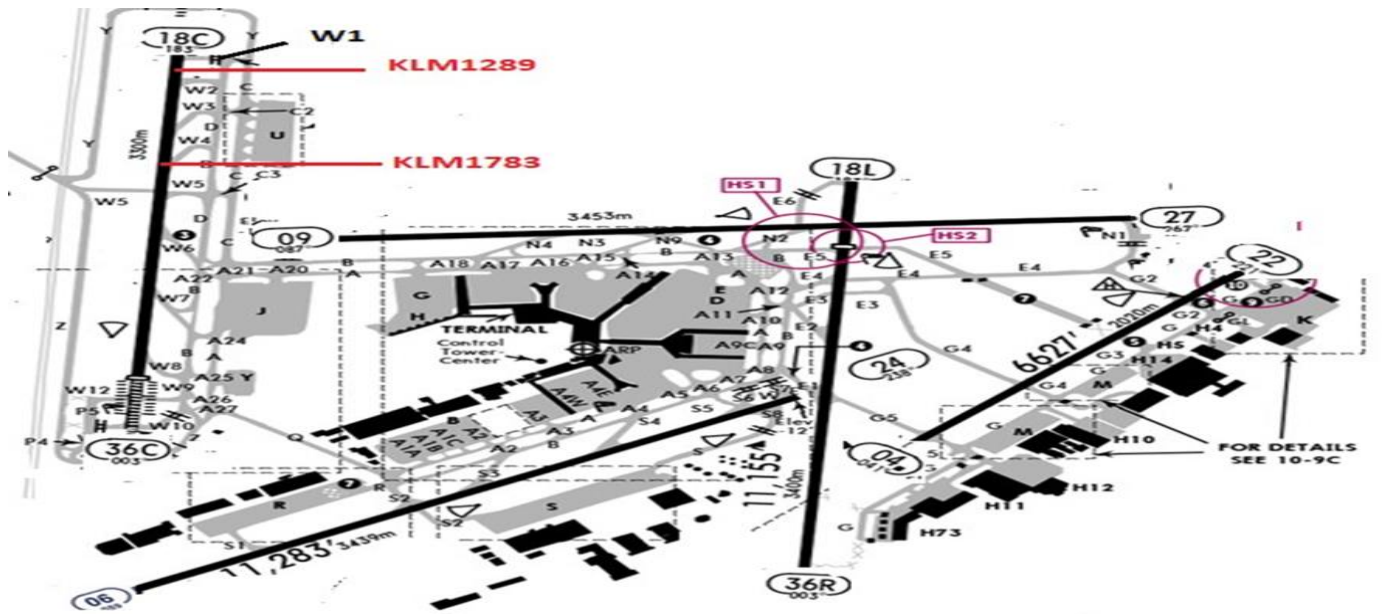
Figure 5. Amsterdam Schiphol Airport 18C/36C Runway and Taxiways

During the incident, while the runway 22 was being used both for takeoff and for landing, the runways 09 and 18C were just being used for takeoffs. Tower controller was providing traffic services for three active runways: 09, 18C and 22. As shown in figure 5, the incident occurred in 18C runway for which the controller provide takeoffs and landing services. At the time of the incident, KLM1289 reached 18C runway start point via W1 taxiway and KLM1783 reached intersection departure point via W4 taxiway. The tower controller had granted takeoff clearance to KLM1783 before the two other aircraft ready for departure, but since KLM1783 was moving slowly while turning onto the W4 intersection, it had not yet begun its takeoff roll. The tower controller, who forgot that he had already granted takeoff clearance to KLM1783, gave takeoff clearance to KLM1289 from the 18C runway heading about 2 minutes later. Upon hearing that KLM1289 was cleared for takeoff, KLM1783, which had passed the W4 holding point, stopped just before entering the 18C runway. KLM1783, which was stopped at the runway intersection, informed the tower controller that they were "on the runway." However, the tower controller, confusing the traffic, issued a takeoff clearance to KLM1783 from the W4 intersection. Hearing that KLM1289 was also cleared for takeoff from the 18C runway heading at the same time, KLM1783 did not proceed with the takeoff clearance and maintained its position. The pilots of KLM1783 could not see the runway threshold 18C due to the angle of the W4 intersection taxiway. Thirty minutes before the incident, two separate events involving the same tower controller were recorded. The first incident involved a light aircraft with VFR clearance that posed a brief risk to traffic taking off from the 18C runway. Then, 20 minutes before the incident, the controller granted takeoff clearance to one aircraft from the 18C runway but also permitted another aircraft to taxi to the 18C runway via the W4 intersection (DSB, 2018).

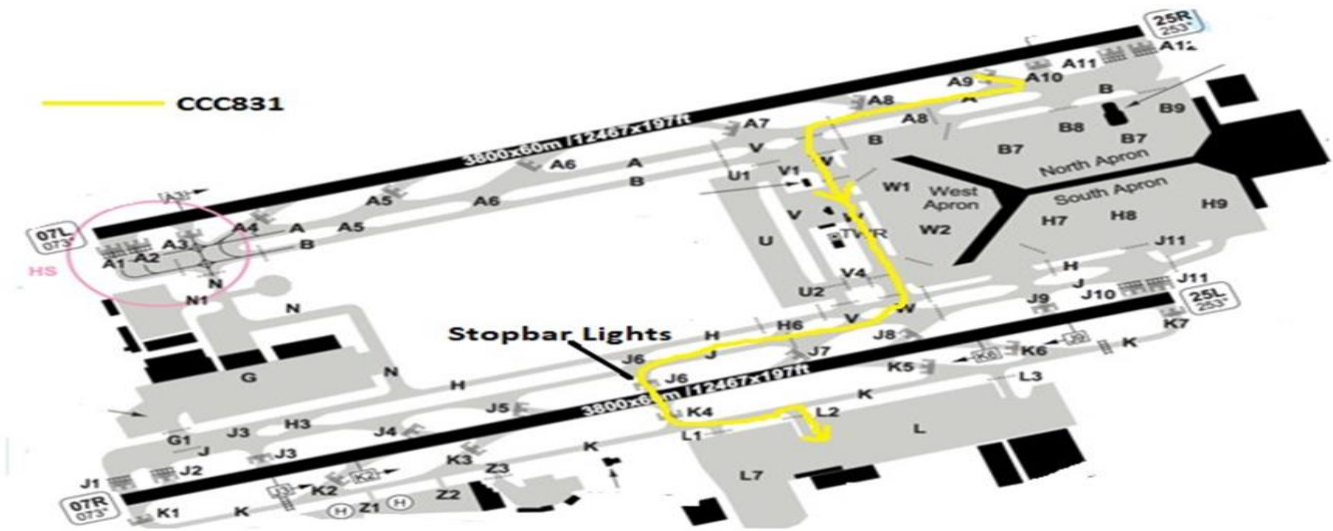
Figure 6. Hong Kong International Airport 07L/25R and 07R/25L Runways and Taxiways

On September 22, 2017, at Hong Kong International Airport, a runway incursion occurred when an Air Cargo Global aircraft (call sign CCC831), a B744 type, crossed the runway from J6 Taxiway just as a Hong Kong Airlines A333 aircraft (call sign CRK236) began its takeoff roll on Runway 07R. The pilots of CRK236 immediately aborted the takeoff upon noticing another aircraft crossing the runway. At the time of the incident, the controller, who was an instructor at the ground control position, was providing training to a trainee controller. Throughout the roughly one-hour period of ground control operations, the instructor controller occasionally took over the position when traffic increased or the trainee controller struggled, before handing it back to the trainee. After the CCC831 traffic, as indicated in Figure 6, landed on runway 07L, it exited the runway and switched to ground control frequency, where it was instructed by the ground controller to taxi via A, W, J, and J6 holding point. When CCC831 arrived at J6 taxiway, the ground controller, due to not fully understanding the position of the aircraft, did not transfer CCC831 to the frequency of the tower controller for the runway crossing and instead instructed the aircraft to taxi via K and L2 taxiways to its parking stand. At the same time, tower controller, unaware that CCC831 was crossing runway 07R, granted takeoff clearance to CRK236. As CRK236 began its takeoff roll and reached the vicinity of taxiway K2, crossing traffic was spotted the and the takeoff was immediately aborted (AAIA, 2021).

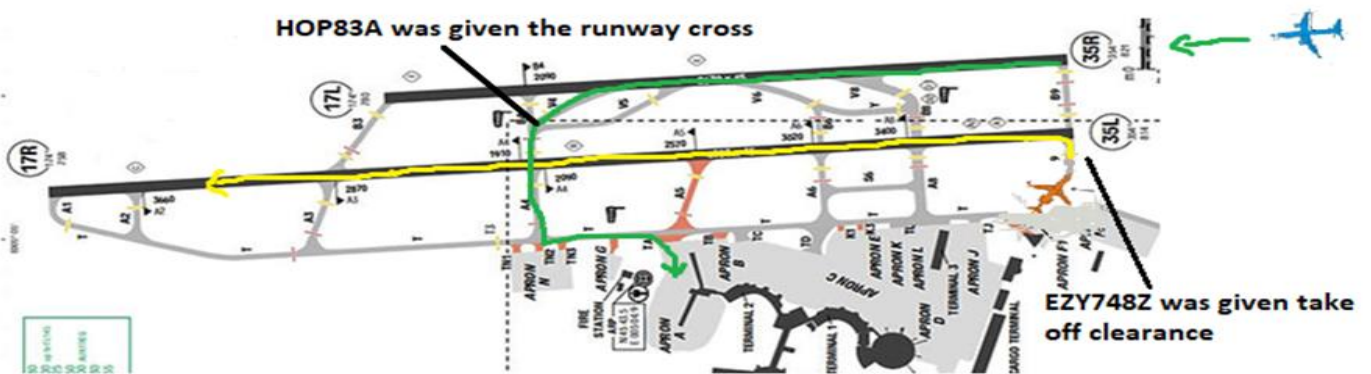
Figure 7. Lyon Saint-Exupéry Airport 17L/35R and 17R/35L Runways and Taxiways

On March 17, 2017, at Lyon Saint-Exupéry Airport, after landing on runway 35R, the CRJ700 aircraft of Air France Hop (callsign HOP83A) was cleared to cross runway 35L as shown in Figure 7. At the same time, an A319 aircraft of EasyJet (callsign EZY748Z) was cleared for takeoff from runway 35L. During the incident, the tower controller gave the takeoff clearance to EZY748Z from runway 35L in English, as shown at the blue point 2 in Figure 7. Thirty seconds before this, the controller also cleared HOP83A, located at the red point 3, to cross runway 35L in French. As EZY748Z began its takeoff roll from runway 35L, HOP83A, which was crossing the runway, noticed the departing traffic and managed to make an emergency stop at the red point 4 (BEA, 2020).

- Failure to control the runway by the tower controller and his low situational awareness
- Heavy air traffic led the tower controller to issue instructions quickly and prematurely, and the absence of another controller to observe or share the workload contributed to the occurrence of the serious incident.

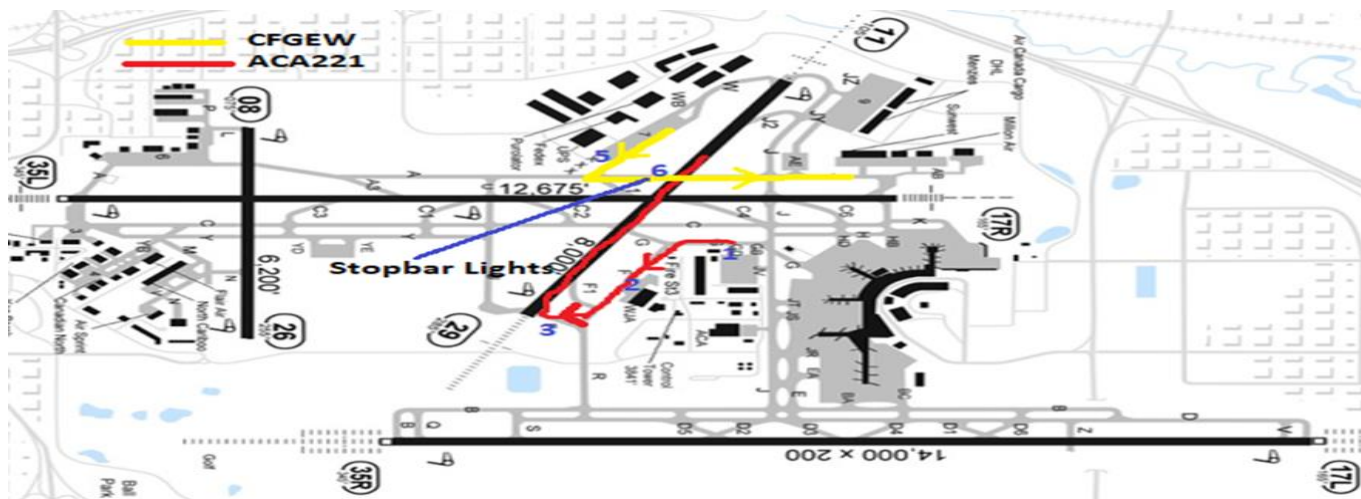
Figure 8. Calgary Airport Runways and Taxiways

On December 2, 2016, at Calgary Airport, as shown in Figure 8, an incident occurred when a Fairchild-Swearingen Airlines SA226 (callsign CFGEW) crossed runway 29 from the midpoint, coinciding with an encounter on the runway with an A320 Air Canada aircraft (callsign ACA221) that had just begun its takeoff run.

At the time of the incident, runway 29 was in use, but the runways had changed several times throughout the day due to wind conditions. As seen in Figure 8, the tower controller gave ACA221 clearance for takeoff from position 3 (indicated in red) while, simultaneously, the ground controller granted CFGEW clearance to cross the runway. The urgency of the ground controller in clearing the crossing stemmed from the desire to quickly separate CFGEW from another CRJ900 traffic at the intersection of taxiways A and J. The pilots did not have the opportunity to intervene in the situation because ACA221 was on the tower frequency and CFGEW was on the ground control frequency (TSB, 2018).

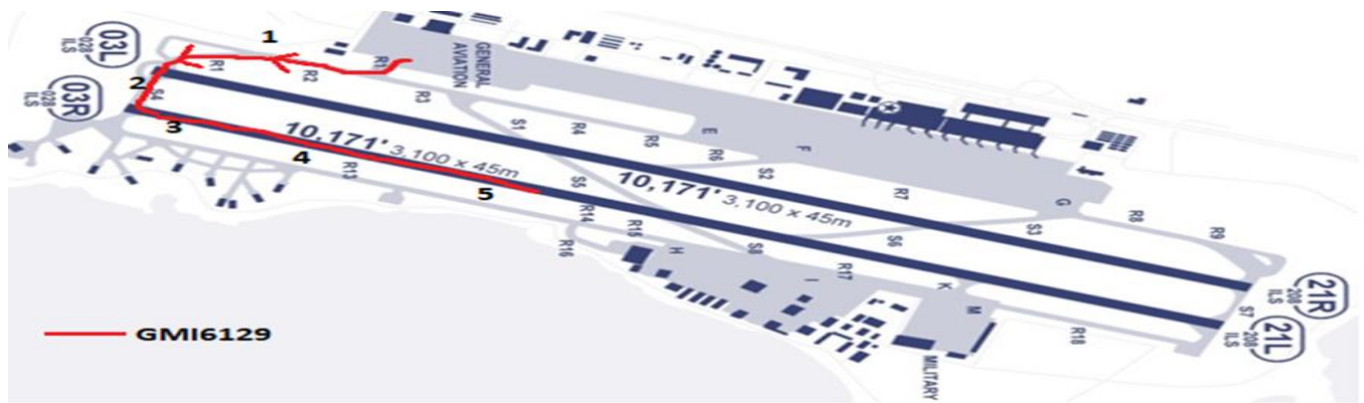
Figure 9. 03L/21R and 03R/21L Runway and Taxiways

On January 7, 2016, at Gran Canaria Airport, a Germania Airlines B737 (call sign GMI6129) began its takeoff from runway 03R with the permission of the tower controller, but the takeoff was canceled by the same controller upon noticing an object on the runway. During the incident, while at position 1, as shown in Figure 9, GMI6129 was instructed by the tower controller to cross runway 03L. When GMI6129 reached position 2, the crew reported that the stop bar lights were illuminated and maintained their position. Despite this, the tower controller granted GMI6129 clearance to enter the runway and take off. Although GMI6129 saw a vehicle on the runway immediately to its right after receiving the takeoff instruction, it continued the takeoff run, thinking the vehicle did not pose an obstacle. When GMI6129 reached position 4, the tower controller noticed another vehicle in the middle of the runway, canceled the take off of GMI6129 and GMI6129 was able to stop at position 5 after it had been instructed to cancel its take off. On the day of the incident, automatic ATIS (Automatic Terminal Information Service) broadcast continuously announced that 03R runway was closed due to construction (CIAIAC, 2016).

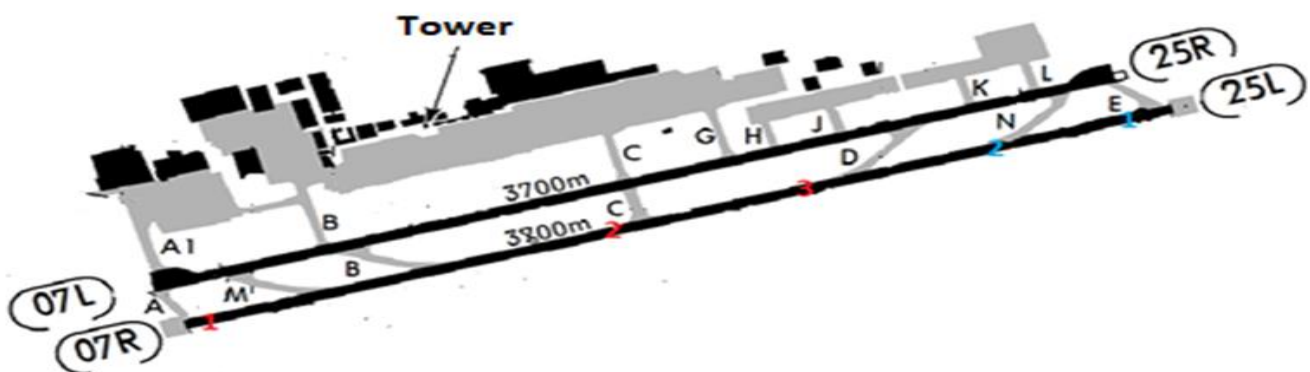
Figure 10. Addis Ababa airport 07L/25 R and 07R/25L Runway and Taxiways

The tower controller granted ET805 clearance for takeoff from runway 07R at the red position 1, and the aircraft began its takeoff roll. When the aircraft reached V1 (138 knots) and arrived at red position 2, the crew noticed a vehicle on the runway at blue point 2. They immediately applied brakes and managed to stop at red point 3. When ET805 stopped, it was

100 meters away from the vehicle. The sudden braking caused the brakes to overheat, resulting in the blowout of four tires, and ET805 had to be towed to the parking area by a tug (ECAA, 2014).

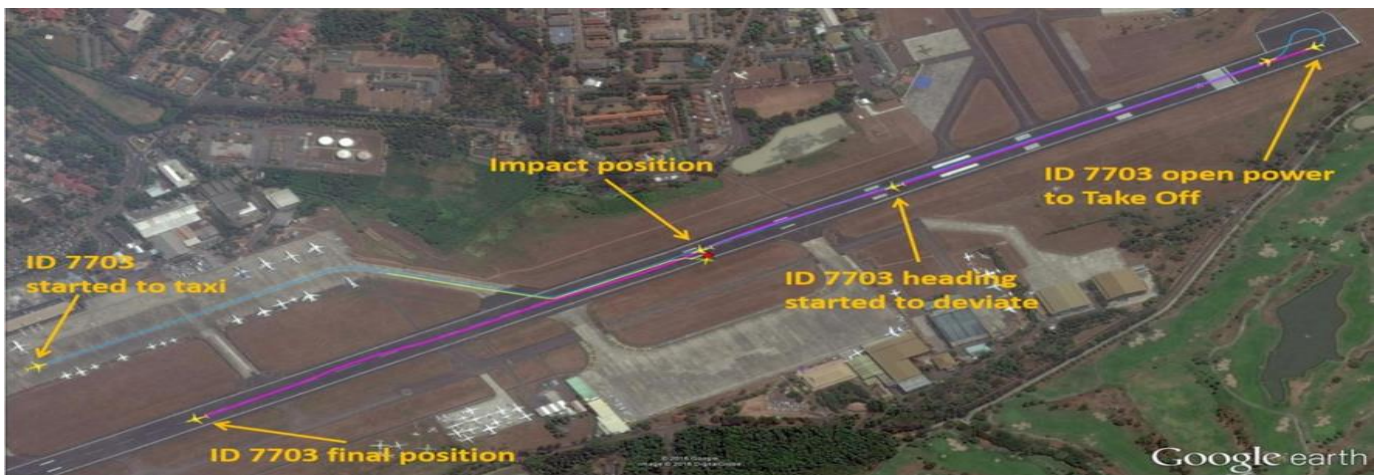
Figure 11. Jakarta Halim Airport 06/24 Runway and Taxiways (ANS, 2016)

After takeoff clearance was given to ID7703 on the tower frequency 118.6 MHz, as determined by the tower controller, permission was also granted by the assistant controller via handheld radio for the ATR 42 to be towed to the southern apron area (KNKT, 2016).

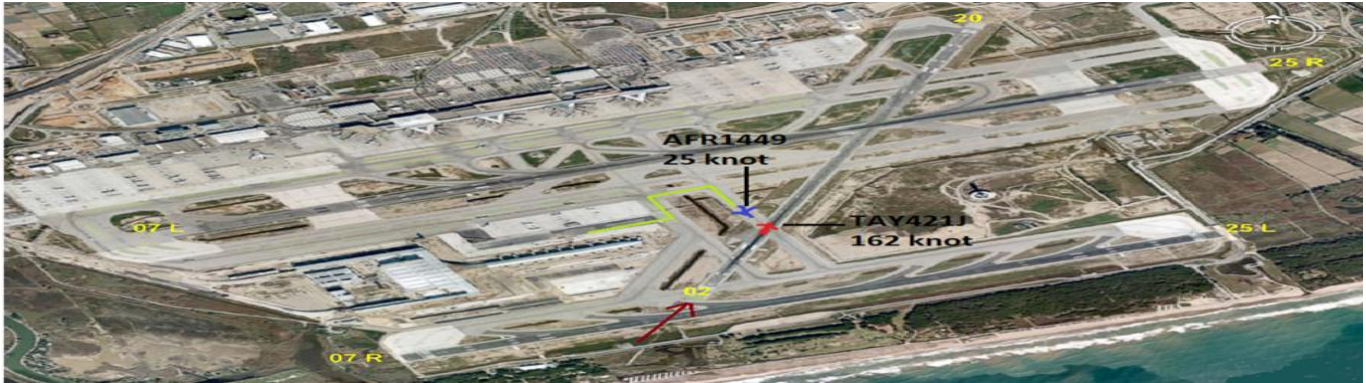
Figure 12. Barcelona El Prat Airport 07L/25R and 07R/25L Runway and Taxiways

ground controller instructed an A321 aircraft operated by Air France (call sign AFR1449) to cross runway 02 via taxiway D2 (as indicated in Figure 12). As shown in Figure 12, when the ground controller granted AFR1449 clearance to cross runway 02, the stopbar lights at taxiway D2 were illuminated. The pilot, noticing the stopbar lights were on, reported the situation to the ground controller, but the ground controller reiterated the clearance to cross. With the awareness created

by the stopbar lights, AFR1449, while monitoring its surroundings, reported to the ground controller that it was following traffic that was about to touch down on runway 02. Subsequently, the ground controller instructed AFR1449 to maintain its position. During the incident, TAY421J was on the tower control frequency while AFR1449 remained on the ground control frequency (CIAIAC, 2015).

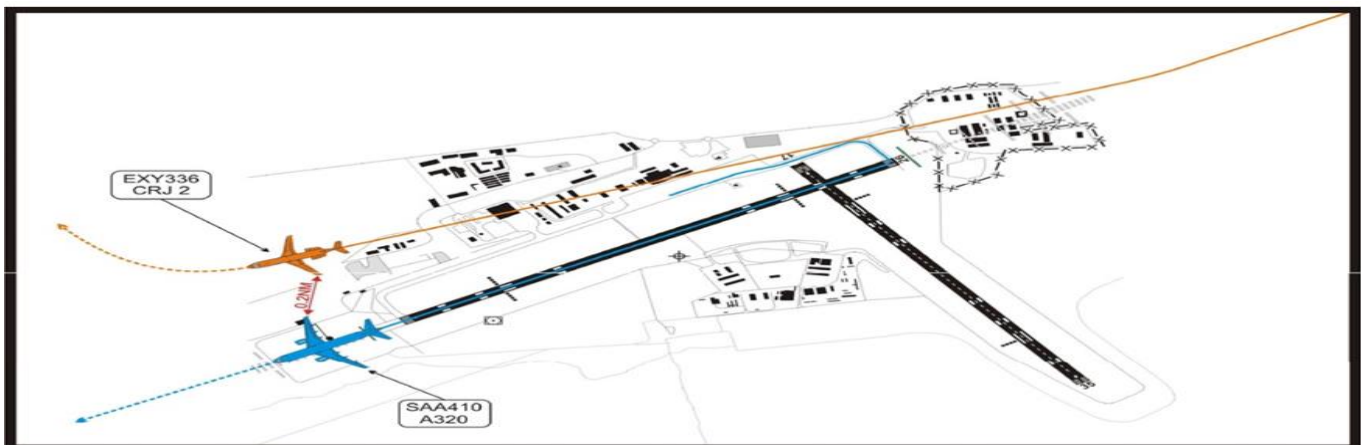
Figure 13. South Africa Port Elizabeth Airport 08/26 and 17/35 Runways and Taxiways (SACAA, 2014)

The incident occurred on July 10, 2014, at Port Elizabeth Airport in South Africa, during daylight conditions. As the South African Airways A320 (call sign SAA410) began its takeoff roll from runway 26, the Expressways CL600 aircraft (call sign EXY336), which was approaching runway 26 and was 1 NM from touchdown, decided to go around and executed a right maneuver to ensure its own separation, as indicated in Figure 13.

In addition to not having enough controller at the tower at the time of the incident, there was also a trainee controller on training. EXY336 was approaching Runway 26 visually due to the ILS system being controlled by the flight control aircraft. When SAA410 approached Runway 26, it indicated that it was ready for an immediate departure. Although EXY336, which the tower controller had previously contacted but forgotten, was 2 NM away from the touchdown point, the controller

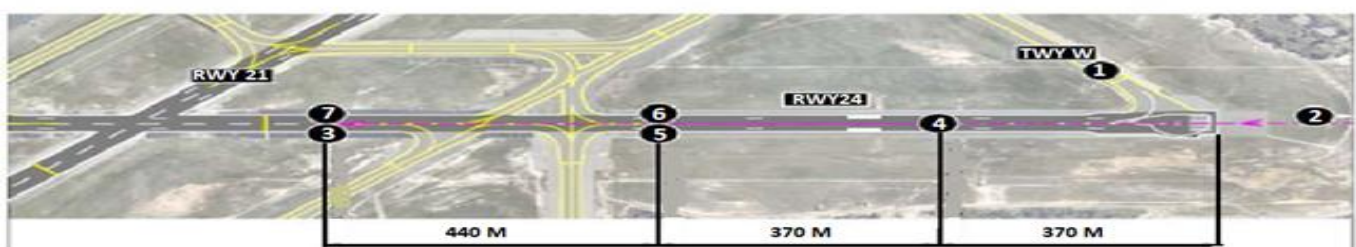
Figure 15. Australia Perth Airport 03/21 and 06/24 Runways and Taxiways (ATSB, 2015)

As shown in Figure 15, when QJE1921 landed on runway 24, approximately 370 meters from the runway threshold, the co-pilot noticed the flashing lights of a vehicle at position 3 on the runway and reported it to the captain. The captain initiated a go-around and, after touching down on the runway and moving approximately 370 meters without slowing down, the aircraft took off again from position 5. Meanwhile, the safety vehicle was positioned on the centerline of runway 24, approximately 1180 meters from the threshold, facing the opposite direction of the approaching QJE1921. The driver of the vehicle did not see the aircraft until it passed about 150 feet over the vehicle (ATSB, 2015).

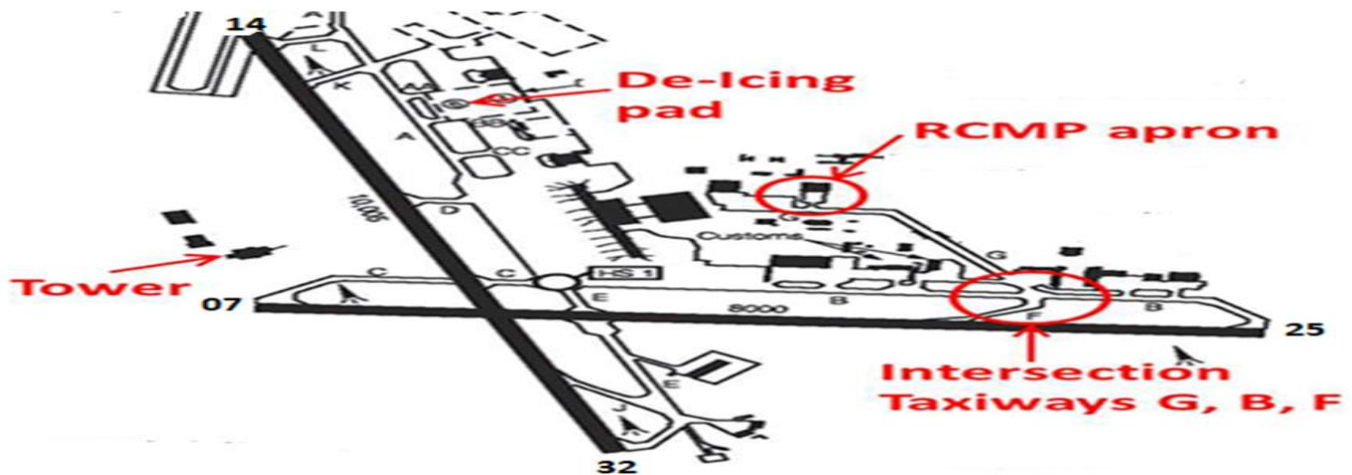
Figure 16. Ottawa Macdonald Airport 07/25 and 14/32 Runways and Taxiways

with the call sign CGFOX, taxiing from the police apron to the 07 runway holding point, crossed the center of the 14 runway as Dash 8 aircraft of JAZZ Aviation, with the call sign JZA988, was beginning its takeoff from the 14 runway, as shown in Figure 16.

As shown in Figure 16, after completing the de-icing process, JZA988 requested taxi clearance to runway 07. The ground controller advised JZA988 to take off from runway 14 due to the long taxi route and the need for more space on runway 07, and cleared the aircraft to taxi to the holding point of runway 14, which was accepted by the traffic. At the same time, the aircraft with the call sign CGFOX, requesting taxi clearance from the police apron, was cleared to taxi to the runway 07 threshold via taxiways G, B, and C. Since the ground controller did not enter the details of CGFOX into the ground radar, the traffic could not be observed on the radar. When the tower controller cleared JZA988 for takeoff from runway 14 and the aircraft began its departure, CGFOX, which was taxiing via taxiway C, started crossing runway 14. Because JZA988 was a relatively small aircraft with a capacity of 60 passengers, it lifted off early, and no adverse incidents occurred (TSB, 2013).

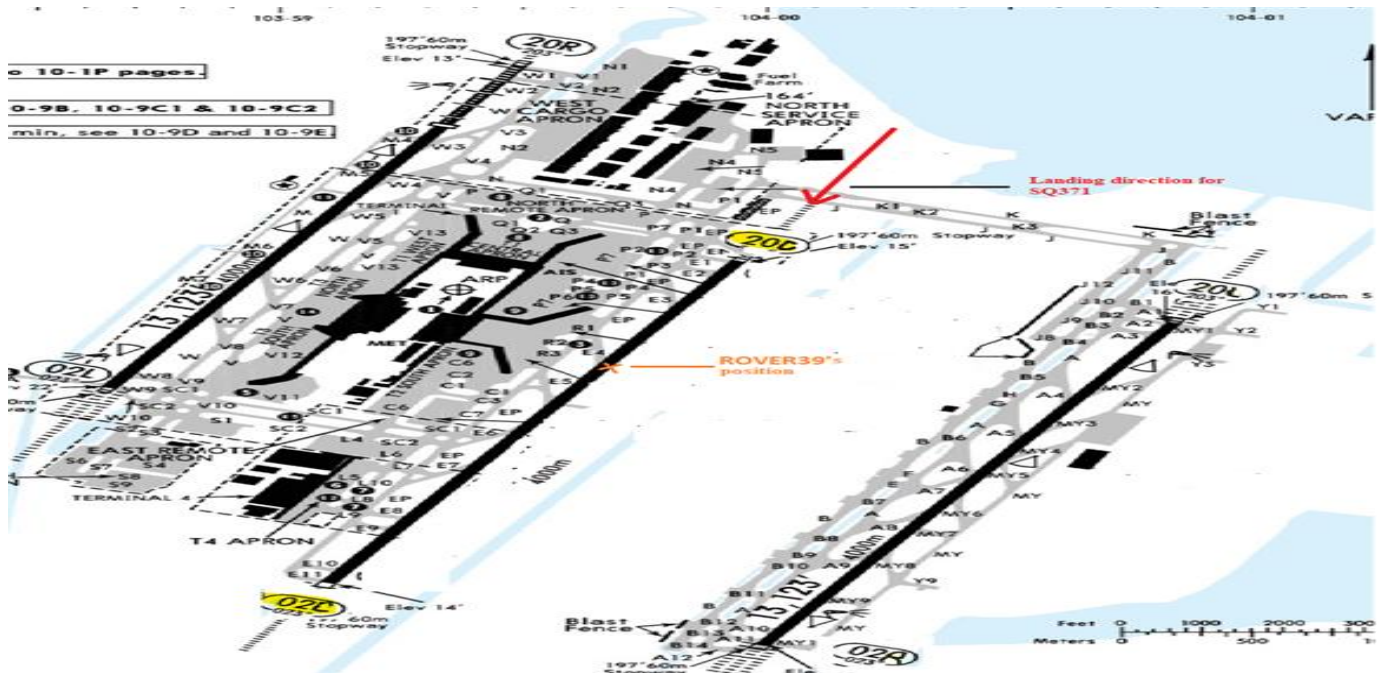
Figure 17. 02L/20R, 02R/20L Runways and Taxiways

clearance, the vehicle entered the runway. The stopbar lights, which should have been turned off when aircraft and vehicle

crossings were allowed, were illuminated at the time the vehicle entered the runway.

Eight seconds after ROVER39 had entered the runway, tower controller granted clearance for landing to SQ371. The tower controller did not visually scan the runway or check the ground radar before granting landing clearance. Additionally, the controllers had frequently turned off the audio alert feature of the ground radar due to the frequent false warnings it gave. After SQ371 landed, the pilots noticed the vehicle on the runway near the E4 taxiway, as shown in Figure 17. They manually applied the brakes and veered slightly to the right of the centerline, allowing the wing of the aircraft to pass over the vehicle. It was found out that the vehicle in question was operated by a runway maintenance company contracted by the airport operator, and at the time, it was being driven by a driver who did not have the proper authorization to use a handheld radio (AAIB, 2013).
