## Architectural Heritage After the February 6th Kahramanmaraş Earthquakes: Preliminary Observations on Historical Masonry Structures

Sedef KOCAKAPLAN SEZGIN<sup>1\*</sup>

, Özden SAYGILI<sup>2</sup>

<sup>1</sup> Bursa Technical University, Faculty of Engineering and Natural Sciences, Department of Civil Engineering, Bursa, Türkiye<sup>2</sup> AtkinsRéalis, Leeds, United Kingdom

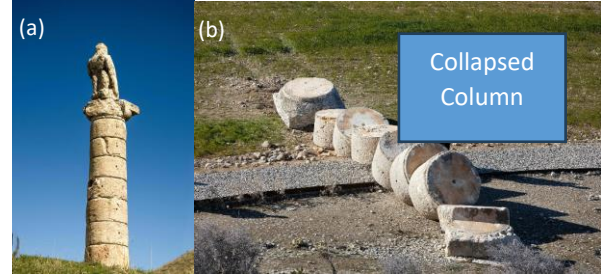
**Figure 2.** Karakuş Tumulus (a) Eagle column (ArkeolojiSanat, 2023) (b) collapsed column.

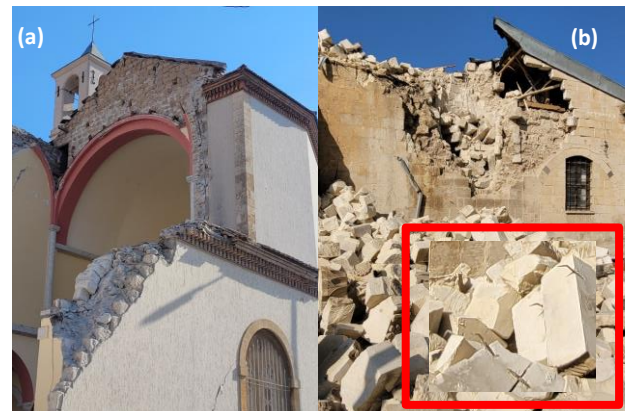
The construction materials that were used for the historical structures in the earthquake affected region mostly consist of rubble stone and cut stone. The substandard quality of both the stones and mortar, compounded by degradation over time, has led to poor seismic performance. An illustration of stone disintegration is evident in Figure 7a, representing the Latin Catholic Church of Iskenderun constructed around

The use of cut stones is another widely utilized construction method and material. The stones forming the cut stone wall are generally quarry stones. In the production of cut stone walls, just like alongside traditional structures, stones that are most abundant in their regions and naturally more economical were used in construction. The depth of the stones to be used is arranged to provide the wall thickness. The construction of cut stone walls can be with the use of mortar in between or without any joints. In the construction of jointless cut stone walls, the stones should be connected to each other using connectors of metal (iron or copper). Figure 7b demonstrates the failure of the minaret of the Şirvani Mosque in the city centre of Gaziantep, which was constructed using cut stone (Tayla, 2007). In addition to the slenderness of the minaret, the opened metal connectors in between the stones observed during the field reconnaissance.

**Figure 7.** (a) Rubble stone masonry disintegration due to poor quality of materials, (b) cut stone disintegration due to opened metal connector equipment in between.

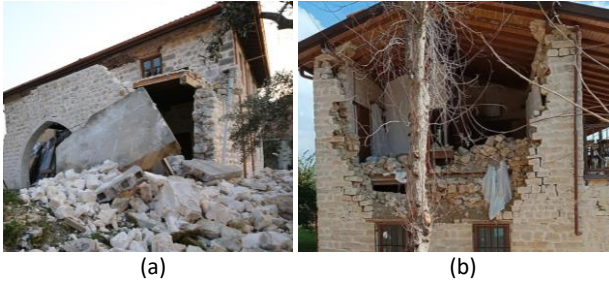
Unreinforced masonry (URM) refers to structures lacking reinforcement (mainly timber elements) or possessing insufficient reinforcement. Analyses conducted on the damage sustained by buildings in the aftermath of various earthquakes have exposed the seismic vulnerability inherent in URMs (Cetin et al. 2020, Oyguc and Oyguc 2017, Vlachakis et al. 2020, Karatas and Bayhan 2023, Nasery et al. 2024). URM buildings can be built with two- or three-leaf rubble stone masonry (Vlachakis et al. 2020). Figure 8a depicts the Church of Mary in Samandağ, Hatay, which suffered damage due to the absence of transversal interlocking stones, resulting in masonry delamination. It

is noteworthy that the Church of Mary sustained minor damage after the earthquakes on February 6th but experienced severe damage following the Samandağ aftershock on February 20, 2023, with a magnitude of 5.8.(Anadolu Ajansı, 2023).

**Figure 8.** Poor quality, multi-leaves stone masonry buildings (a) Church of Mary, Samandağ, Hatay (Anadolu Ajansı, 2023), (b) English Protestant School, Samandağ, Hatay (Haber Global, 2023).

Figure 8b illustrates another example of the damage to a two-leaf stone masonry building corresponding to English Protestant School in Samandağ, Hatay. An important detail in the construction of URM structures is the corners. Typically, corners are constructed using quoin

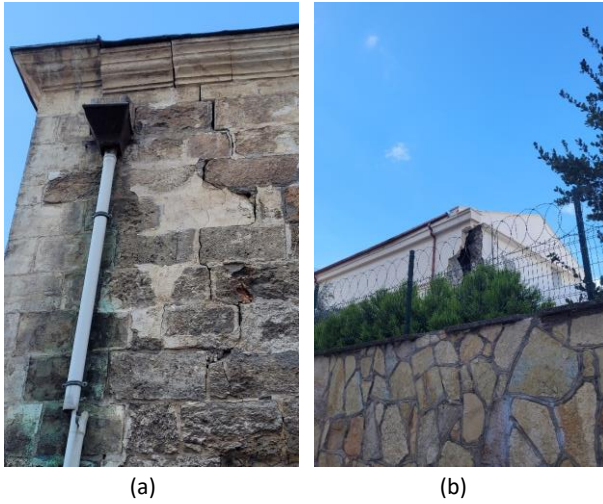
**Figure 9.** (a) Proper connection of quoin stones, Karagöz Mosque, Gaziantep. (b) Insufficient connection of quoin stones, St. Nicholas Orthodox Church of Iskenderun, Hatay.

stones, facilitating the connection of transversal walls, and mitigating the risk of local or global failures (Vlachakis et al. 2020). Figure 9a provides a tangible example of the implementation of quoin stones at the Karagöz Mosque in the city centre of Gaziantep, while Figure 9b illustrates the lack of quoin stones in the corner of the St. Nicholas Orthodox Church of Iskenderun in Hatay. The corners of URM buildings during the restoration process should be provided with rigid corner connections to prevent separations or cracks. In timber-laced masonry, vertical and horizontal reinforcing timber bars enhance the strength and ductility of the walls (Oyguc and Oyguc 2017). Figure 10a and 10b exemplify a timber-laced masonry structure, the Kahramanmaraş Saraçhane Mosque, constructed in the 18th century.

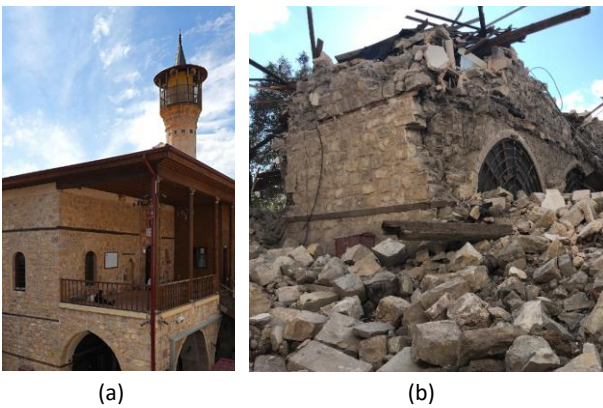
**Figure 10.** (a) Kahramanmaraş Saraçhane Mosque before the earthquakes (Go Türkiye, 2020). (b) Damage after the Kahramanmaraş earthquakes.

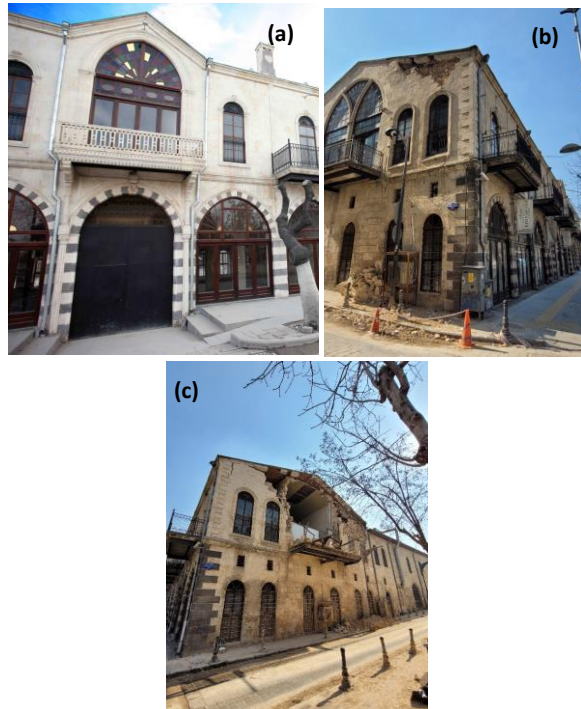
The distance of Bayazhan to the fault rupture line for the first earthquake is around 58 km. According to Figure 12b, the disintegration, mainly delamination of the external leaf, of masonry was observed during the site investigation conducted by the authors. In literature, this

behaviour is also described as the "zero" mechanism, occurring when a masonry portion is incapable of resisting nearly any horizontal force and disintegrates into pieces (Indirli et al. 2013, Vlachakis et al. 2020). Figure 12c illustrates the overturning of gable end walls known as local failure mechanism which is due to the inadequate connection with the roofing system and the walls. Similar failure mechanism is also reported by Güleç (2023) in which the author observed failures due to inadequate connection between roof system and the walls.

**Figure 12.** Bayazhan in Gaziantep, (a) Bayazhan before Kahramanmaraş earthquakes (Photo Credit: Gaziantep Provincial Directorate of Culture and Tourism). (b) Damage at the walls of the east side of Bayazhan. (c) Damage at walls the west side of Bayazhan.

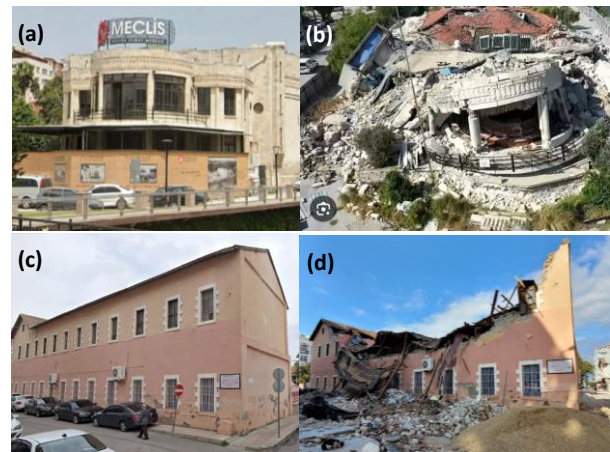
building was completed in 1928, and the building consist of cut stone load-bearing walls and reinforced concrete column forming the core around the courtyard. As depicted in Figure 13b, the load-bearing system constructed with cut-stone completely collapsed, and the reinforced concrete columns failed, exhibiting weak column behaviour at the connections. Figure 13c and 13d depict Mithatpaşa Primary School, built in 1926 by the French, located in Iskenderun Province in Hatay. The school, constructed with rubble stone featuring long walls and a timber roof, experienced complete collapse of the roof and the second floor during the Kahramanmaraş earthquake sequence.

**Figure 13.** (a) Hatay Council Building before Kahramanmaraş earthquakes (Google Earth, 2022). (b) Hatay Council Building, damage after the earthquakes (CNN TURK, 2023). (c) Mithatpaşa Primary School, Kahramanmaraş earthquakes (Google Earth, 2022). (d) Mithatpaşa Primary School, damage after the earthquakes.

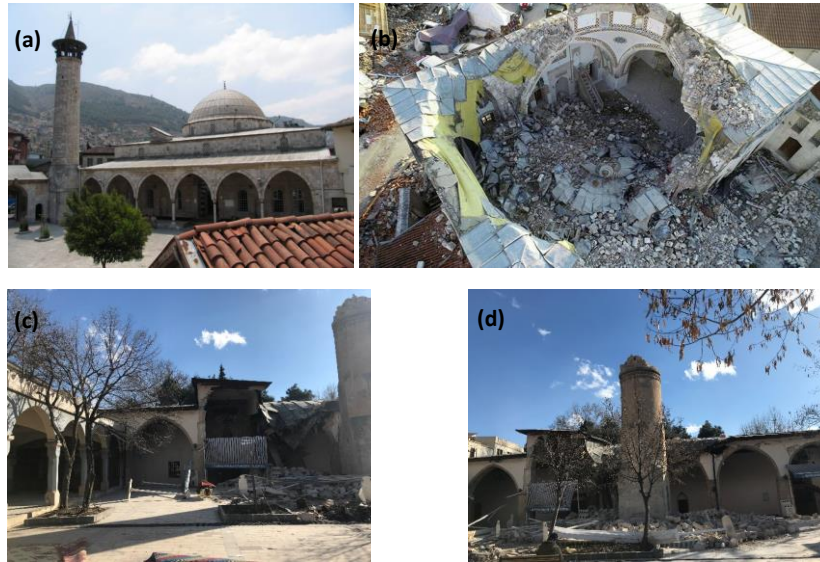
Figures 14a and 14b represent the complete collapse of The Habibi Neccar Mosque, situated in Antakya Province, where high PGA values were documented (AFAD, 2023; Erdik et al., 2023). The Habibi Neccar Mosque, initially constructed around the 7th century and recognized as the first mosque in Anatolia, underwent reconstruction around the 11th century and has undergone multiple repairs over time (Hatay Governorship, 2024). The Habibi Neccar Mosque is a masonry structure that was constructed with cut stone. The collapse of the masonry dome was followed by the out-of-plane behaviour of the masonry walls. URM walls are most vulnerable to flexural out-of-plane behaviour (Oyguc and Oyguc, 2017). The partial collapse of the Grand Mosque of Kahramanmaraş is depicted in Figures 14c and 14d, with the partial collapse of its minaret. The Grand Mosque of

**Figure 14.** (a) Habib-I Neccar Mosque before the Kahramanmaraş Earthquakes (Google Earth, 2022). (b) Damage in Habib-I Neccar Mosque the after the earthquakes (DHA, 2023). (c) Damage in The Grand Mosque of Kahramanmaraş after the earthquakes, (d) Damage in The Grand Mosque of Kahramanmaraş after the earthquakes.

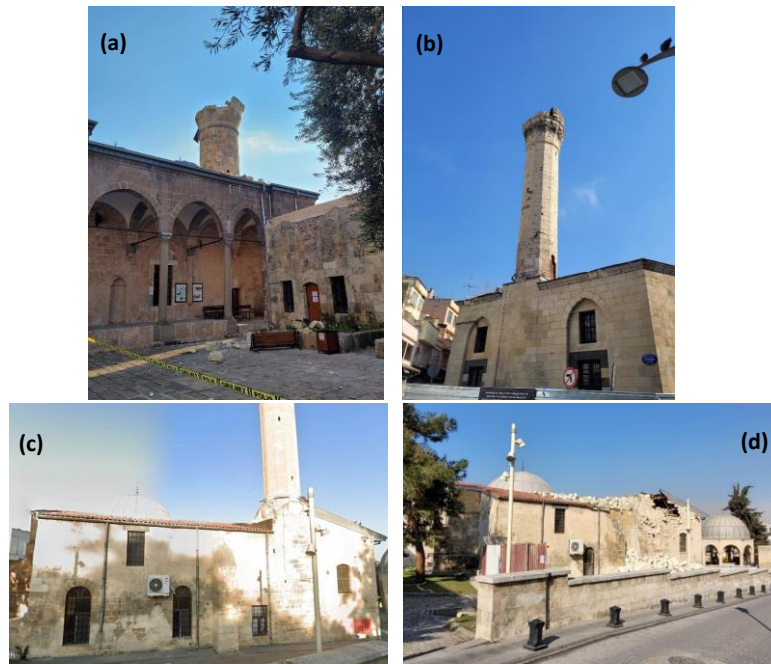
photographs offer a detailed illustration of the damage incurred by the minarets, showcasing the diverse structural alterations resulting from the seismic events. By presenting these images, the objective is to offer a more holistic insight into the effects of earthquakes on historic masonry structures, particularly minarets. Through this presentation, the aim is to contribute to the advancement of more effective measures for earthquake-resistant design and construction practices in the future. As an example, Figure 16a shows the minaret of Sarı Selim Mosque in Iskenderun, constructed in the 16th century, while Figure 16b illustrates the minaret of Karagöz Mosque in Gaziantep, built in the 18th century, both

constructed using masonry techniques. According to both figures, damage is evident in the balcony section of the minarets. As reported by Doğangün et al. (2007), minarets are more susceptible to damage in areas such as the hood, upper part, balcony, and transition sections during seismic events. The region above the balcony experiences maximum displacement, and the lack of stairs in the upper body contributes to reduced rigidity, leading to a rapid increase in the displacement. Figure 16c and 16d shows the Şirvani Mosque in Gaziantep constructed in 17th century as masonry structure. The collapse of the minaret lead to extensive damage also at the mosque.

**Figure 16.** (a) Damage in the minarets at Sarı Selim Mosque in Iskenderun, Hatay. (b) Damage in Karagöz Mosque in Gaziantep city centre. (c) Şirvani Mosque in Gaziantep before the Kahramanmaraş Earthquakes (Google Earth, 2022). (d) Collapse of the Minaret of Şirvani Mosque after the earthquakes.

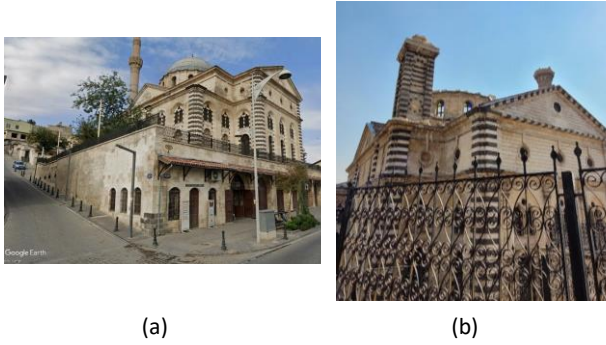
Figure 17a and 17b illustrates the Gaziantep Kurtuluş Mosque prior and after the Kahramanmaraş earthquake sequences. The Gaziantep Kurtuluş Mosque, formerly known as the Virgin Mary Church, is a 125-year-old structure constructed with cut stone. Originally built as a church in 1892, this historic building, situated in Gaziantep, served as a prison after its church function until 1980. Subsequently, it underwent conversion into a mosque (Güllü and Karabekmez, 2016). The central dome, spanning approximately 12 meters in diameter, has a height of 30 meters above the ground (Güllü and Karabekmez, 2016). The collapse of the dome occurred in the mosque, which is mainly due to significant diameter of the dome and due to the insufficient connection to the

body of the main structure. The typical damage at the balcony of the minaret also occurred in the mosque.

**Figure 17.** Kurtuluş Mosque in Gaziantep before the Kahramanmaraş Earthquakes (Google Earth, 2022). (b) Dome and minaret damage in Kurtuluş Mosque after the earthquake.

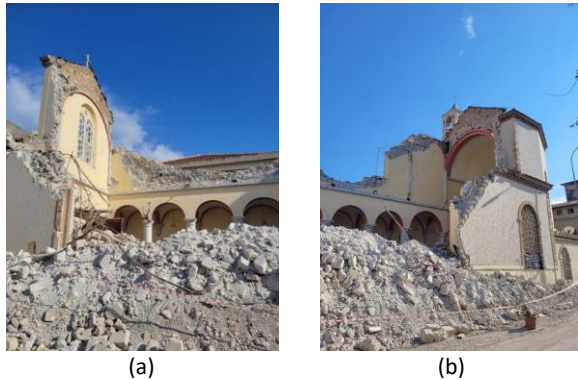
Churches are the significant historical structures of the region with their architectural features. Out-of-plane failure mechanism were observed in the churches. In the absence of a 'box like behaviour' of structures, the internal forces of the walls perpendicular to the seismic action give rise to out-of-plane bending. Long walls or walls with insufficient transversal support suffers vertical, one-way bending as seen in Figure 18 in Iskenderun Catholic Church. The walls experienced out-of-plane failure, also due to the top part of the façades might inadequately connected with the roof, and the wall behaves as a cantilever about their base (rocking type of failure) (Vlachakis et al., 2020).

**Figure 18.** Iskenderun Catholic Church (a, b) Out-of-plane damage in the Iskenderun Catholic Church after the earthquake.

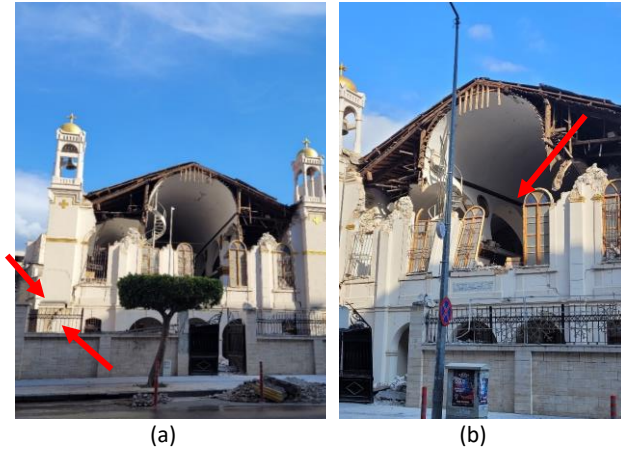
Multiple failure mechanisms observed during the field studies in St. Nicholas Orthodox Church in Iskenderun, Hatay (see Figure 19). The distance of the church to fault rupture is around 18 kilometres. The church's construction was initiated in the 1870s and features masonry construction, with load-bearing walls composed of brick or stone. The church experienced damage during the Amik earthquake of 1872 and reopened after 1876. Out-of-plane mechanism of the front wall at the entrance of the Church were examined as reported in Figure 19a and 19b.

**Figure 19.** St. Nicholas Orthodox Church in Iskenderun, (a, b) Observed combined in-plane and out-of-plane mechanisms in the St. Nicholas Orthodox Church after the earthquake.
