Seismic Rehabilitation of a Reinforced Concrete School in Northern Cyprus Following the 2023 Turkey Earthquake Sequences

Sasan BABAEI¹

Foad KARIMI GHALEH JOUGH^{1*}

¹Faculty of Engineering, Department of Civil Engineering, Final International University, Via Mersin 10, AS 128, Kyrenia, Northern Cyprus

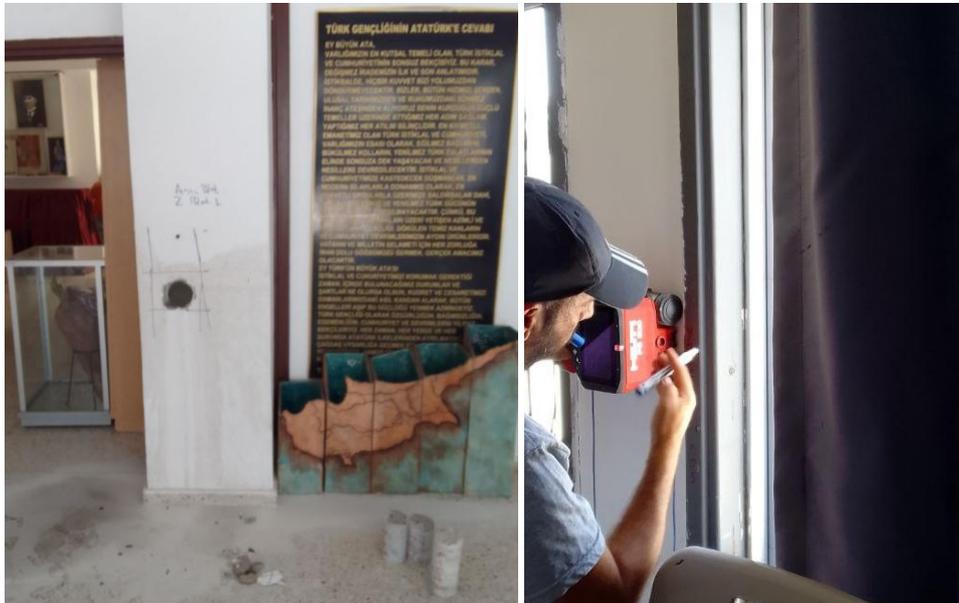
Laboratory testing revealed that Blocks A and B share similar concrete quality, specifically a C16 grade, with a maximum compressive strength of 16 MPa. In contrast, Block C has C18 grade concrete, providing a slightly higher compressive strength of 18 MPa in its original sections. Although the newer sections in Block C may use even higher-strength concrete, a conservative assumption was made to treat the entire structure as built with C18 concrete. Site inspections also did not reveal any steel strength degradation due to corrosion of the rebars. These findings most closely correlate with the Turkish Standard TS 708 (1973) for reinforcement steel.

Figure 3. Laboratory test for validation; a) Extracted concrete cores for compression test; b) Scanning concrete rebars

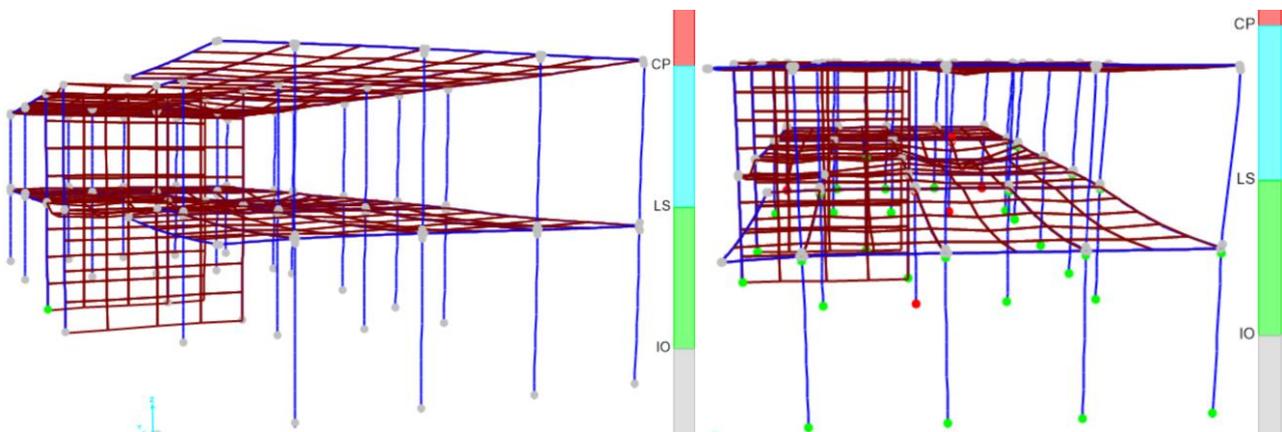
Figure 5. Hinge formations in the frames of block A at the end of the seismic sequence; a) X direction, b) Y direction

An analysis of Block A shows that the structure remained elastic in both directions during the first sequence of ground motion. However, during the second sequence, known as the Elbistan earthquake, hinges began to form in primary elements, specifically the columns. Figure 5a and 5b display the deformation of Block A in the X and Y directions. In the X direction, where shear walls are incorporated around the staircase, the structure demonstrated high resistance, with only one hinge reaching the life safety level. In contrast, columns in the Y direction sustained significant damage: ten columns reached the life safety state, three columns reached the collapse prevention state, and nine columns experienced total collapse, as shown in Table 2. Notably, none of the beams in the structure failed, likely due to their large cross-sectional dimensions of 30 by 80 cm, which provide high moments of inertia and enhance flexural capacity. Additionally, the beams were reinforced with sufficient longitudinal rebar, enabling them to exhibit ductile behavior.

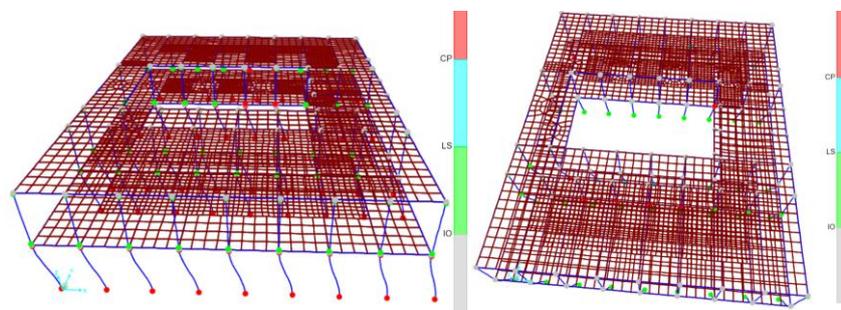
**Figure 6.** Hinge formations in the frames of block B at the end of the seismic sequence; a) X direction, b) Y direction**Table 3.** Building's blocks Columns and beams dimensions and reinforcements

Figure 6 illustrates the seismic behavior of the second block, Block B, in both the X and Y directions after the completion of the second ground motion sequence, as indicated in Table 3. None of the primary or secondary elements—namely, columns and beams—experienced hinge formation after the first sequence. However, as the intensity of the second ground motion increased, 38 columns reached the life-safety state, while 52 columns approached a collapse state in the X direction. Notably, none of the columns remained in the immediate occupancy category. In the Y direction, similar behavior was observed but with less severe damage: 25 columns remained in immediate occupancy, 51 reached the life-safety threshold, 4 were at collapse prevention, and 10 were in a collapse state. This analysis indicates that the structure in both the X and Y directions lacks sufficient lateral resilience to sustain these ground motions. Reinforcement techniques are recommended in both directions, particularly in the X direction, where a greater number of columns failed. Similar to Block A, none of the beams in Block B experienced hinge formation, likely due to their larger cross-section dimensions of 30 by 80 cm.

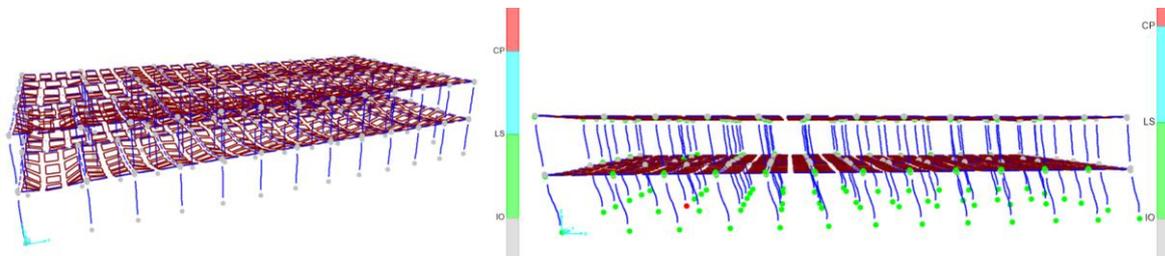
Figure 7. Hinge formations in the frames of block C at the X direction at the end of the; a) mainshock, b) aftershock

Unlike the other two blocks, Block C experienced hinge formation even after the first seismic sequence in the Y direction. However, in the X direction, none of the structural elements experienced hinge formation,

allowing the structure to remain in immediate occupancy. Figure 7 illustrates that, after the second sequence of ground motion, 113 columns in the X direction reached the life-safety stage, with only one column reaching the collapse state.

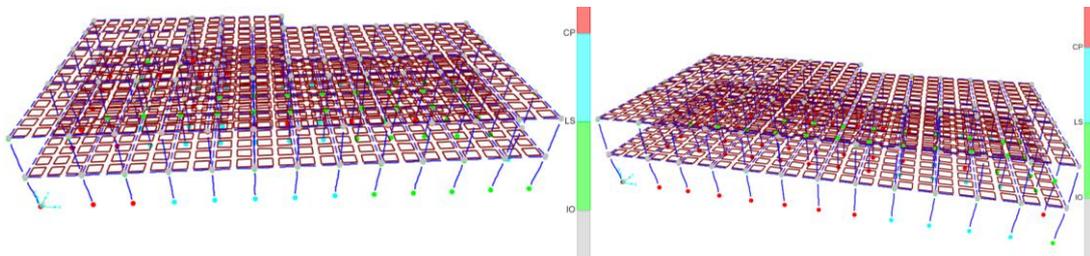
Figure 8. Hinge formations in the frames of block C at the Y direction at the end of the; a) mainshock, b) aftershock

In the Y direction, as shown in Figure 8, even after the first seismic sequence, 57 columns reached the life-safety stage, 23 columns were at collapse prevention, and 29 columns reached collapse. This damage intensified with the second sequence: only 6 columns remained in immediate occupancy, 56 reached the life-safety stage, 10 were at collapse prevention, and a significant 48 columns reached collapse.

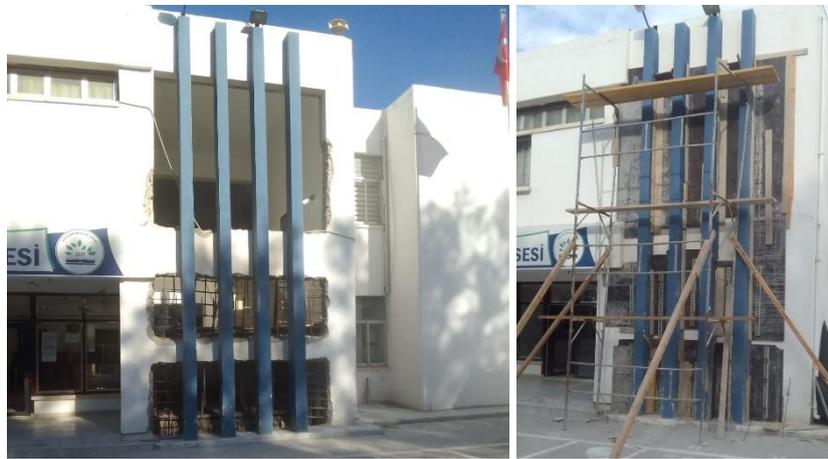
Figure 12. Shear wall added to block A; **a)** wall demolishing, **b)** Concrete pouring

Figure 12 and 13 illustrate the implementation of 25-centimeter shear walls and X-brace frames incorporated into the structure.

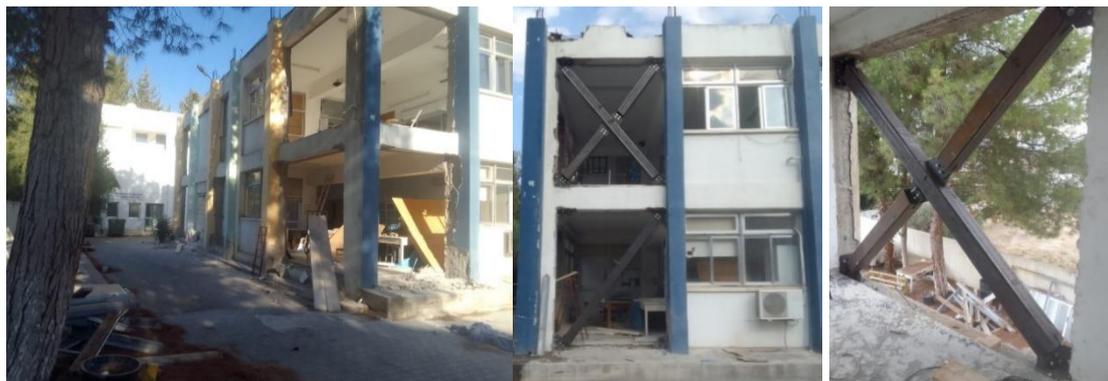
Figure 13. X-braced frames added to block C; **a)** wall demolishing, **b)** Braced frame implementation **c)** Tube 200x200x12.5
