Investigation and Protection Recommendations Sinan Bridges in Istanbul

Serdar Kasap*

Construction techniques and current conditions of Sinan Bridges are analyzed under the light of above-stated effects. As sample structures, survey works were performed on Mimar Sinan Bridge in Buyukcekmece and Kapuagasi Bridge over Haramidere; restitution and restoration projects were tried benefiting from written and visual sources and the traces on the structures. Structural problems within the current condition of the structures were scrutinized and intervention suggestions were made. Recommendations were made to solve protection problems arising from the location of the structures.

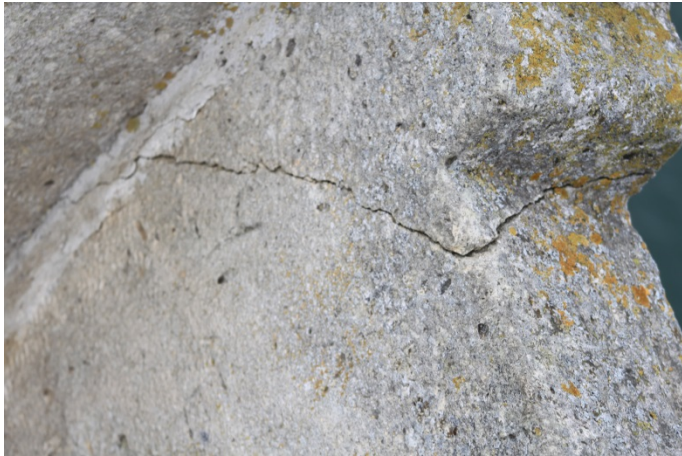
Photo: 6. Buyukcekmece Bridge (Cracks and Fractures)

- Scour and fractures in flood splitters and piers should be repaired.

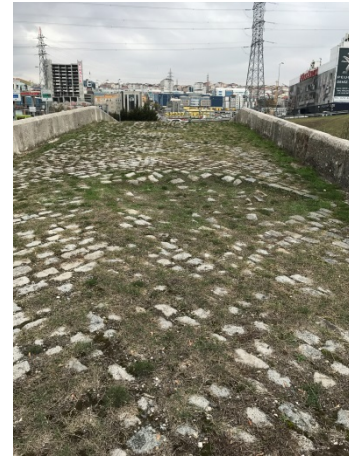
Photo: 9. Kapuagasi Bridge (Damages)

- It is suggested to repair the deteriorations in the discharging cells, built with bricks, and relieving arches in a method suitable for the construction technique.

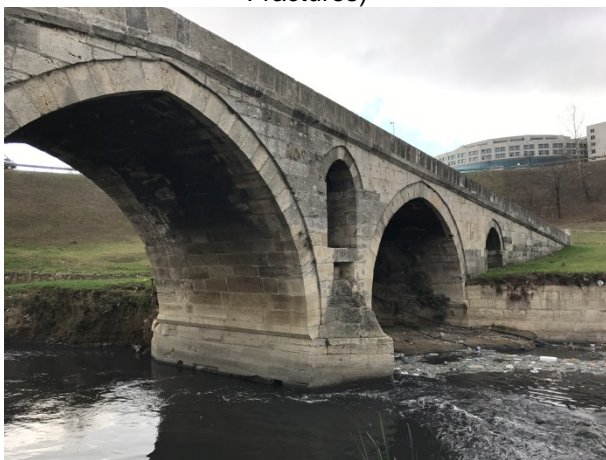
Photo: 7. Kapuagasi Bridge (Surface Accumulation)

- The accumulations of environmental wastes and the dirt build-up brought by the changes in the regime flow must be removed

- Surface cleaning is required in facade stones and arch interior with an appropriate method.

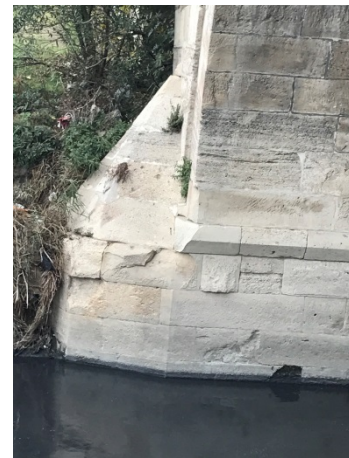
Photo: 10. Kapuagasi Bridge (Fragmentation)

- Missing and deteriorated king piers should be renewed staying true to the texture of the structure.

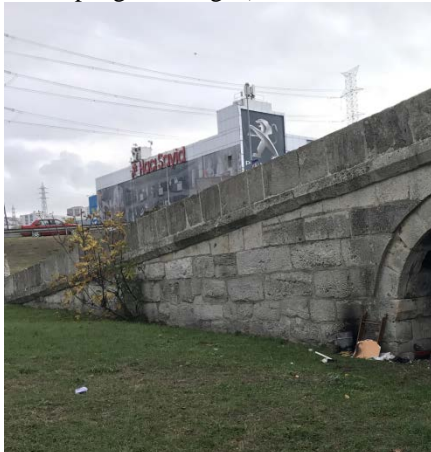
Photo: 8. Kapuagasi Bridge (Surface Accumulation)
