Art-Sanat

Architectural Investigation and Material Characterization of Byzantine Brick Masonry Church: A Case Study of the Üç Ayak Church

Merve Başgül¹ & Şerife Özata²

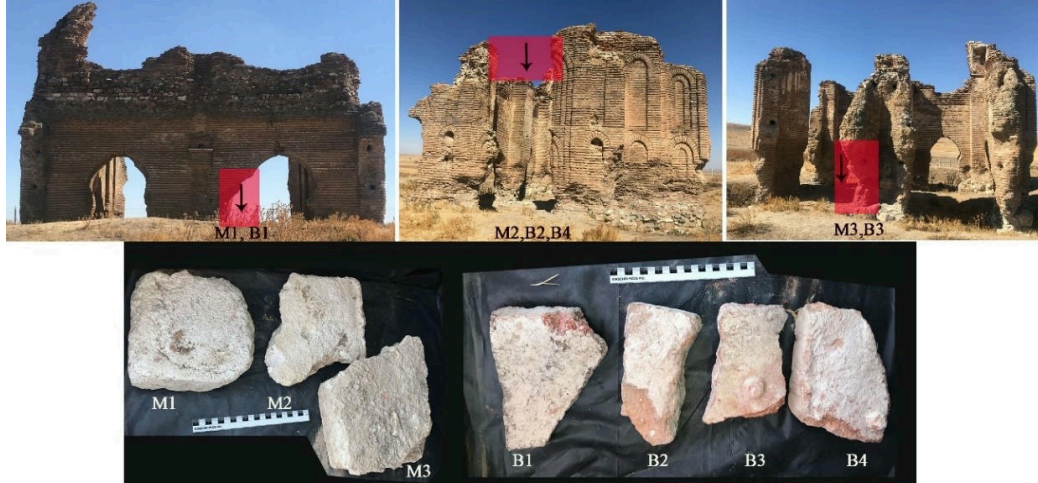
In the Üç Ayak Church, three mortar and four brick samples were collected from distinct areas under the supervision of the authorities. Notably, the structural integrity of the standing portion of the building remained unaffected, as the samples had already fallen. The mortars, identified as M1, M2, and M3, along with the bricks denoted as B1, B2, B3, and B4, are depicted in (Figure 2). The marked areas in red in (Figure 2) indicate the estimated falling locations of the samples.

Figure 2: Estimated location of the taken brick and mortar samples

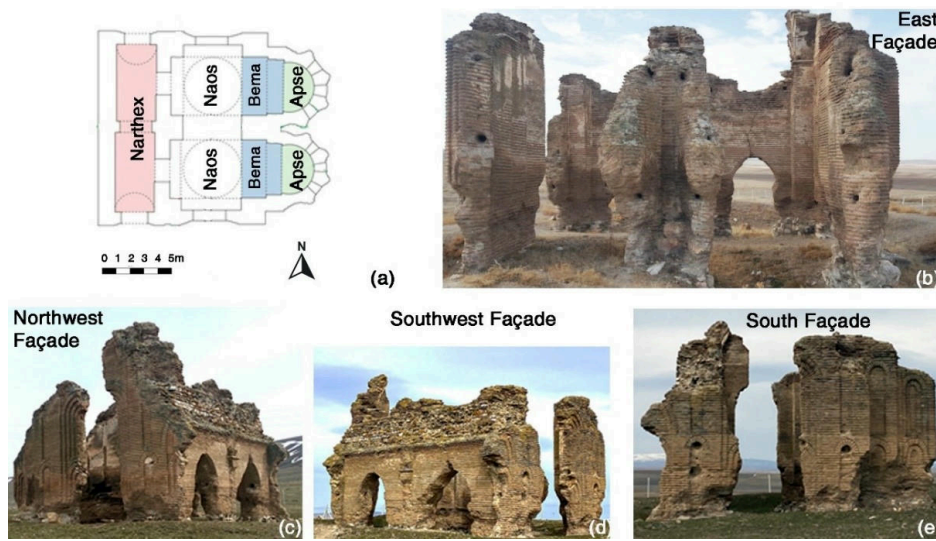
Figure 4: Figure 4: (a) Plan of Üç Ayak Church, (b) Current situation of the south façade, ruined apses, (c, d, e) Current condition of the façades

Based on the comparison of the old photographs in (Figure 3) and the up-to-date photo in (Figure 4), it can be deduced that a section of the apse has been missing since the early discovery of the building. It is estimated that there was a semi-dome over the apse. The apse in the plan shared in (Figure 3) drawn by Crowfoot²⁸ differs from the actual apse discovered during excavations²⁹, which has five façades that add dynamism to the building's design.

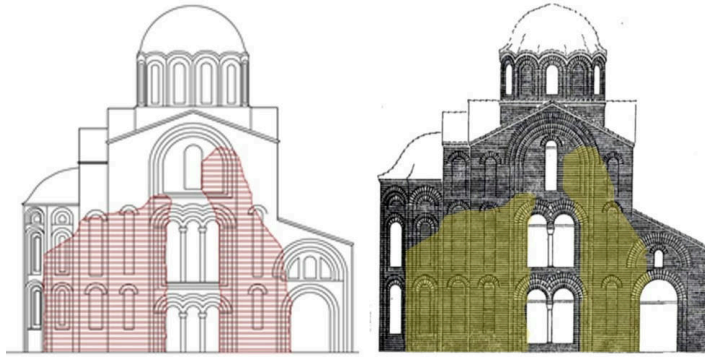
The highest point of the remaining walls, which were constructed without plaster, is 10 m (Figure 5). The style of the narthex walls remains unknown as they have not survived to this day, but the narthex has a single story. Despite the center of the north façade of the church being destroyed, it is clear that there are two different levels of niches on this façade made up of four intertwined arches. The architectural survey depicts that the upper sections of the niches were designed with round arches and double-triple windows set into these niches. The evidence of triple windows was found on the apse façade. Although it is stated that there is a drum in the dome, which is claimed to be about 17 m high³⁰, the accuracy of this information is doubtful since the cupolas are generally built without a drum on the pendentive structural elements. If the dome were built using squinches on a square plan, the drum part might have been formed. Based on this information, two different possible restitution drawings of the north façade are presented in (Figure 5). These drawings on the left and the right have been modified from sources published by Eyice in 1968³¹ and 2004, respectively, and³² the remains are shown in (Figure 5).

Figure 5: Different representative restitutions of the north façade

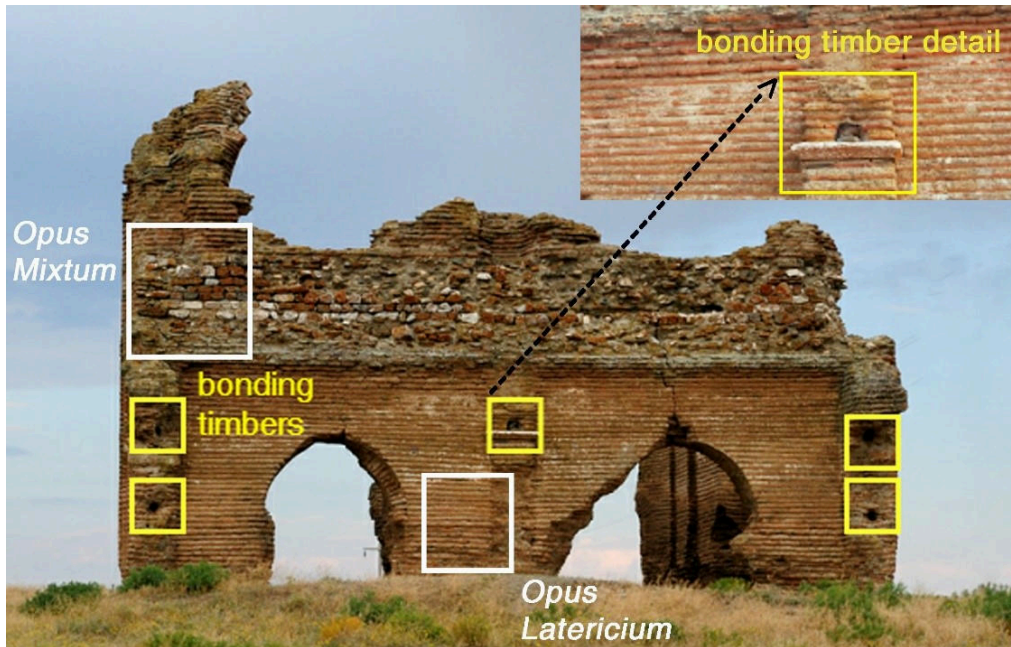
Based on the brick workmanship, it can be said that the walls were built with the *Opus latericium* technique, while the *Opus mixtum* technique, which characterizes hybrid construction, was used throughout the building since there are also stones. The types of brick quality mentioned are marked on the image in (Figure 7).

Upon the 90-cm-thick structural walls, a single circular wooden bond beam measuring 18 cm in diameter is positioned at approximately 380 cm above the ground level, resting atop the designated arches. On the piers measuring approximately 140x170 cm, three square wooden beams, each measuring approximately 18x18 cm, are installed at heights of around 40 cm, 160 cm, and 300 cm, originating from the stone-formed plinth level, which stands at 50 cm high. Some of these bonding beams are shown in (Figure 7). Schweinitz³⁶ stated that wooden beams placed inside the walls during the construction of the building increase the resistance of the building against earthquakes. This information is partially correct because the bonding timbers used with a certain level of spacing within the brick masonry wall reduce the slenderness and improve the earthquake performance and the stability of the structure.

Figure 7: The bonding timbers in between the masonry brick wall and brick quality samples on the west façade
Source: Prepared by Ş. Özata

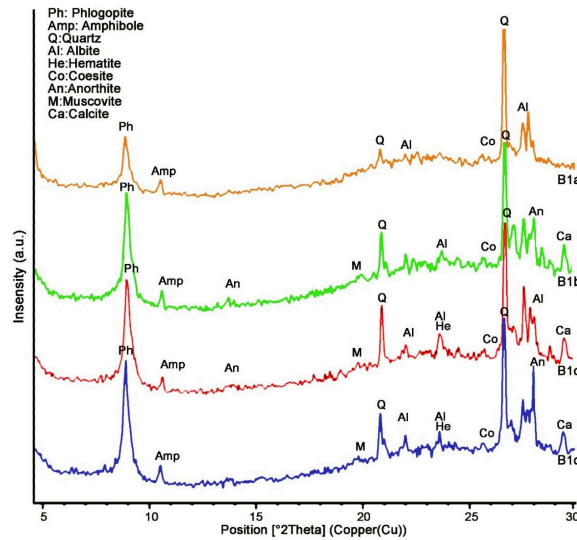
As a result of the XRD analysis of the ethylene glycol-treated four brick samples between 2°-30° (2θ), phlogopite (KMg₃(AlSi₃O₁₀)(OH)₂), muscovite (KAl₂(AlSi₃O₁₀)(OH)₂), albite (Na(AlSi₃O₈)), anorthite (CaAl₂Si₂O₈), quartz (SiO₂), coesite (SiO₂), calcite (CaCO₃), hematite (Fe₂O₃) and amphiboles (X⁵⁴₇Si₈O₂₂(OH)₂) peaks were observed, which were shared in F.8. Doyleite (Al(OH)₃), calcium-silicate-hydrate (CaSi₈O₂₄)₁₂ H₂O compounds along with amphibole, quartz, albite, anorthite and muscovite were detected in the mortar samples (Figure 9).

Figure 9: XRD patterns of four different parts of Üç Ayak Church brick (B1)

According to the literature⁵⁸, brick firing temperatures vary between approximately 450 °C and 900 °C. Since coesite was formed in the material, it can be estimated that the Üç Ayak bricks were fired at 700-900 °C. Quartz was not observed in the bricks fired at 1050 °C. Calcite is a carbonate group mineral that starts to appear in fired bricks at 800°C and decomposes at 870°C⁵⁹. It can be inferred that the use of calcium-deficient clays from locally available non-calcareous raw material sources is likely, given the low levels of Ca detected in the composition Table 2. Hematite is produced in non-calcareous bricks at a firing temperature of 850°C, and its presence indicates the temperature at which the bricks were fired⁶⁰. The amphibole peaks indicate the formation of other minerals such as Mg and Na. The relatively small number of these oxides in Table 2 supports this argument. According to these data and the analyzed XRD peaks, the firing temperature of the Üç Ayak Church bricks is estimated to be between 850 °C and 900 °C.

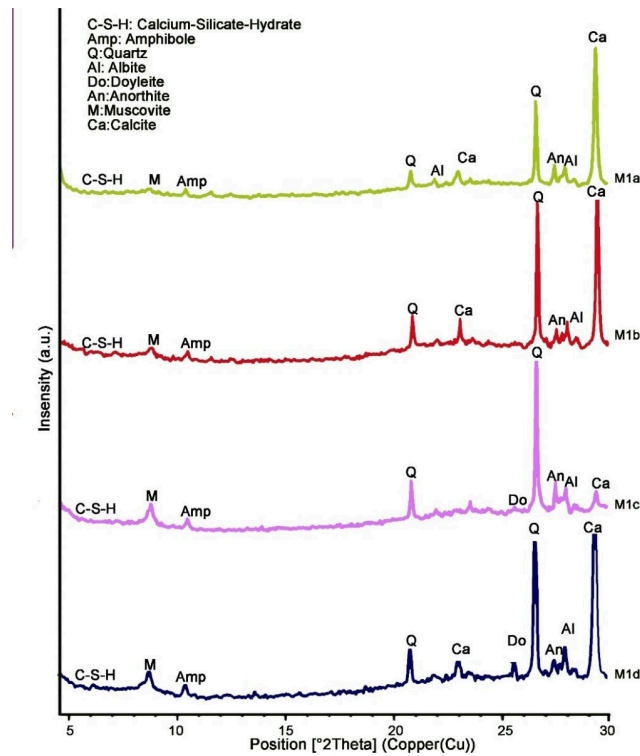
Figure 10: XRD patterns of four different parts of Üç Ayak Church mortar (M1)
Prepared by authors

Doyleite is a rare type of aluminum oxide that is detected weakly in some samples. Although the presence of C-S-H is obviously a significant indication of hydraulicity⁶¹, the peaks are quite weak. These are sometimes caused by pozzolanic activity at the interface between the brick and mortar. Accordingly, the main materials of the mortar are considered sand and lean lime, which is produced by calcining and slaking limestone that contains 2% to 8% clay⁶².

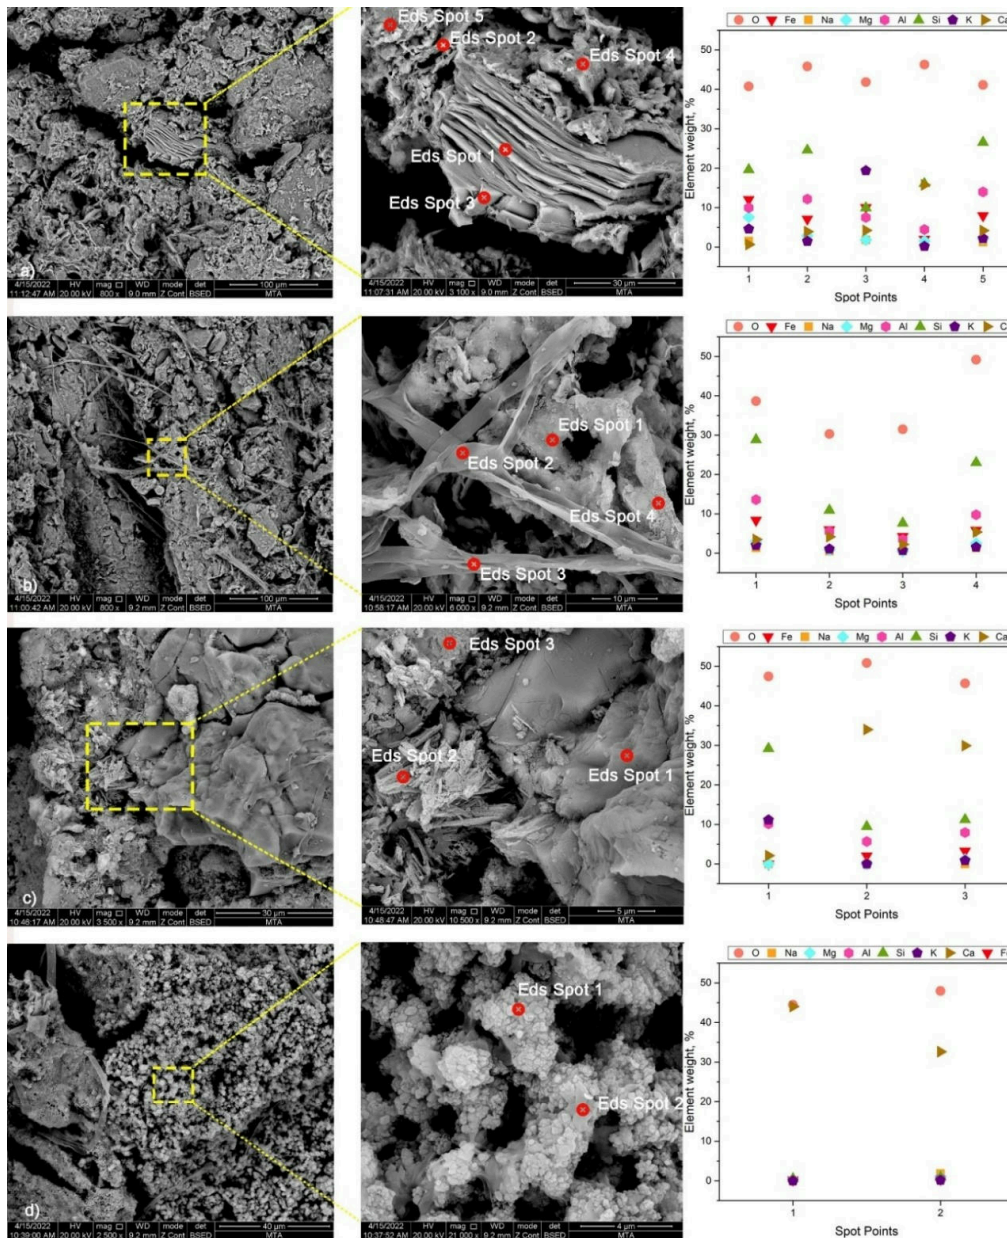
It is anticipated that no vitreous phase is found in the bricks fired between 800 °C and 870°C⁶³. The heterogeneous morphology observed in the SEM images serves as evidence that there is no vitreous phase present. The SEM images depicting a partially compact morphology provide further confirmation that the brick was formed at a temperature of 850-900°C, consistent with the XRD phases.

Figure 11: SEM micrographs magnified 800-21.000 \times and EDS spot points along with element weight percentages of the same brick sample from $\dot{U}\check{c}$ Ayak Church

All EDS spots in (Figure 11a) have a high amount of Si, as expected according to the XRD phases of the Byzantine brick. EDS spot #4 has a high amount of Ca as this area may be an intersection between mortar and brick. Since hematite is also seen in the brick, iron is detected at certain levels in all spots in (Figure 11a). For a vivid red to be seen on the bricks, there must be at least 5% iron⁶⁴. The EDS results clearly show that the observed redness of the Byzantine bricks is due to iron.
