## ENGINEERING SEISMO-GEOLOGICAL JUSTIFICATION OF THE BAYIL LANDSLIDE IN 2018

### Objective

Determining the contours of a probable landslide-prone territory based on the method of engineering seismic exploration and studying the deep structure of fractured environment.

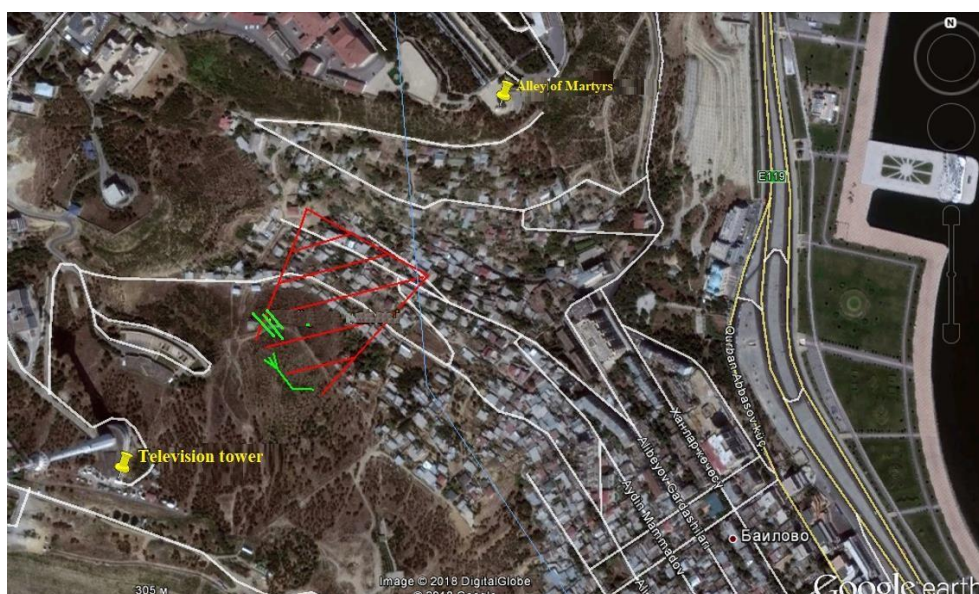
Fig. 1. General view of the landslide with observed main fractures in the area

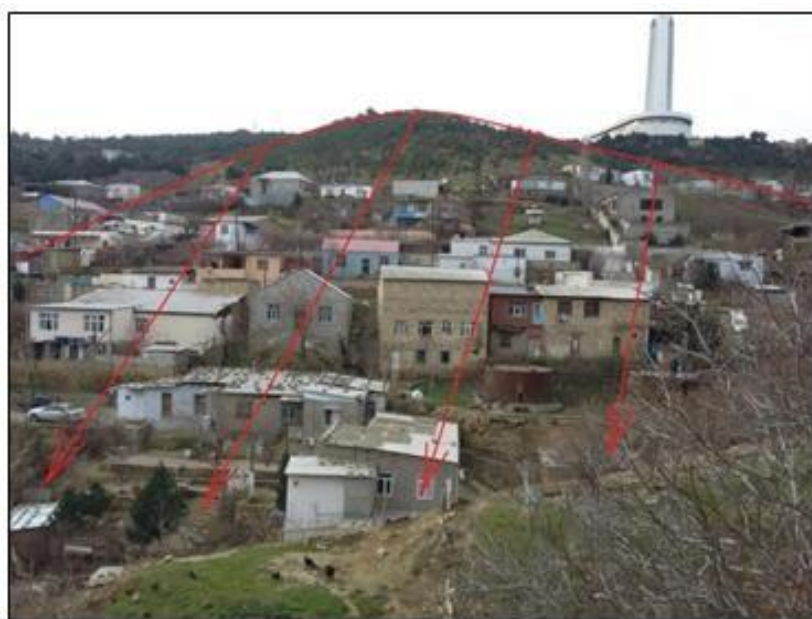
Fig. 2. View of houses in the affected area of the prognosed landslide (width 200 m, length 220 m).

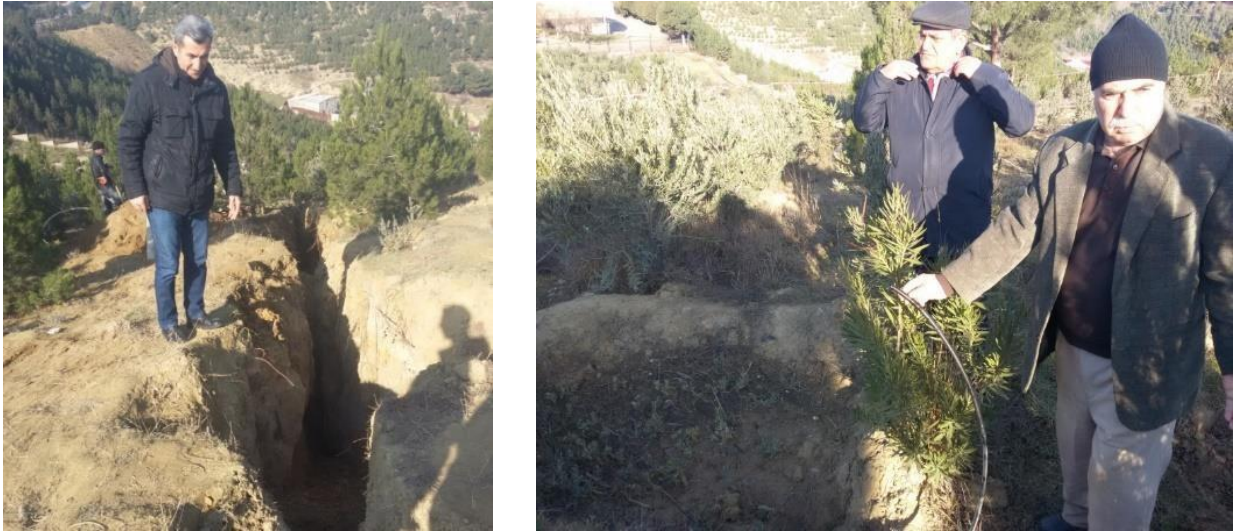
Before the start of the study, the site was visually inspected and a number of anthropogenic interventions affecting landslide activation were noted. These include the cutting of a slope in the form of a terrace for growing tree seedlings and for building houses, as well as the absence of a sewer line in these houses.

Fig. 4. Visual observations at the site

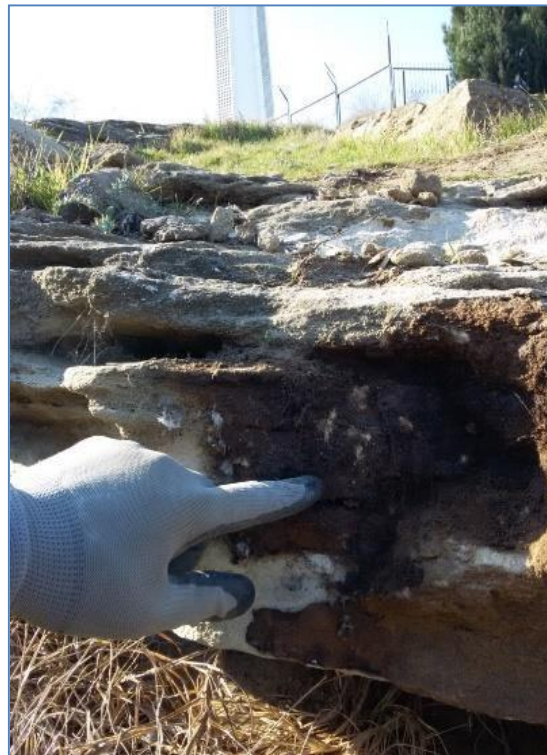
Fig. 5. Water leaks in sandstone layers in the northwestern flank of the landslide zone

At the same time, 60-70 m to the north-west of the exploration well at a relative height of 95 m, groundwater leaks were found through sandstone layers, and when sampling soil from a depth of 2 m from the front of the fractured area, clay-loamy soils were found in the form of porridge (Fig. 5, 6).

One of the factors substantiating the reality of landslide risk is the deepening of sandstone layers, where water leaks were observed, under the predicted landslide massif (the area where cracks were observed) and the identification of clay-loamy soils in the form of a porridge on the front of the massif (based on sampling from 2 meter depth).

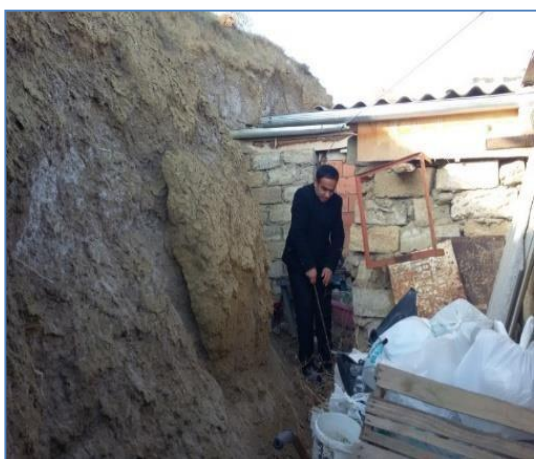
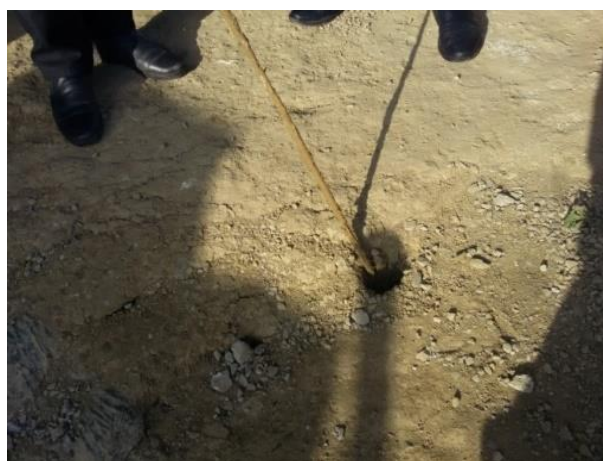
Fig. 6. Slope cut in front of the landslide zone and rock sampling from a shallow depth

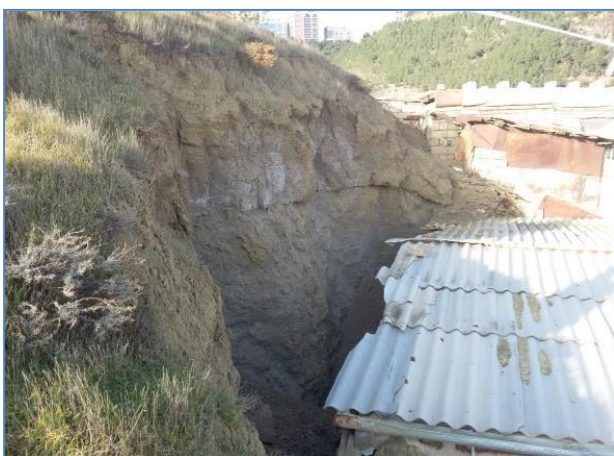
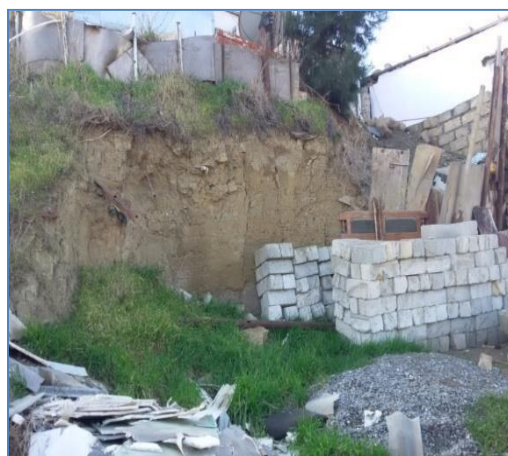
Fig. 7. Slope cut in front of the landslide zone

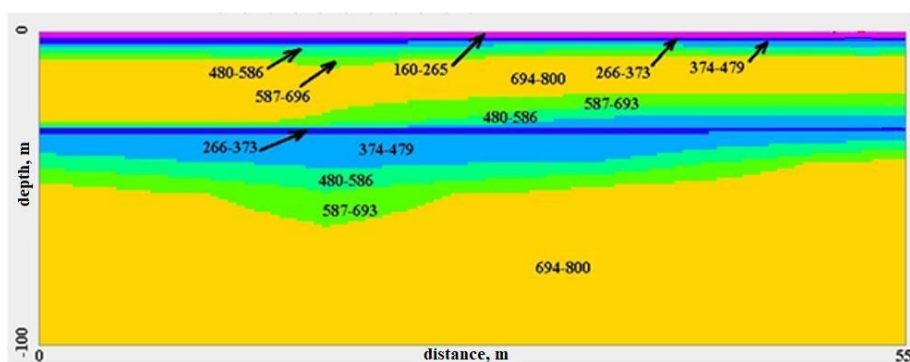
As can be seen from the geological section of the well, the upper lithological section of the study area is composed of a complex of rocks of the Quaternary (Q4) age (semi-hard clays, clastic limestones, fine-grained sands and sandy clays). Sandstone formations are often found among the engineering-geological elements mentioned. Groundwater was not observed during drilling (Fig. 9).

Fig. 9. 2D shear wave velocity section on seismic profile №1

According to seismogeological data on seismic profiles № 1, 5 and 6, sandy-argillaceous rock layers were revealed at a depth of 31.5-41.5 m, with a thickness of 10 m and a low wave speed of 350 m/s (on profile 1), 340 m/s (on profile 5), 360 m/s (on profile 6) and at a depth of 28-44 m, with a thickness of 16 m (on profile 7) with a wave velocity of 360 m/s.

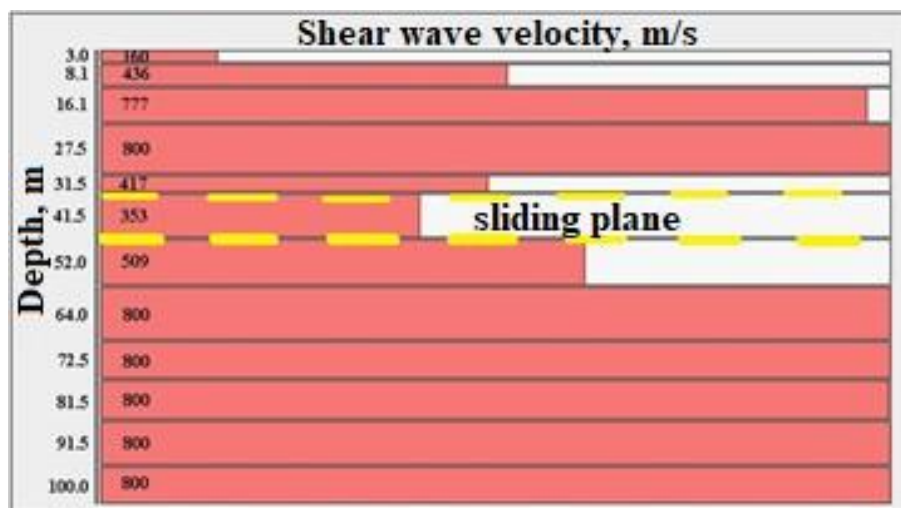
Fig. 10. 1D shear wave velocity section on seismic profile № 1

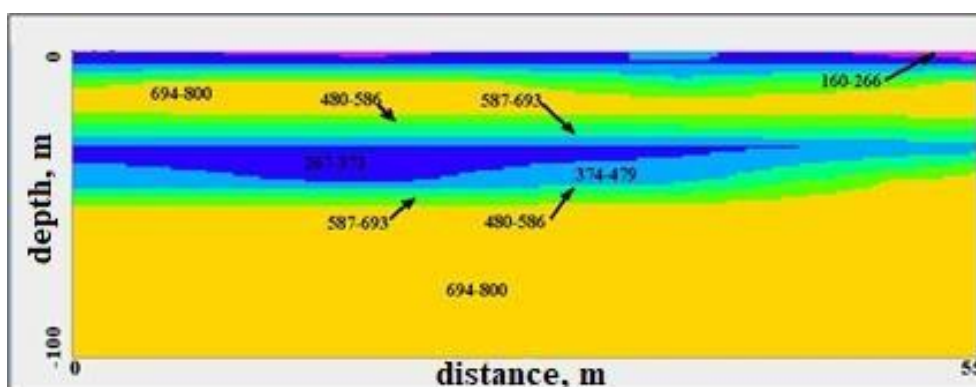
Fig. 12. 2D shear wave velocity section on seismic profile № 5

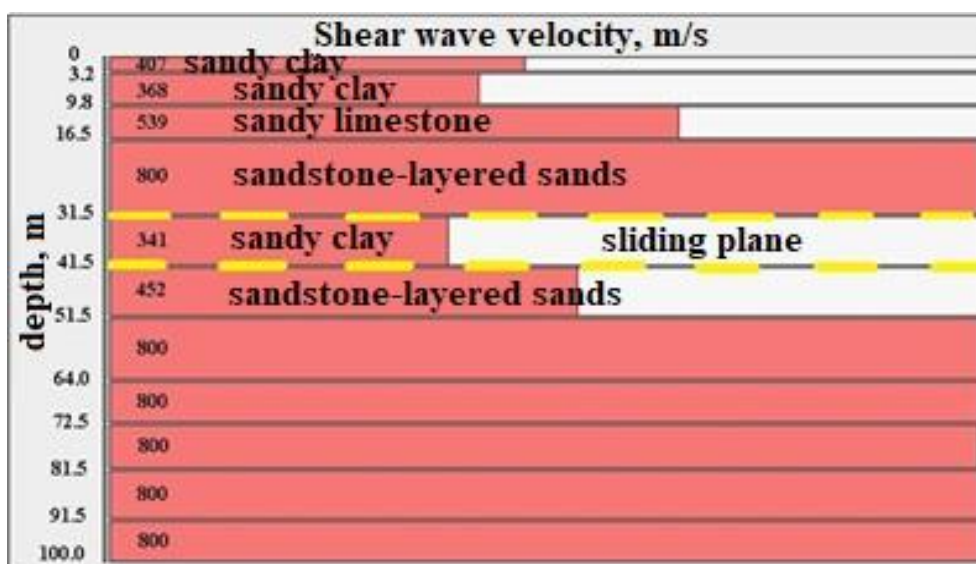
Fig. 13. 1D shear wave velocity section on the seismic profile № 5 and seismic georeferencing

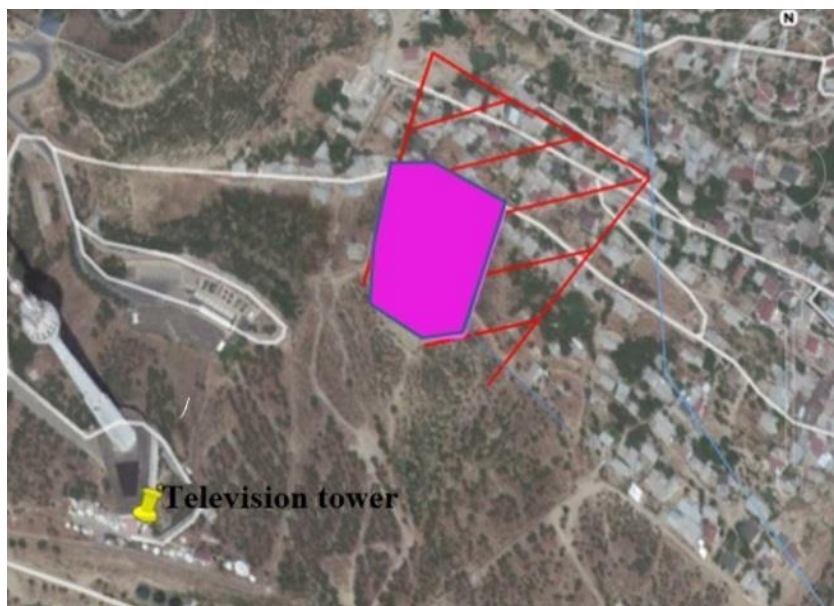
On February 10, 2018, a landslide occurred in the study area, four houses, fences and outbuildings were destroyed, cracks formed in the remaining houses and a very dangerous situation arose (Figure 15-18).

Fig. 14. Landslide on February 10, 2018

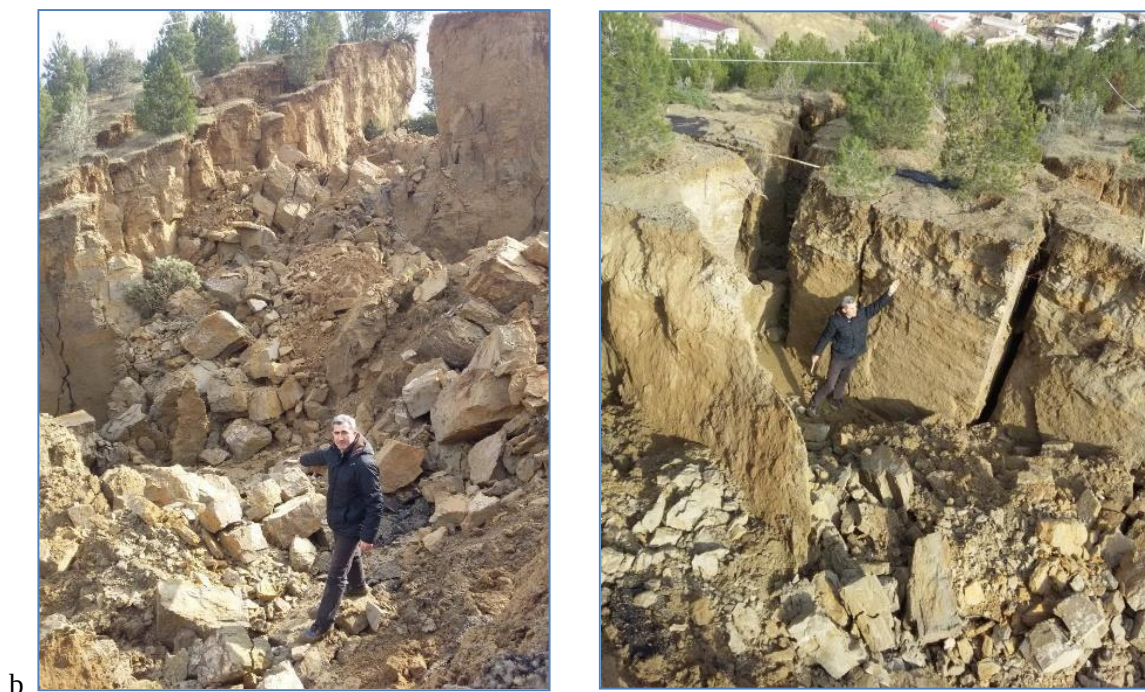
Fig. 15. Terrain change observed at a depth of about 10 m at a distance of 19 m at the top of the landslide

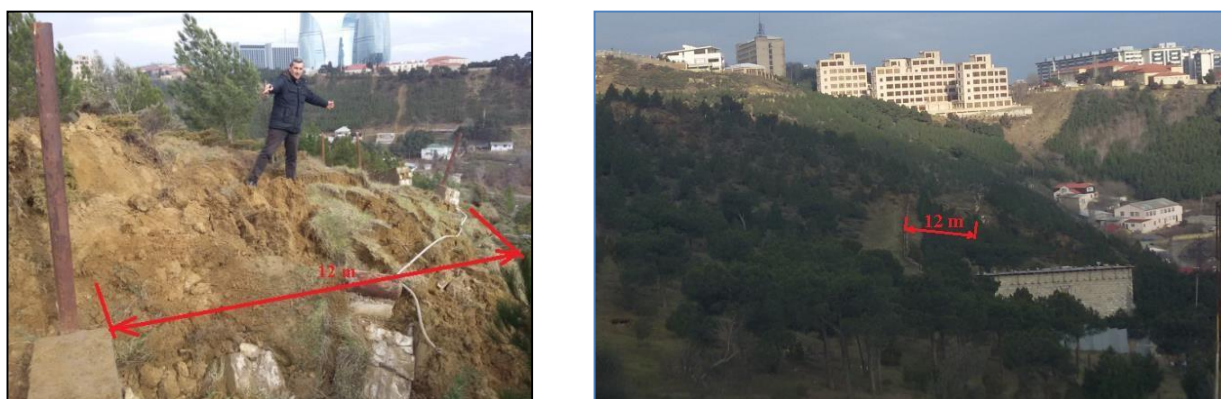
Fig. 16. Relocation of a stone fence

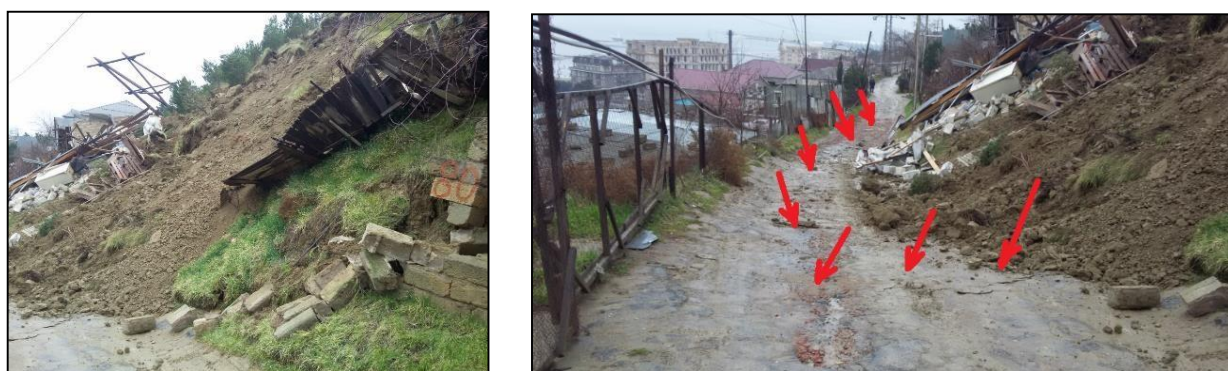
Fig. 17. Destruction, observed cracks and uplifts on the surface at a distance of 130 m from the edge of the landslide
