## Structural analysis of Ahlat Emir Bayındır Bridge

There are many historic buildings belongs to many civilizations in the Ahlat province. The fact that these structures survive for a very long time is directly related to the construction techniques of these structures. Emir Bayındır Bridge is one of the buildings that could stay solid. With this study, it is aimed to investigate the behavior of the bridge under earthquake effect. First of all, general information is given about the bridge. In this study, structural analyzes were carried out for the Ahlat Emir Bayındır Bridge after on-site inspections. Information about the damage that occurred over time in the bridge is given in this study. Observation based structural analysis form has been created for the bridge. A finite element model of the bridge was created with the help of on-site measurements. Analyzes were made for the created finite element model in different load cases. The obtained results were interpreted and recommendations were made.

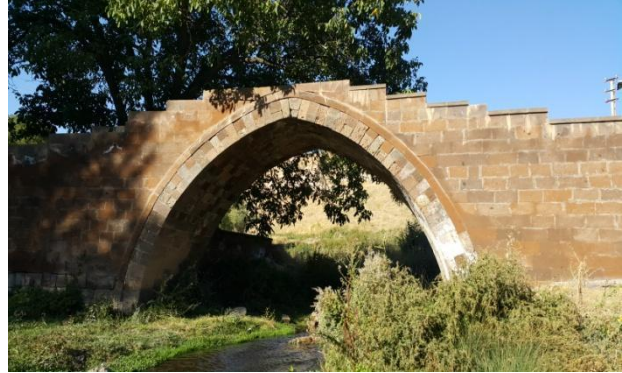
Figure 1. Emir Bayındır Bridge

The railings on the side of the bridge were constructed gradually according to the bridge slab. There are eight steps, 4 on downstairs and 4 on upstairs, on the bridge slab in total. Stairs are used in entrance and exit of the bridge. The bridge was built from Ahlat Stone, which is unique to the city of Ahlat. This is a beautiful example of pointed arched bridges. Since the bridge is narrow and stepped, it is used only by the pedestrians today (Figure 1).

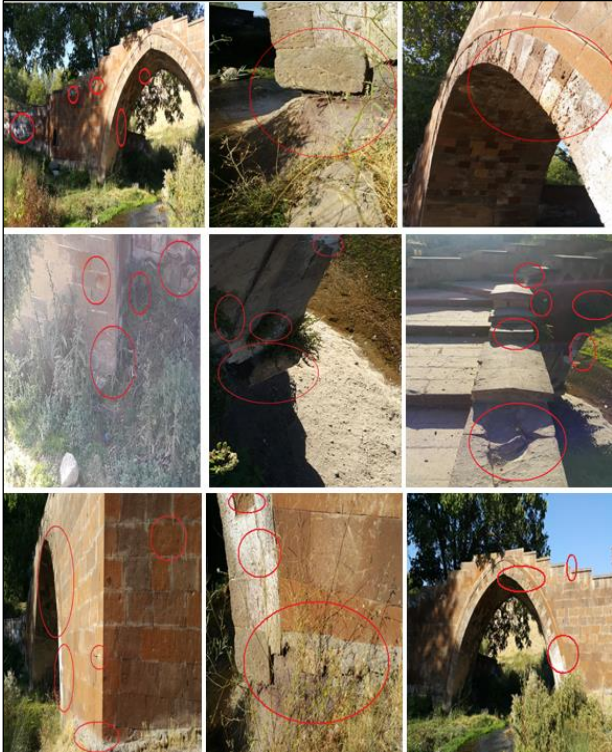
Figure 2. The observed damages in Emir Bayındır Bridge

Ahlat stone was used in the construction of the bridge. (Bakiş et al., 2014). Today, the structure is used for transportation purposes and it is closed to vehicle traffic because it is narrow and stepped. The distribution of the structural system elements is uniform. The bridge was damaged due to treasure searching and street writing of the people of the region. Depending on the time, various damage has occurred due to other environmental factors such as wear and tear. Ahlat stone, which is belongs to the group of natural stones, was used on the walls, covering and slab of this structure. It has get through the Van earthquake without any damage in 2011. It is known that there is not too much wear and tear besides, heat differences and frost affecting humid environments causes fragmentations and fractures due to the soft spongy nature of the Ahlat stone. Moisture-induced deterioration has observed on the areas of the stone contacting with water. It would be beneficial to make the necessary water isolation in the natural soil connection joints of the structure base. Freezing-thawing, which is environmentally effective especially in cold periods, is one of the most important factors in the deterioration of the building materials on the site. These problems are partially observed on the bridge. Lichen formations which formed due to dry climate and high carbon content, are attract attention. Lichen formations can have negative effects on the appearance and properties of natural building stones over time. One of the most important factor negatively effects on historical buildings is water. Water, alone or in combination with other environmental factors, negatively affects the mechanical properties of building stones and accelerates deterioration. However, low water flow rate keeps the water damage on the bridge at very low levels. Generally, there are scours on bridge legs. There is a separation between the stones at one or two points of the bridge. Some of the bridge railing top stones is completely missing, and some of them have fracture damage. There are moisture induced traces on the bridge. Mass losses and color changes are exists on the front surface of the belt part of the bridge due to the effects of wear. Lichen occurrences are seen in different parts of bridge. On the other hand, joint losses have occurred in some parts. Observationally determined structural analysis form of the Emir

Bayındır Bridge is shown in Table 1. The images of damage and deformations are shown in Figure 2.

In time, the mass losses, wear and tears have occurred in the component stones of the bridge under natural conditions. In addition, lichen formations on these stones have also damaged the stones over time. Moisture influences have occurred on some stones place to place due to water effects. Authorities are continuing to work on fixing these occurred damages and protecting the stones from damage in the future.

All of these stresses were obtained from G + 0.3 QEX + QE<sub>y</sub> load case. Stresses that may occur on the bridge can be carried without any problems. However, calculations can be made on the bridge in future studies in order to different earthquake effects. Damages that may occur on the bridge over time, must be observed and timely intervened and by this way, bridge should be transferred to the next generation.
