Seismic Risk Assessment of Existing RC Buildings in Muğla

Vesile Hatun AKANSEL1*, Mehmet Artun BAKİ2

Seismic Vulnerability, Walk-Down Survey, Preliminary Assessment, Reinforced Concrete Building

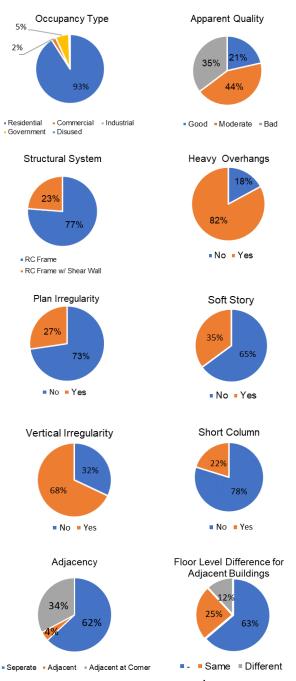
Figure 7 Classified Data for RYTEİE (2019) survey parameters

In Fig. 7, different classifications are displaced to observe the data. The buildings are classified according to their occupancy type as 93% residential, 5% government and 2% commercial buildings. 77% of the buildings are reinforced concrete frame system and the rest have a structural system type as reinforced concrete frame with shear walls. It has been determined that the apparent quality of 35% of the buildings is "Bad", 44% is "Medium" and 21% is "Good".

The majority of the buildings suffer from the heavy overhang effects. Heavy overhangs were observed in 82% of the buildings examined. Among all buildings, 27% of the buildings have a plan irregularity.

Another problem mostly observed in buildings was the irregularities in the vertical. The vertical irregularity caused by the discontinuity of the vertical elements of the structural system was found in 68% of the buildings examined. Among these buildings, the soft story was the most common problem encountered. Furthermore, gusset-supported cantilever beams or columns were also determined. Soft story irregularity was encountered in 65% of the total buildings. Short column effect, which is one of the other weaknesses that negatively affects the behavior of the buildings during earthquakes, is not common and the ratio is at the level of 22% in database.

Another important parameter is the floor level difference between adjacent buildings. Leveling differences of adjacent buildings can increase the failure during earthquake. Since 62% of the buildings are separate, the probability of collapse is less than the adjacent ones. The floor level of 25% of the adjacent buildings is at same level or critical and at different levels in 12% of adjacent buildings.
