Modelling of the Oil Spill in M/V LADY TUNA Accident and the Evaluation of the Response Operation in Simulated Condition with PISCES II

How to cite: Aydın, D. & Solmaz, M. S. (2019). Modelling of the Oil Spill in M/V Lady Tuna Accident and the Evaluation of the Response Operation in Simulated Condition with PISCES II. *International Journal of Environment and Geoinformatics (IJEGEO)*, Vol. 6(2): 213-224, DOI: 10.30897/jegeo.579066

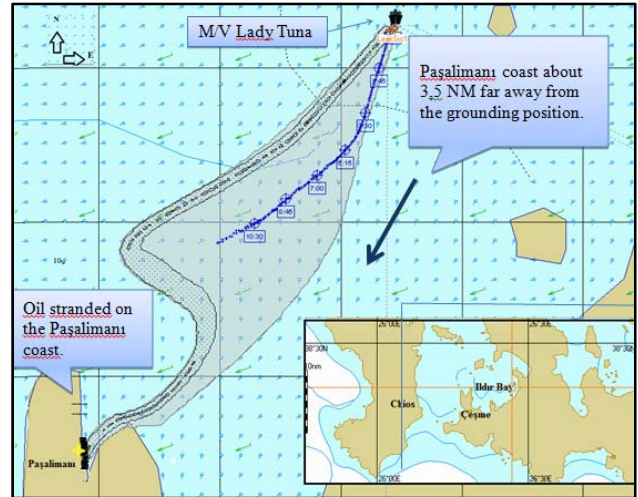
Figure 14. Scenario-1: The Oil Stranded on the Paşalimanı Coast (Δt: 12 h).

The area shown in gray color indicates the area where oil is spreading for up to 12 h from the beginning of the scenario (spilled oil; 60 tons) (Fig. 14). The program shows the information “Oil impact on land” on the window screen. The oil reached on the Paşalimanı coast (0,02 %) about 12 h later following the spillage (Table 5).

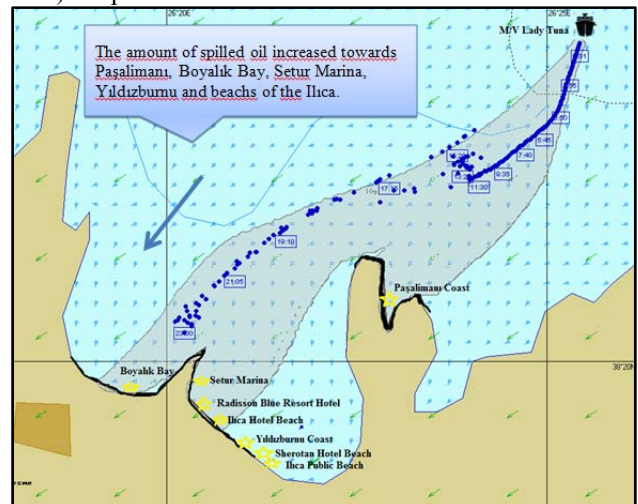
Figure 15. Scenario-1: The Movement direction of the oil slick (Δt: 36 h).

As a result of the scenario, the movement direction of the oil slick after 36 h from the accident is shown in Fig. 15. It is clearly seen that the oil was stranded at Paşalimanı coast, the Boyalık Bay, the Setur Çeşme Marina, the Radisson Blue Resort Hotel beach, the Ilıca Hotel beach, the Yıldızburnu coast, Sherotan Hotel beach and the Ilıca public beaches. The pollution and spill parameters (after 36 h) are presented in Table 6.

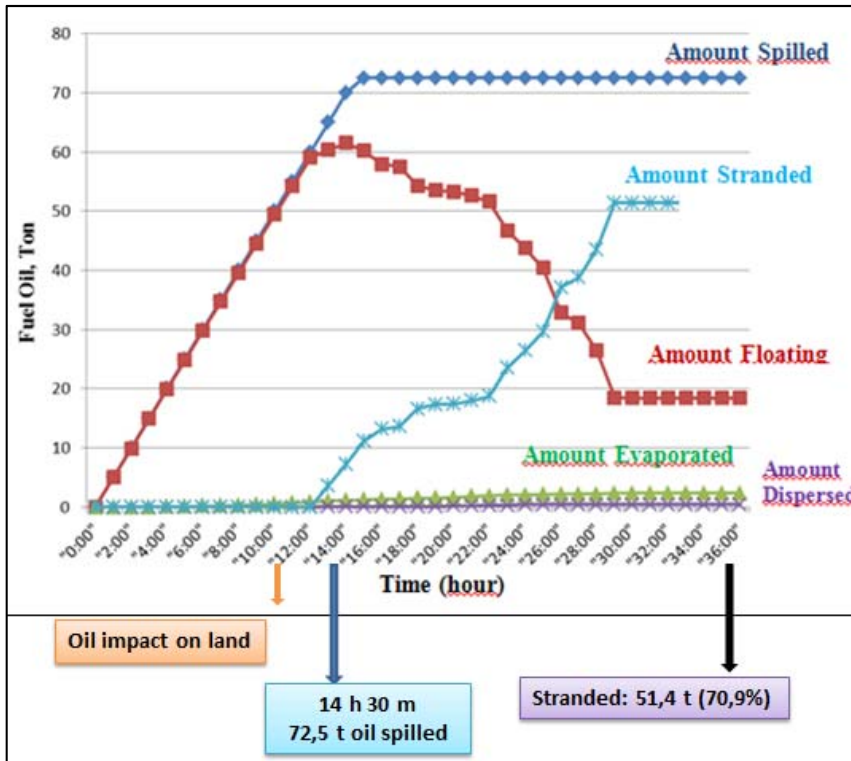
Figure 16. The Graphic of the Spill/ Pollution Statistics of the Scenario-1.

incident in the simulated condition as graphically (Fig.16). So, the following results are obtained in the Scenario-1;

- After 14 h and 30 minutes following the accident, 72,5 tons fuel oil leaked from the ship's tanks (5 tons/per hour).
- The amount of stranded oil (which began about 12 h after the spillage), is 51,4 tons (70,9 % of the spilled oil) as well as the floating oil amount is 18,4 tons (25,4 % of the spilled oil).

- The amount of floating oil increased until 14 h following the accident. After this time the floating oil rate decreased because the oil reached on the coast as well as the fuel leakage ended after 14 h and 30 min.

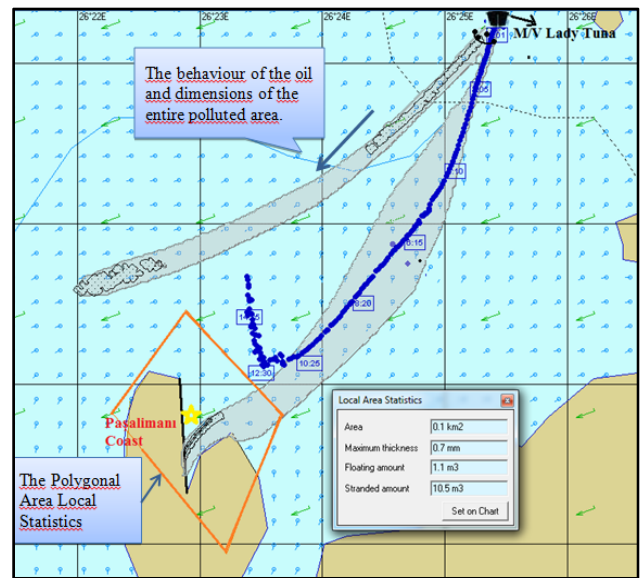
Figure 19. The Behavior of the Spilled Oil and Local Area Statistics (Δt : 15 h).

The display of oil pollution in gray color indicates the size of the entire polluted area from the start of the scenario until 15 h following the spillage. After using the resources of response on the sea, it is observed that the direction of oil has changed.

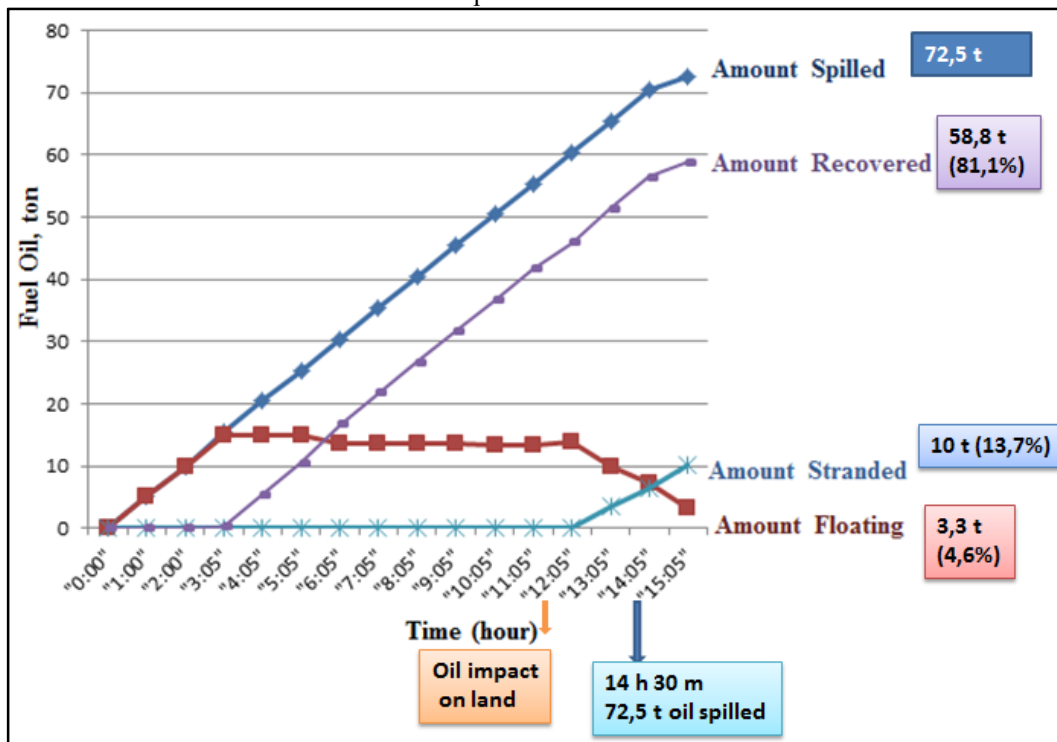
Figure 20. The Graphic of the Spill/Pollution Statistics of Scenario-2 by Creating the Response Operation.

- Thanks to the response operation, the amount of the oil which reached the shore reduced. The spill

statistics presented that 81,1 % of the spilled oil (58.8 tons) was recovered when the oil spill response actions was taken without losing time.

- The simulation PISCES II showed a significant influence on the efficiency of oil spill recovery from the surface of the sea. The spill statistics revealed that 81.10 % of the spilled oil (58.80 tons) was recovered and the stranded oil was limited to 10 tons after the response operation was managed without losing time. Thus, the spilled oil did not spread on the sea and cause less damage to the marine environment.
