Damage Assessment and Mortar Identification in Beylerbeyi Palace

Fuat ARAS¹◆

¹ *Anadolu University, Faculty of Engineering, Civil Engineering Department, Eskişehir, Turkey*

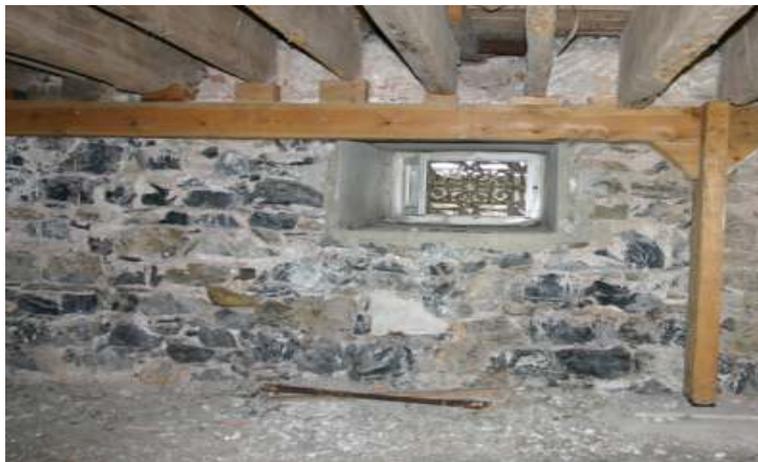
the construction technique of the structure is clearly understood. Thicknesses of the walls are changing between 2 m and 1 m and it is often 1.4 m on that floor. High humidity existence is monitored on that part although it has several ventilation openings. Figure 4 illustrates one of the ventilation openings on the foundation while high humidity is shown in Figure 5. The high level of humidity affected both the timbers, forming the slab system by causing decay and the masonry walls by causing cracking. Figure 6 shows the chipped timber members in order to prevent the propagation of the decay. It is obvious that ventilation openings in Beylerbeyi Palace are not adequate to prevent high humidity. Recent studies have revealed that ventilation by using the appropriate machinery equipment can be used as a solution against high humidity [2].

Figure 4. Ventilation opening in the foundation floor.

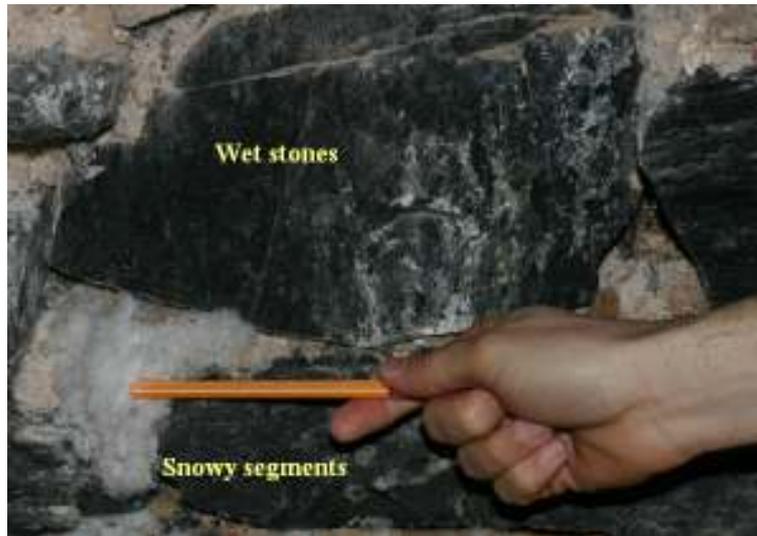
Figure 5. High humidity over stones and its effects.

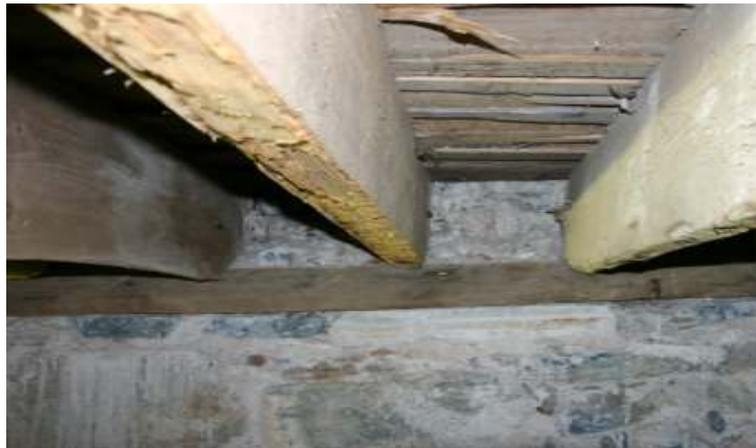
Figure 6. Chipped timber beams due to decay on the foundation floor.

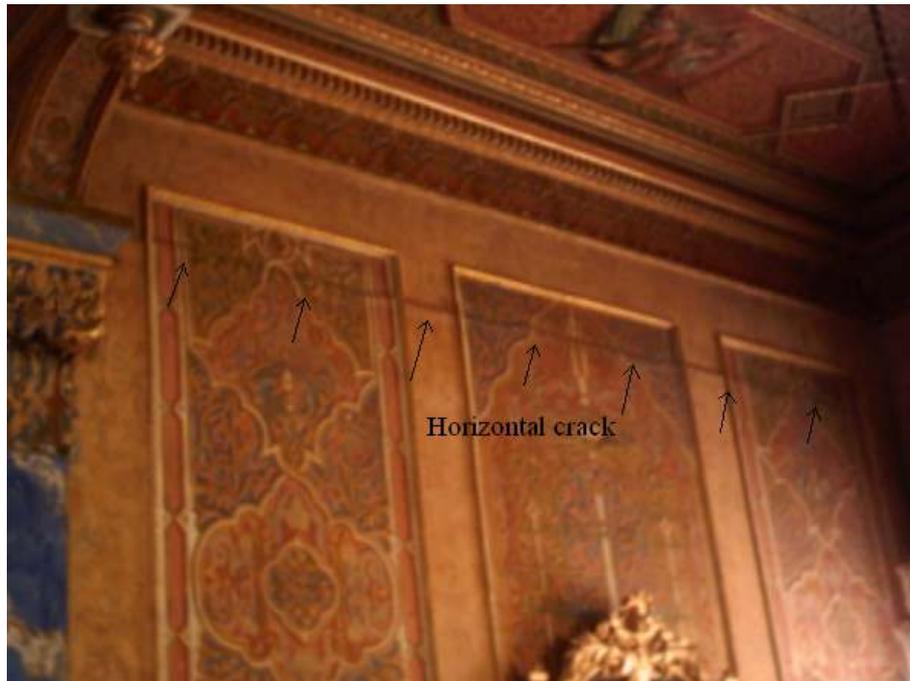
On the first and second floors of the structure several cracks were observed. Since no restoration process has been carried out in the mabeyn part of the palace, everything is original. On the other hand in the harem part of the palace repair works were performed to cover the cracks. For this reason most of the detected cracks are in the mabeyn part on the stucco plaster. Since the reproduction of stucco plaster is impossible nowadays, authorities do not touch the cracks to repair them. Similarly the timber coverings of the rooms in mabeyn part have very wide cracks which make it hard to interpret their effect over structural safety. If the cracks

stem from the damage occurred on the wall beneath the covering, special care must be taken. Other wise these cracks are harmless and they only disturb the beauty of the rooms. Through Figures 7 – 9, the observed cracks are shown. The cracks can be classified into three categories as follows:

Figure 7. Horizontal crack in the Mabeyn part.

Not only is the existence of the damage but also their reasons are in importance. The existing damages may stem from the horizontal earthquake loads, ground settlements, or aging and atmospheric conditions. The palace experienced two strong earthquakes (1894 and 1999) since it was built. As mentioned the palace has timber floor system which is not adequate to supply rigid diaphragm action on the floor levels. In this condition the horizontal cracks can be induced by the out of plane movement of the walls whereas the inclined cracks at the corner of the openings like windows and doors are the sign of in-plane action under horizontal loads. In this respect it can be concluded that these cracks are probably induced by the horizontal earthquake load. On the other hand stress analysis by using an efficient computer package program is essential for a certain conclusion.

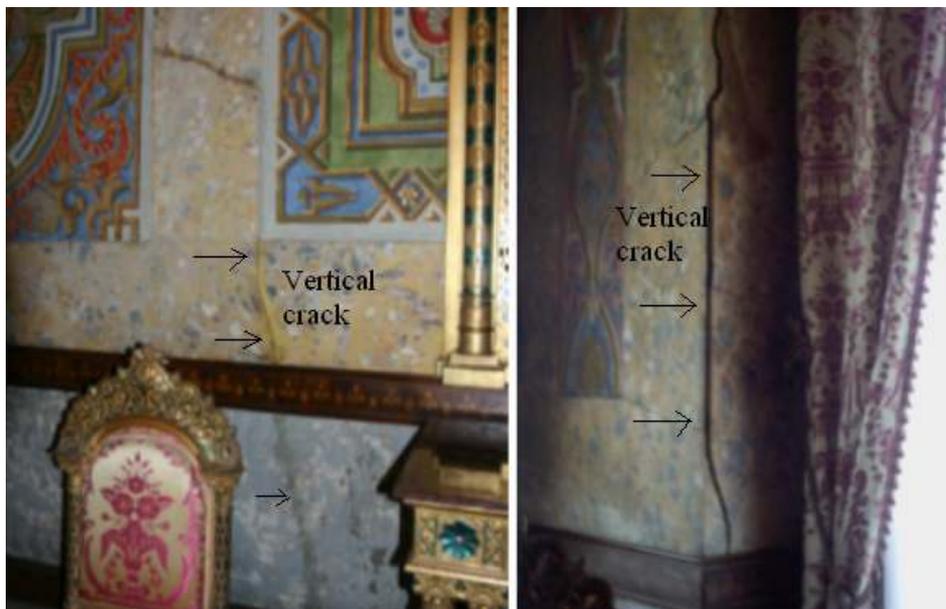
Figure 8. Vertical crack in Mabeyn part.

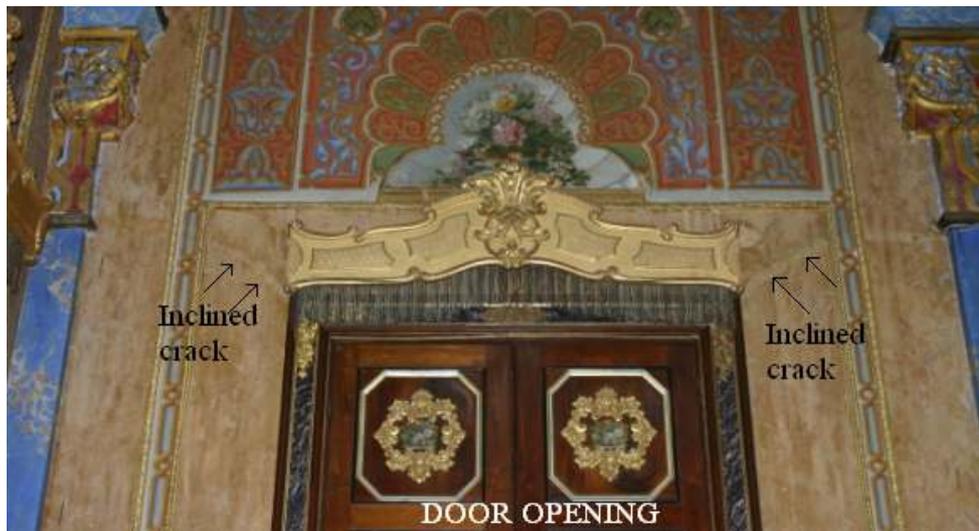
Figure 9. Inclined cracks on the corners of the door.

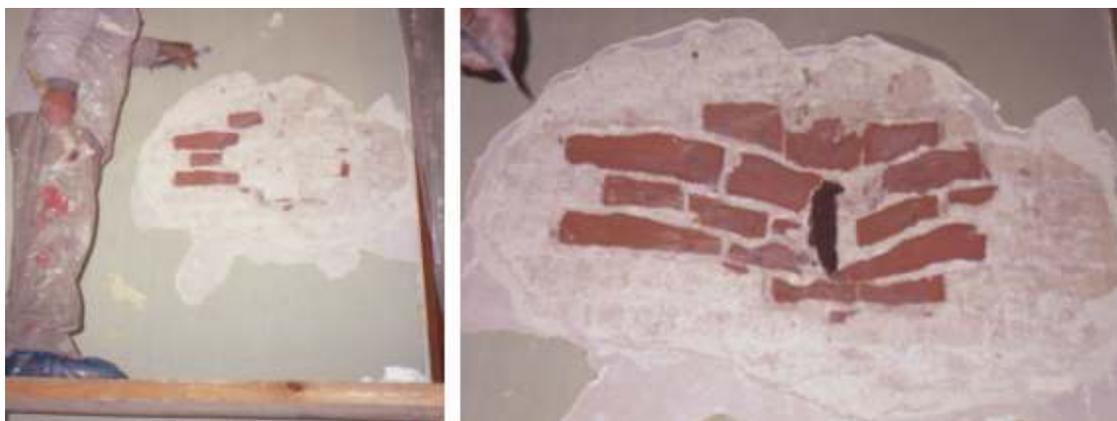
Another type of damage is caused by the metal clamps placed within the masonry walls. The oxidation of cast iron clamps used within the masonry caused swelling and finally cracking of the wall in a room and stair case in harem part. This damage ended up with the separation of about 50*50 cm² wall part in the room as seen in Figure 10. The same fact has repeated the damage in the staircase of harem part. This crack formation is shown in Figure 11. Together with the damages observed of foundation floor, the damages induced by the oxidation of metal clamps can be named as damages caused by aging and atmospheric conditions.

Figure 10. Damage induced by the oxidation of metal clamps before and after the separation of wall part in the room.

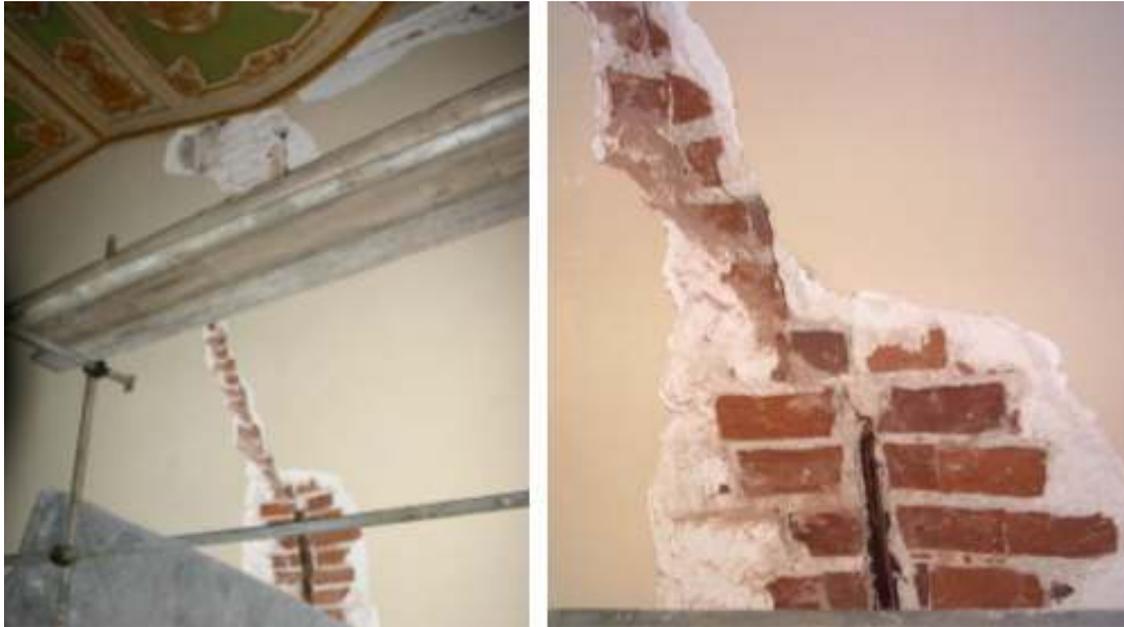
Figure 11. Damage induced by oxidation of the metal clamps in the staircase of Harem part.

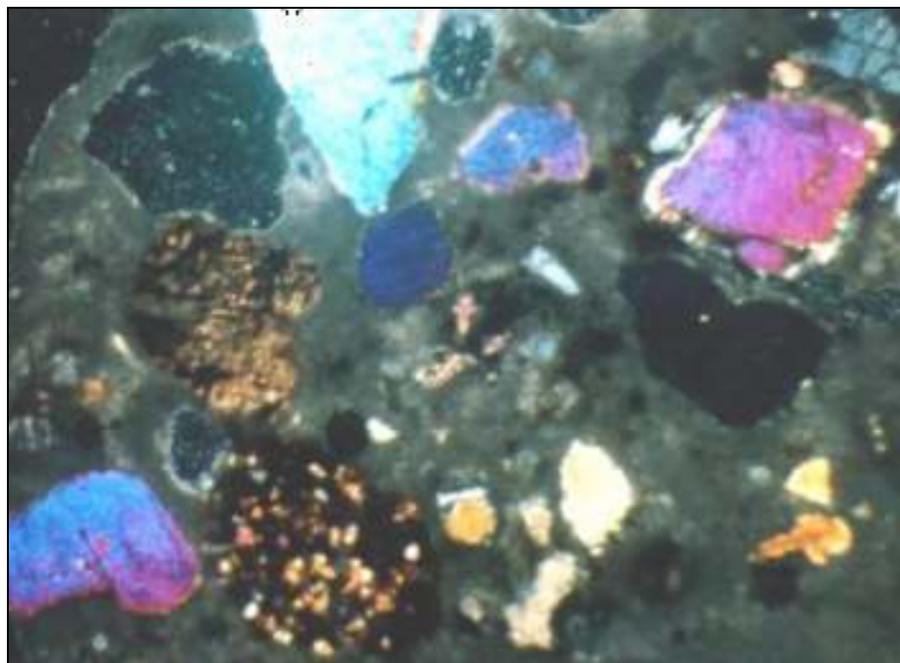
Thin-section analysis showed that, about 60% of the mortar is binding material and remaining part is the grains. The general grain size is about 500 μm and less. It occasionally reaches to 1 mm. These grains contain

mineral particles, quarts particles and clearly identified brick powder particles. Table 1 summarizes the identified ingredients of the thin-sections.

Figure 13. Photograph of thin-section under microscope.

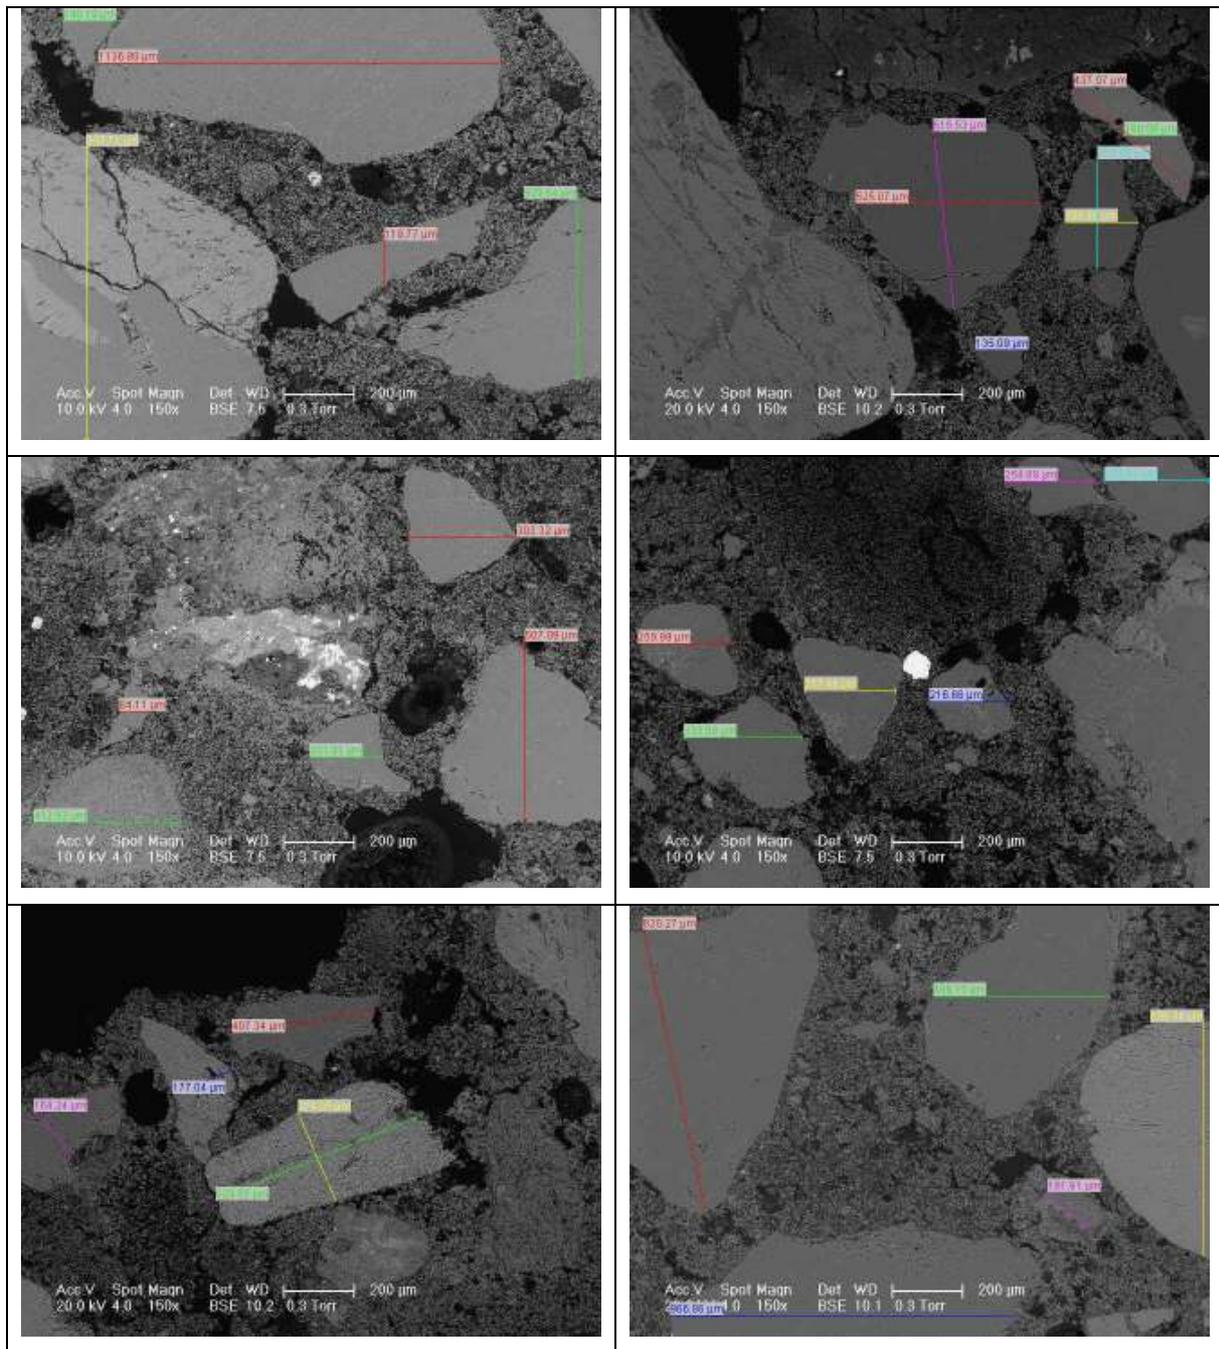
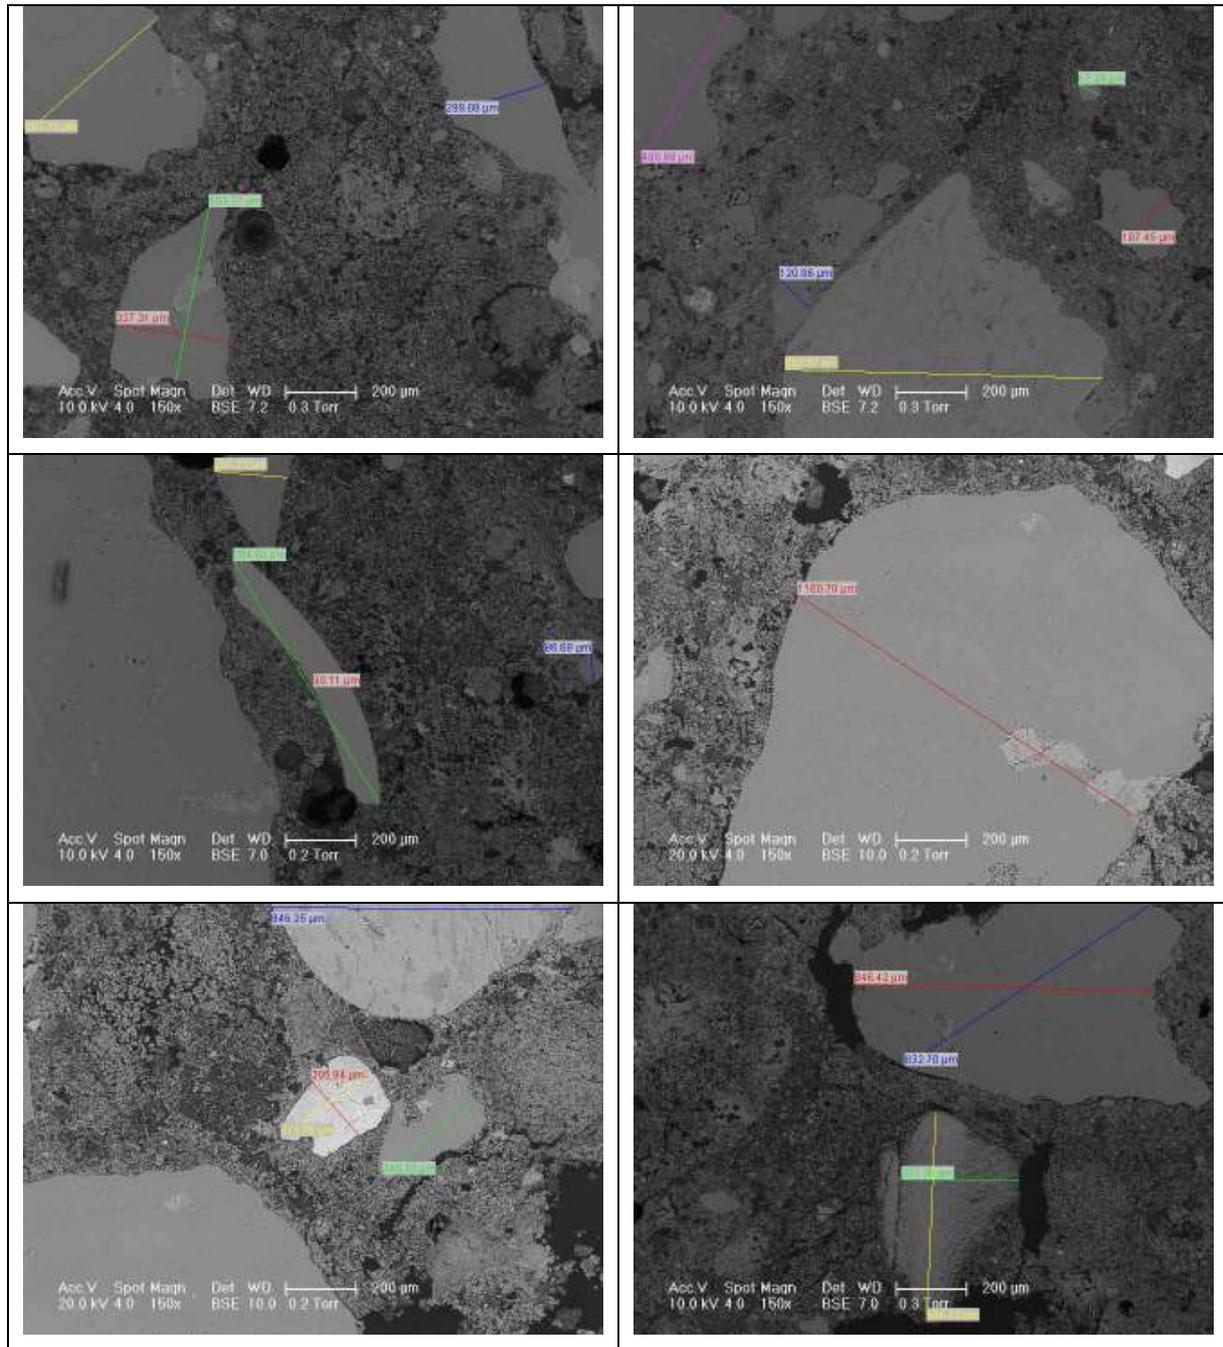
Good connection between particles and binding material was observed through the SEM views. No gap or cracks were determined. Particle size distribution can easily be determined from SEM views (Figures 15 –

17). It is seen that the grain particle size, used in mortar is greater than that used in plaster. According to SEM views the maximum size is determined as about 1800 μm .

Figure15. SEM views from the mortar between the bricks.

Figure 16. SEM views from the mortar between the bricks.

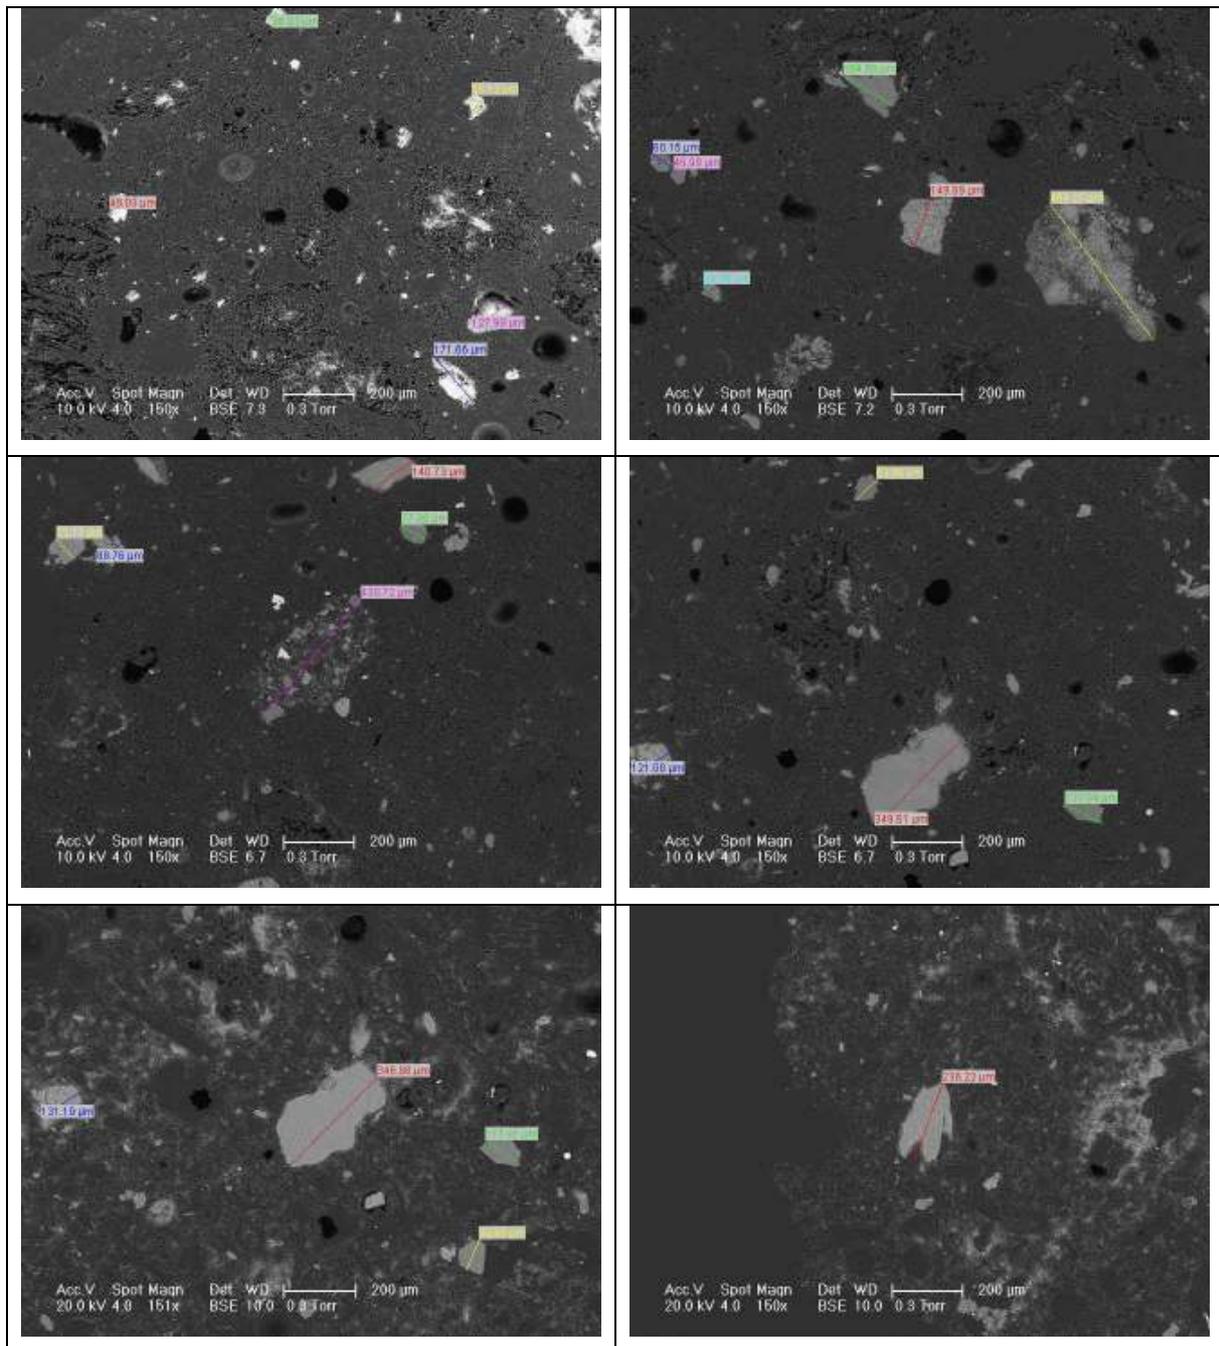
Figure 17. SEM views from the plaster.

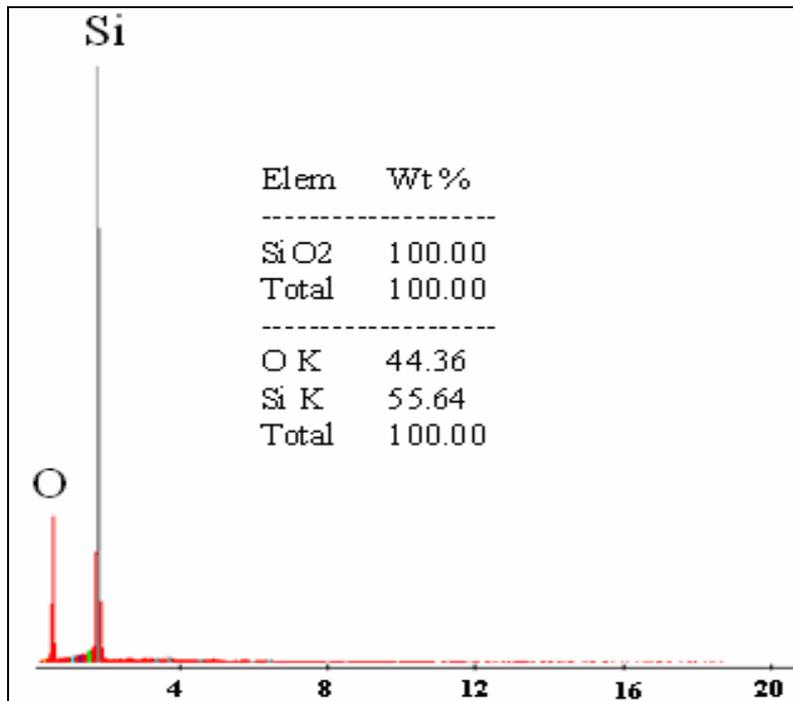
The EDX analyses were performed simultaneously with the SEM. It was determined that the mineralogical origin of the particles is quartz, SiO₂ and derived from the aggregates containing sand and brick powder. Figure 18 represents the EDX analysis for a particle,

Figure 18. EDX analysis of particle in SEM view.

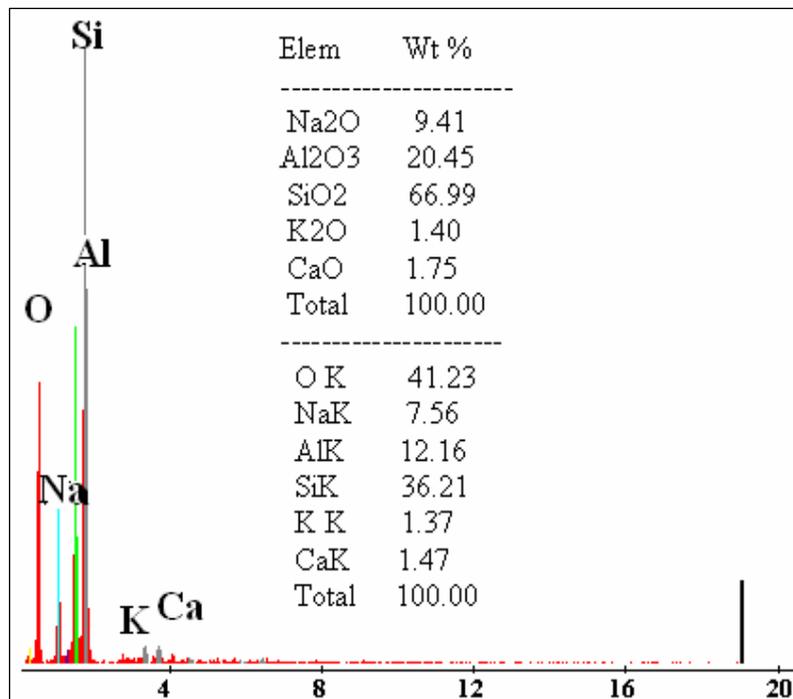
seen in SEM view as in grey colour. Wt % column shows the weight ratio of the each element and oxides. Occasionally feldspar minerals were seen through the EDX patterns of aggregates (Figure 19).

Figure 19. Identified feldspar elements, EDX analysis of particle.

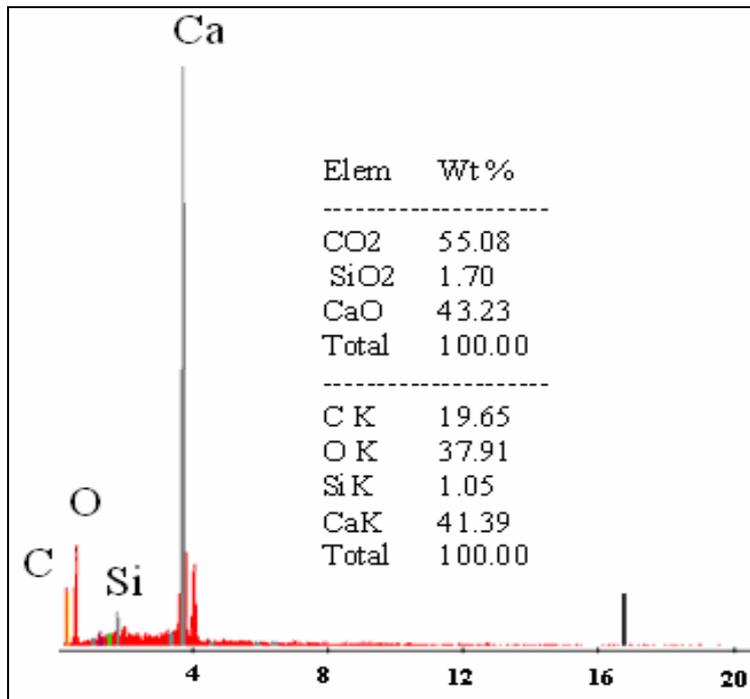
EDX analysis showed that the origin of the binding material between the particles is calcite minerals. Calcite is originated from carbonated lime [5]. Figure

Figure 20. EDX analysis of binding material in SEM view.

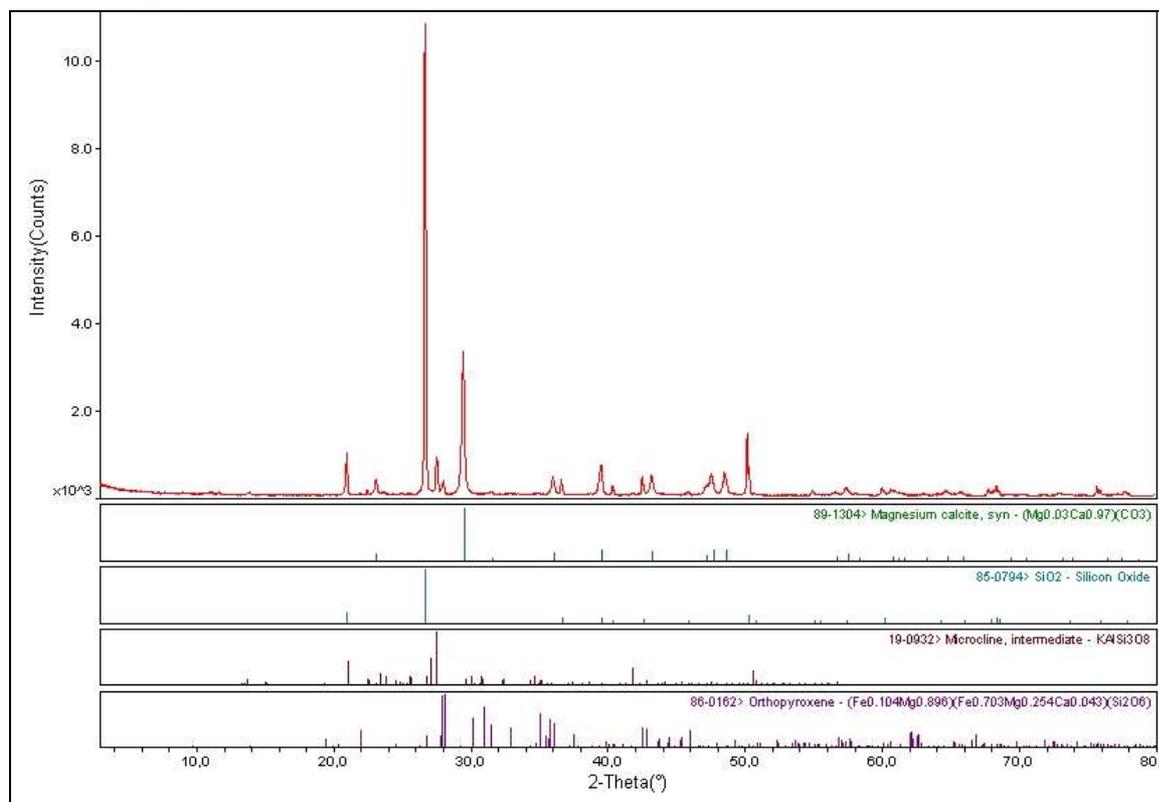
X-ray Diffraction (XRD) clarifies the nature of the mineralogical phases present in the sample [6, 7, and 8]. Pulverized mortar specimen were analyzed under Rigaku D/Max-Ultima+/PC XRD device and diffractogram were obtained for each specimens. Figure 21 shows one of the XRD diffractograms. Mineral ratios for each specimen were estimated by using line magnitudes and areas. The results verified the existence of calcite and quartz elements. Six specimens were

analyzed and it is seen that each of them consists of quartz, calcite and feldspar minerals with varying ratios. Table 2 summarizes identified component ratios for each specimen. These specimens were taken from the two different room of the palace and all specimens belong to mortar between bricks. The average of ratios indicates that, about 65% of the horasan mortar is calcite derived from carbonated lime, 30% of the mortar is quartz, derived from aggregates, and 5% is feldspar, (Na, K, Ca), (Si₃Al)O elements.

Figure 21. XRD diffractogram of W-02 specimen in Table 2.
