The Investigation of Municipal Buildings and Their Environments in Ankara with Regard to Turkish Standards Related with Accessibility

Ayşe Şeyma ARSLANTAŞ^{1,♣}, Can GÜNGÖR²

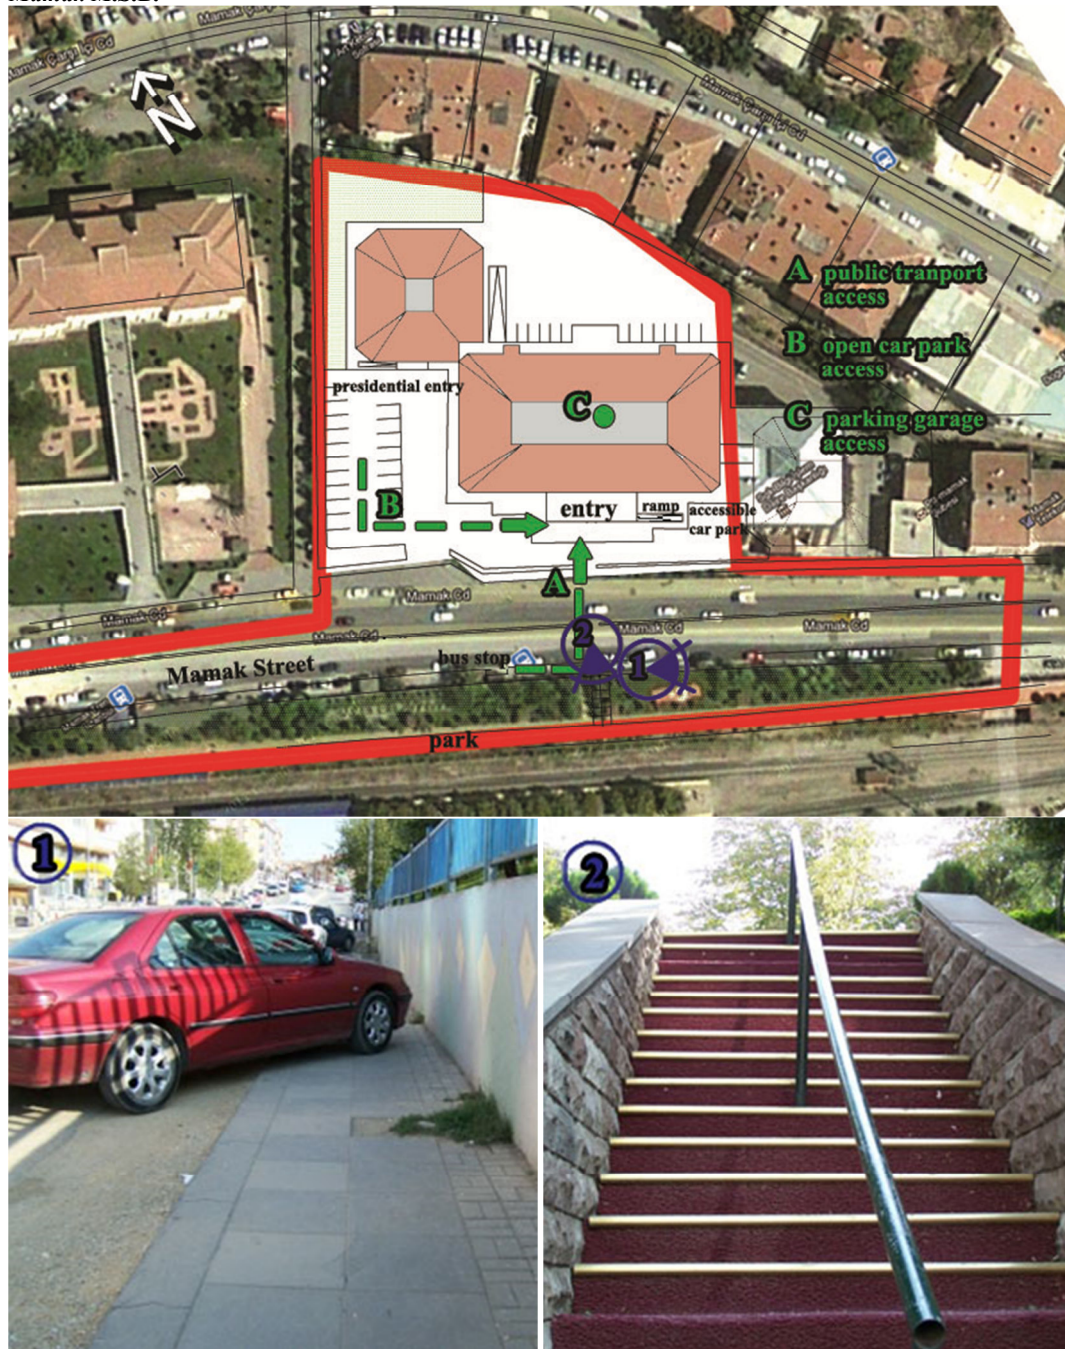
Figure 2 Even pavement-road levels causes obstructions on route / un-protected external stairs form weather conditions, lack of side railings and non-slip markings on edges of stairs / External ramp well designed but not protected from weather conditions and not signed with perceptible markings around Mamak M.S.B. (Photograph: Ayşe Şeyma Arslantaş 2012)

- External stair surfaces are made of slippery materials and are not protected from weather conditions (TS 12576 Section 5.3.2)
- The height of the stairs reach higher than 180cm but there are neither half-way landings after 8-10 stairs nor there are side or mid railings where necessary (TS 12576, Section 5.3.1)
- The width of the accessible route is not 120-150cm consistently (TS 12576 Section 5.1.1)
- The screws binding electrical post are not hidden appropriately to prevent tripping (TS 12576 Section 5.1.7.1)
- The protective obstacles from parking cars on pavements are not located so that the pavements are occupied with cars. (TS 12576 Section 5.1.6)

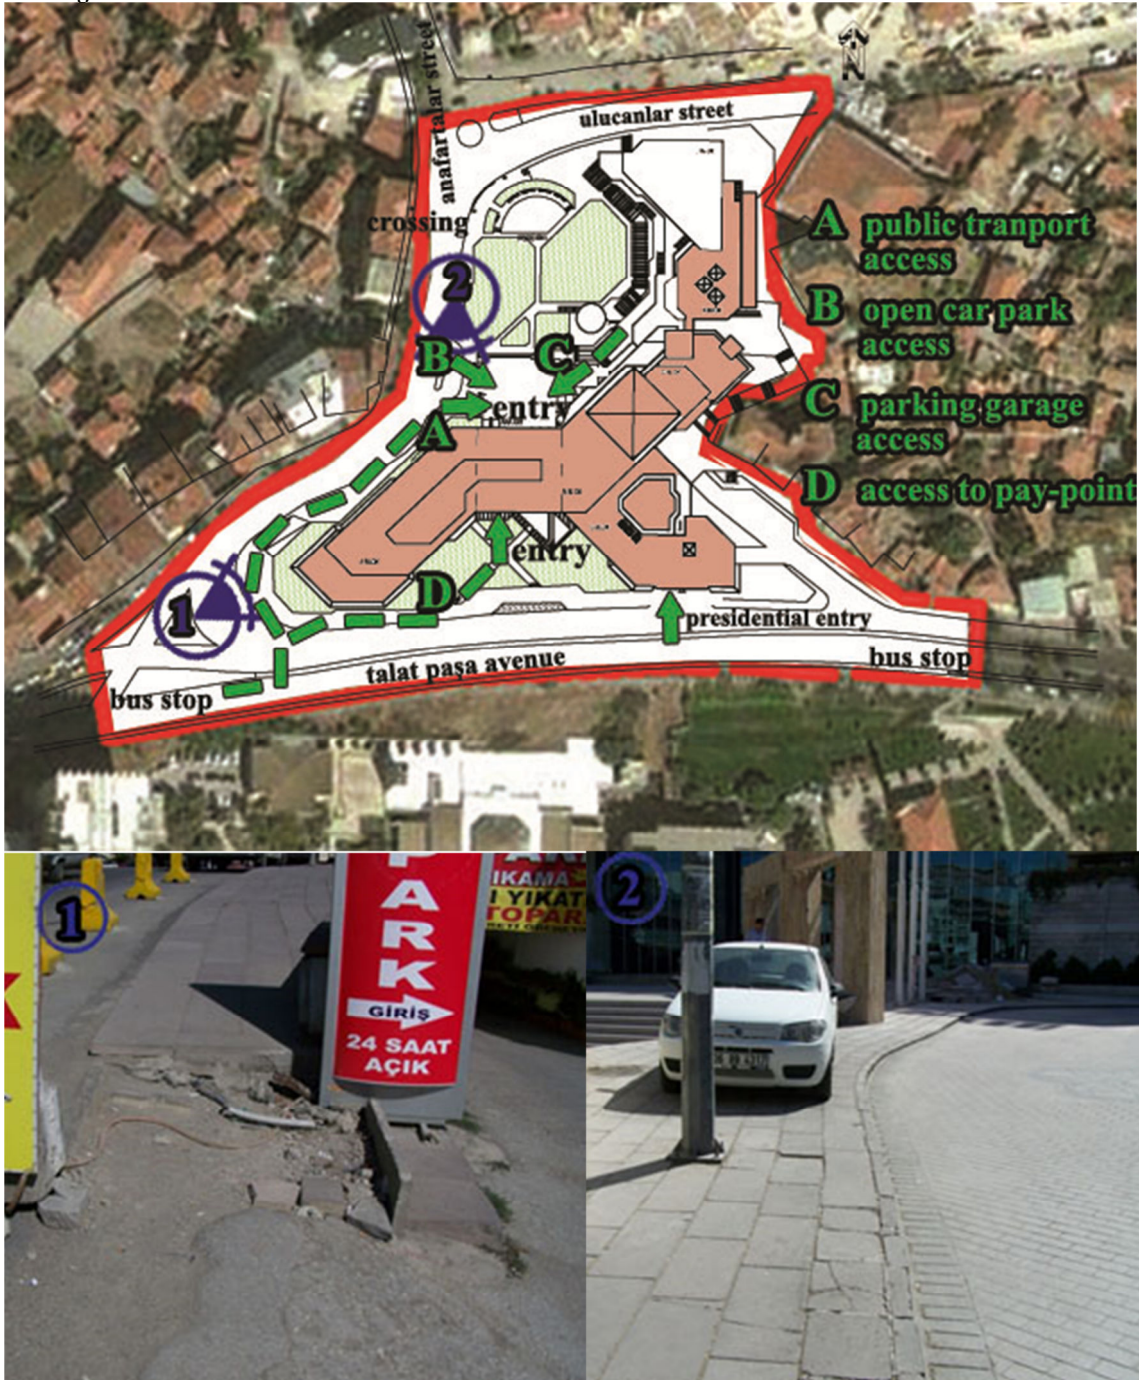
Figure 3 Non-even pedestrian walkways, deficient dimensions for accesible route, non signing with perceptible markings around / Non signed accesible car park, there are no curb ramp and non even pedestrians walkway Pavement road levels, non uniform external stairs / unprotected external stairs from weather conditions and lack of railings and non-slip markings around Altındağ M.S.B. (Photograph: Ayşe Şeyma Arslantaş 2012)

- The ramps along the pedestrian walkways are not as wide as 900cm and are not between 6% to 8% slopes (TS 9111 Section 4.3.7)

- The width of the accessible route is not 120-150cm consistently (TS 12576 Section 5.1.1)
- In sloped pedestrian walkways even though the slope is higher than required there is no appropriate ramp according to the standards (TS 9111, Section 4.4.2.2)
- The cross slope of the pavement is higher than 5% (TS 12576 Section 5.1.3)
- In ramps higher than 15cm there are no railings, side protection or perceptible markings (TS 9111 Section 4.3.3.2)
- Even though there are level differences on pavements there are no protective railings (TS 12576 Section 5.1.6)
- Slippery materials are used in routes in an around building site (TS 9111 Section 4.3.5)

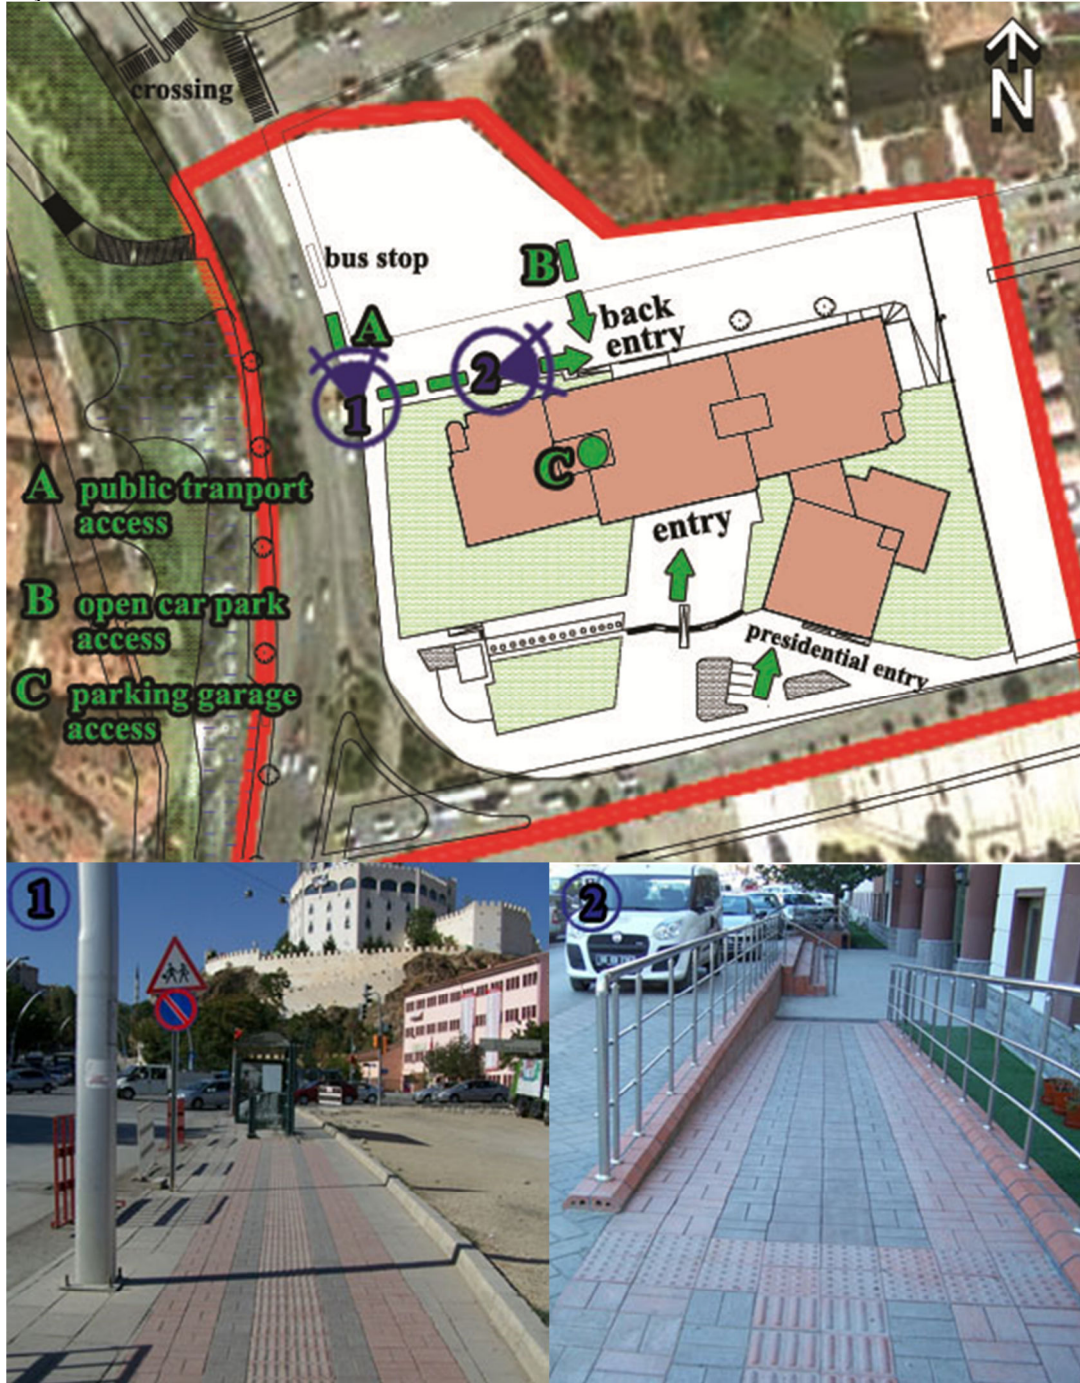
Figure 4 Enough dimensions for pedestrian walkways but obtrusive surfaces on lamppost / Low-slope ramp and perceptible (but not in contrasting colored) markings along the route / lack of informative signage / Non-conforming railings and protruding edges on each stairs around Keçiören M.S.B. (Photograph: Ayşe Şeyma Arslantaş 2012)

- There are protruding grains and pavement materials on pedestrian roads (TS 12576 Section 5.1.5)
- Perceptible markings are not made of different color (TS 12576 Section 5.1.5.1)

- Railings are not continued parallel to the ground at least 30cm long at the end and beginning of the ramps and (TS 9111, Section 4.4.3.4)
- Accessible route is not properly signed from the regular route (TS 9111, Section 4.4.2.2)

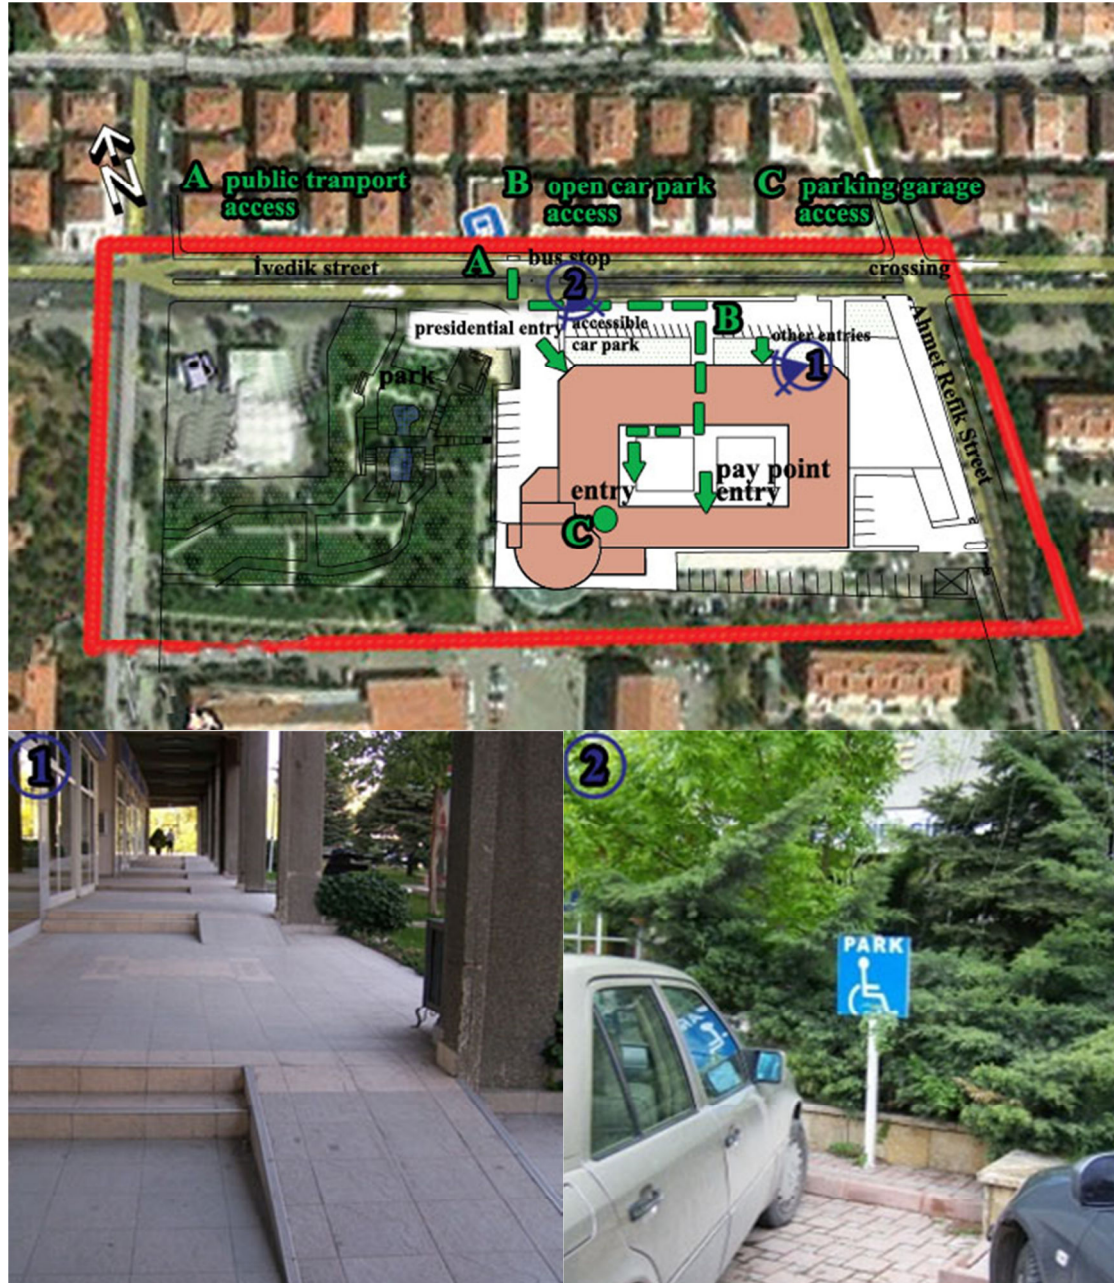
Figure 5 Lack of side railings and informative signage around / Low-slope ramp with no-perceptible markings along the route Yenimahalle M.S.B. (Photograph: Ayşe Şeyma Arslantaş 2012)

- The width of the accessible route is not 120-150cm consistently (TS 12576 Section 5.1.1)
- In ramps higher than 15cm there are no railings, side protection or perceptible markings (TS 9111 Section 4.3.3.2)
- The screws binding electrical post are not hidden appropriately to prevent tripping (TS 12576 Section 5.1.7.1)

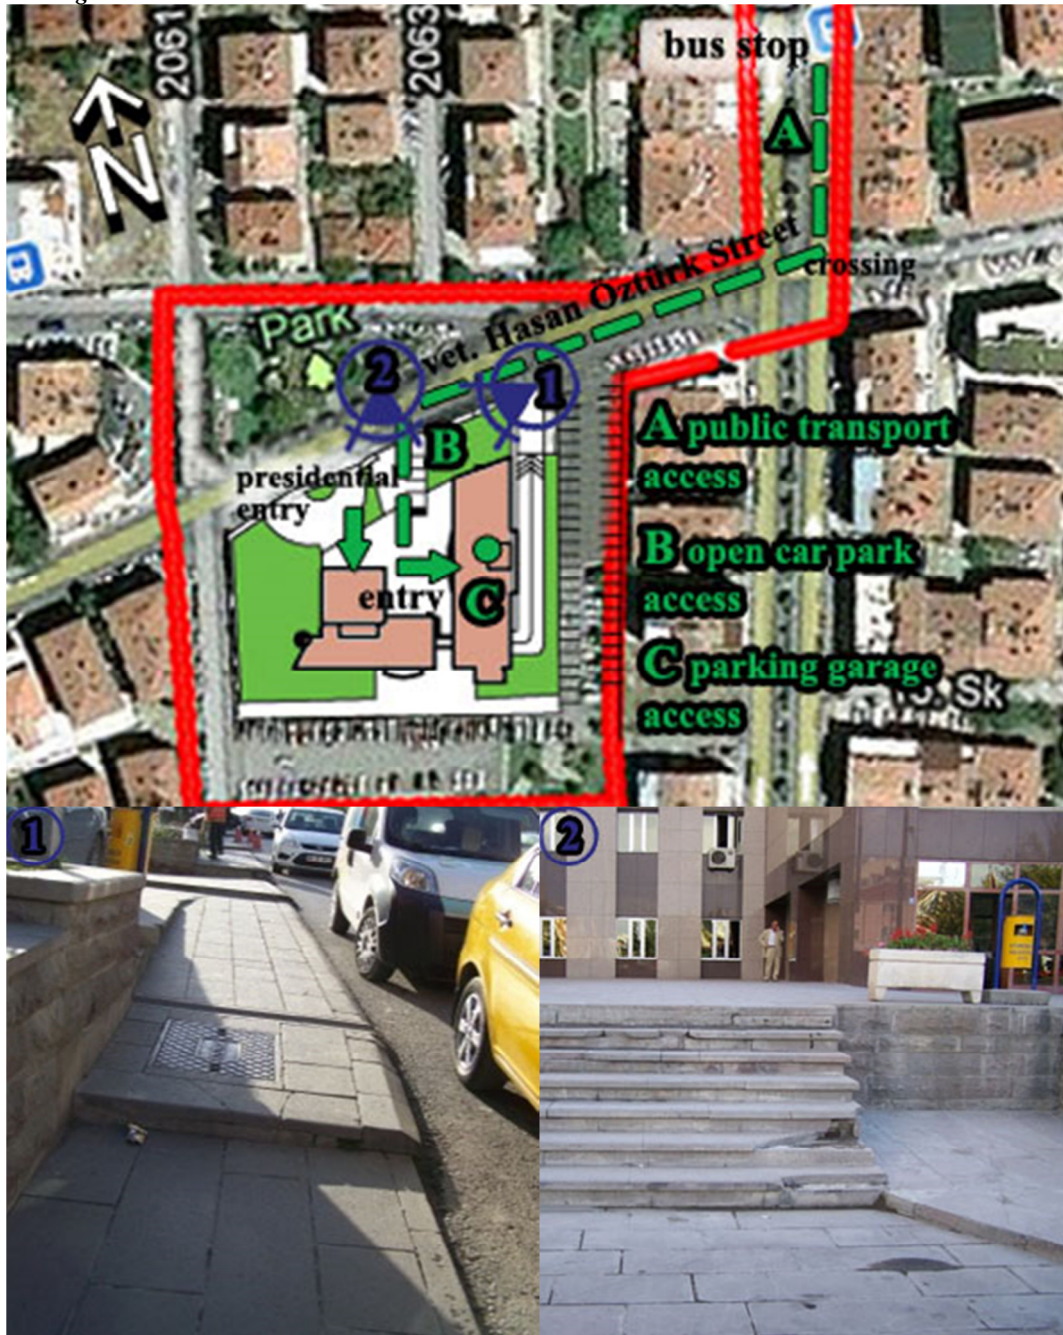
Figure 6 non-even pedestrian walkways along the route/ lack of side railings and informative signage / un-protected external stairs from weather conditions around Etimesgut M.S.B. (Photograph: Ayşe Şeyma Arslantaş 2012)

- The cross slope of the pavement is higher than 5% (TS 12576 Section 5.1.3)
- There are no ramps or curb maps where there is more than 13mm height differences throughout the pavements where necessary (TS 9111 Section 4.3.6) (TS 12576 Section 5.2)
- In sloped pedestrian walkways even though the slope is higher than required there is no appropriate ramp according to the standards (TS 9111, Section 4.4.2.2)
- The ramps along the pedestrian walkways are not as wide as 900cm and are not between 6% to 8% slopes (TS 9111 Section 4.3.7)
- Curb ramps 8higher than 5% slope) are not designed as hard non-slip materials and contrasting colored with low barbed materials (TS 12576 Section 5.2.3)
- There are no railings on sides of stairs. (TS 12576, Section 5.3)
- External stair steps have protruding edges (TS 12576 Section 5.3.3)

- In ramps higher than 15cm there are no railings, side protection or perceptible markings (TS 9111 Section 4.3.3.2)
