Academic Platform Journal of Natural Hazards and Disaster Management (APJHAD)

Volume 5 Issue 1, June 2024

Title	Authors	Pages	
An Innovative Retrofitting Technique of an Industrial Prefabricated Building Without Evacuation	Suat Yıldırım, Yüksel Ilkay Tonguc	1	29
Cloudbursts Strike over Foothills Himalaya of Uttarakhand, India: A Case Study from Maldeota, Dehradun District	Sushil Khanduri	30	45

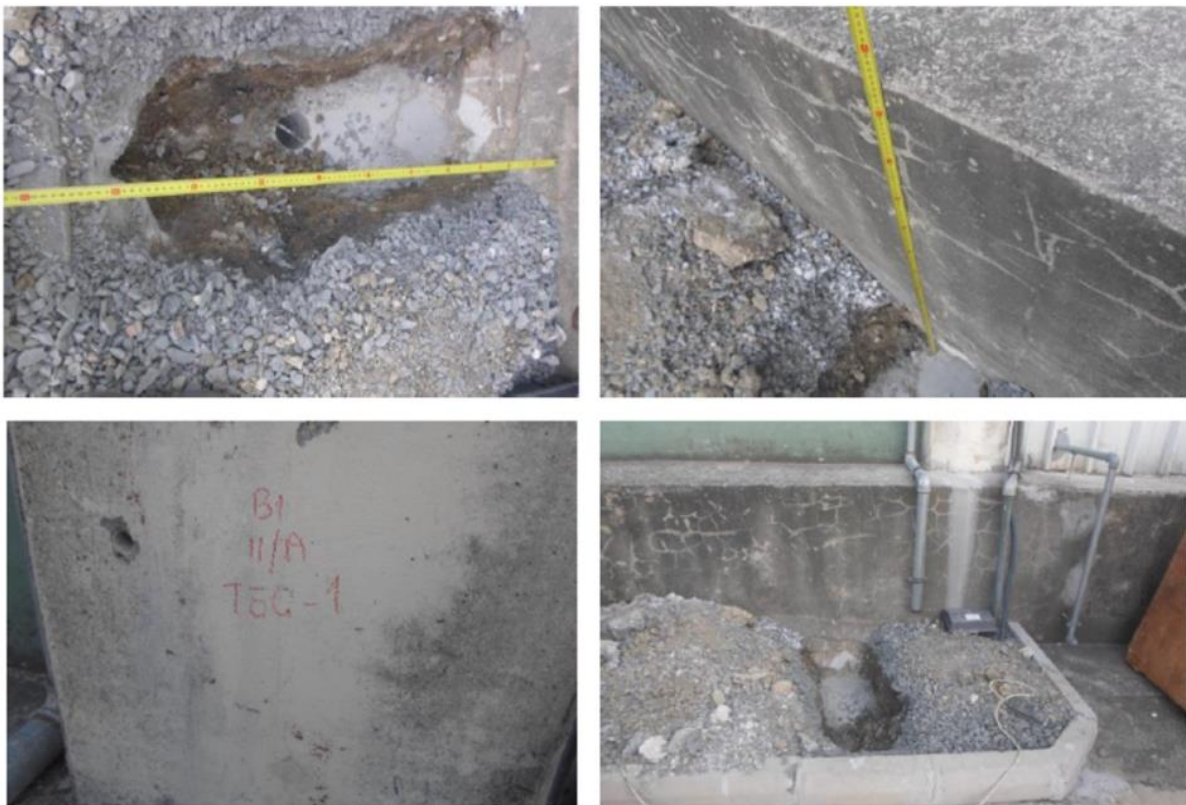
Figure 3. Foundation test pit excavation

Foundation System determination is based on construction project drawings provided by the client and confirmed by the excavation of two foundation test pits (Figure 3), the building utilizes a single-footing foundation system. The individual footings measure 360 centimeters by 360 centimeters with a height of 70 centimeters.

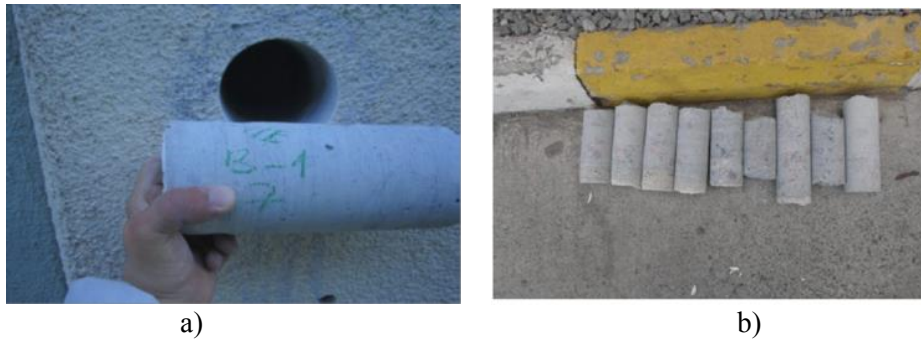
Figure 4. a) b) Concrete core sampling

To assess concrete quality, 17 core samples were extracted from selected columns (Figure 4). The compressive strength was calculated based on TBEC-2018 and determined to be 26,3 MPa for the B1 block. Additionally, reinforcement type, orientation, diameter, and corrosion levels were determined for 11 columns using a stripping-destructive method (Figure 5).

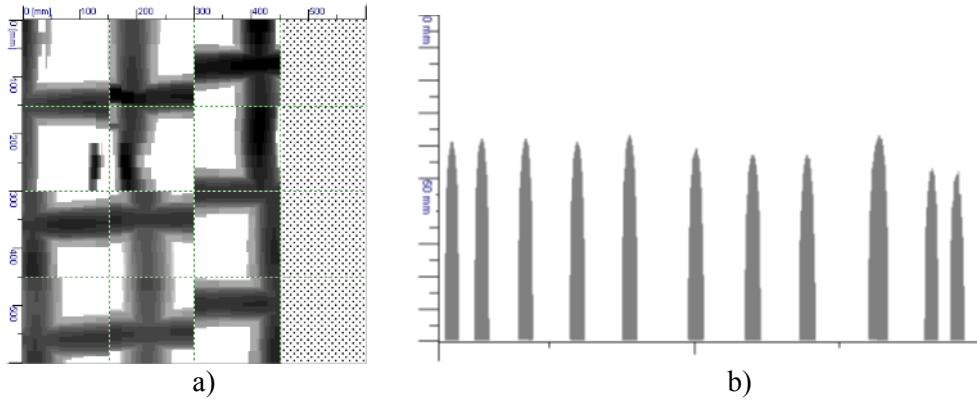
Figure 6. a) 60cmx60cm scan view from a column b) Vertical scan view of a column starting from the bottom. (1,6m-1,8m length)

Furthermore, Ferro-scan technology was employed on 19 vertical members to accurately determine the number and orientation of the reinforcing bars (Figure 6).

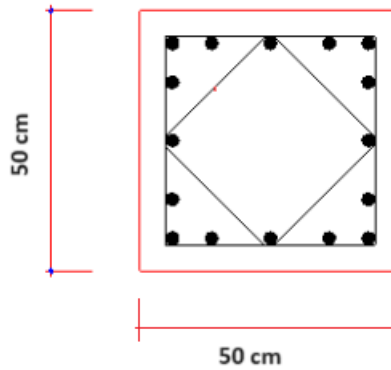
Figure 7. Determined reinforcement layout in a 50cmx50cm column

The determined reinforcement layout and details are presented in Figure 7 and Table 2. No corrosion and foundation settlement are detected in the structure.

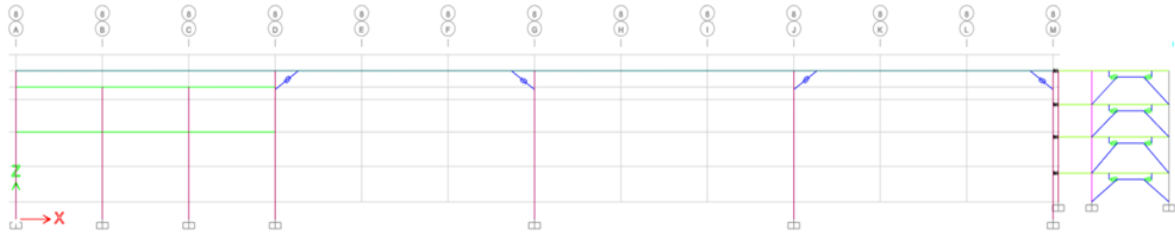
Figure 26. B1 and B2 blocks adjacent to each other

Another important mutual problem of B1 and B2 blocks were pounding each other during the earthquake due to insufficient dilatation space between two adjacent blocks (Figure 26).

X-direction displacement of Block B1 decreased to 129 mm after retrofitting with dampers, but it still exceeds the existing space of 50 mm between the two blocks. This discrepancy suggests a potential for pounding to occur during seismic events. To further investigate this concern, a time history analysis was performed. For this purpose, inelastic spring HERTZ modeling is preferred and gap members are modeled between two adjacent blocks as seen in Figure 27.

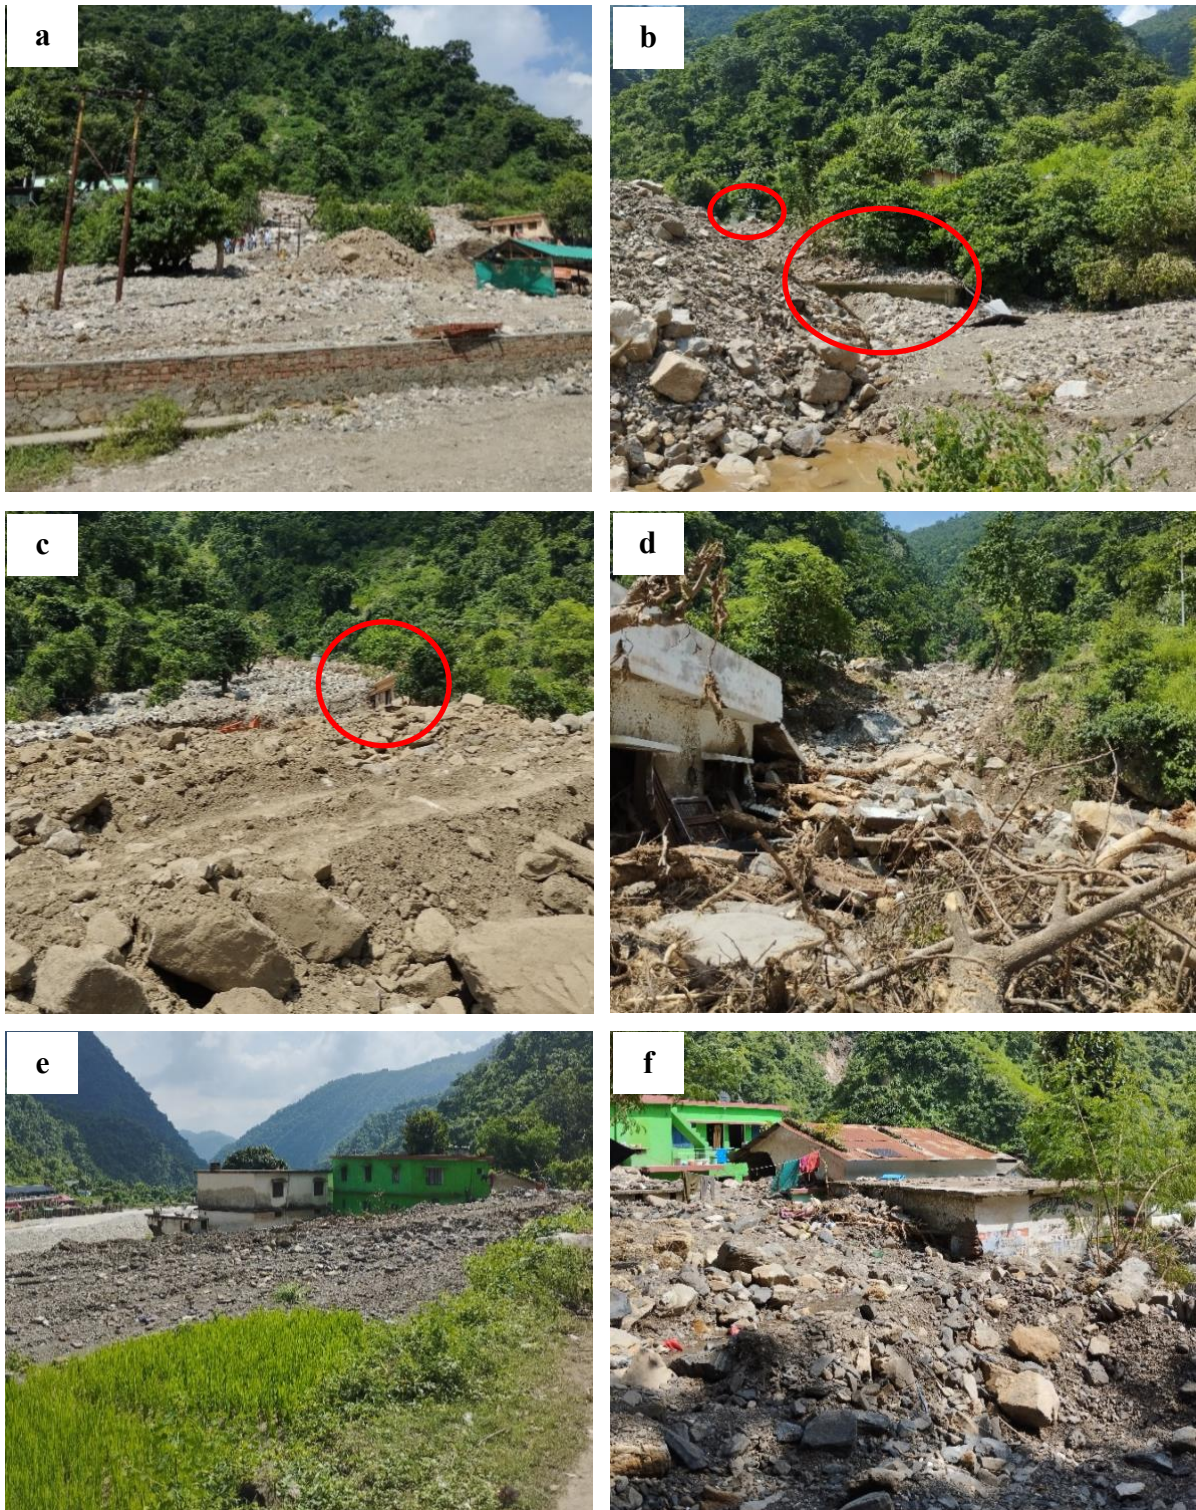
Figure 3. Photographs illustrate the devastated Bhaishwar and Sarkhet villages after heavy rainfall or cloudburst ensured debris flows; (a) accumulated debris in front of Musniwaa *Nallah* at Bhaishwar, (b) houses covered with debris at Bhaishwar, (c) Badly hit a house located at the course of Musniwala *Nallah* at Bhaishwar, (d) severely damaged a house due to change in course of Mushniwala *Nallah* at Bhaishwar, (e) overrun agriculture fields and damage to houses in front of the local stream at Sarkhet village, and (f) public and private properties covered with debris of local stream at Sarkhet village

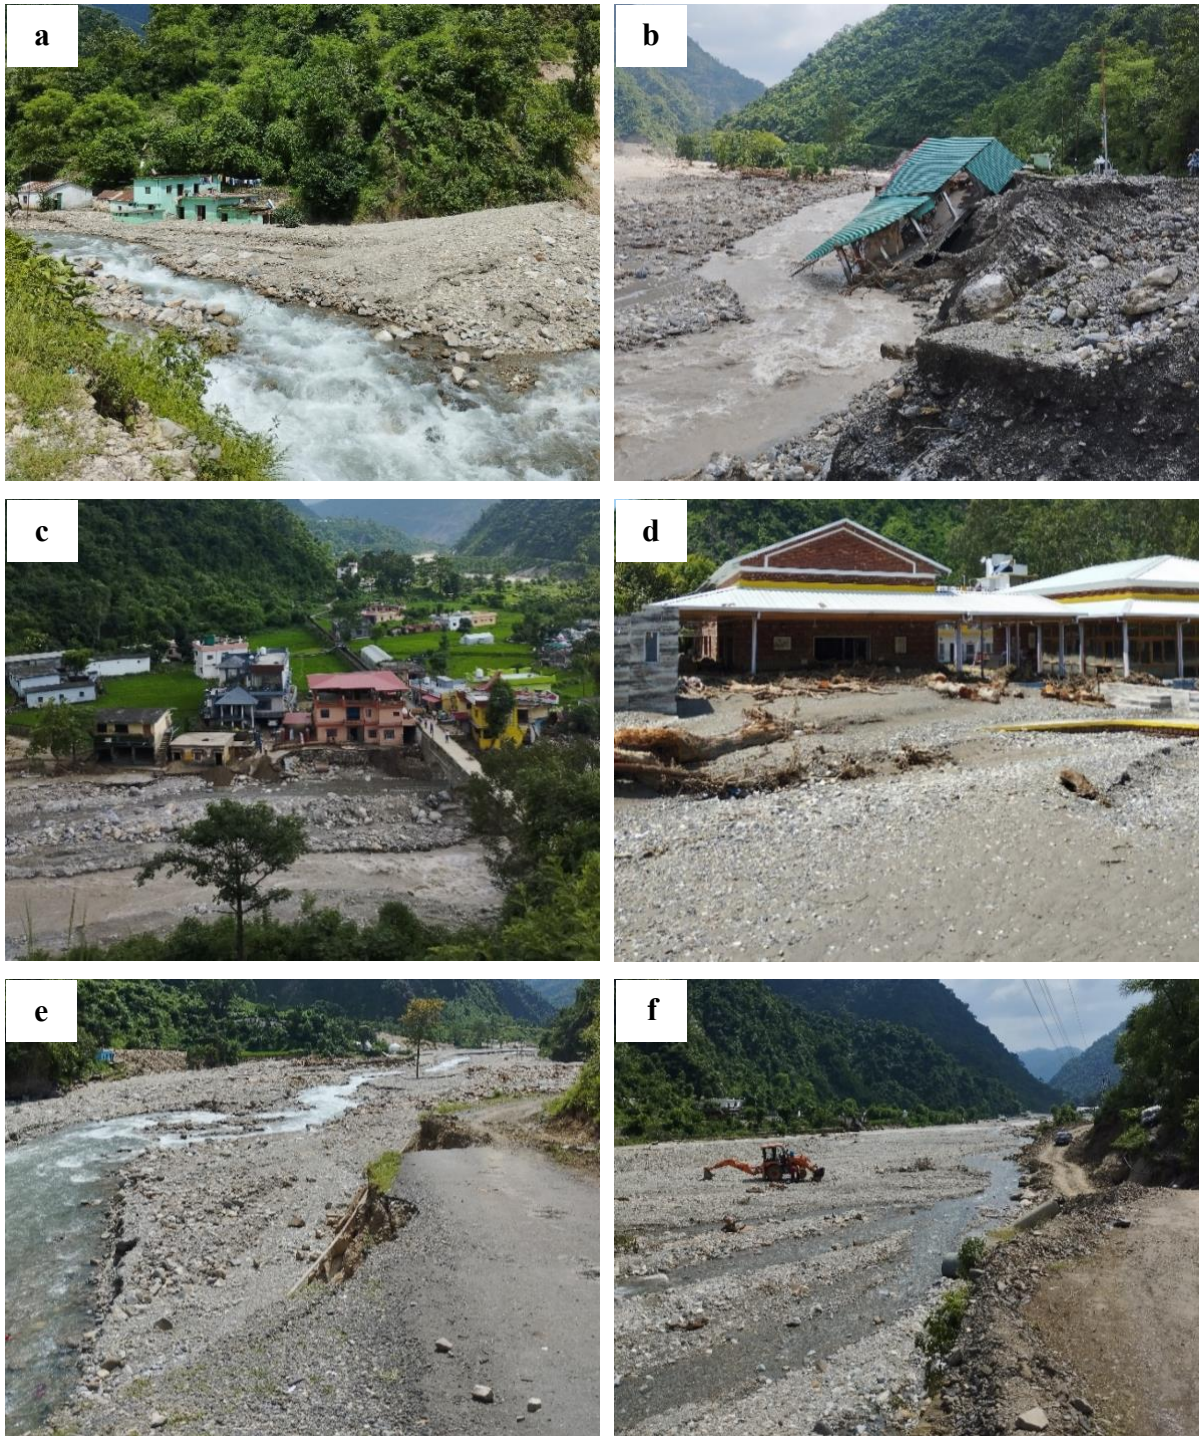
Figure 4. Flash flood damages in both the banks of Bandal *Nadi*; (a) Damage to habitation of Dhantu Sera on the left bank, (b) damage to a building located East of Bouta at right bank, (c) Houses damaged at village Kumalda on the left bank, (d) damage to Four Banyans Spirit & Nature Resort downstream of the confluence of Bandal *Nadi* & Song *Nadi*, (e) washed away road on the right bank between Dhantu Sera and Bhaiwar villages, and (f) wiped out road between Sarkhet and Bhaiwar area on the right bank
