A Proposal for the Conservation and Integration of Historic Diyarbakır City Walls: the Urfa Gate, Towers and City Walls

Nursen IŞIK^{1*}, Fatma Meral HALİFEOĞLU², Süleyman İPEK³

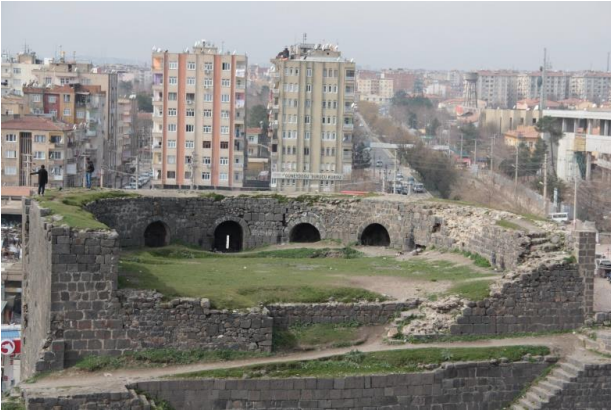
Figure 7. The photographic view of the top of Tower 20

- Looseness and abrasion in the majority of the steps on the stairs,
- Cracks and fissures in the grid niches of the tower,
- Destruction in all dendants¹ on the top of the tower as shown in Figure 7,
- A significant amount of mortar loss at the upper end of the wall, on the south side of the tower,
- Loss of stone material at the lower end of the tower, and
- Humidity-caused damage to the stone rows near the ground.

5. In Tower 20 top layer and flooring collapse led to a holistic loss and on the surface of the north outer-facade it triggered large swellings that pose threats. The surface should be extensively analyzed by field experts. If needed sectional dismantling should be conducted and in tandem with horizontal carrying elements in the interior space it is suggested to make reformation.

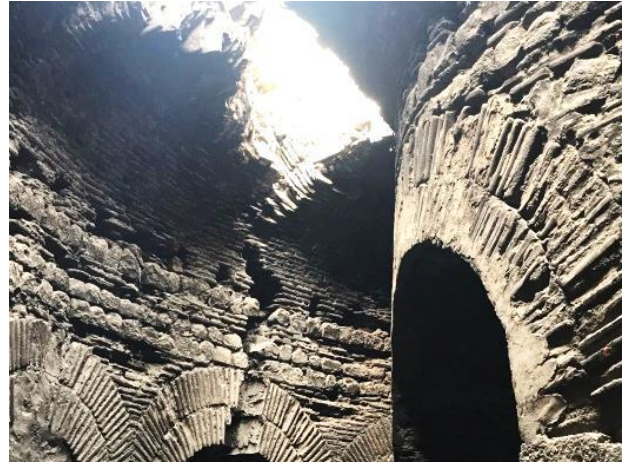
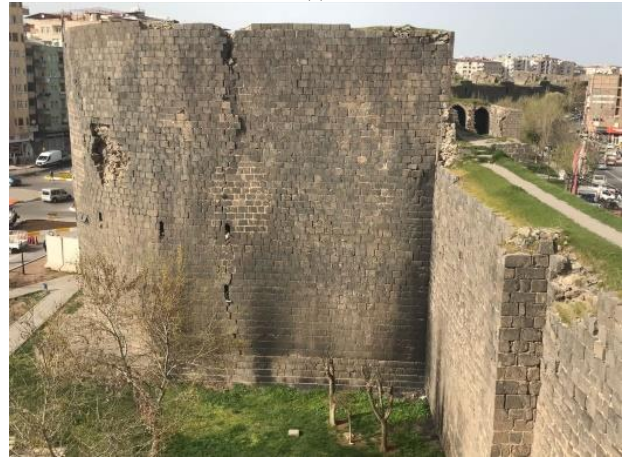
- Partial losses of material and mortar from the ground floor corridor, which was built with vaulted brick,
- Earth-filled ground floor,
- Vertical fissures on the south facade of the wall, which faces the exterior of the city wall,
- Slumps emerging from the vaults on the western side,
- Deep structural cracks that continue from the dome up to the grids on the west and south sides of the first floor as indicated in Figure 8, and
- Some slumped grid niches, which were then filled with earth, on the U-shaped first floor, and slit formations on the top layer dependent on these slumps as exhibited in Figure 9.

Figure 8. The photographic views of the cracks on Tower 20': (a) the first-floor cracks and (b) structural cracks

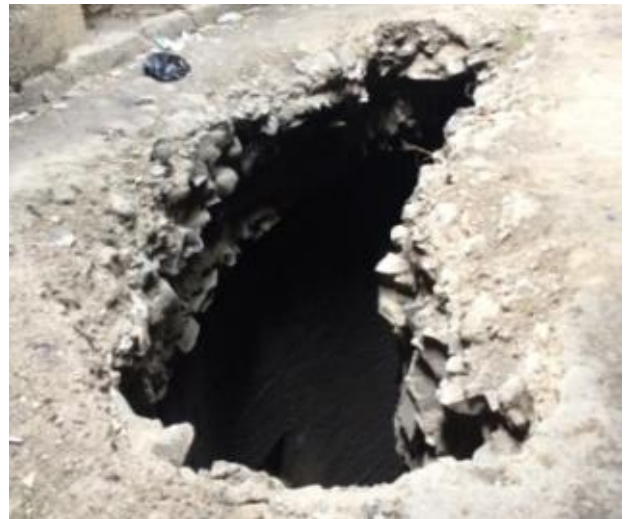
Figure 9. Slit formation on Tower 20' due to the slumps

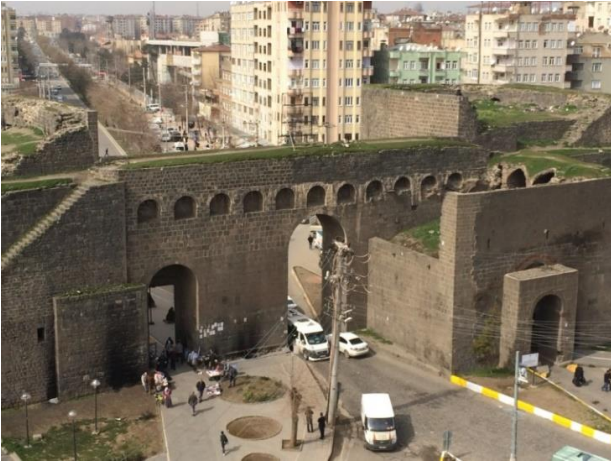
- The poor conditioned upper section of the gates, which is interconnected via successive lines of arched arcades² (porticos), and adversely affected porticos by vibrations caused by motor vehicles and natural conditions as can be seen in Figure 10,

Figure 10. A photographic view of porticos on the Urfa Gate

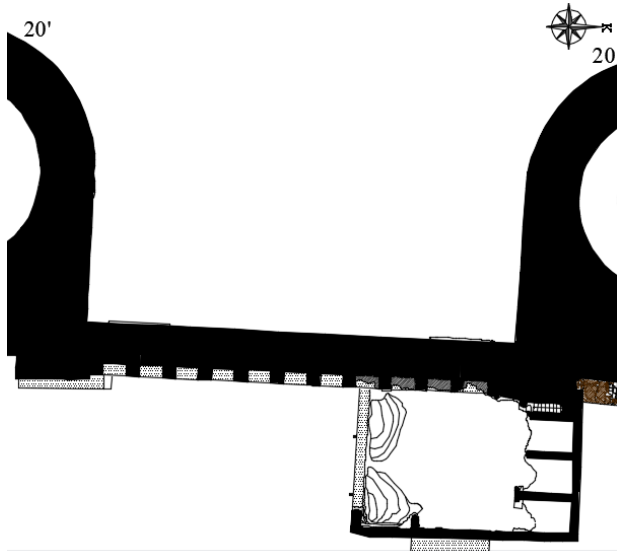
Figure 11. The niche plan at the elevation of 11.99 m

- 11 arched arcades/niches on the outer walls as shown in Figure 11; covering of 4 of the niches on the north gate with earth and rubble as demonstrated in Figure 12,

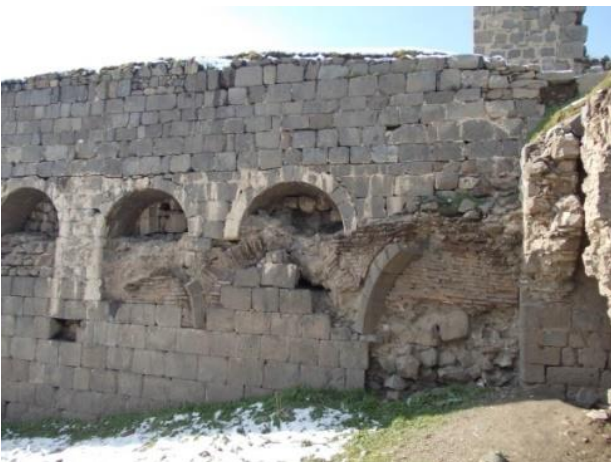
Figure 12. A photographic view of the soil and rubble-filled niches

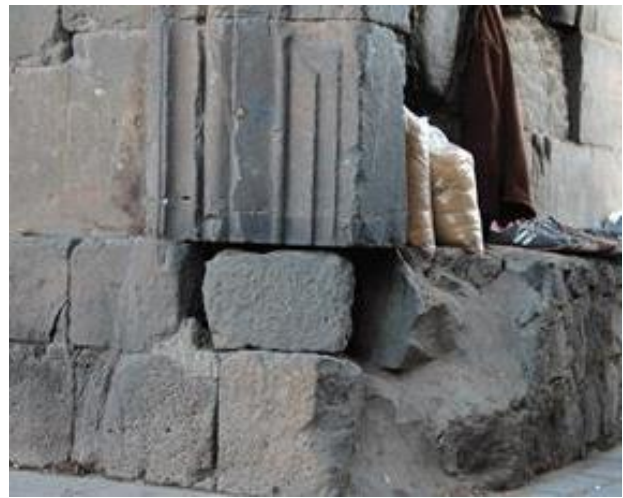
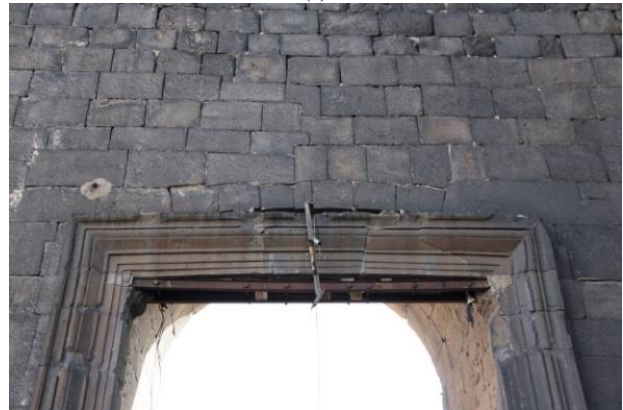
- Capillary cracks on the lintel of the north gate and soot on the walls owing to fires,
- Total demolishing of the south wall of the North Gate and fissures due to exposure of the east wall,
- Covering of the first floor of the north gate with soil and random deformations on it,
- Capillary cracks, loss of the stone, and mortar discharge at the western end of the middle gate (G2) transition, which faces the exterior of the city walls,
- Weakening at the wall section of the site ensue from prolonging the original gap in the arched middle gate (G2), through which there is intense vehicle traffic, in 1944 and random fissures and cracks caused by this weakening,
- The material loss at the bottom sections of the south gate due to structural breakdown and pressure from the stone material (shown in Figure 13a) and cracks on the gate lintel (shown in Figure 13b),

Figure 13. The south gate (designated as G3): (a) the material loss at the bottom and (b) cracks on the gate lintel

9. Resistance loss that emerged in the interior transition corridor of the south gate due to loss of material should be corrected by using a near-authentic material, applicable technique, and workmanship.

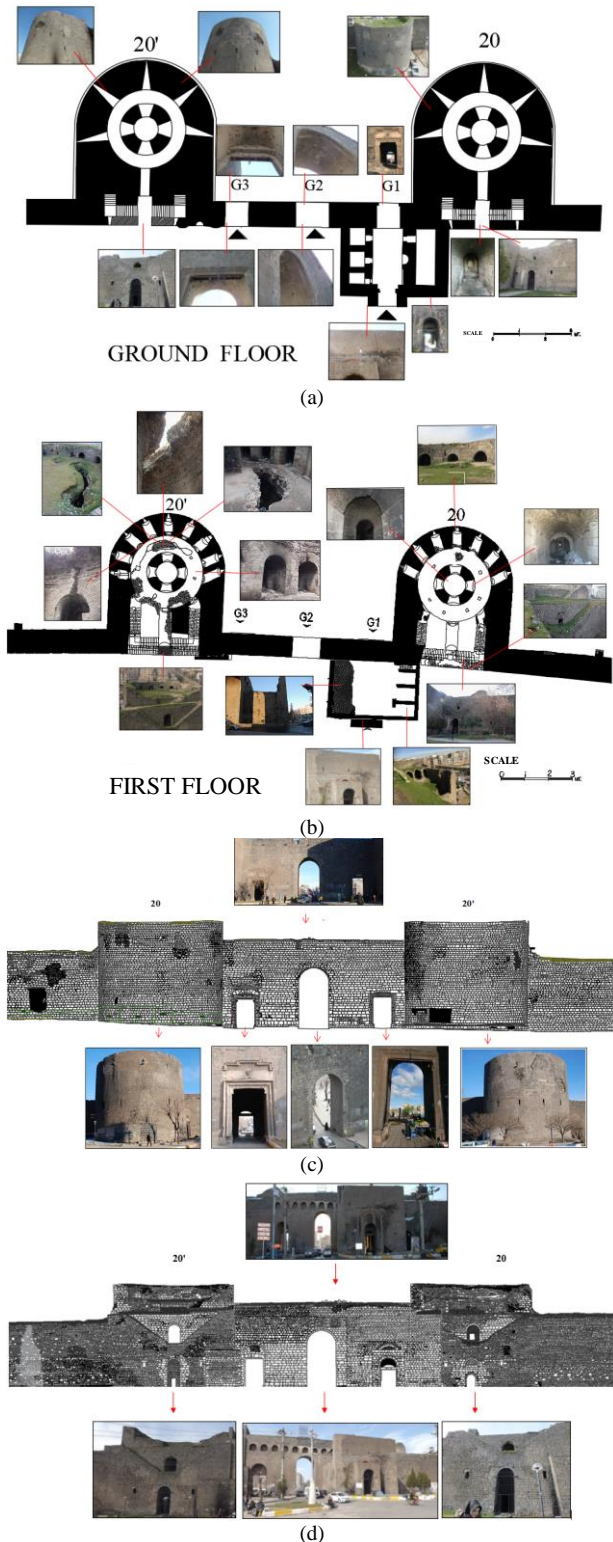
In the end, the damages on the east and west ends of the gate transitions were photographed for future records. These damages were highlighted in drawings of the facades as demonstrated in Figures 14a, 14b, 14c, and 14d.

Figure 14. Photographic view and schematically representation of the fissures and cracks on the Urfa Gate, transition, and towers from: (a) ground floor level, (b) first-floor level, (c) outside the city walls, and (d) inside the city walls
