EVALUATION OF THE CURRENT CONSERVATION STATE OF THE GÖKTAŞLI MOSQUE, MANİSA

MANİSA, GÖKTAŞLI CAMİ'NİN GÜNCEL KORUMA DURUMUNUN DEĞERLENDİRİLMESİ

Suna BÜYÜKKILIÇ KOŞUN * - Mine HAMAMCIOĞLU TURAN **

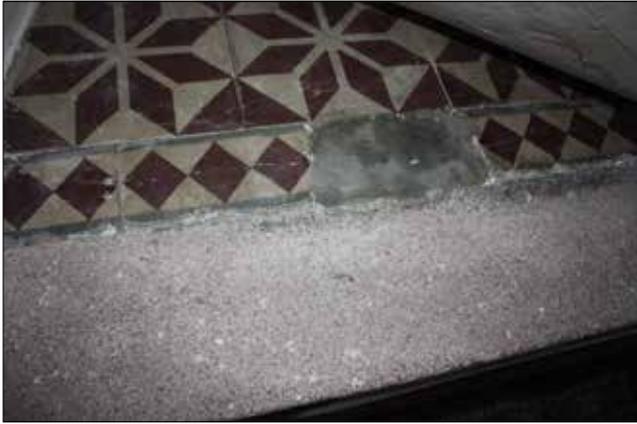
Photo 12 - Reintegration of sill covering with cement mortar instead of mosaic. / *Denizliklerin mozaik yerine çimento harcı ile bütünlenmesi.*

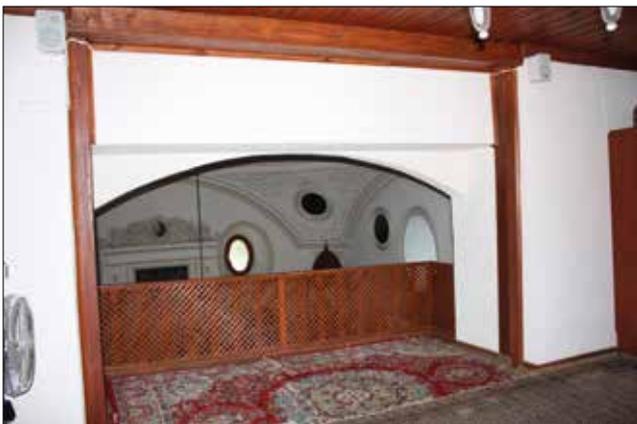
Since its erection as a masjîd in 1493, the monument is an object of veneration and its place hosts praying rituals; it has spiritual value. However, the qualities of the women's section added to the building are not appropriate for experiencing the awe-inspiring qualities of the original praying hall. Visual connection is insufficient; the ceiling is low (Photo 14). This space prevents women to unite with the mosque whole. Spiritual value is sustained but it can not be experienced by women.

Photo 14 - Women's section, insufficient visual connection with the Prayer Hall and low ceiling. / *Kadınlar bölümü, harim ile yetersiz görsel ilişki ve alçak tavan.*

- neither compete with their scales nor hinder the perception of original qualities⁶.
- Separator within the Prayer Hall may be used to include women to the spiritual atmosphere of the holly space.

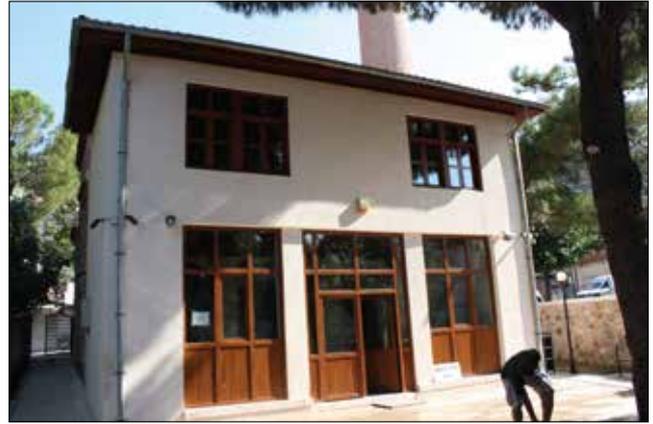
Photo 13 - Additional Last Comers' Hall, closed space. / *Ek son cemaat yeri, kapalı mekan.*

- Mass additions to modest scaled mosques should

⁶ If absence of the Last Comers' Hall is an original characteristic attributing rareness value to the monument, its addition should be thought very carefully.

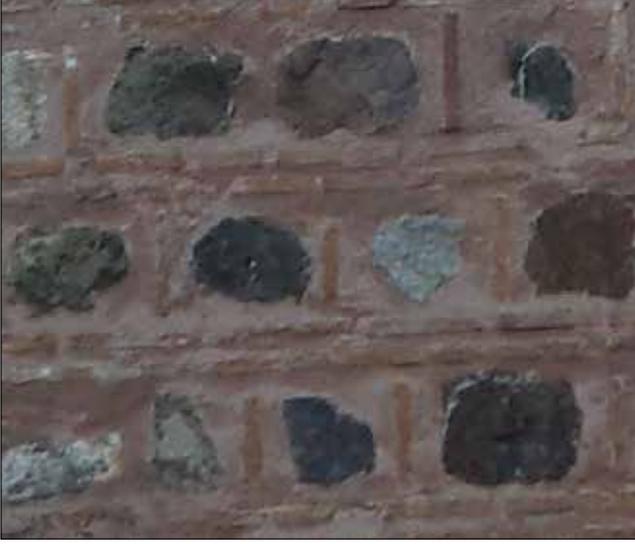
Photo 15 - Göktaşlı Mosque, western façade, excessive mortar usage. / *Göktaşlı Cami, batı cephesi, aşırı harç kullanımı.*

- Meticulous workmanship should be provided at the intervention applications. E.g. excessive mortar usage at the joints should be avoided.
- Appropriate colors should be used. E.g. eye catching colors at the mortars such as rose-pink should not be preferred.

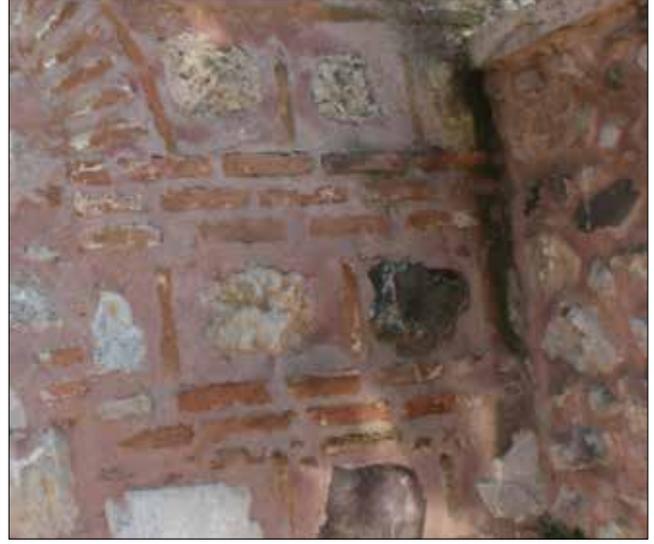
Photo 16 - Göktaşlı Mosque, western façade, salt crystallization and microbiological formation. / *Göktaşlı Cami, batı cephesi, tuz kristalleşmesi ve mikrobiyolojik oluşum.*

- Technical requirements such as sufficient drainage system should be provided.
- Daily life objects such as digital clocks, wardrobes, etc. should not be overused and should be placed in accordance with the restoration project.

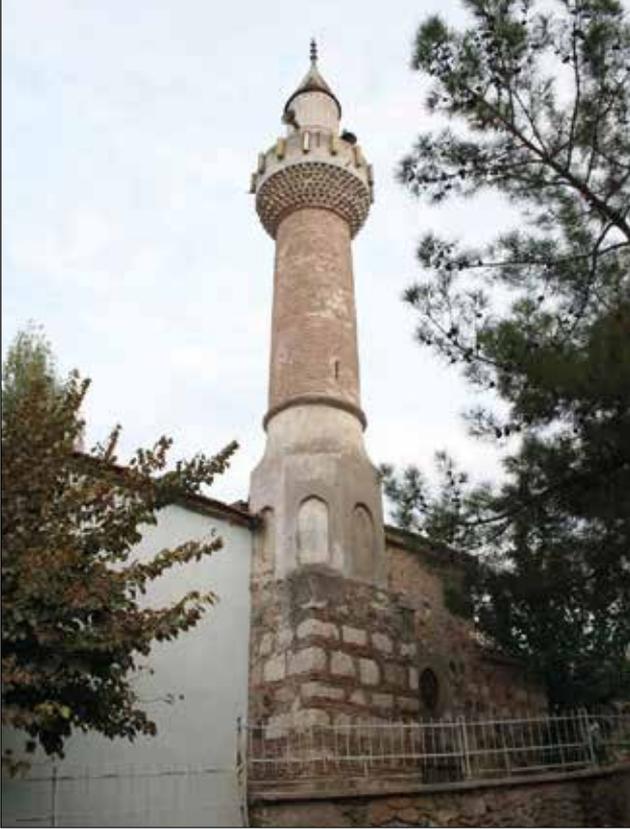
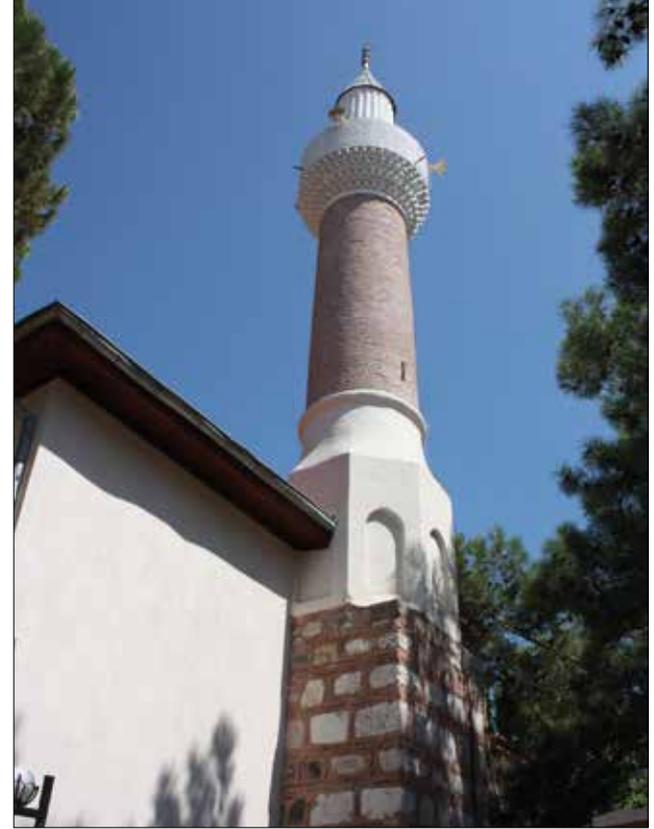
Photo 17 - The minaret, plastered portions, before (left) (RDPF, 2008) and after the 2013 restoration (right). / *Minare, sıvalı kısımlar, 2013 restorasyonu öncesi (sol) ve sonrası (sağ).*

been valid in terms of emphasizing the age value. However, not revealing noble patina of age at the minaret (Photo 17) elements was inconsistent with this approach. Besides that, elements renewed such as interior plastering, plastering at the minaret (Photo 17), *Külâh* and roof tiles also reduced age value.

- Intervention decisions at the project should be consistent. E.g., patina/lacunae at *Petek*, *Şerefe*, cornice of *Şerefe*, transition elements, *Pabuç*, etc. should be exhibited as similar to the exhibition of arch traces.
