PRELIMINARY OBSERVATIONS AFTER THE 2020 AEGEAN SEA EARTHQUAKE

The October 30, 2020 Aegean Sea Earthquake occurred with a magnitude of M6.6 and caused significant damages across the city of Izmir, Turkey. Specifically, this paper presents the preliminary observation results based on; ground motion properties, local site conditions, code-based design procedures, and the structural damage mechanisms. In order to achieve this purpose, critical spectral characteristic of strong ground motion records were evaluated in advance. Then, the variables given in code-based design results were investigated based on base shear to structural weight ratio. Local site effects were considered by comparing the spectral amplitudes obtained for different strong ground motions recorded from stations with different soil characteristics (i.e. the shear wave velocity (VS30) averaged over top 30m of the soil profile). Primary temporal distributions of recorded earthquake sequences followed by the mainshock were detailed and the directionality characteristics of the strong ground motion recorded after the mainshock were summarized. Moreover, observed damage patterns in buildings are discussed and possible re

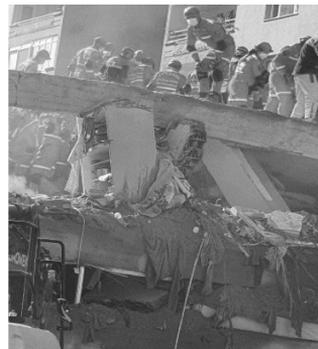
Depending on the October 30, 2020 Aegean Sea Earthquake, several buildings located around the city of Izmir were strongly affected. A catastrophic scene from the site is given below in Figure 7.

Figure 7: Life area served by a single refrigerator coincidentally

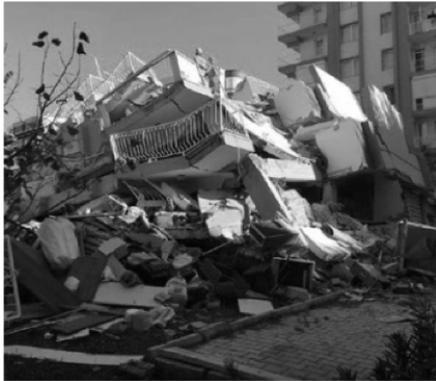
Following the valuable investigations and observations from the site (i.e., Figs 8 and 9), common reasons for damage patterns are reported by different utilities summarized as follows:

- Damages due to material characteristics (e.g., inadequate strength of concrete and reinforcement materials),
- Irregular structural systems (e.g., soft-story and/or weak-story mechanisms),
- Secondary retrofitting or modifications in structural systems without taking into account current codes,
- Effect of local soil conditions,
- Deficiencies in application of structural details at site,
- Removal of infill walls.

Figure 8: Collapse mechanism observed at the site (Photo from [10])

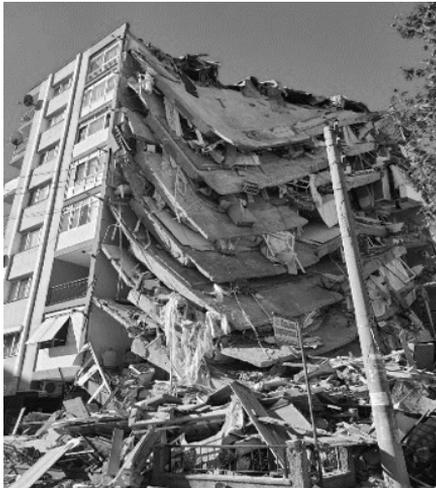
Figure 9: Partial collapse mechanism observed at the site
