# Modeling of support system for preventing retrogressive slide of Ambarlı landslide in Avcılar district, Istanbul

İbrahim KUŞKU<sup>1\*</sup>, Süleyman DALGIÇ<sup>2</sup>

<sup>1,2</sup>Department of Geological Engineering, Faculty of Engineering, Istanbul University, Istanbul, Turkey.  
ibrahim@istanbul.edu.tr, dalgic@istanbul.edu.tr

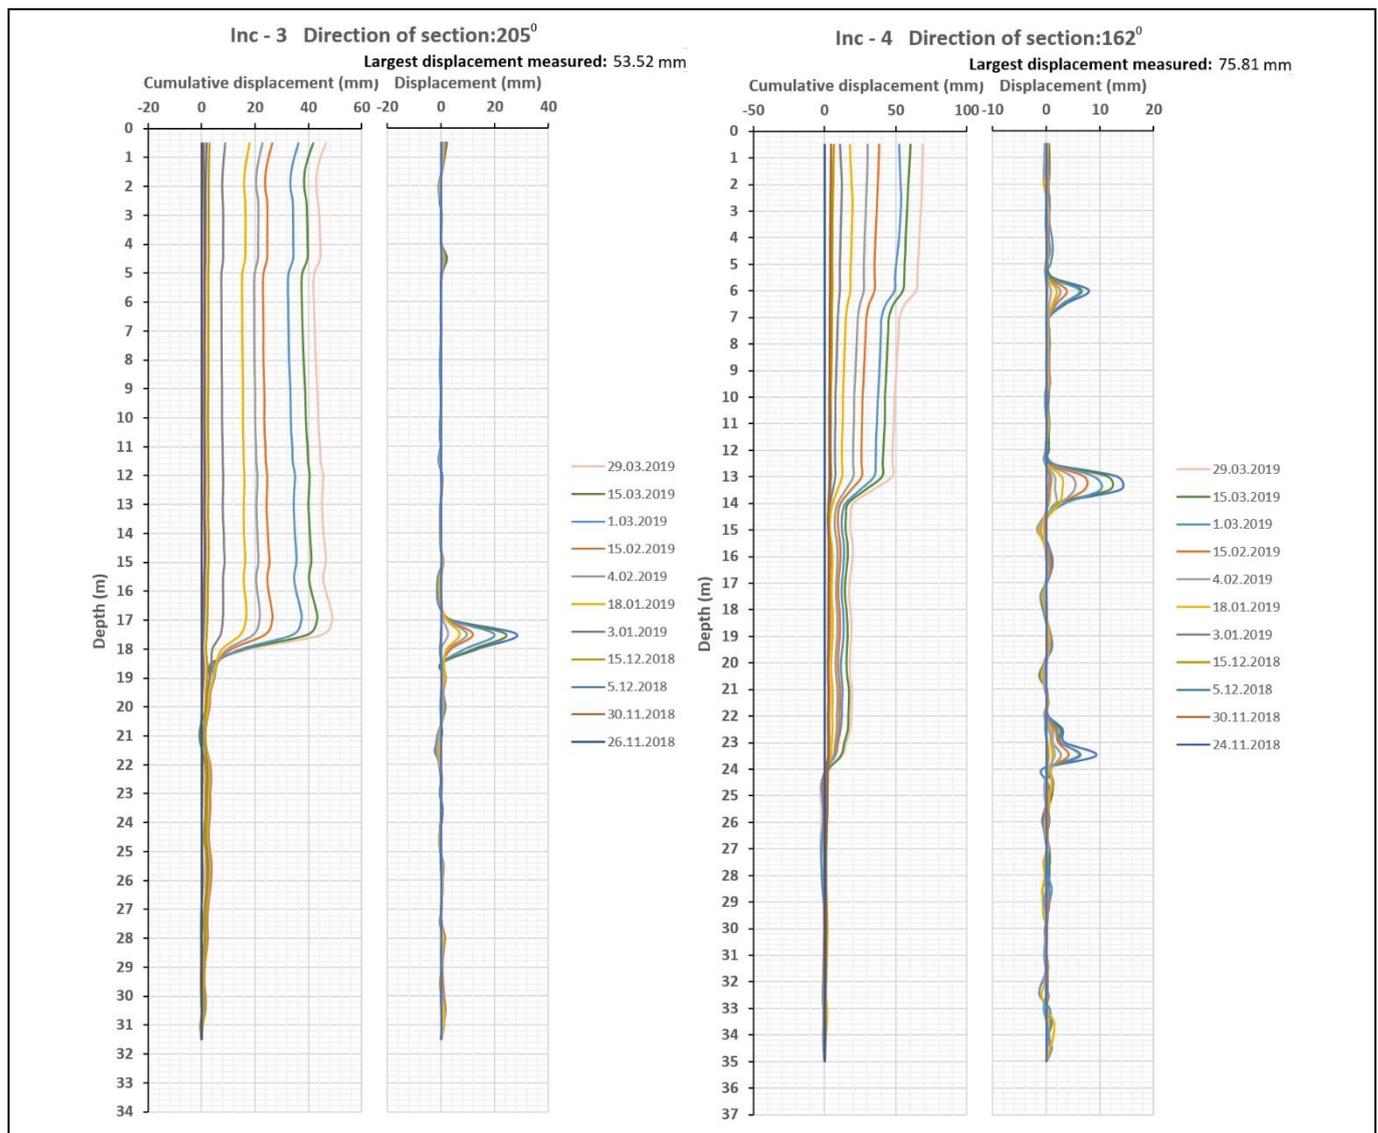
Inclinometer measurements conducted for 5 boreholes in the frame of this study yielded slip planes at depths between 5.0 m and 24.0 m. The slip determined at a depth of 5.0 m in borehole Inc-1 outside of landslide area occurs in the artificial fill at the contact of units of the Çekmece formation. In boreholes Inc-3 and Inc-4, 1 and 3 slip planes were observed, respectively. The depth of slip planes is 18.5 m in borehole Inc-3 and 6, 14 and 24 m in Inc-4 (Figure 3). The maximum displacements are 10.89 mm in Inc-1, 4.55 mm in Inc-2, 53.52 mm in Inc-3, 75.81 mm in Inc-4 and 5.46 mm in Inc-5. According to cumulative displacement velocity estimations, the maximum displacement rate is 0.086 mm/day in Inc-1, 0.037 mm/day in Inc-2, 0.397 mm/day in Inc-3, 0.549 mm/day in Inc-4 and 0.044 mm/day in Inc-5. The movements are toward the hillside slope and the average values are 172°K in Inc-1, 207°K in Inc-2, 205°K in Inc-3, 62°K in Inc-4 and 260°K in borehole Inc-5.

Figure 3. Inc-3 and Inc-4 depth-displacement graphics.
