THE RISKS OF NONSTRUCTURAL BUILDING COMPONENTS IN THE CONTEXT OF EARTHQUAKE AND PEDESTRIANISED STREETS IN HISTORIC CITY CENTERS: ISTANBUL BEYOGLU CEZAYIR STREET CASE

İlke CİRİTÇİ

Gül YÜCEL

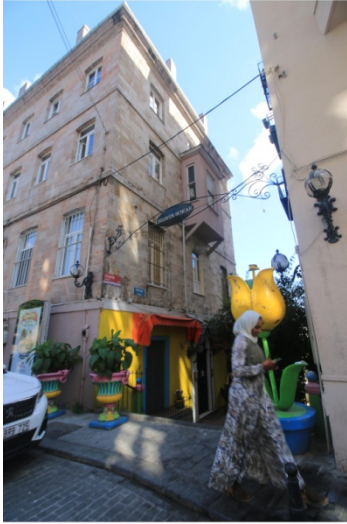
Building-10

It is possible to take prevention action for many of the elements considered to be risky in the structures and to reduce the potential risk in case of disaster. In Fig.7, it is seen that in most of the buildings the air conditioning unit is mounted on the main wall of the facade. This increases the risk particularly in the buildings that are older than a century, weak for heavy loads and the mortars and the connective feature has decreased and has weakened. Similarly, there are heavy iron railings on balcony or terraces, most of the buildings along the street. Most of them are not original, new constructed. These appendices are the group that poses the greatest risk in the earthquake.

- The building nonstructural components in the pedestrianised streets should be strengthened for providing street safety and protection any injuries.
- It may be proposed to move the air conditioner units to the roof or to move only the air conditioner by designing another element adjacent to the existing structure, which separate from building structure.
