Application of IOS/Android Rapid Evaluation of Post-Earthquake Damages in Masonry Buildings

Mehmet Fatih IŞIK^{*a}, Ercan IŞIK^b, Ehsan HARIRCHIAN^c

To cite this article: M. F. Işık, E. Işık ve E. Harirchian, "Application of IOS/Android Rapid Evaluation of Post-Earthquake Damages in Masonry Buildings", *Gazi Journal of Engineering Sciences*, vol.7, no.1, pp. 36-50, 2021. doi:10.30855/gmbd.2021.01.05

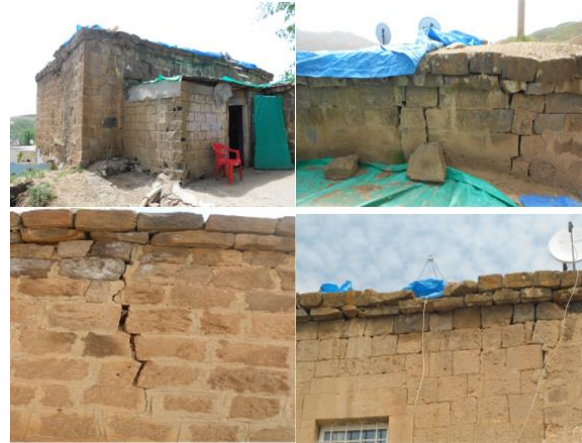
of walls. There is a heavy load on the structure due to earth shelter. On the load-bearing wall placed at the rear front of the structure, there were some segregations larger than 2 cm and some stones were replaced. There were some segregations larger than 2 cm on the left side of the structure and those larger than 1 cm on the facade. The fact that fixation of the floor and shelter to the walls is insufficient is one of the reasons of the damage. The damages on this building are given in Figure 3.

Figure 3. Damages on masonry building-1 (1.Bina hasarları)

3.1. Lengths of the Heavily Damaged Walls	Damage condition observed	5.90	6.20	0	0
	Segregation of out-of-plane collapsed wall and Concurrent walls ($\geq 20\text{mm}$); diagonal/X cracks on Corner/Front walls ($\geq 10\text{mm}$);				
		X1 = 5.90 (m)	Y1 = 6.20 (m)	X2 = (m)	Y2 = (m)

3.1. Lengths of the Moderately Damaged Walls	Damage condition observed	5.90	0	0	0
	Segregation of out-of-plane collapsed wall and Concurrent walls (10~20mm); diagonal/X cracks on Corner/Front walls (5~10mm);				
		X3 = 5.90 (m)	Y3 = (m)	X4 = (m)	Y4 = (m)

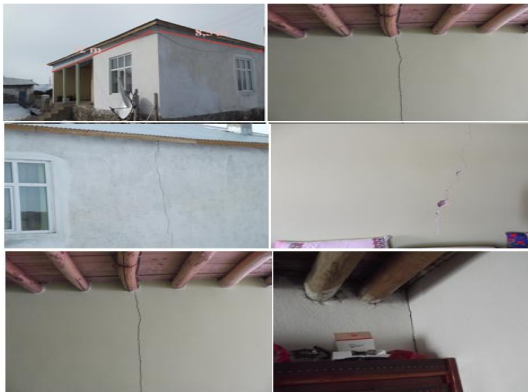
The building was built of single story from the local stones. The building is used as residence. The building was built in the form of a rectangular with a size of 11.50m x 8.50m. A heavier load was created on the building by adding a roof on the earth shelter. There were some segregations larger than 2 cm at the corner junction points of the rear front of the building. The fractures and cracks in the right flank front were measured to be larger than 1 cm. While on the left flank front, there were fractures and cracks larger than 2cm. There are local wall damages ranging from 0.5 to 1.5cm in the middle partition walls within the building. Images of the building and damages are shown in Figure 4

Figure 4. Damages on masonry building-2 (*2. Yiğma binadaki hasar durumu*)

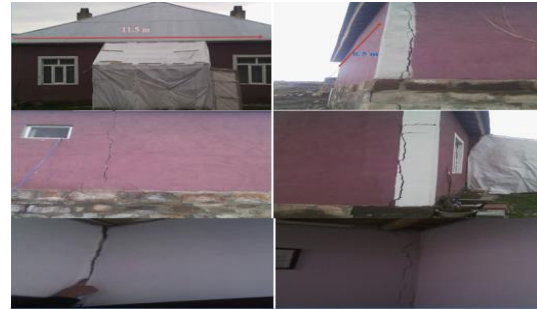
The building was built of single floor from the local stones. The building is used as residence. The building was built in the form of a rectangular with a size of 12.00m x 8.50m. A heavier load was created on the building by adding a roof on the earth shelter. Damages ranging from 0.5 to 1 cm were formed on the walls that make up the middle partitions of the building, while there are moderate damages ranging from 0.5 to 2 cm were formed on the outer wall. Images of the building and damages are shown in Figure 5.

Figure 5. Damages on masonry building-3 (*3. Yiğma binadaki hasar durumu*)

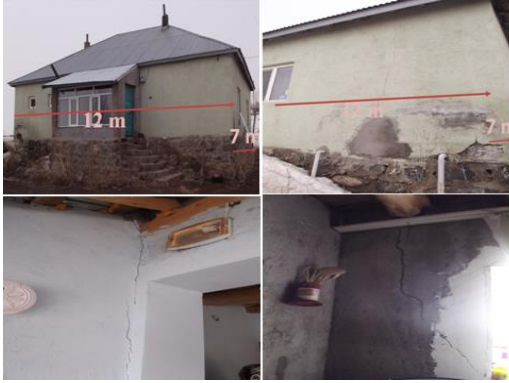
The building was built of single floor from the local stones. The building is used as residence. The building was built in the form of a rectangular with a size of 12.00m x 7.0 m. A heavier load was created on the building by adding a roof on the earth shelter. Damages ranging from 0.5 to 1 cm were formed on the walls that make up the middle partitions of the building, while there are trivial damages ranging from 0.5 to 1 cm were formed on the outer wall. Images of the building and damages are shown in Figure 6.

Figure 6. Damages on masonry building-4 (4.Yığma binaya ait hasarlar)
