Research Article Academic Platform Journal of Natural Hazards and Disaster Management 2(1), 1-15, 2021 DOI: 10.52114/apjhad.903387

Flash Flood struck Dhauliganga valley on February 7, 2021: A Case study of Chamoli district of Uttarakhand Himalaya in India

¹ Uttarakhand State Disaster Management Authority, Department of Disaster Management, Uttarakhand Secretariat, 4 Subhash Road, Dehradun-248001, Uttarakhand, India

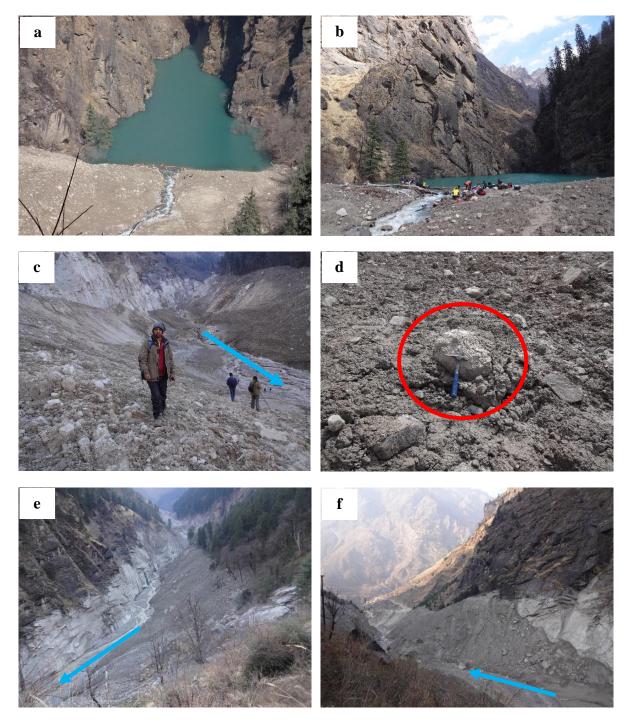
The devastating flash flood of February 7, 2021 made significant changes in the river morphology around the confluence of Raunthi Gadhera and Rishiganga. Between 9 and 11 February, 2021 the course of Rishiganga stream was permanently blocked by the debris brought down by the Raunthi Gadhera after breaching of landslide dam. Flooded water saturated debris with boulders and ice blocks of Raunthi Gadhera directly hit the valley wall which back flowed upstream along the Rishiganga dumped a huge sediments and created an artificial lake (Fig. 2a). Based on satellite imageries first by Uttarakhand Space Application Centre (USAC) on February 9, 2021 and later by Indian Institute of Remote Sensing (IIRS) were provided the information of a lake formed along the course of Rishiganga. The same was confirmed by the reconnaissance teams on February 11, 2021. As observed on February 11, 2021 water was not draining out of this lake. The Rishiganga was curved out channel from the center of the lake through which water is continuously draining out on February 12, 2021.

The lake area can be approached from both Paing and Murunna villages which are situated on the right and left bank of Rishiganga respectively. It is placed along Rishiganga about 500 m upstream of the confluence of Raunthi Gadhera with Rishiganga at an altitude of 2389 m asl having embankment of approximately 100 m and visually estimated linear length of around 500 m (Fig. 2a). It was observed that both the sides exposures of thickly to medium foliated, moderately jointed and slightly to moderately weathered quartzites that of Suraithota Formation of Vaikrita Group of rocks having with vertical cliffs. The muddy debris is to be observed on the both banks of Raunthi Gadhera whereas the Rishiganga was completely covered with huge muddy debris till lake.

It was also observed that the Rishiganga curved out around 8 m wide channel by the erosion of the natural embankment in the center portion till dated February 19, 2021. As directed to personnel of ITBP and SDRF, physically widen the channel and cleared of obstructions of logs (Fig. 2b). The channel was thus widened up to 20 m between February 22 and March 2, 2021 to ensure proper draining out water from the lake. Just upstream to confluence of Rishiganga with Raunthi Gadhera, huge slope materials was eroded on the left bank of Raunthi Gadhera while thick pile of sediments was deposited on the right bank of the same because of the flooding (Fig. 2c). This sediments comprising of a mixure of ice blocks, rock fragments, morainic material and boulders of quartzite, granitic gneiss and mica schist with silty-clayey matrix (Fig. 2d).

To the downstream of confluence, slope materials which was laid over valley side dipping rocks on the left bank of Rishiganga was badly eroded till North of Murunna village and pedestrian

route was also completely washed away which was located on the same materials (Fig. 2e). Thereafter, debris cone and old landslide mass were also badly eroded on the right bank of Rishiganga up to confluence of Rishiganga with Dhauliganga at Rini (Fig. 2f).

Figure 2: Changes in river morphology on the aftermath of flash flood; (a) lake formation over Rishiganga; (b) physically widen the channel and cleared of obstructions of logs; (c) eroded left bank while aggradation on the right bank of Raunthi Gadhera; (d) ice block observed in the transported debris materials; (e) badly eroded slope materials on the left bank of Rishiganga river; and (f) eroded debris cone and old landslide mass on the right bank of Rishiganga at Rini

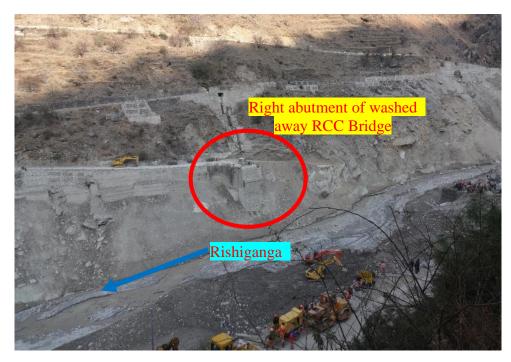
As many as 204 persons went missing while 12 persons injured in the flash flood incidence and except for 9 local inhabitants of these 5 of Rini, 2 of Tapoban and 2 of Ringi villages and 2 Police personnel others were from amongst those engaged by the hydropower projects that were devastated in the incidence. Out of total, 77 bodies could be recovered while 184 farm animals were lost in this incidence (Data source: State Emergency Operations Centre (SEOC), Uttarakhand). According to Hydroelectric project Authority, about 30-35 persons were reportedly working in a tunnel that was chocked with silt and debris transporting by flooded water of Dhauliganga river. Total of 6 bridges were swept away by the floodwaters of which 5 pedestrian bridges which were located on the Dhauliganga river at Rini, Bhangyul, Juwagwad, Tapoban and Vishnuprayag while one motorable RCC bridge over Rishiganga river on Joshimath – Malari State Highway at Rini in which disrupted connectivity for the residents of 13 villages (Fig. 3).

Figure 3: Washed away a motorable RCC bridge over Rishiganga river on Joshimath – Malari State Highway at Rini

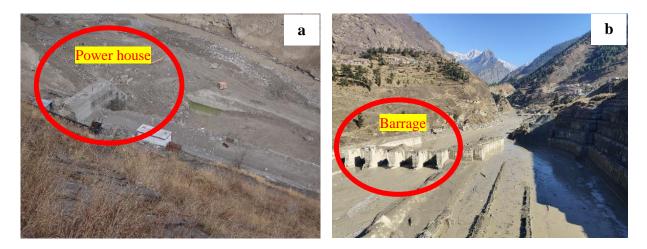
The flash flood of Rishiganga resulted in swiping away of an operational hydropower project of 13.2 MW capacity on Rishiganga upstream of Rini (Fig. 4a). To the downstream, flooded water of Rishiganga and Dhauliganga river severe damage to another under construction hydropower project of 520 MW of National Thermal Power Corporation (NTPC) at Tapoban on Dhauliganga river (Fig. 4b).

Figure 4: The devastated hydropower projects; (a) washed away power house of Rishiganga hydropower project upstream of Rini; and (b) severally damaged barrage site of Tapoban-Vishnugad hydropower project at Tapoban

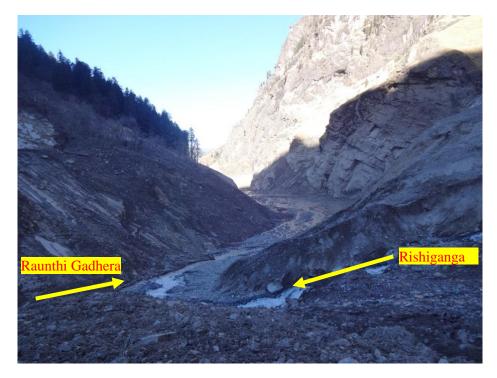
A massive rock fall along with hanging glacier avalanche took place during the winter on February 7, 2021 when the discharge of glacier fed rivers is minimum. The affected area however witnessed precipitation on February 4 and 5, 2021 with experienced snowfall in the higher reaches. Subsequent damming and sudden breach of the same caused flash flood in the Raunthi Gadhera which gushing down wherein thick overburden covers was badly eroded on the left bank of Raunthi Gadhera. At the confluence of Raunthi Gadhera and Rishiganga (Fig. 5), flooded water saturated bouldary debris of Raunthi Gadhera directly hit the valley wall and damming the same place for a while wherein back flowed of sediment leaden discharge along the course of Rishiganga up to 500 m. Increasing hydrostatic pressure result in this temporary dam was breached and to left behind a huge sediments along with boulders and ice blocks over the course of Rishiganga and created an artificial barrier. This completely blocked the course of Rishiganga and after filling of water left behind the same materials formed a lake. This has totally changed the river morphology of the Rishiganga valley.

Figure 5: At the confluence of Raunthi Gadhera with Rishiganga where key damming was observed

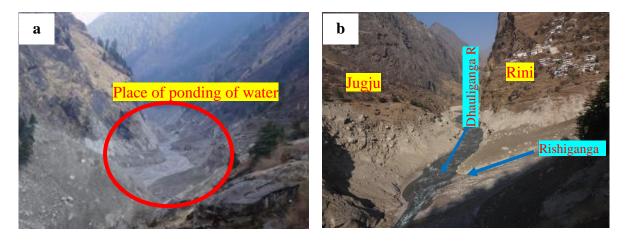
Another intermittent ponding was observed in the North of Murunna village wherein suddenly narrow valley came across. Because of erosion of a huge overburden mass on the left bank of Rishiganga, there was enough space for accumulating water. In this area the valley walls was showing water mark which was observed up to 50 m height (Fig. 6a). After adding discharge result in increasing hydrostatic pressure, sudden release of the flooded water swept away operational Rishiganga Hydroelectric project of 13.2 MW capacity along with working

personals in its. At the confluence of Rishiganga and Dhauliganga river, intermittent ponding was also observed resulting into temporary ponding along the course of the Dhauliganga river up to 1.5 km (Fig. 6b). Sudden release of a huge volume of water saturated debris of both the rivers caused massive devastation in the downstream. Major destruction have however occurred at Tapoban where Tapoban-Vishnugad barrage of 520 MW was being under construction along with working personals. The intake tunnel was chocked with muddy debris where around 30 - 35 personals were working.

Figure 6. Intermittent ponding of streams; (a) Rishiganga to the N of Murunna village and (b) Dhauliganga river near its confluence with Rishiganga

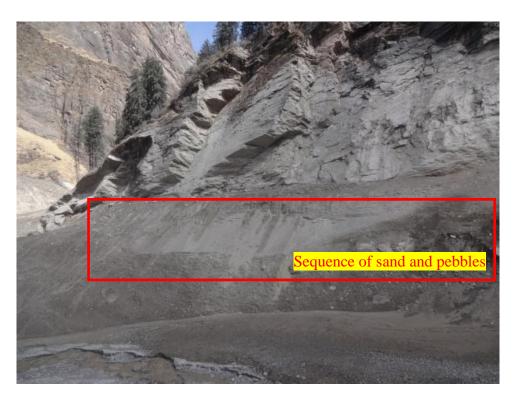
It is important to note that just upstream to confluence of Raunthi Gadhera and Rishiganga, occurrence of lacustrine deposits that consist a layers of sand and pebbles on the right bank of Raunthi Gadhera which was indicating evidence of paleo lake in the same region. These deposits has now been mostly eroded in the flash flood of Raunthi Gadhera (Fig. 7). In the earlier, floods in the Rishiganga created a 40 m high blockade near village Rini which was formed a lake. This lake was silted up by May 1970 and eventually breached in July 1970 [11].

Figure 7. Lacustrine deposits on the right bank of Raunthi Gadhera near its confluence with Rishiganga
