Investigation of Crater Formation on Coatings via Combination of SEM-EDX and FT-IR Microscopy

Ayça Biçen^{id}, Nazlı Güvenç^{id}

Kansai Altan Boya Sanayi ve Ticaret A.Ş. Ankara Asfaltı 25.km - 35730 Kemalpaşa, İzmir

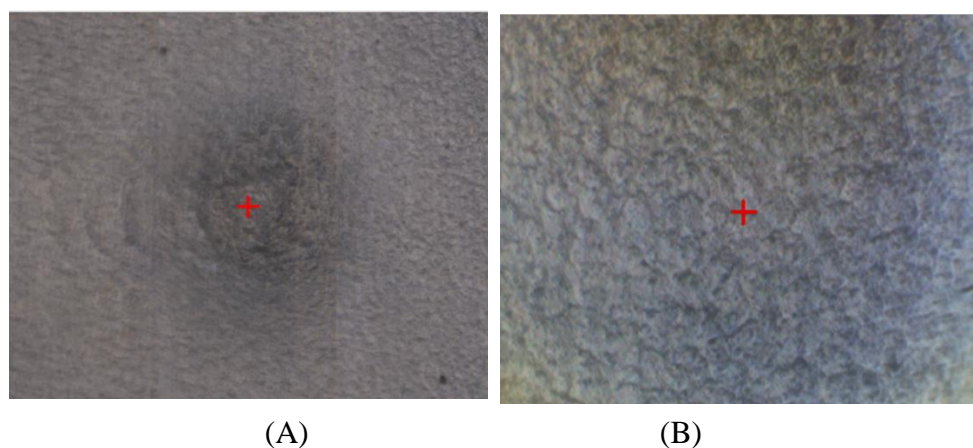
FT-IR microscopy is a well-established method for the chemical identification of particles or contaminants and for the visualization of the distribution of certain substances in complex compounds. Crater areas on the surface of coated panel were analyzed and compared to the reference area. As shown in Figure 1, crater area was clearly observed by IR imaging system and compared to the reference area. Afterwards, line and point map analysis were performed by ATR attachment. For the determination of structural differences, which might originate from environmental contaminations or coating components, defective area and reference area were comparatively examined.

Figure 1. FT-IR microscope images of the crater area (A) and reference area (B).

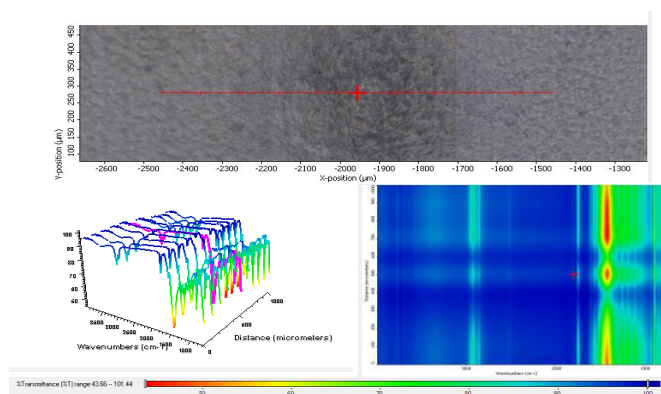
In Figure 2, line map analysis of the crater area is shown. The spectra collected in line map of crater area and reference area were analyzed in the matter that catches the best difference between the compared areas. The overlay of the spectrums showed that collected data around crater region was reproducible. Furthermore, alteration of the intensity between spotted regions in line map were shown in Figure 2.

Figure 2. Line map data of the crater area.

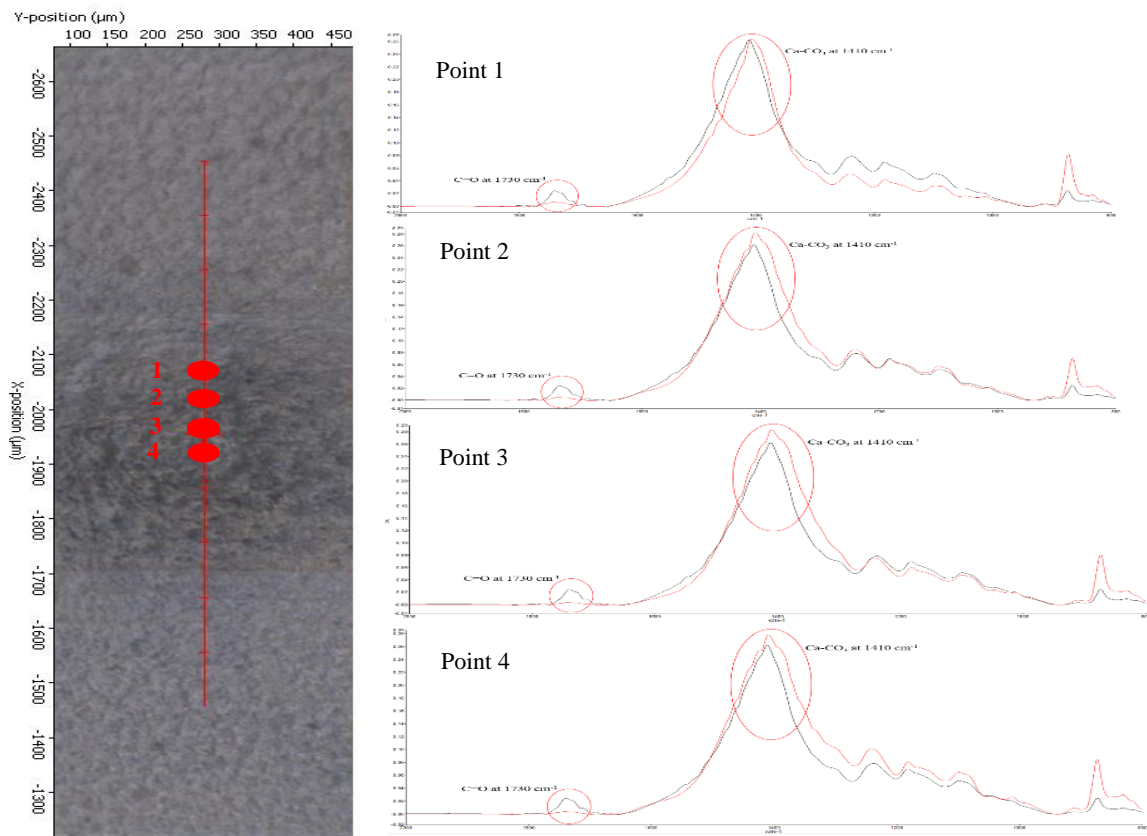
FT-IR spectrum of each point were obtained by line mapping for the crater area, as shown in Figure 3. According to baseline corrected FT-IR spectrum results shown in Table 1, it was determined that the ratio of the CaCO_3 derived from Ca-CO_3 stretching at 1410 cm^{-1} to ester bond derived from C=O stretching at 1730 cm^{-1} in the spectra was higher for the crater area than the reference area. Consequently, it might be concluded that the ratio of CaCO_3 is getting higher towards the crater area.

Figure 3. FT-IR spectra comparison of chosen spectra from line map. The spectra of the crater areas are shown in red and the spectra of the reference areas in black.

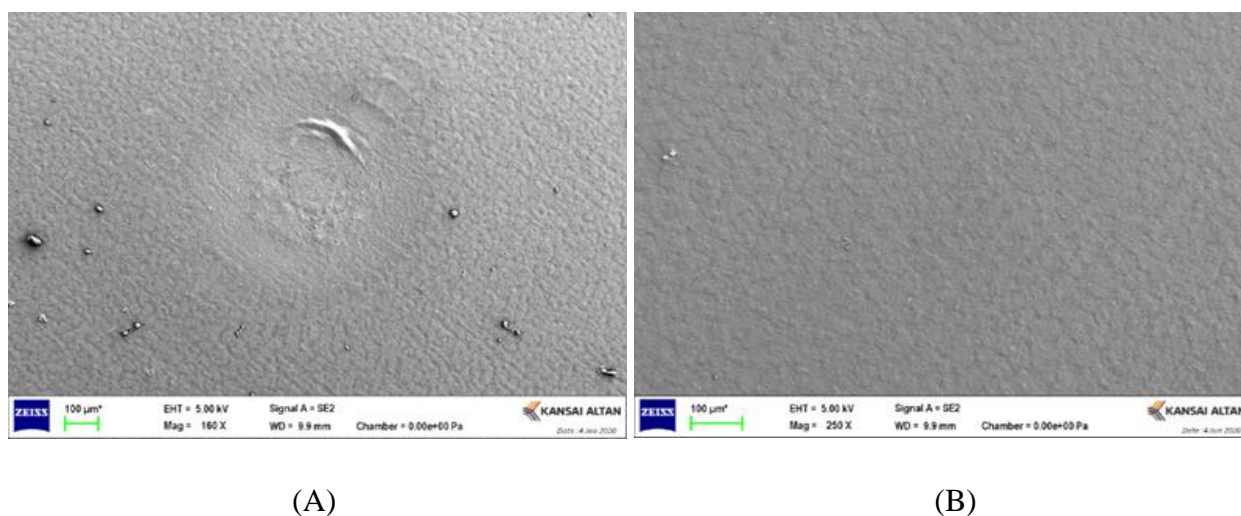
The SEM image comparison of the crater area and the reference area is shown in Figure 4. Crater formation on the surface of coated panel was clearly observed. EDX analysis determined the ratio of Ca element to be higher in the crater area than the reference area.

Figure 4. Comparison of images that belong to crater area (A) and reference (B) respectively.

It might be concluded that this result originates from the agglomeration of the calcite that is involved in the coating formulation. On the other hand, no trace of contamination was found on the surfaces. EDX results with different methods such as full scan, point scan and mapping of the crater area are shown in Figure 5 and EDX results of the reference area are shown in Figure 6. In order to investigate the reproducibility of the data, crater and reference areas that were scanned with different methods were compared according to the ratios obtained from the EDX results.

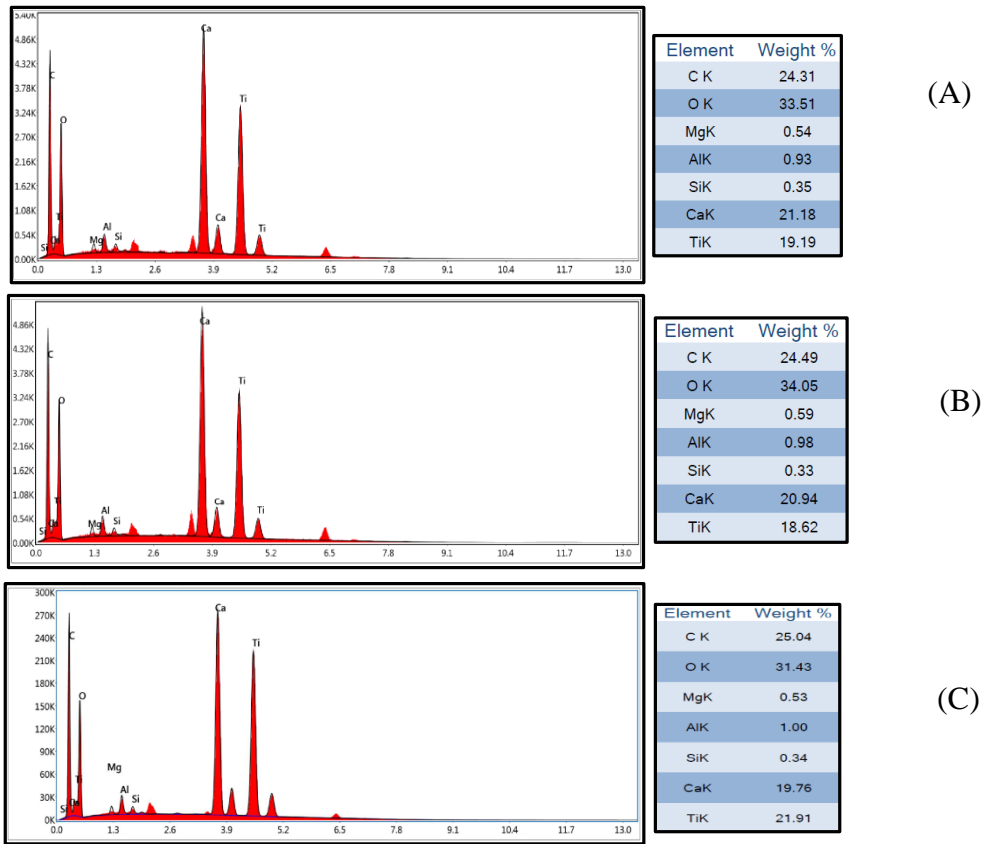
Figure 5. Full scan (A), point scan (B) and mapping (C) EDX results of the crater area, respectively.

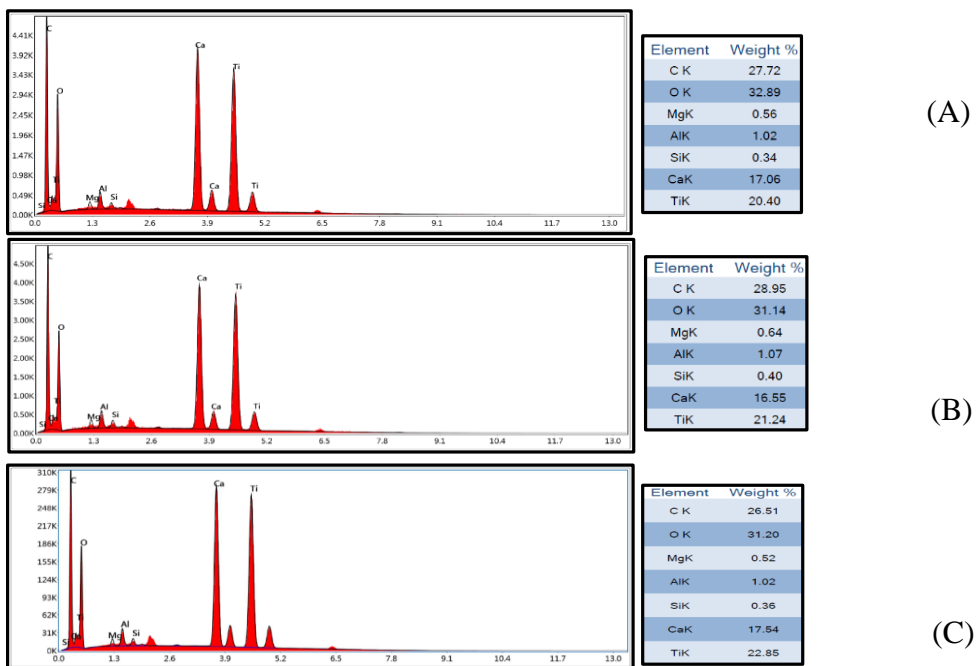
Figure 6. Full scan (A), point scan (B) and mapping (C) EDX results of the reference area, respectively.

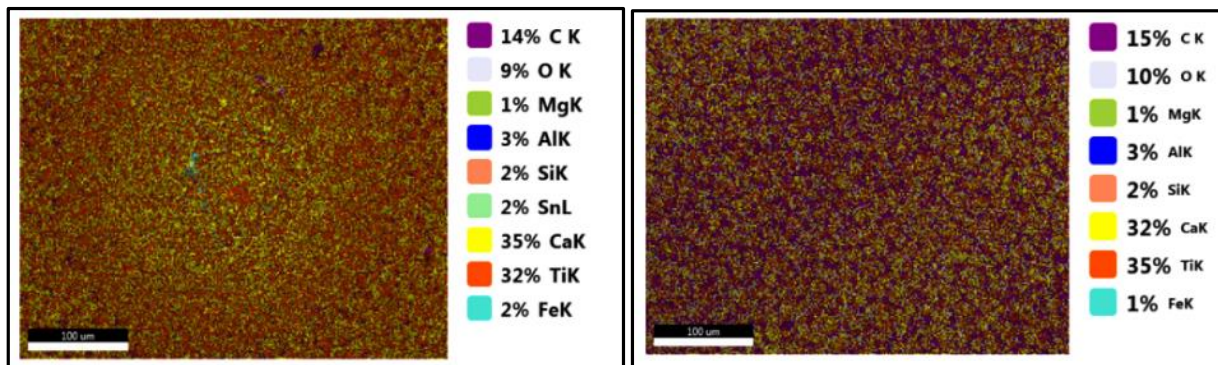
Regarding the results of SEM-EDX evaluations, mapping analysis of the crater panel and reference panel were performed to visualize agglomeration of Calcite in crater surfaces (Shown in Figure 7).

Figure 7. Overlay images of the crater area and the reference area, respectively.

In the mapping results shown in Figure 7, different colors were assigned to each element and overlay images were obtained with respect to overlapping elemental content of individual elements. The percentages of each element indicated on the images are based on their Region of Interest (ROI) value. These values show the total element count in the mapping image, and each color shows the distribution of related element with this count in the image area. Although the count of Ca element between the crater area and reference area are similar, visual results obtained from mapping indicate that the ratio of Ca element (shown in yellow) is higher in the crater region than that of the reference. Consequently, it might be concluded that this finding and SEM-EDX analysis support each other.
