**INVESTIGATION OF REHABILITATION PROCESS OF A REINFORCED CONCRETE
BUILDING IN TURKEY UNDER THE RISK OF EARTHQUAKE**

Keywords: Reinforced Concrete Building, Rehabilitation, Grand Tarabya Hotel, Earthquake Risk, Seismic Intervention

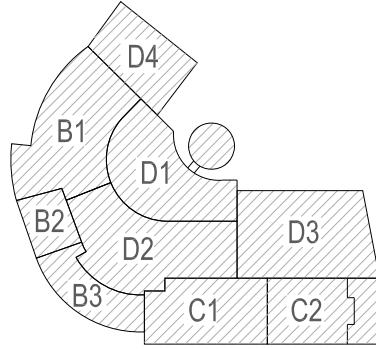
Hotel. Remaining blocks B1, D1, D2, D3 & D4 are low-rise structures (Figure 3). Reinforced concrete slabs are formed as one-way or two-way reinforced concrete slabs (10 cm) and as ribbed slabs in large spanning. When the Hotel was built there was no seismic code in Turkey. Thus, the existing lateral structural system is weak, consisting of only non-ductile beam/column frames. Thus, significant damage can be expected in a major earthquake. Comprehensive rehabilitation decision has been taken for these reasons.

Figure 3. Original expansion joints scheme of Grand Tarabya Hotel
(Şekil 3. Büyük Tarabya Otelinin özgün dilatasyon derz şeması)
(DO-KA/Tuncel/EPS, 2003).

With the retrofitting project designed in such a way to meet requirements for the lateral loads affecting the building, the D4 block was left out of the project and blocks B2, B3, C1, C2 and D2 are joined up and made into one block (Figure 3).

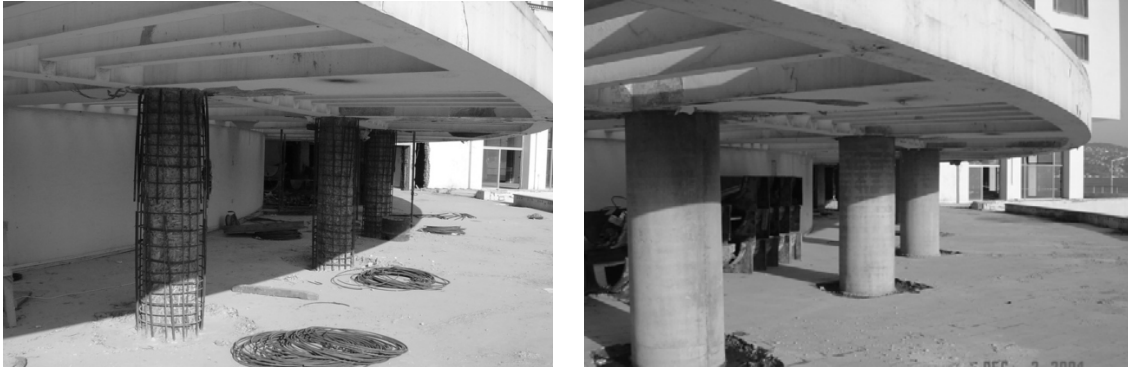
Figure 4. Jacketing existing columns
(Resim 4. Kolonların mantolanması) (DO-KA/Tuncel/EPS, 2003)

For this joined up block consisting of bedroom blocks and common spaces, retrofitting methods such as jacketing of the reinforced concrete elements, addition of reinforced concrete walls and "Friction Pendulum" system which isolates seismic movements were applied in order to provide for the "immediate occupancy level" in the aftermath of an earthquake (Figure 4, 5). The other three blocks (B1, D1, D3) were retrofitted with reinforced concrete column jacketing and the addition of reinforced concrete walls in order to provide for the "life safety level" expectations.

The requirements arose for the retrofitting of whole building to be provided by strengthening of footings, expanding the sizes of spread footings, placing new footings under the additional reinforced

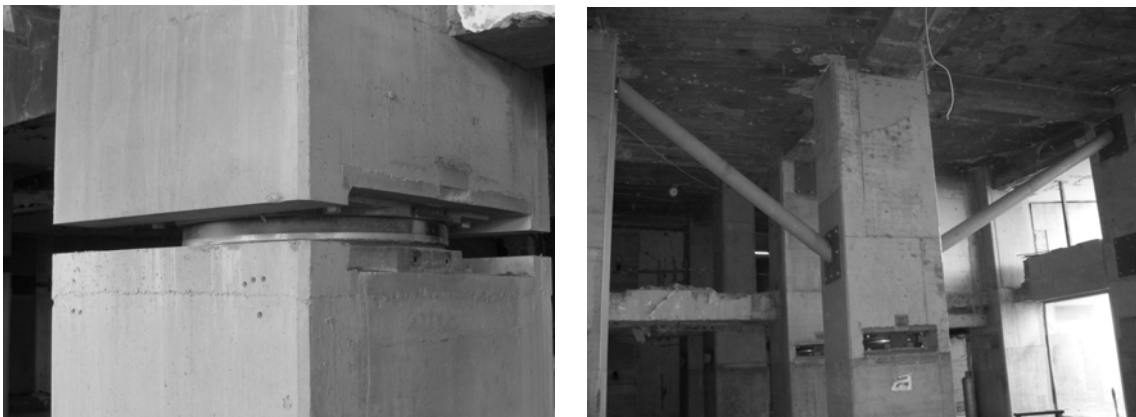
Figure 5. Isolator system and steel braces
(Resim 5. İsolatör sistemi ve çelik kuşaklar) (DO-KA/Tuncel/EPS, 2003)

concrete walls and joining up spread footings to build continuous footings. Additionally when deemed necessary footing elements were supported with lean concrete filling underneath. The part of the building consisting of joined blocks was equipped with an isolator system, which ensures that the earthquake loads have minimum effect on the building. These equipments were placed on the upper parts of the ground floor columns (110 cm down from the ceiling). In the joined up block in line with the locations of the placements of isolators, columns on the ground and first floors were strengthened with the reinforced-concrete jacketing system and hence there were losses of space on these floors. On the other floors, mainly additional reinforced concrete walls were used and the reinforced concrete jacketing applications were used locally. By means of this retrofitting design the loss of space at these flats was minimized. Additionally, as the floor height was rather high on the entrance hall, steel braces were used to achieve stability between the columns of lobby (Figure 5). The expansion joints separating this part from the other parts were increased to 40 cm because of the 32 cm movement capacity of the isolator system. In the area where the expansion joints had been increased, the reinforced concrete columns and beams which were cut off, were replaced locally by additional reinforced concrete walls and steel frame structure systems.
