STABILIZATION OF A FAILED SLOPE WITH PILED STRUCTURES

M. Rifat KAHYAOĞLU, Gökhan İMANÇLI

Dokuz Eylül University, Faculty of Engineering, Department of Civil Engineering, 35160/İzmir

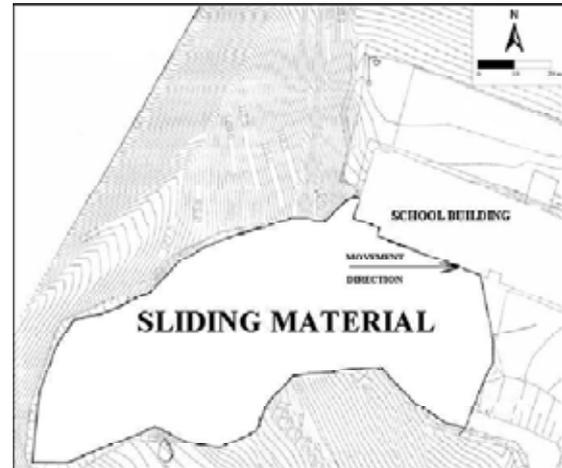
Figure 2. Map of sliding material (zone) in the school area.

As a result of deterioration of the balance of the disturbed rocks along the sliding surface and of the natural ground water flow due to the excavations, the soil mass slid to the west of the school building. The slide was mapped on Figure 2.

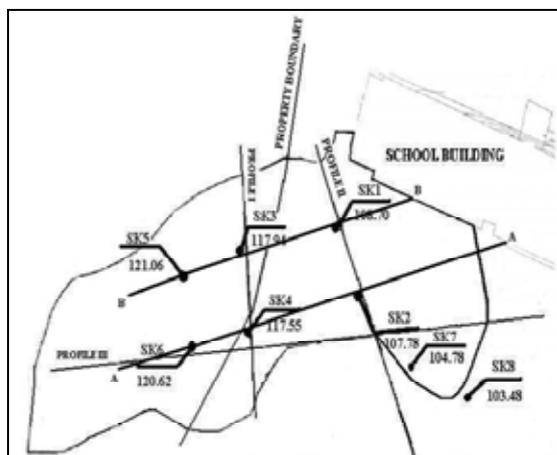
Figure 3. Map of borings and geophysical profiles' locations.

Bore holes were conducted with rotary drilling technique. The total number of the bore holes was eight. Six of these were located on and the remaining two were off the sliding zone. The locations of the bore holes were shown in Figure 3.

The thickness of the landslide zone was determined to be varying in between 4.5 m–10 m. The minimum was in the SK-2 location and the maximum was in the SK-5 location. This variation reflects the three-dimensional geometry of the sliding wedge. Geophysical investigations have also indicated similar results.

In order to understand underlying structure (bed rock slope, discontinuities etc.) of the terrain better, geophysical studies have been conducted on three different axes (Profile I, Profile II and Profile III in Figure 3) alongside selected borings.

Two factors have been distinctive during the selection of the best location of the pile system. The first one among them has been the obligation of staying within the parcel border shown in Figure 3.

The parcel border has brought restrictions also on coordinating the slope. The second distinctive factor for selecting the best location has been the thickness of the slid mass above the bedrock. After examining the alternatives, the direction of SK-1/SK-2 boreholes (Profile II) has been determined as the most economical and the most suitable location for the site topography.

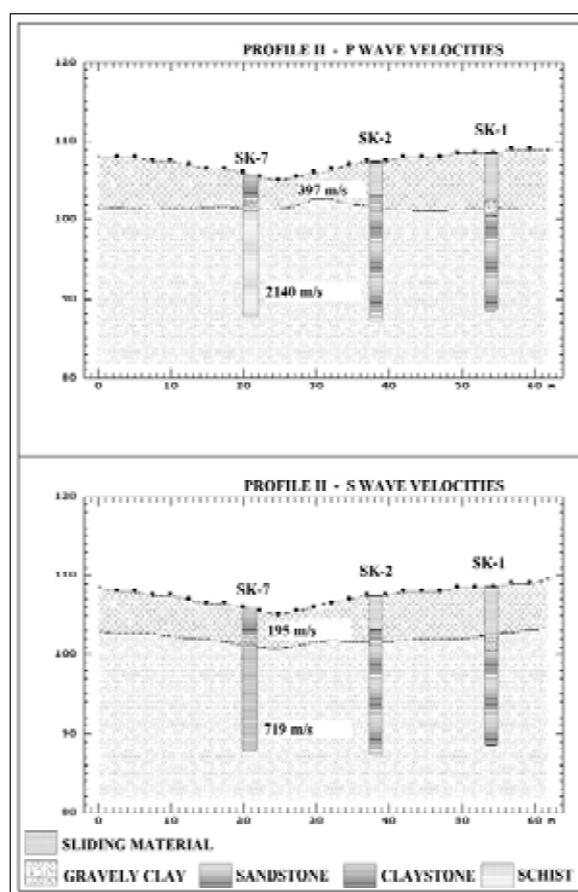
Figure 4. Profile II – Elevation of P and S wave velocities.

P and S wave velocities, given in Profile II, were calculated 397 m/s and 195 m/s at the top, and 2140 m/s and 719 m/s at the bottom, respectively. Rather big differences of wave velocities in the upper and lower parts of related sections reflected the quality differences between the upper soils that participated sliding and lower stable formations. Poisson's ratios were calculated as 0.34 m/s at the top and 0.44 m/s at the bottom. The thickness of upper weak layer represented in this profile varies in between 4-8 meters. This thickness range was in accordance with the borehole findings (Figure 4).

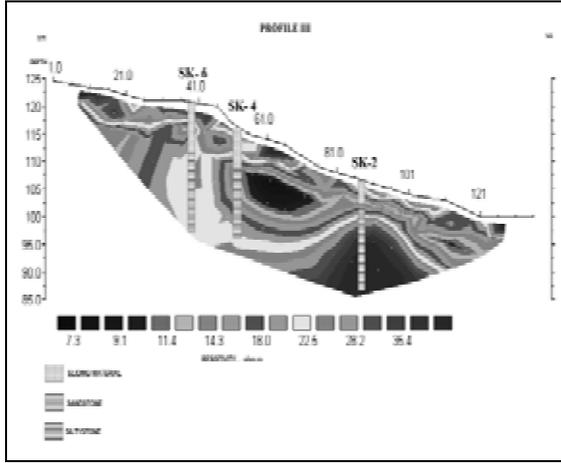
Figure 5. Profile III - Two-dimensional resistivity tomography.

Profile III (tomograph of resistivity) passes just from the south of SK-6 and SK-4 borings and extends towards the west. Landslide geometry is seen in the mid part of the profile as a half circle (Figure 5).

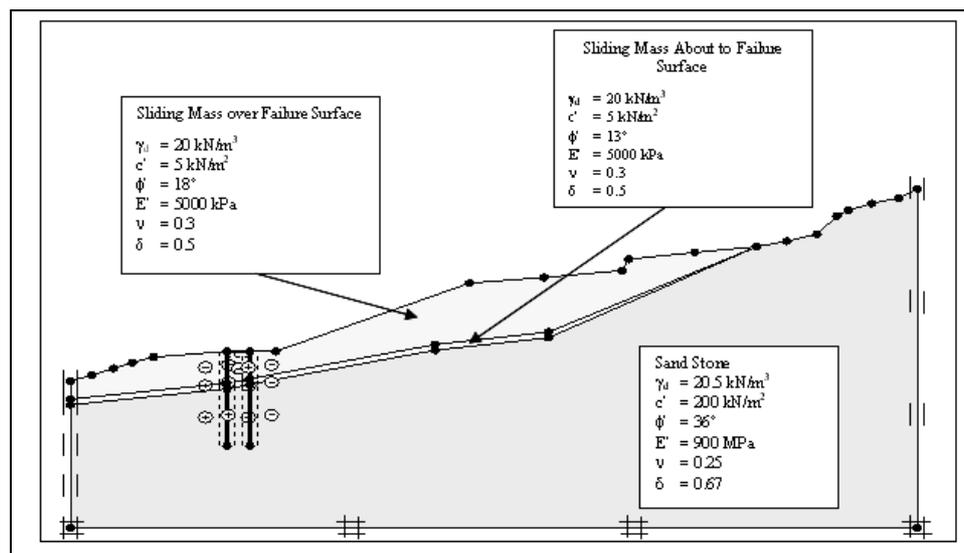
Figure 6. The profile for finite element analysis.

Soil has been modeled to be composed of three zones for the analysis of the piled retaining system. These zones were sandstone at the bottom, sliding mass at the top and a thin failure layer in between.

Shear strength parameters were chosen for failure layer are $c' = 5 \text{ kN/m}^2$, $\phi' = 13^\circ$. Other parameters for failure layer around sliding surface were saturated unit weight, γ_{sat} , effective modulus, E' , Poisson's ratio, ν , and pile-soil friction factor, δ . The values of these parameters have been taken as 20 kN/m^3 , 5000 kN/m^2 , 0.3 and 0.5 respectively. Sliding mass above the failure surface has been found to be composed of silty sand and partially saturated. Assigned parameters for sliding mass were $c'=5 \text{ kN/m}^2$, $\phi'=18^\circ$, $\gamma_{\text{sat}} = 20 \text{ kN/m}^3$, $E' = 5000 \text{ kN/m}^2$, $\nu = 0.3$, $\alpha = 0.5$ and, for sandstone are $c'= 200 \text{ kN/m}^2$, $\phi'=36^\circ$,

$\gamma_{\text{sat}} = 20.5 \text{ kN/m}^3$, $E' = 900 \text{ MPa}$, $\nu = 0.25$, $\alpha = 0.67$. The bedrock parameters have been idealized by using the approach given by Bell and Culshaw (1993). The soil model and assigned parameters were shown in Figure 6.

The most critical state for the piled retaining system has been earthquake loading. A thin layer of the sliding zone over the bottom sandstone has been modeled with residual strength parameters. Relatively high shear strength parameters' values have been artificially appointed to the sliding mass above the failure surface in order to provide leaning on the piles without shear failure above sliding surface. In the case of earthquake, it has been assumed that the horizontal drains would dissipate the pore water pressure on failure surface.

According to the results of two dimensional finite element analysis using Plaxis, the values of maximum moment, maximum normal force and maximum tensile force affected on piles have been found as 511.18 kNm, 579.63 kN, and 572.81 kN, respectively in the axis on the side of school building. For the piles placed in the axis on the side of landslide, these values have been found as 780.16 kNm, 296.80 kN, and 219.66 kN respectively. The maximum deflection of the piles has been calculated as 3.5 mm.

The piled retaining system has been designed to consist of double-row 49 reinforced bored piles with 120 cm diameter and 15 m length having a 1,13 m² cross section and 32φ26 reinforcement. This length ensured a socket length of 8 m in the bedrock. Center to center spacing between the rows and between the piles in a row have been arranged as 3.15 m and 2.4 m, respectively.

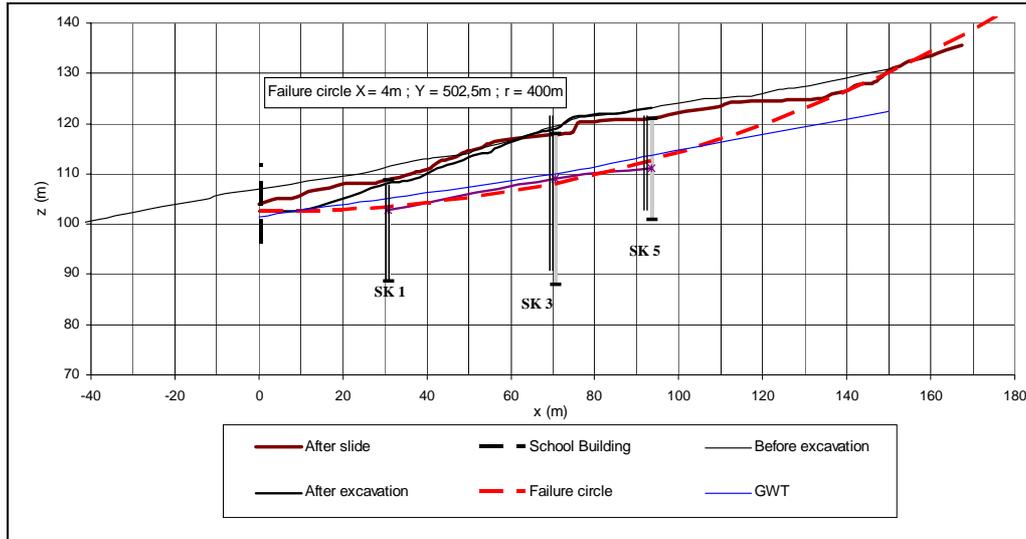
Figure 7. B-B cross section.

By using related topographic maps, two different cross sections (Section A-A and Section B-B) (plan views of these cross sections) of the ground surface before the excavation, after the excavation and after the slide have been drawn. The representative cross section, B-B was presented on Figure 7 with failure circle, ground water table and boreholes.

The value of effective frictional angles that provide a value of $F = 1$ for factor of safety against sliding have been determined by back analysis using Stable $\phi' = 12^\circ$ for the section given in figure.

This value of $\phi' = 12^\circ$ for section B-B was the same as the value of $\bar{\phi}' \cong 12^\circ$ which is the average of residual effective values determined by direct shear tests. It can be concluded that the sliding mass was dominantly composed of silty and clayey sand and, this soil class has been effective on the low value of friction angle. Stable analyses of the slope considering the ground surface before excavation and the value of angle of shearing resistance as $\phi' = 12^\circ$ have been performed and the minimum value of safety factor against sliding has been found to be as $F = 1.26$. This value of F indicates that stability of this slope was not sufficient even before the slope arrangement.

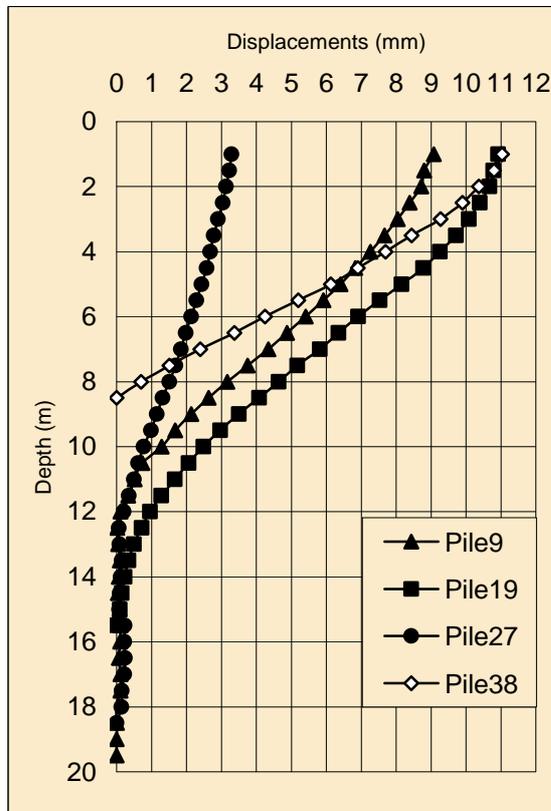
Figure 8. Cumulative displacement graphics using the data on 22.04.2005.

The latest cumulative displacement graphics of four stations (Pile-9, Pile-19, Pile-27 and Pile-38) have been plotted in Figure 8 for the purpose of comparison. According to the latest measurements conducted on 22.04.2005, the greatest pile head displacement occurred in the direction of slide for Pile-38. The value of this maximum displacement was 11.03 mm. The greatest pile head displacements in the other inclinometer stations for Pile-9, Pile-19, and Pile-27 were 9.08 mm, 10.92 mm and 3.29 mm, respectively.

It can be observed that the displacements occurred seem not to increase linearly with time, but increase with a decreasing velocity even after the intense precipitation period of 2005. It has been thought that the causes of the measured displacements may be the weight increase of the sliding mass due to precipitation and, shear strength decrease due to possible pore water pressure increase on the sliding surface. Thus, the sliding mass has transmitted its expected load by leaning on the retaining system. The limited maximum value of pile head displacements and the fact that measured displacements increase with decreasing velocity suggest that this piled retaining system would not experience hazardous displacement in the future.

The slopes of the pile elastic curves were zero in the region of pile cap and pile bottom elevations. Pile elastic curves attained a reverse slope around 6-meter depth. The shapes of the elastic curves were consistent with the socket effect in the weak rock at the bottom and rigid pile cap at the top.
