## Cultural Heritage and Science

# Architectural Inventory and Building Condition Assessment Research on Masonry Structures of Kanlıdivane Archaeological Site, Mersin

(Research Article)

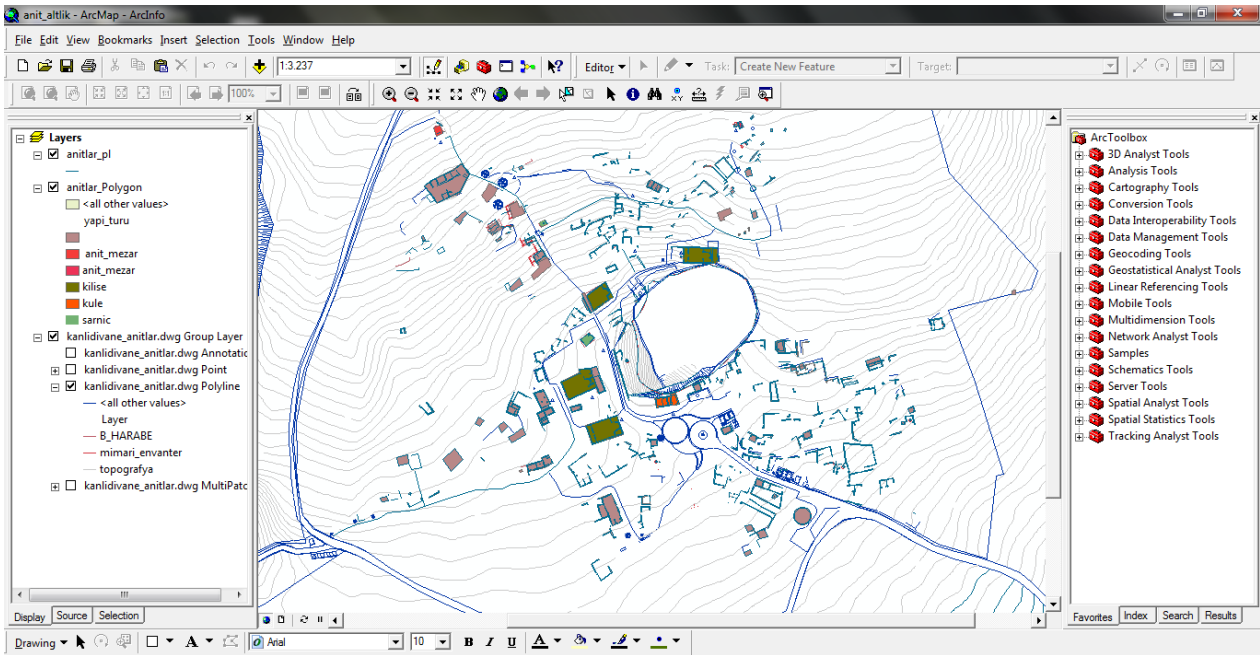
Figure 3. GIS database for spatial distribution of condition assessments

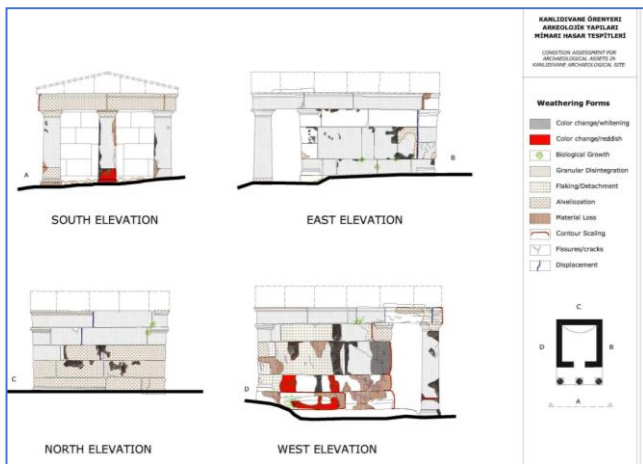
Building scale assessment studies base on visual observation techniques during field studies. The results have been mapped onto the architectural survey drawings (Figure 6).

**Figure 6.** Mapping of material deteriorations and degradations on architectural survey drawings

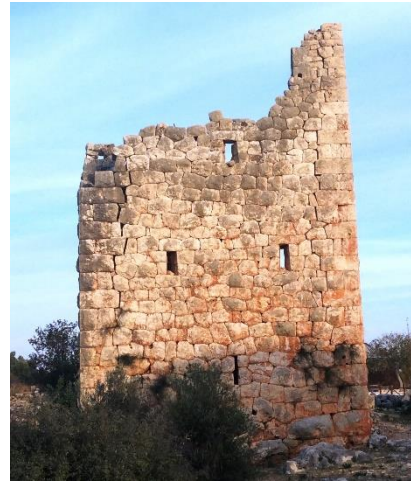
**Figure 7.** Hellenistic period Tower constructed with polygonal masonry technique in Kanlıdivane

The Hellenistic Tower, located at the south edge of the geological pit with its remarkable polygonal masonry technique has been suffering from structural cracks occurred in the corners of the building. The superstructure of the building and upper wall sections have been already destructed, but planimetric layout is very well preserved. The building must be included into structural reinforcement program such as filling with repair mortars and retrofitting interventions in order to avoid the vertical wall sections to fall apart from each other. The Hellenistic Tower is the oldest masonry technique in the region and one of the rare examples of its similars. The Byzantine church no 4 located at the north edge of the geological pit material degradation process has already lost its southern wall and main roof covering the main hall of the building. The weak wall sections (when compared to Hellenistic and Roman period construction technique) and limestone morphology of stone material used in the walls causes severe deterioration problem because of the atmospheric conditions and rainwater. The standing walls are facing sugarization and contour scaling problems in some of the structurally critical points such as door and window lintels. This may cause partial destructions in the existing walls or dome section of the apsis part. Therefore, the building must be included into architectural conservation program for both structural repairment and material conservation interventions.

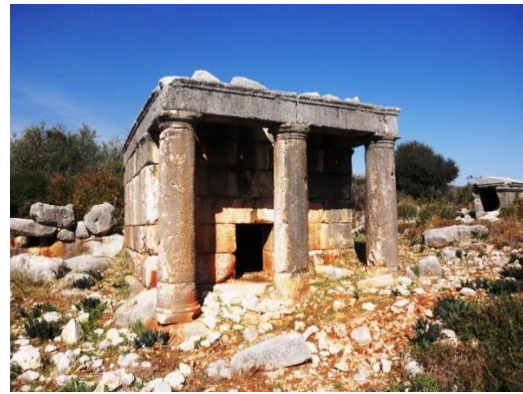
**Figure 8.** Roman period Monumental Temple constructed with isodom masonry technique in Kanlıdivane

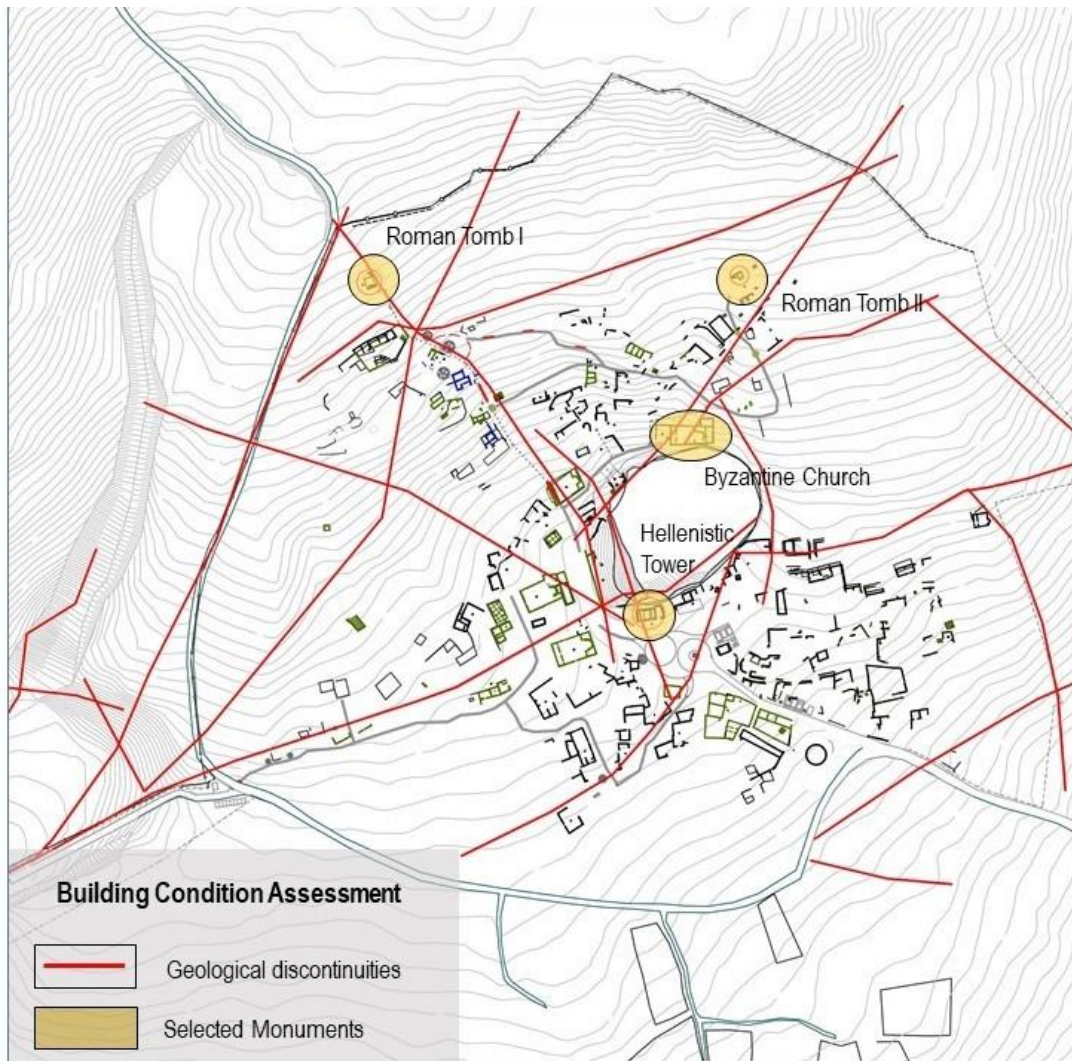
The second criteria that affected structural performance and condition level of the monuments were their locations in the site and relationship with the ground during construction phase. Some of the was location in the site. The most severe natural risk in the site is the geological discontinuities. Previous geological surveys conducted by Güler and Tağa in the Kanlıdivane Archaeological Site have shown that there are severe geological discontinuities problems including landslide movements especially around the geological pit (Güler & Tağa, 2011). They also observed locations of geological crack lines because of past earthquakes (Figure 9). The limestone morphology of the ground makes it more vulnerable because of geological discontinuities and abrasion impact of surface and ground water. The fallen wall pieces from the archaeological site into the geological pit supports this analysis.

**Figure 9.** Locations of historic monuments selected for building condition assessment research in relation with the geological discontinuities in the site

Results of comparative analysis on building condition assessments conducted on selected monumental buildings (Hellenistic Tower, Roman Tomb I, Roman Tomb II, Church) have shown that the monuments constructed on rocky platforms located away from the geological pit or past earthquake lines are in very good condition (Roman Tomb II). The monuments constructed around the geological pit, are in severe danger since the landslide movement is still active. The Hellenistic Tower with its polygonal masonry technique and geometrical proportions could survive better when compared to Byzantine period church although it was constructed centuries before. Lastly, the Byzantine church with its weaker masonry wall section have been destroyed and architectural integrity have been lost. The building has totally lost its southern façade located by the pit and the superstructure. The apsis section was gradually preserved with its domed superstructure.
