# The 30 October 2020, $M_w$ 6.6 Sisam (Samos) Earthquake: Interpretation of Strong Ground Motions and Post-Earthquake Condition of Nearby Structures

**Abstract:** A major magnitude  $M_w$  6.6 earthquake struck offshore of the city of İzmir, Turkey and the city of Neon Karlovasion, Greece which has the epicenter located at north of Sisam/ Samos Island in the eastern Aegean Sea on October 30th, 2020. The moment magnitude of the earthquake has been reported variously, such as 6.6, 6.9 and 7.0 by different agencies. Seismic instruments indicate the earthquake originated at a depth of 17.2 and 21 kilometers according to the Disaster and Emergency Management Presidency (AFAD) of Turkey and USGS. Doğanbey Payamlı, Ürkmez, Gümüldür, Kavakdere are the closest coastal villages of İzmir to the epicenter. The earthquake affected the mid-rise buildings located on the soft soil and then, tsunami stroked the coastal villages of İzmir. In this study, the strong ground motion records in a distance range from epicenter to 150 km are analyzed to investigate the characteristic of the ground motions. The post-earthquake field observations mainly for the mid-rise reinforced concrete structures are re

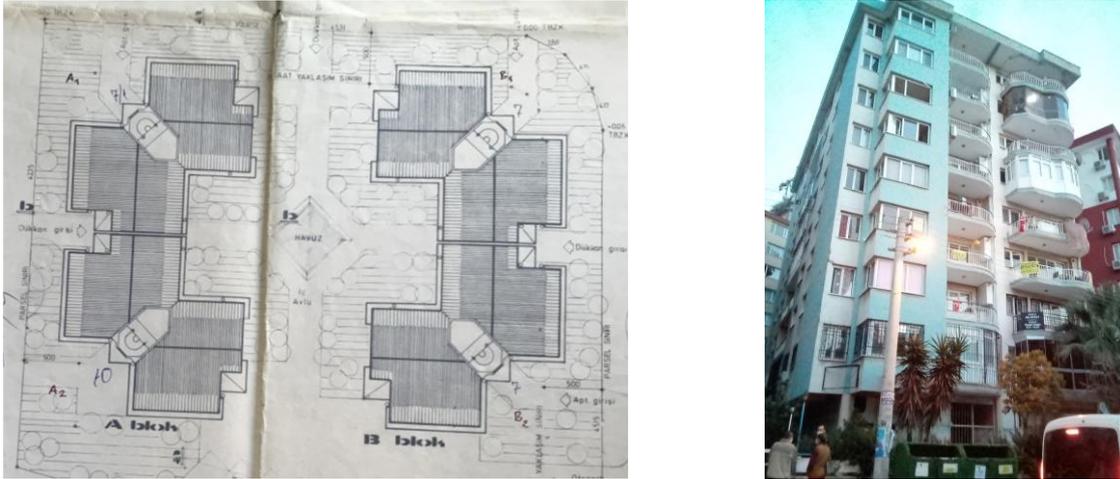
Behavior of a multi-story building during a strong earthquake highly depends on the structural configuration. Irregularities either in horizontal or vertical configuration can lead severe damages during an earthquake. **Figure 11** shows irregular structures located in Mansuroğlu region of Bayraklı district of İzmir. Many buildings in this small area appear to have tall floor and open plaza features on the ground level. Also, shear walls which increases the lateral rigidity were not used in these buildings.

Figure 11. Irregular Configurations in Mansuroglu region, Bayrakli district of İzmir

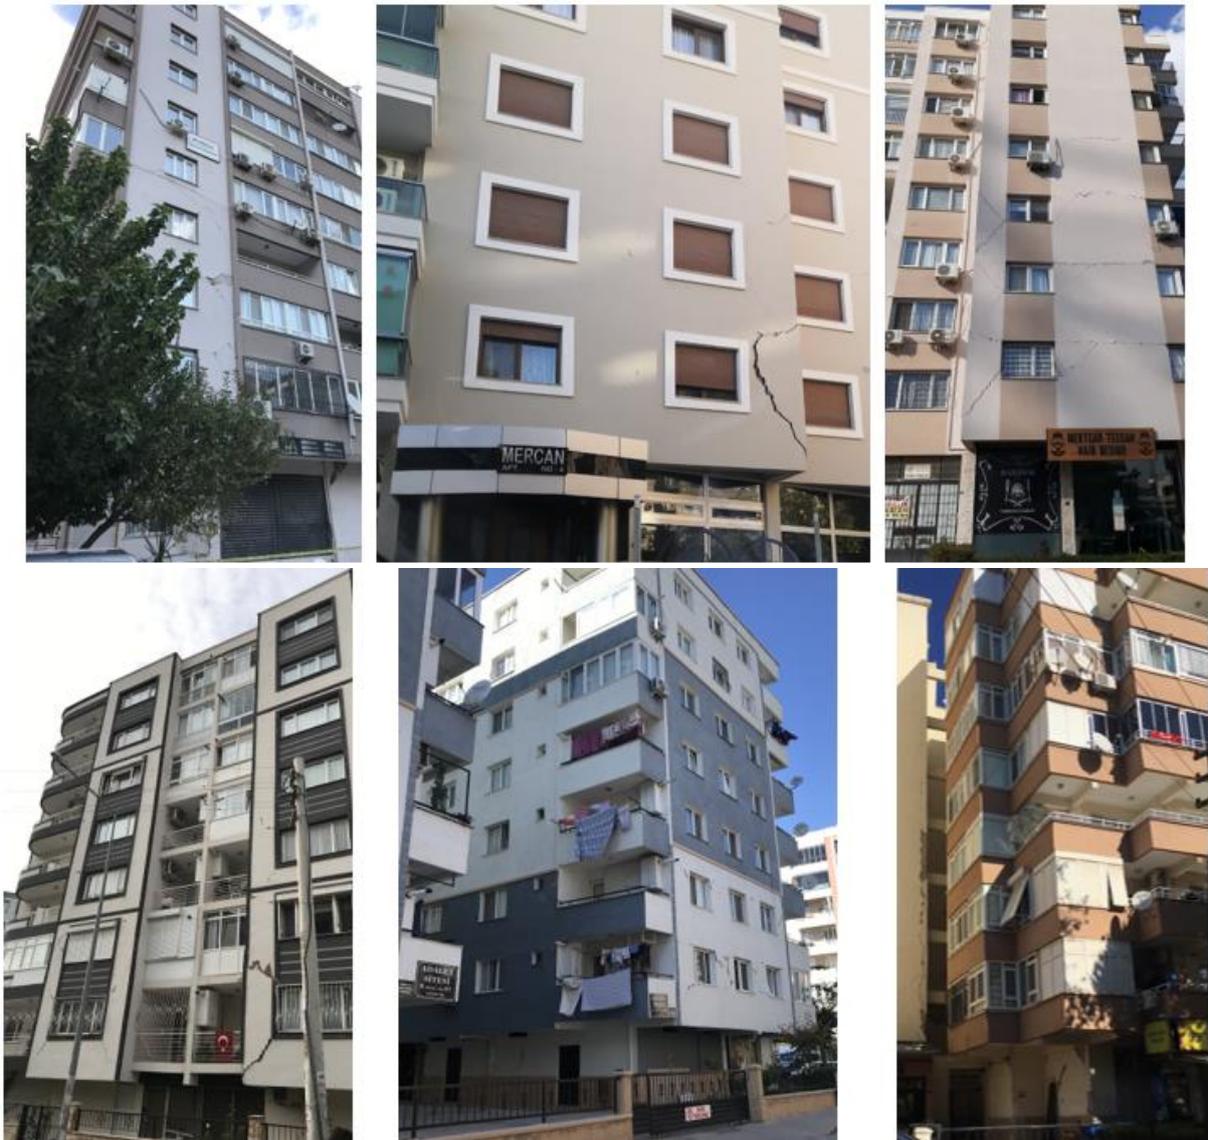
many application problems during the construction were reported in post-earthquake reconnaissance reports [1,7,19]. Buildings with overhang floors are also very common in İzmir, Turkey and these overhangs were the cause of the structural damages in many buildings. **Figure 12** shows the damages that occurred at the overhang locations. Columns at cantilever beam connections which intersect with overhangs are subjected to high stresses and this causes significant structural damages at these critical locations. It might be a good practice to use of reinforced concrete walls instead of columns at the cantilever beam intersections to increase the rigidity at these junctions if the overhangs are unavoidable.

Figure 12. Damage of Buildings with Overhangs

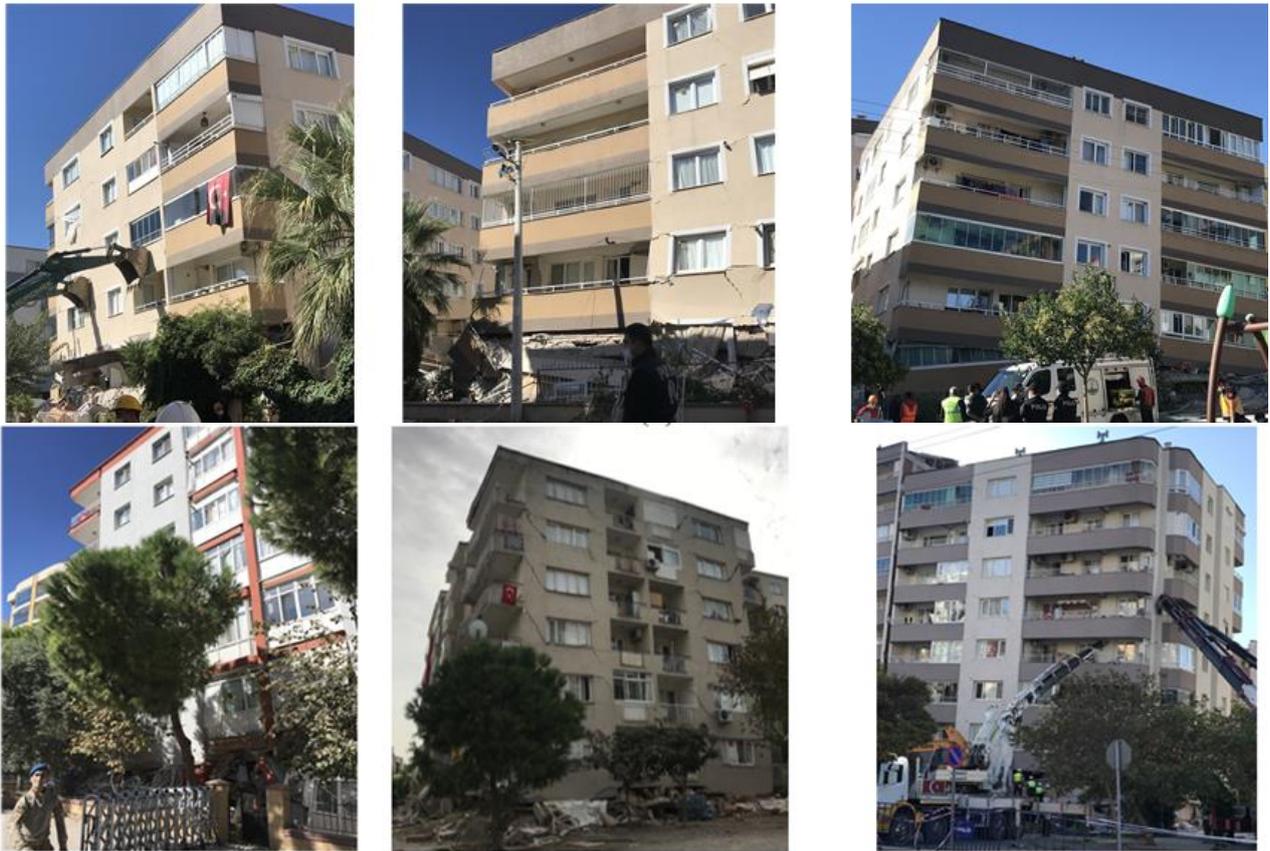
Large openings at the first floor have been used in the buildings for architectural purposes for many decades. Unless specific measures are taken by engineers, first floors typically have lower strength and stiffness due to lack of walls compare to the upper floors. Discontinuity in the structural system results damage concentration at the weaker or more flexible story which is commonly called soft-story mechanism. **Figure 13** shows the buildings that have suffered extensive soft-story damage/collapse. Large openings on the street side, for store windows or other purposes lead to a significantly weaker and more flexible structural frame than on the other side of the building, which has few openings, and cause topping of the

building toward the street side as shown in **Figure 13**.

**Figure 13.** Partially collapsed buildings due to the soft story mechanism at the first floor in Bornova district in İzmir, Turkey

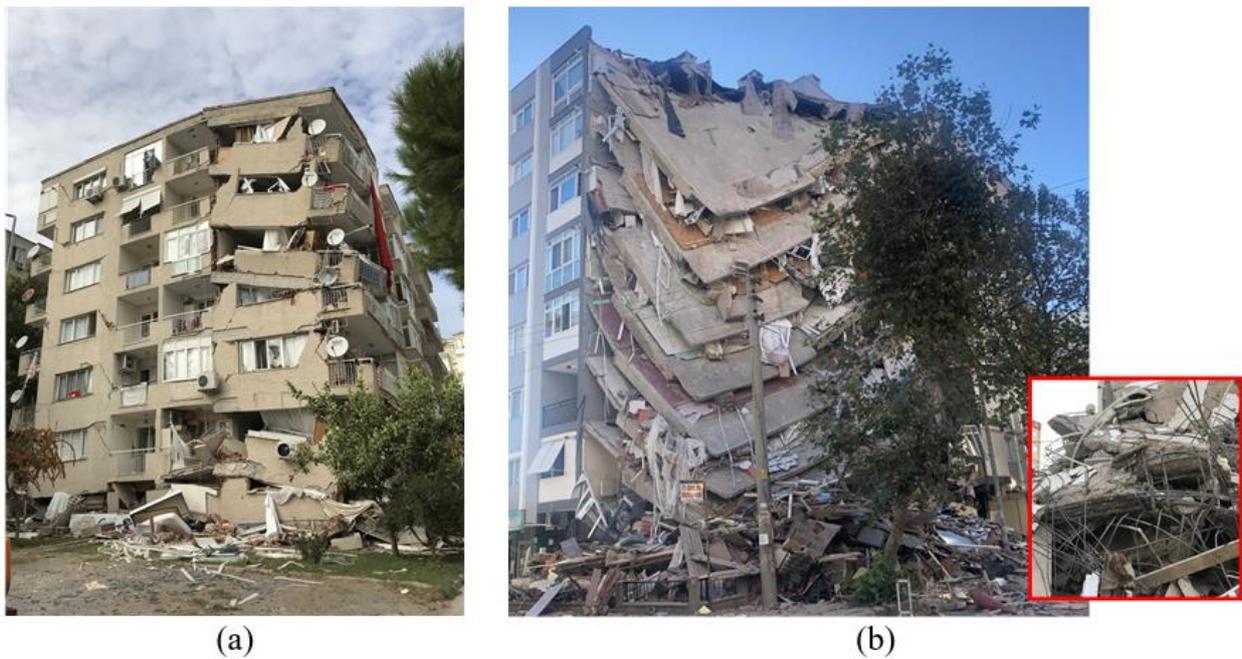
Plan geometry and rigidity distribution in plan can cause torsional irregularity. For instance, if shear walls or rigid core are located on one side of the building, flexible and rigid parts occur in the structure. Earthquake loads affect the gravity center of the structure however, the rigidity center of the structure responds to these loads for redistribution of internal forces. If the eccentricity between these two is large, torsional moment occur around the center of rigidity and causes unbalanced perimeter resistance which impose excessive forces in the farthest edge or corner columns. **Figure 14** shows examples of corner column failures. For instance, one quarter of the building was collapsed since it is located on the street corner, thus having two open sides, because of the increased axial and torsional forces at the corner columns during the main aftershock [see **Figure 14(b)**].

**Figure 14.** Partially Collapsed Building, Located at the Street Corner

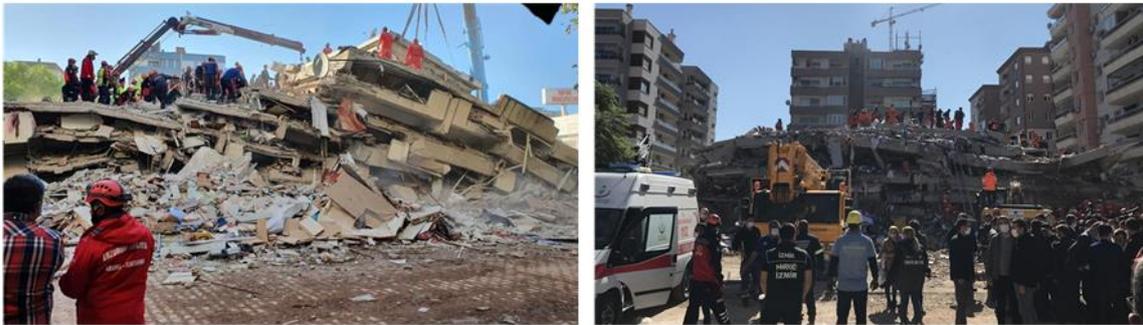
Structures are allowed to be damaged at a certain level under the strong ground motions however these damages expected to be occurred at the end of the beams rather than the columns for ductile behavior in moment frames not to lead collapse. To be able to fulfill this requirement, the ultimate strength of the columns should be greater than the beams at the joints. Field observations showed that weak column strong beam (WCSB) systems are common in İzmir, Turkey might have resulted in numerous story collapses, following excessive column damage as shown in **Figure 15**.

**Figure 15.** Damage due to Weak Column Strong Beam (WCSB) Ratio

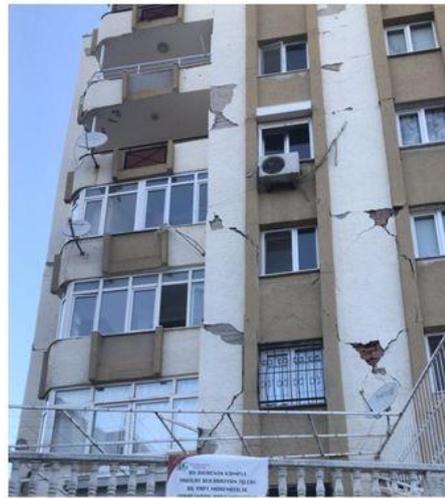
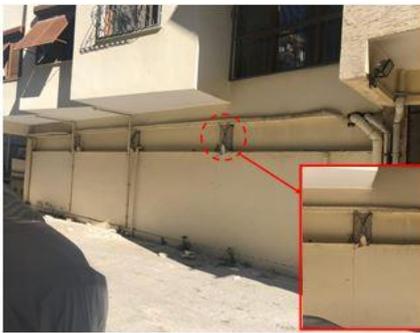
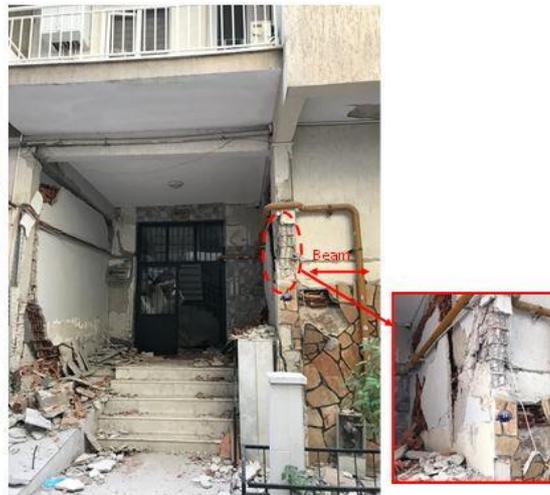
Another common type of column damage was observed when partial height nonstructural partitions were used in the buildings as shown in **Figure 16(a)**. **Figure 16(b)** and **(c)** also shows the short column effects that observed in the field. These partitions or presence of subbasement [**Figure 16(c)**] prevent the development of the column's actual flexural behavior over the height, rather allow them to deform over the free height. Even though, these short parts of the column would make it possible to resist higher lateral forces before the flexural strength of the column is reached, the shear strength of a short column is often first reached and typical non-ductile shear failures occurs.

**Figure 16.** Short column due to presence of lower grade floors.

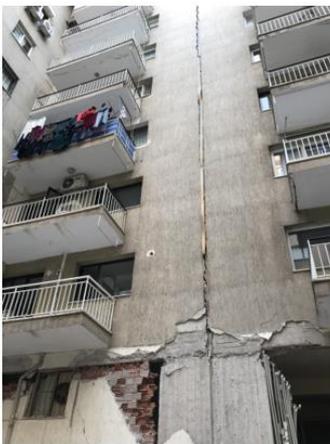
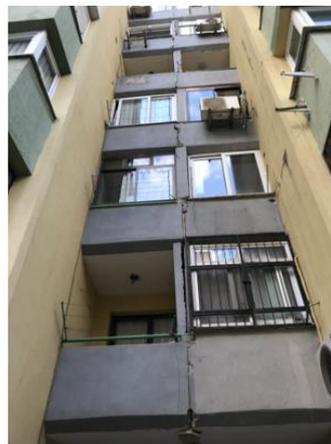
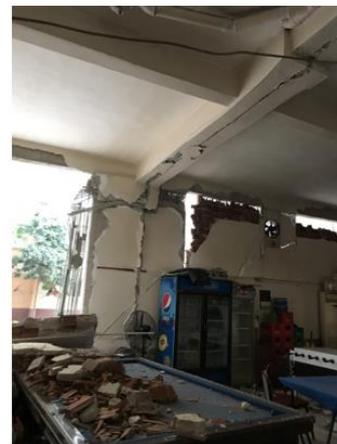
In last couple decades, structural engineers began to recognize that certain building shapes resulted in potentially undesirable effects, such as torsional forces and simple analysis methods may not cover these complex behaviors. To eliminate these effects, seismic joints were utilized to divide a complex shaped building into group of smaller buildings with simple shapes which can be easily analyzed. Depending of the building height and stiffness, the width of the seismic joints needs to be determined. If the width of the seismic joint was not appropriately implemented during the construction, pounding might occur when the adjacent buildings start vibration out of phase during the earthquake which causes collision amongst the adjacent building. **Figure 17** shows the structural damages due to inadequate width of the seismic joints. Previous studies [20,21] showed that nonstructural partitions had positive impact on the seismic response of structures since the use of these reinforced concrete as infills, stiffens and strengthens the lateral load resistance of the structures. However, these nonstructural elements generally neglected by design engineers during the modelling process and this may cause unexpected load distribution during the seismic event. On the

**Figure 17.** Inadequate Earthquake Joints in Bayraklı district of İzmir, Turkey

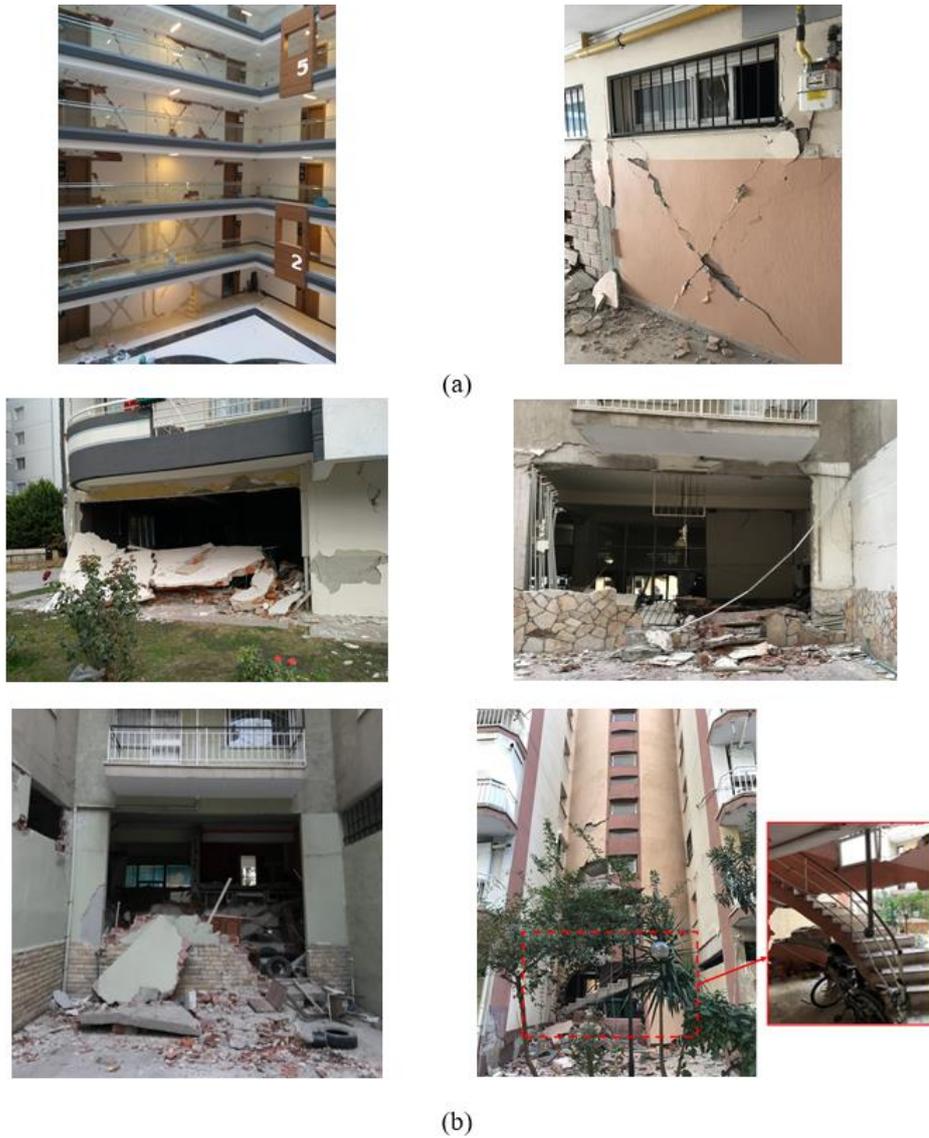
energy dissipation by preventing column damages and contributed to seismic survival. On the other hand, if the infill walls poorly tied to its surrounding frame, out-of-plane collapse of infills could be observed as shown in **Figure 18(b)**. Infills also played a significant role in helping the lateral strength only if the opening are not creating short column effect in surrounding columns and are not creating excessive damage in the surrounding beams such as experienced in Golcuk, Turkey (1999) The strength variation of brick and mortar of infills walls creates different failure modes and may lead to sudden drop in strength of the buildings. Similar trend was also observed in Sisam earthquake. In **Figure 18(a)**, the slab discontinuity in the building results in in plane excessive infill damage [1].

**Figure 18.** Damage of Infill Walls

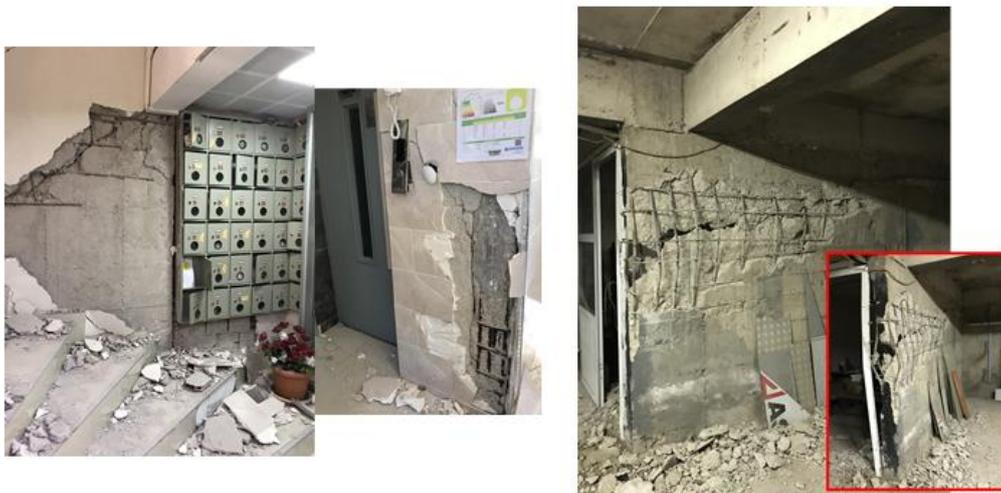
**Figure 19.** Buckling of Distributed Vertical Reinforcement in Shear Walls

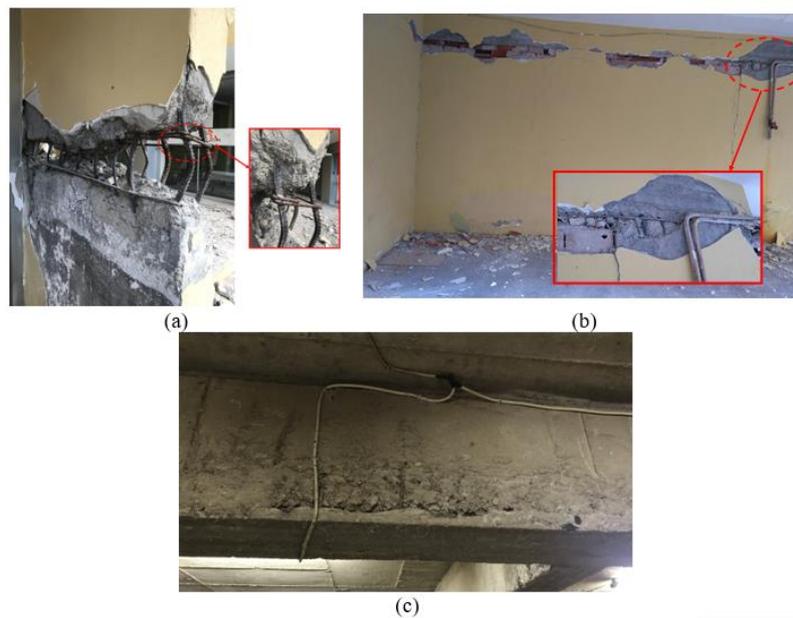
Detailing of reinforcement is very important for the deformation of the buildings. **Figure 20(a)** shows how widely spaced ties with 90° bent hooks were insufficient to contain the damaged concrete and prevent vertical bars from the buckling. Poor formwork installation was observed in many buildings in Bayrakli and Manavkuyu districts of İzmir as shown in **Figure 20(b)**. Misalignment of the formwork caused cracking and structural damages in many columns and shear walls in the structure. Poor quality concrete and concrete materials were also observed in many buildings in İzmir, Turkey. This situation resulted in the concrete to exhibit an excessive porous structure **Figure 20(c)**. Formation of cold joints were observed in many buildings where the cracks were occurred at these points [see **Figure 20(b)**].

**Figure 20.** Defects due to Formwork Installation, Poor Concrete Quality and Workmanship

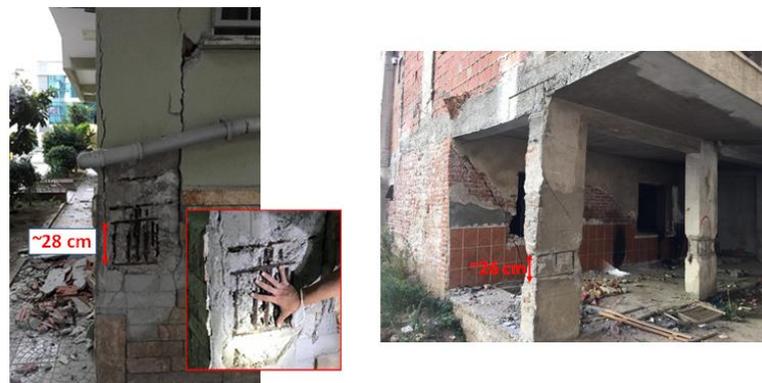
**Figure 21.** Inappropriate Reinforcement Spacing and Excessive corrosion in the reinforcement

**Figure 21** illustrates the reinforcement spacing which exceeds the maximum spacing requirements and inadequate confinement reinforcement. Corrosion in reinforcements took place due to insufficient concrete cover and low quality of the concrete. It was also observed that the anchorage and lap splice lengths were not properly taken care of in many severely damaged buildings as shown in **Figure 22** and **Figure 23**.

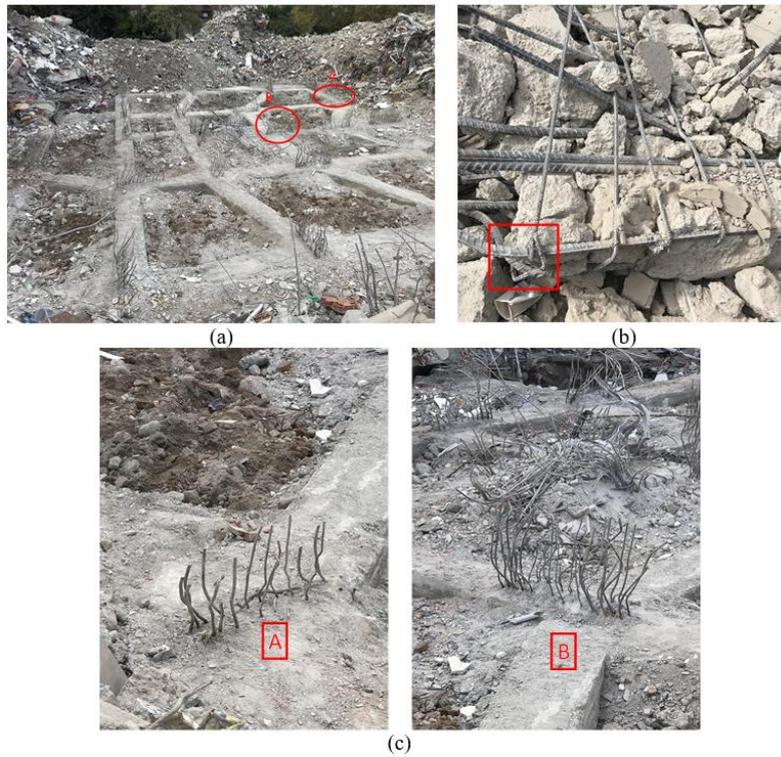
**Figure 22(c)** shows the lap splice lengths which varies through the foundation. Inadequate lap splice length and straight ends

of these laps poorly affects the overall behavior of the columns. Similar to many other buildings, improper hook detailing in stirrups was also observed as shown in **Figure 22(b)**. Irregularities and deficiencies at the structures also caused problems at the overall behavior of structure as shown in **Figure 24**.

Figure 22. Inadequate lap splice length example from a collapsed building at major strike.

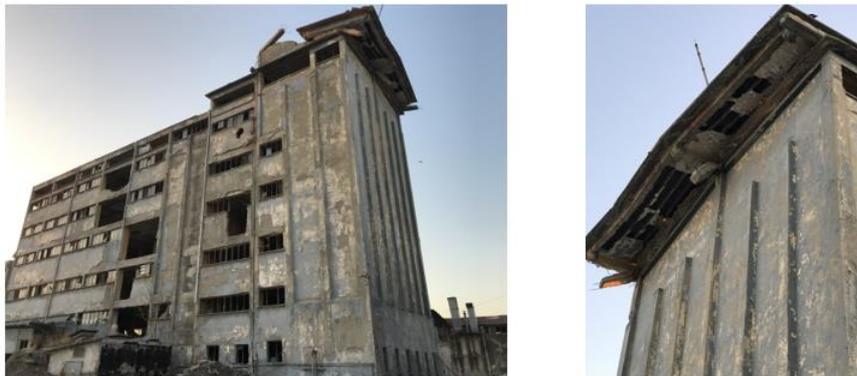
Figure 23. Damage of Abandoned Factory

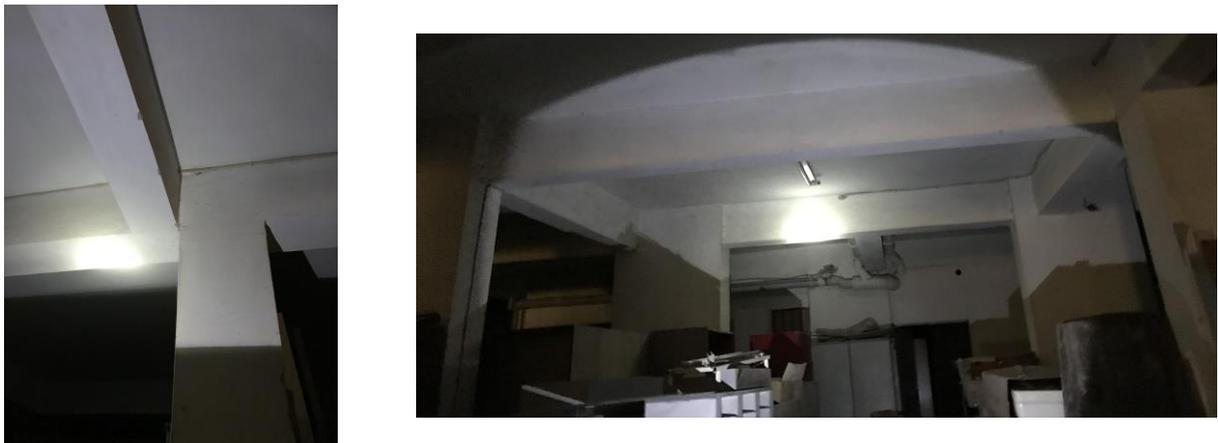
Figure 24. Frame Deficiencies and Irregular Floor Layout

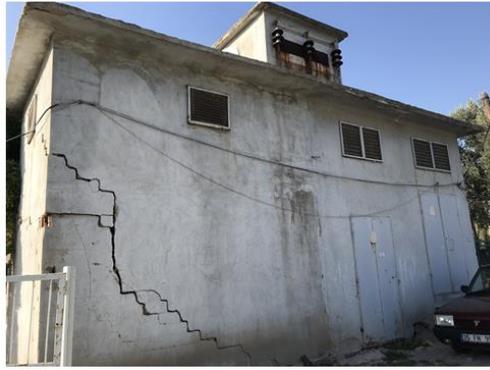
bricks to act together. One common place of the failure is the corners as shown in **Figure 25**. Dimensions and location of the openings in masonry structures were limited by the seismic designed codes since they reduce the area of the load bearing walls. Cracks due to large openings in the walls or windows too close to the corners were observed at some of the university campus buildings as shown in **Figure 26** through **Figure 28**.

Figure 25. Damage at the corner of the masonry power distribution unit

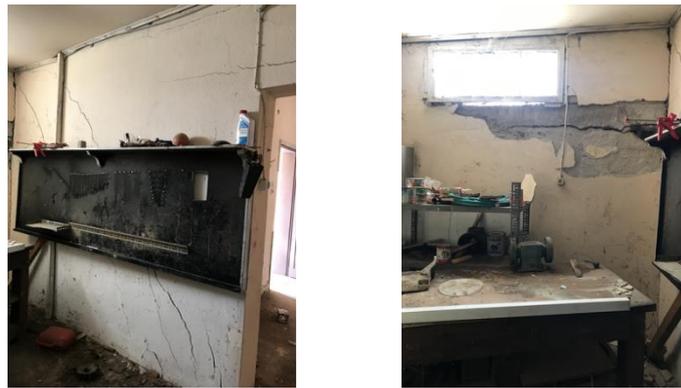
Figure 26. Machine shop of Department of Agriculture at Ege University

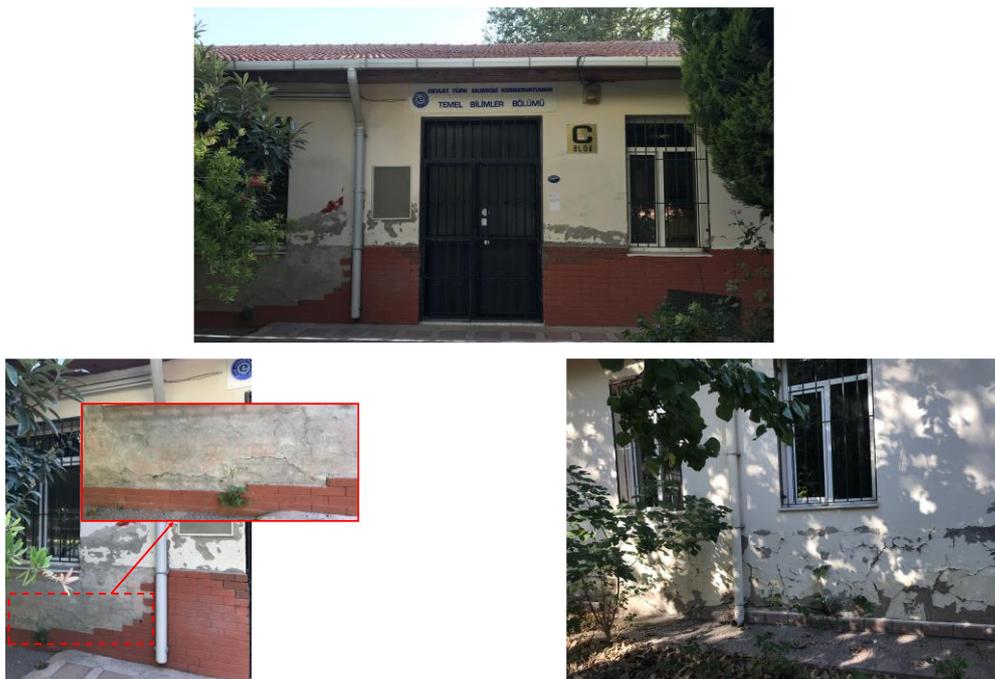
Figure 27. School of Conservatory at Ege University

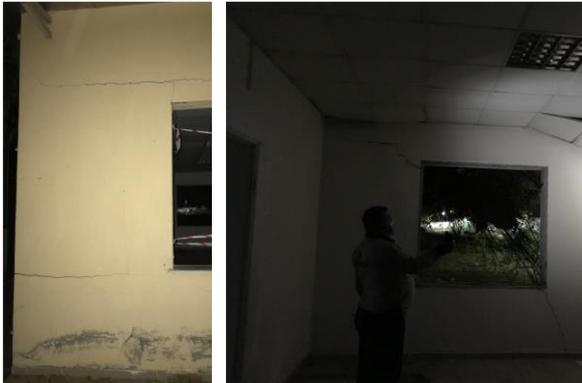
**Figure 28.** School of Medicine Classrooms at Ege University

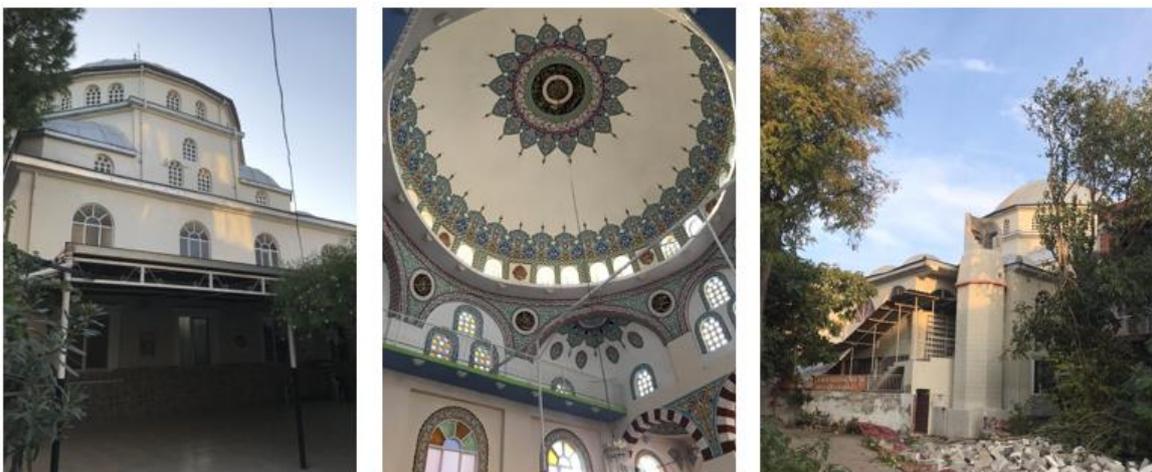
Soil supporting foundations may undergo consolidation or shear failure when subjected to excitation during an earthquake, leading to ground settlement or subsidence. The ground settlement can cause buildings to displace which may lead damages in the masonry walls as shown in **Figure 28**. The nonstructural damage was also observed. The most vulnerable top part of minaret of a mosque was collapsed while the remaining of the mosque was not even damaged. The minaret is connected to the mosque at the two story level and this creates a stiffness and boundary variation in the height and result in cracks usually at the points with abrupt cross-sectional changes which leads the minarets collapse. **Figure 29** shows the partial collapse of the minaret from the part this cross-sectional change starts.

**Figure 29.** Damage of Mosque at the Upper Part of Minaret

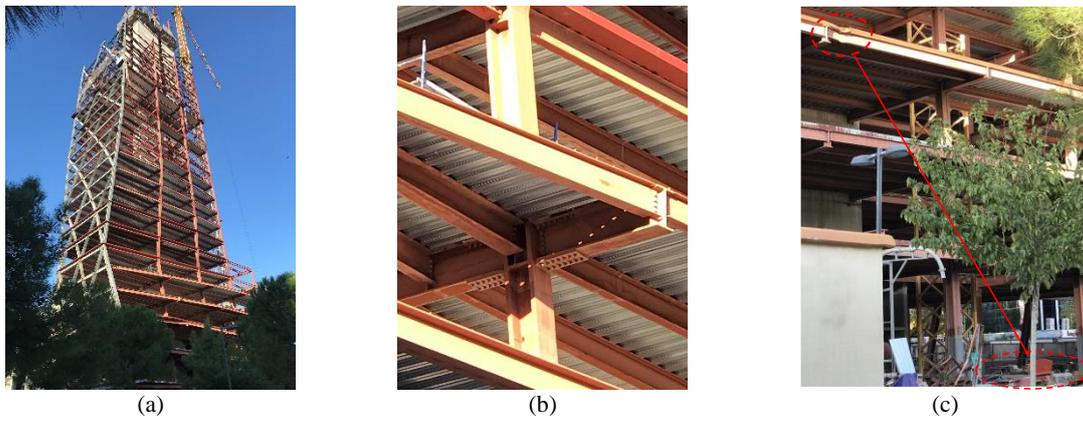
In Izmir, only few buildings were constructed by using structural steel. **Figure 30(a)** shows the steel structural building with a reinforced core in the middle which was under construction when the earthquake hit the city. Before the earthquake, most of the steel frames in the buildings was completed but all the steel beam-to-column joints were visible during the earthquake. Following the earthquake, there was no connection damages on the beam to column junctions as shown in **Figure 30(b)**. However, the column at the last floor which was temporarily attached to the underneath column was collapsed and caused damage to some beams at the third floor as shown in **Figure 30(c)**.

**Figure 30.** a) Steel Building under Construction b) Beam-to-column joints, c) Damage at the third floor beam due to collapse of a column at the construction level.

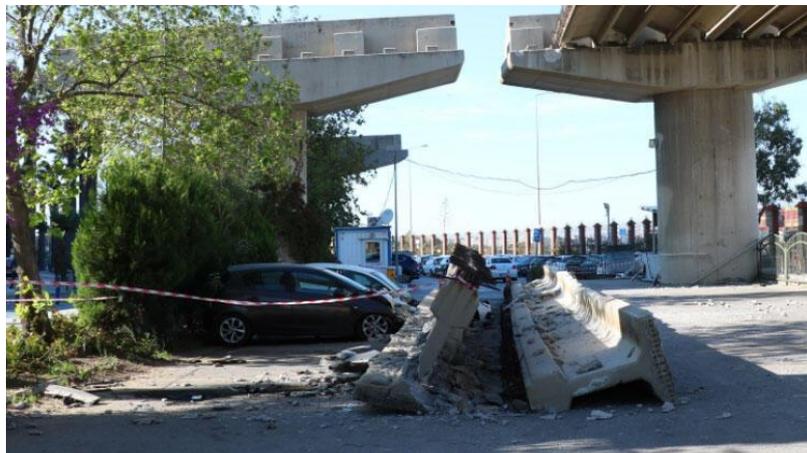
Tall buildings located in Bayraklı district showed good performance except few of them which have excessive non-structural damages. The main reason of having less damage in tall buildings is considered as strong foundations with ground improvement with piles. In **Figure 31**, two remarkable tall buildings, which are Folkart Towers and Mistral located in Bayraklı are given. These two towers showed good performance at main shock and have no significant structural damage. In **Figure 32**, the only damage occurred in bridges/viaducts has been showed. The viaduct is an unfinished construction more than 10 years and the fall of the girder was the result of no lateral support connection detailing.

**Figure 32.** a) Girder fall from unfinished bridge viaduct construction in Alsancak due to no lateral connection detailing (Photo is adapted from <https://i4.hurimg.com/i/hurriyet/75/0x0/5fa6a9f00f254410e87185f2> )
