# A study on the determination of damage levels in reinforced concrete structures for different earthquakes

Bitlis Eren University, Department of Civil Engineering, TR-13000, Bitlis, Türkiye

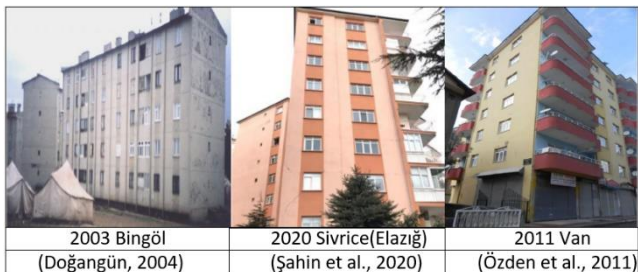
The visuals used in the 1st degree damage grade for the considered earthquakes are shown in Figure 3.

**Figure 3.** Negligible to slight damage for different earthquakes (Grade 1)

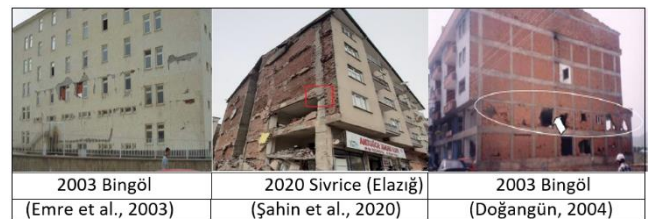
The moderate damage (Grade 2) for RC buildings for selected earthquakes are shown in Figure 4.

**Figure 4.** Moderate damaged RC buildings

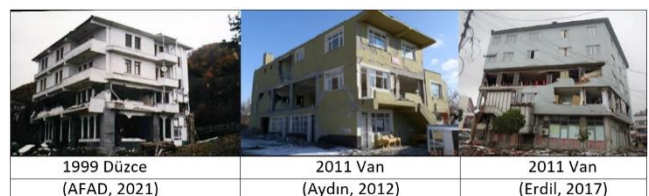
The substantial to heavy damaged (Grade 3) RC buildings for selected earthquakes are shown in Figure 5.

**Figure 5.** The substantial to heavy damaged (Grade 3) RC buildings

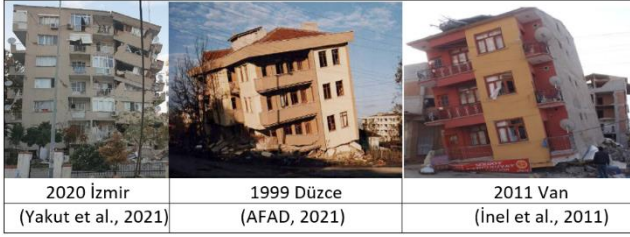
Very heavy damaged buildings for selected earthquakes are shown in Figure 6.

**Figure 6.** Very heavy damaged (Grade 4) RC buildings

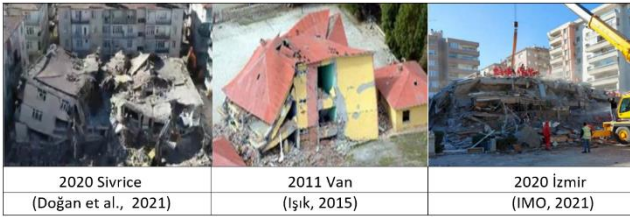
Destruction of some RC buildings (Grade 5) for selected earthquakes are shown in Figure 7.

**Figure 7.** Destruction of (Grade 5) RC buildings

Total collapse, soft story damage, cracks in structural system elements, infill wall damages and damages in column-beam junctions are the damages observed in the buildings studied. The reasons for such damages are that the building does not receive engineering service and that the earthquake-resistant building design principles are not taken into account both in the design and during the construction phase. In addition, poor workmanship, lack of inspection, low material strength and design errors are other factors that can increase the amount of damage. Soft/weak floors, strong beams – weak columns, short columns, irregularities in plan and vertical, which adversely affect the behavior of buildings under earthquake effects, increase the probability of damage to structures. Insufficient lateral rigidity and insufficient use of RC shear walls can negatively affect the behavior of structures under earthquake effects and increase the amount of damage. In addition, factors such as generally made similar mistakes in reinforcement processing (insufficient wrapping, insufficient or incomplete reinforcement arrangements, insufficient or incorrect clamping, etc.) affect the degree of damage.
