The Investigation of Municipal Buildings' Environments with regard to Turkish Standards: Mersin Province Sample

Arzu BİTİGEN SAYLAM^{1,*}, Can GÜNGÖR²

¹*Gazi University Graduate School of Natural and Applied Sciences, Program of Architecture, Ankara, Turkey*

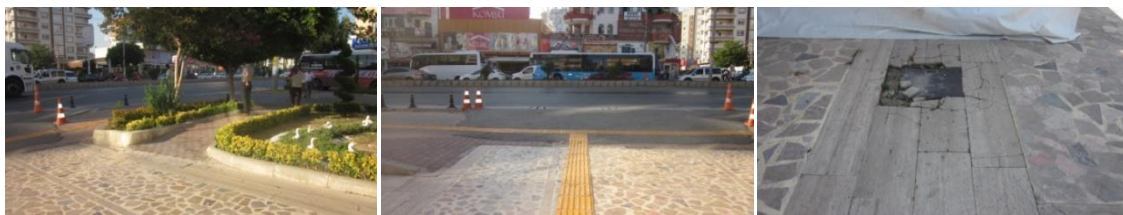
On three sides of the main building,roadways are located. Since it is located on the main street,it is gotten accessed from the bus stop. The implementation of

accessible route cannot be integrated with the bus stop. At the present time,the route to the bus stop is closed by some objects.

Photo 2. Mezitli Municipality Accessible Route Application (Photo: Arzu BİTİGEN SAYLAM, May 2015)

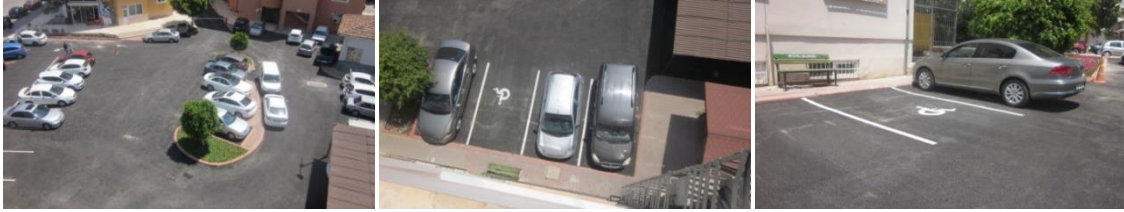
Photo3. Mezitli Municipality Disabled Parking Arrangement (Photo: Arzu BİTİGEN SAYLAM, May 2015)

Implementation of disabled parking was carried out. However, in terms of measurement and instant

availability it was evaluated negatively. Other vehicles have been parked instead of disabled vehicles.

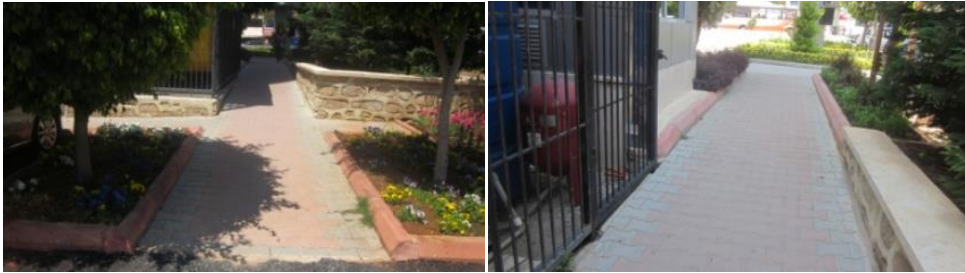
Photo 4. Mezitli Municipality Parking Access Road (Photo: Arzu BİTİGEN SAYLAM, May 2015)

The road, links the parking zone to the main entrance of the municipality, is in unsuitable slope and criteria and

was constructed using improper materials. The one aims to go to the entrance from parking zone needs to get help.

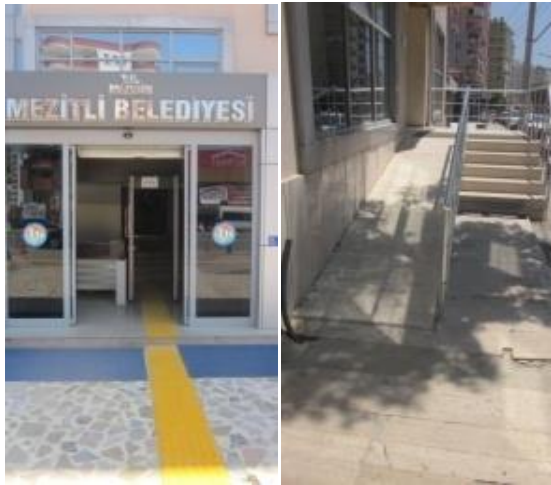
Photo 5. Mezitli Municipality's main entrance and alternative disabled (Photo: Arzu BİTİGEN SAYLAM, May 2015)

Various arrangements have been made in the main entrance of the building for disabled. However the mistakes of measurements and signage have not kept up the sustainability. Disabled entrance takes place alternatively to the main entrance. There are some points to be interfered in terms of slope of ramp, material and implementation.

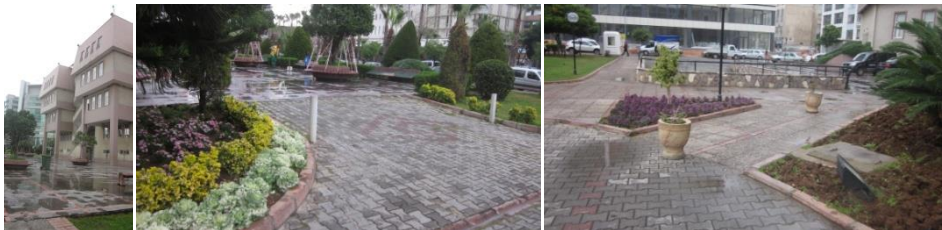
Photo 7. Akdeniz Municipality approach (Photo: Arzu BİTİGEN SAYLAM, February 2015)

There aren't any routes from the sidewalks around the hall to the transition area and from transition area to the entrance. There aren't any routes nearby to navigate or

to provide the disabled move without help. Fixed pots are located in the area which can be positioned as an open car parking for disabled.

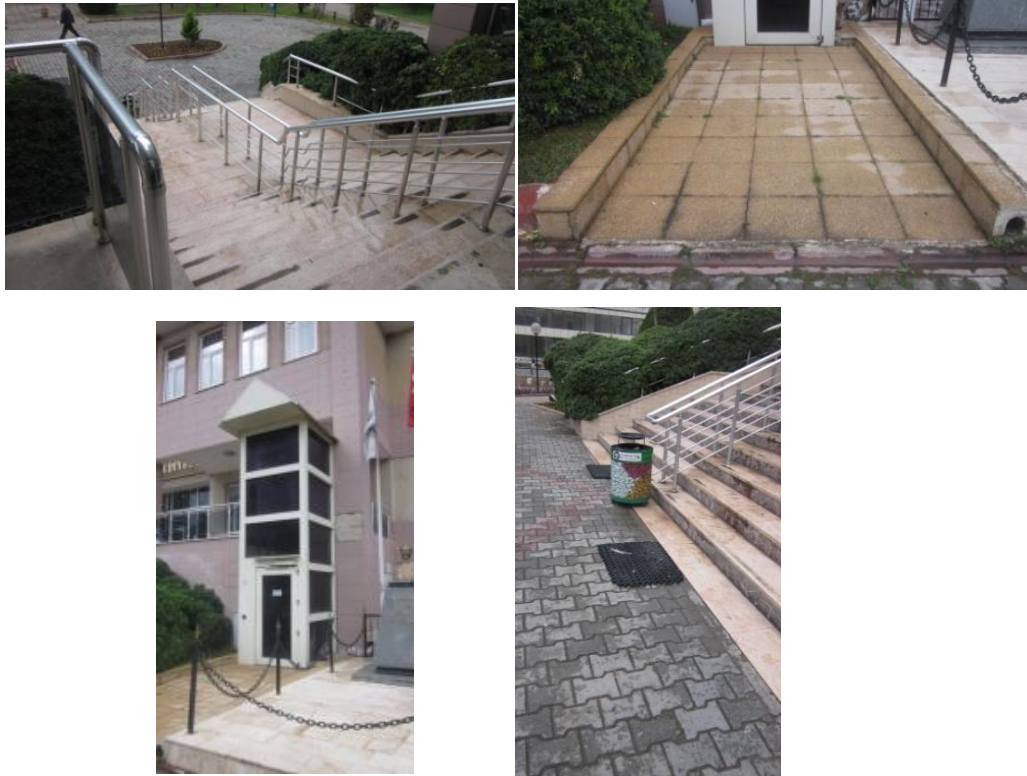
Photo8. Akdeniz Municipality main entrance approaches (Photo: Arzu BİTİGEN SAYLAM, February2016)

One can reach to the main entrance though a multi-step stair. It is almost impossible for the disadvantageous group. Although an elevator is integrated to the main entrance,since its doors are closed in terms of instant availability, it is unable to be used without help. As a result, an accessible route to the entrance can be followed.
