The Restoration Proposal for Göksel Bey Dwelling in Catalca, Istanbul

Ercan Aksoy¹

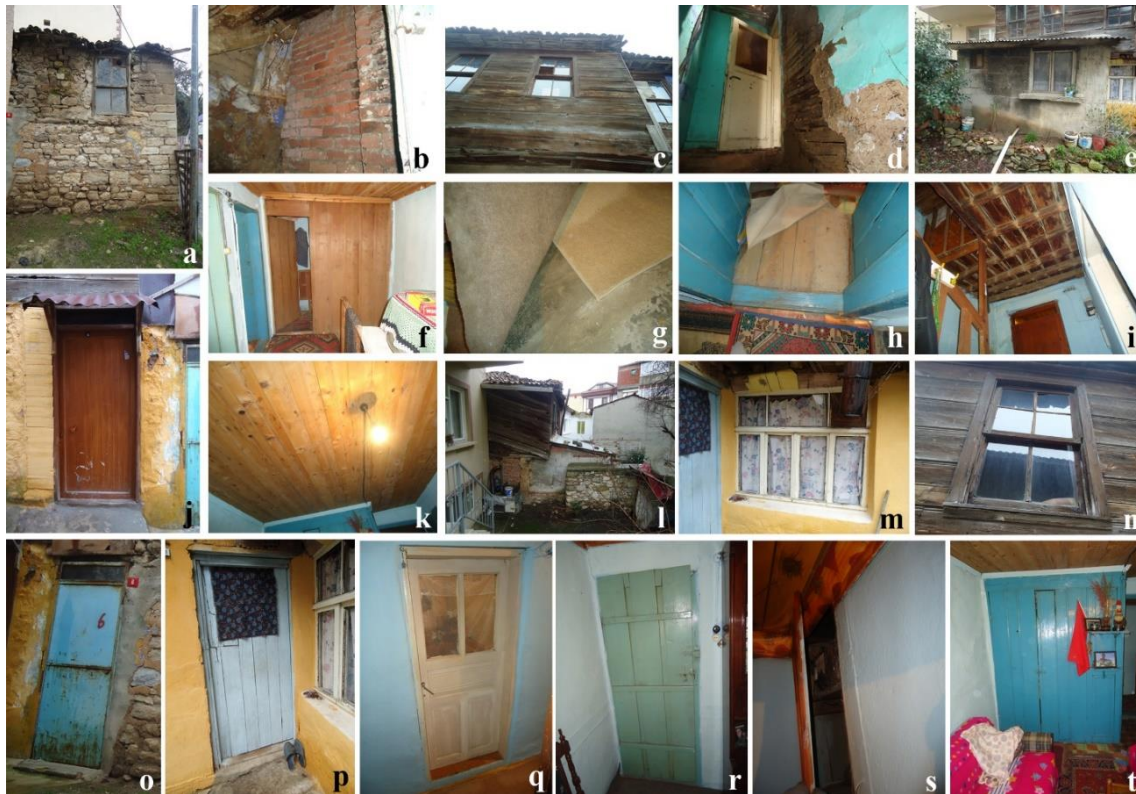
Figure 4. Structural technique, materials and architectural elements

The entrance door of the southern part of the structure is 2,00 x 0,95 meters in size, monoplane and wooden (Figure 4j), and the entrance door of the northern part is 1,90 x 0,80 meters in size, monoplane, and iron (Figure 4o). Both doors are not original and have been recently replaced. The door, which was added in the late period and provides access from the garden, is 1,60 x 0,80 meters, and it's a wooden batten door (Figure 4p). Although the interior doors show a more original formation, they were 1,80 x 0,80 meters in size on the ground floor of the southern block (Figure 4q). In the northern block, there are no door frames, but the passages are 1.90x0.85 meters in size. The upper floor doors are approximately similar in size and are 1,90 x 0,80 m in the south block, while on the north block they are 1.80 x 0.75 m in size. Especially the doors of the southern part are wooden batten doors, and they are original (Figure 4r). The thickness of the doors is 2,5 cm, while the girdles are 6 x 2,5 cm.

The windows are made of wood in the whole structure but have undergone a lot of changes. The ground floor windows of the southern block are located entirely on the southern facade and are 1,40 x 1,20 m in the Room (Figure 4m), 1,00 x 1,00 m in the Kitchen, and 0,50 x 0,40 m in the Restroom. Double-wing joineries are not original. The ground floor windows of the northern block are 1,55 x 0,90 m in the Room, 0,80 x 0,75 m in the Hall and 0,50 x 0,50 m in the Restroom. The upper floor windows are original in the south block and are 1,30 x 0,75 m in size, and they are made in the form of guillotines (Figure 4n). In the northern block, there are double-wing window types, which are 1,35 x 1,10 m in size.

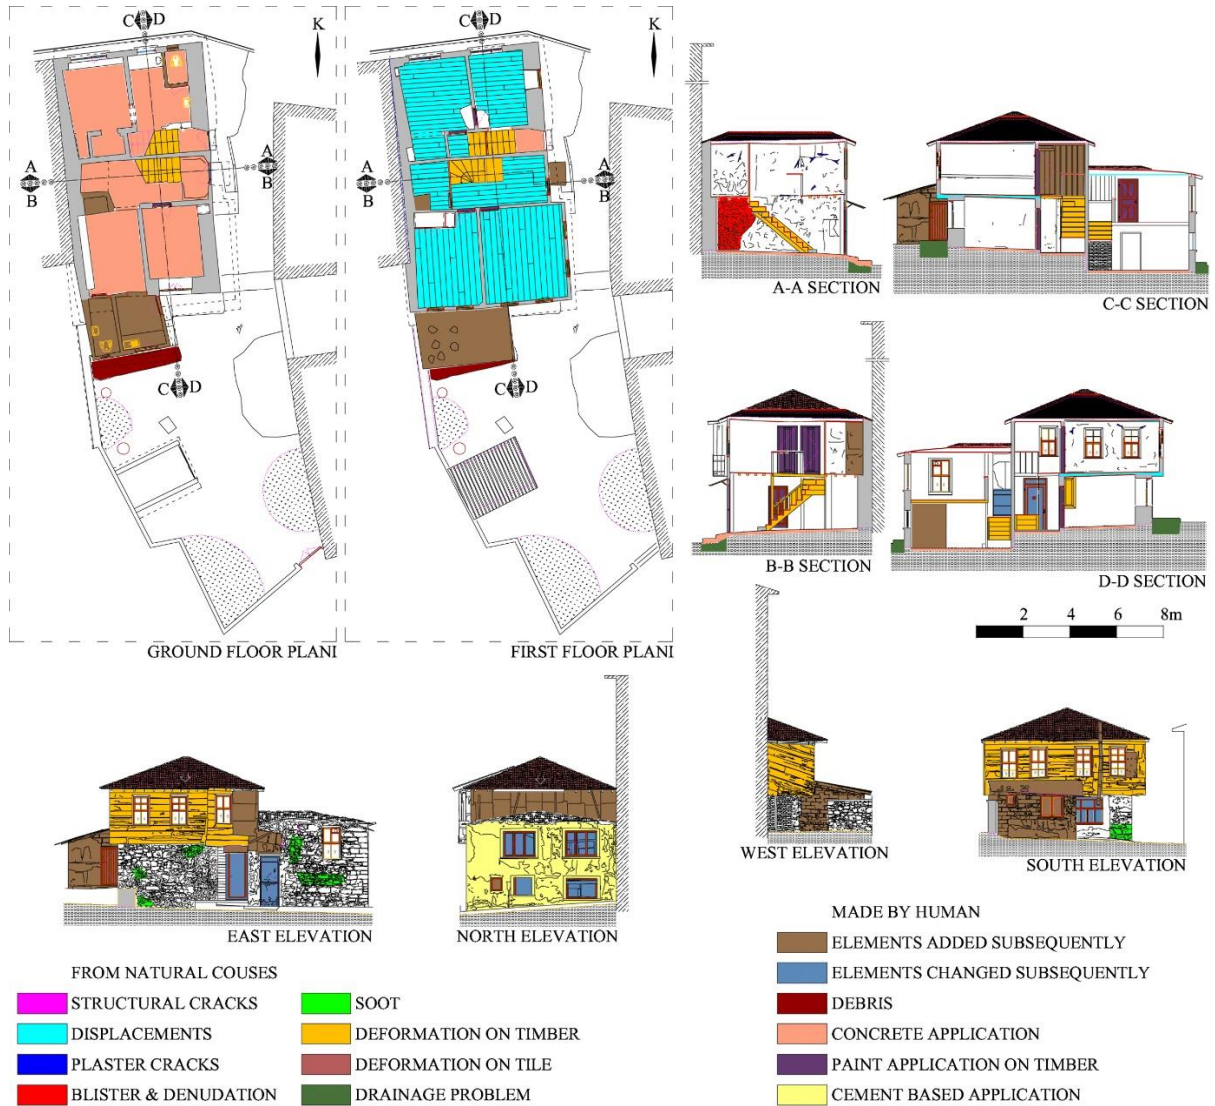
Figure 5. Deteriorations and corruptions

Although there is no collapse in the structure in general, there are different deteriorations depending on different effects. Although these deteriorations are generally due to environmental, natural, and atmospheric effects, they can also be of human origin. For this reason, deteriorations were studied as deteriorations of natural origin and human origin (Yılmaz & Sağıroğlu, 2016) (Figure 5).

Deteriorations of natural origin occur spontaneously, seen both in the structure and material. Natural deteriorations that have occurred in the Göksel Bey Dwelling include structural cracks that occur in the stone wall, deflection occurred on the ceiling and floor, cracks in interior plaster, plaster loss, staining on exterior materials, deflections in wood material in stairs, beams, cabinets and wood wall cladding, tile problems, and drainage problems (Figure 5).

Distortions made consciously or unconsciously by people can also be seen in structures. These distortions in the Göksel Bey Dwelling were as follows: elements added or changed (ground floor restroom and kitchen spaces, the cabinet section, north wall cladding), deposits of debris and

concrete (ground floor coating), and cement applications (north facade plaster) and paint application on the wooden material (the doors) (Figure 5).

- The existing roof of the structures will be completely dismantled and a wooden roof with a free-standing roof will be made. The eaves plate and under-eaves covering of the roofs will be rebuilt due to their decay.

- Depending on the hipped roof solution, epoxy painted metal rain gutter and epoxy painted metal rain downpipe will be made to the eaves in the direction of rain flow to prevent rainwater damage.

- The existing wooden entrance doors to the east of the building will be removed and replaced with new wooden doors. The door frame wall in the southern block will be completed with a stone wall mesh system and will be plastered with brick dust mortar and painted with lime whitewash.

- The wooden staircase, added later, located in the entrance part of the building to the south will be removed, and a new wooden staircase will be made. In the same way, a new wooden staircase will be built due to the fact that the existing staircase of the northern structure is unusable.

- The niches, Kitchen and Restroom-Bathroom spaces on the ground floor of the south block will be removed. In order to return it to its original state, the northern wall of the area will be made with a brick decking wall system between the framing to create a Kitchen space.

- All wooden door and window joinery of the structure will be dismantled, the original ones will be restored, and the old ones will be replaced with new wooden doors and guillotine windows with double heat glazing.

- Wooden beams will be made by correcting the level in the wooden ceilings of the ground floor. The later-period ceiling coverings of the 1st floor will be removed, the lower layer will be reviewed and the beams that need to be changed will be replaced with new ones. A slatted wood veneer will be made by correcting the leveling defects.

- Plastering will be scraped on the interior walls of all existing rooms. If surface abrasions are more than 5 cm, then stones or bricks will be replaced. For surface abrasions less than 5 cm, the stone or brick will be protected and plastered with brick dust mortar and lime whitewash will be applied on it. The timberwork slats will be replaced with new timberwork by protecting the wall. The outer walls will be covered with wood in accordance with their original state.

- All existing wooden building elements and new woods used during the repair will be impregnated against water and fungus damage, and a fire-resistant, UV-resistant, dark-colored wood protector will be applied to them.

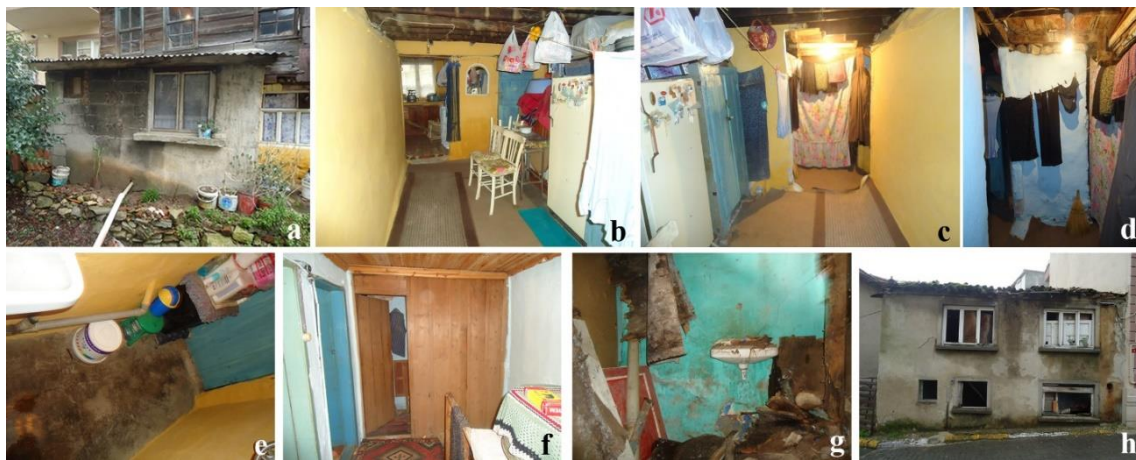
Figure 7. Photographs of elements with deteriorations and corruptions

It is important to conduct a comparative study in order to obtain resources in the restitution study (Karakurt & Sağıroğlu, 2016). Therefore, comparative studies were carried out with the houses located in Çatalca, and comments were made accordingly (Figure 8). In addition, although there are excessive interventions in the structure, it is possible to detect them with traces from the structure. Kitchen and Toilet spaces were made with briquette material on the west wing of the southern facade of the ground floor (Figure 7a). This also caused the deterioration of the Room wall of the structure, which should be composed of two rooms, and the filling of the windows, which were probably the same as the ones in other rooms (Figure 7b). In addition, the niche part, which was made in the northwestern corner of the same room, formed an anomaly (Figure 7d), and since the Room's door was removed, the space has become a corridor (Figure 7c). Compared to the buildings in the same region, it is understood that the floor coverings should have stonework in the living space and wood in the rooms. However, the floors were changed with concrete (Figure 7e). On the

upper floor, it is understood that the Hall section with a smooth rectangular line is divided to create a cabinet (Figure 7f). The small window on the north facade has recently been made due to the recently added Restroom (Figure 7g), and the other ones are not in their original dimensions according to the data from the building (Figure 7h).
