The Effect of Periodic Inspection and Safety Criteria on the Service Life of Steel Construction Conveyors

Ersin Asım GÜVEN^{1*}

In this study, collapse of a coal conveyor has been investigated. The steel components, welded zones and bolt joints have been studied in terms of corrosion, strength, hardness, and microstructural analysis. Location and time information is hidden due to personal data protection law.

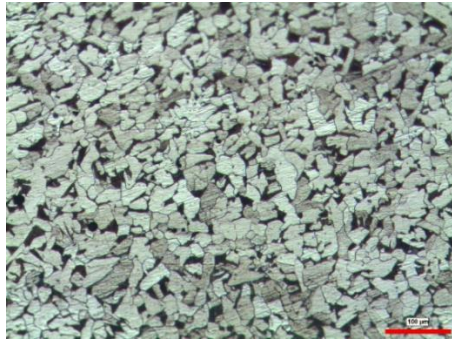
Figure 3. Microstructural image of A2 sample.

Due to the fact that the A2 profile was in the lower segment covered with coal dust, the corrosion effect on the sample was tried to be investigated. In the sample taken on this profile, it was observed that there was only corrosion on the outer surfaces, but no

corrosive effect penetrating into the base metal occurred, and it was determined that the material microstructure was in accordance with the standard “Beynitic” structure of St3Sx structural steel (Figure 3).

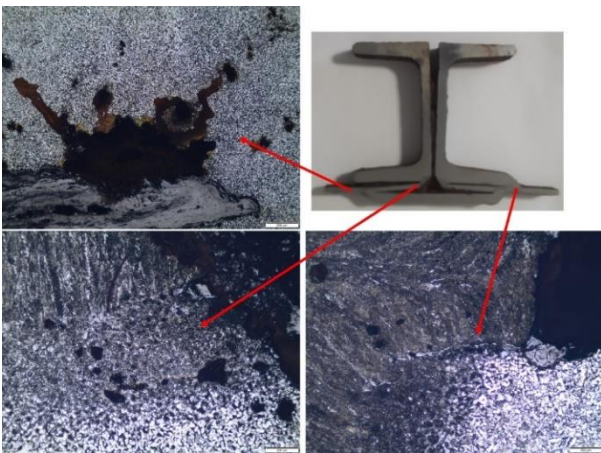
Figure 4. Welded zone of U type profile.

However, in the examination, made on the welded part, corrosion and crack formations were observed, and showed in Figure 4. But even if the cracks were critical size, the lack of load bearing functions of the welded seams was not considered as the main cause of collapse.

As detailed, structural steel strength level was detected that, these steel components are still in their service life. The corrosion effects are located only the outer surface and no evidence is detected in main core. However, the welding seams of steel joints

contain heavy corrosion cracks and corrosion effect reach the interior side. But the good part of this situation is, the welded joints were not subjected to loading.

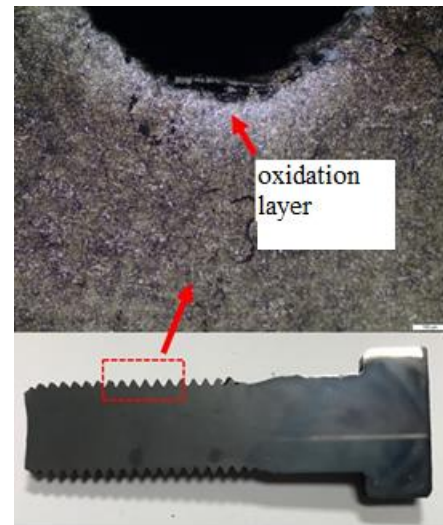
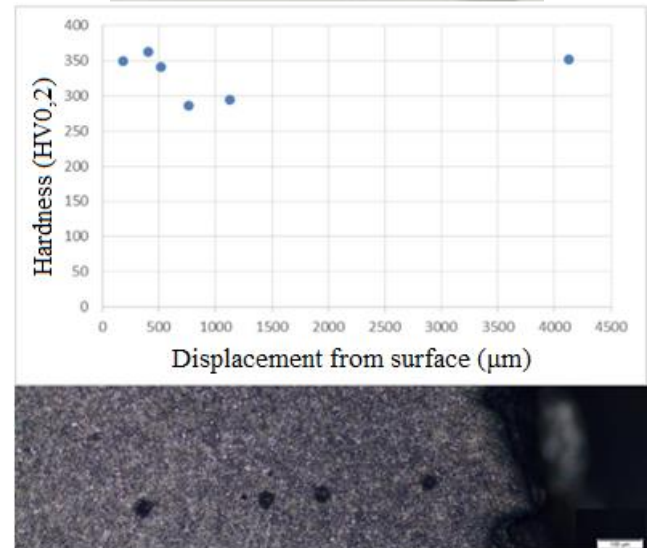
Figure 5. Oxidation layer on the bolt outer layer and hardness.

In the examination made on the bolt, it was determined that the corrosion layer (Figure 5) observed on the surfaces did not penetrate the material, therefore corrosion did not adversely affect the mechanical properties of the material. The hardness change of the bolt material from the outside to the inside was investigated by making microhardness measurements. As seen in Figure 5, it was observed that there was no microhardness difference between the outer surface and the inner part of the bolt, the hardness results preserved the trend and mean value is about 320 HV.

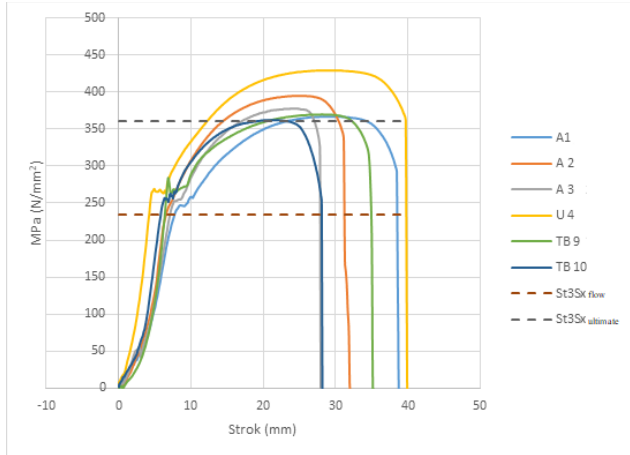
Figure 6. Tensile test results of steel samples

According to the tensile tests seen in Figure 6, it has been understood that the St3Sx structural steel, which forms the structure, meets the yield and tensile stresses and % elongation at break values determined in the standards. Accordingly, despite the 36-year service period, there was no decrease in

strength in the samples taken. For this reason, it has been understood that all profile drawing specimens comply with the design standards [13].

It was understood that coal dust accumulated in the lower segment had no effect on the steel, since no strength reduction was observed in the samples coded A1-A2 and A3 taken from the lower segment.

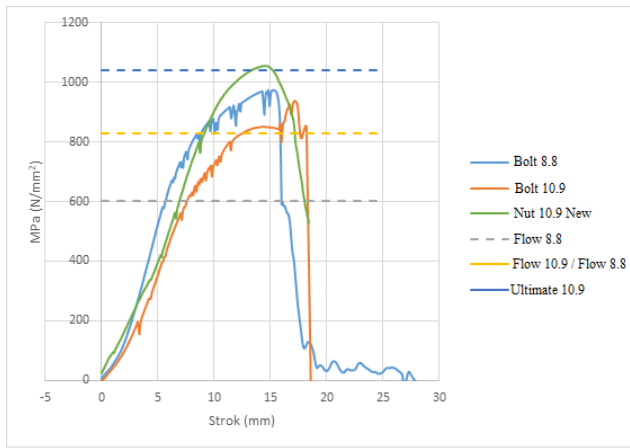
Figure 7. Tensile test results of bolt and nut.

In the tensile tests performed on the bolts, the tensile damage area in the 8.8 class bolt is in the bolt thread region as expected (Figure 7 and Figure 8). This bolt met the tensile strength with yielding [13]. In the tensile tests performed with two different bolts of 10.9 class, the damage is in the region of the nut threads (Figure 9). According to yield and tensile strength, 10.9 bolt-nut connection could not meet the standard values [14]. According to ISO 898-1 and 898-2 standards, the yield limit of the nut material is expected to be higher than the bolt material under all conditions, and it is known that the damage should be on the bolt instead of the nut.

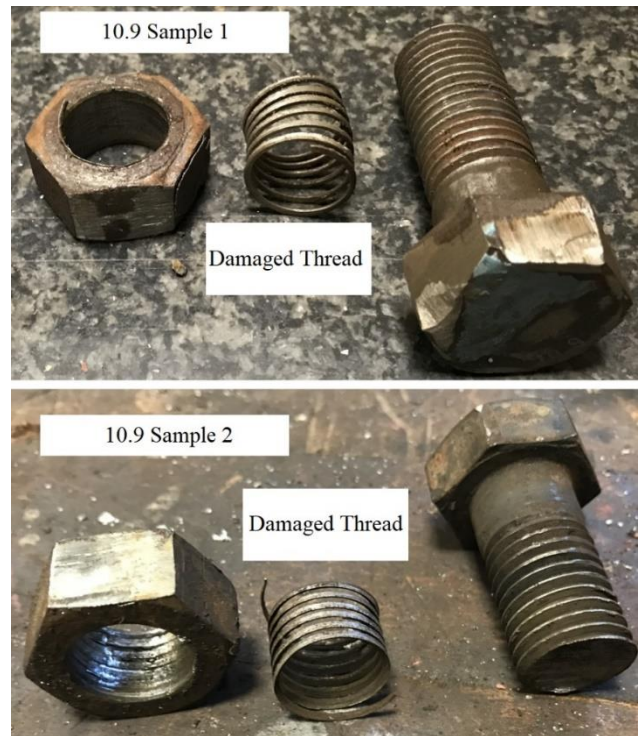
Figure 9. Nut damage of 10.9 class.

Accordingly, a nut whose class is known with certainty was obtained and a 10.9 class bolt was

subjected to a tensile test again (Figure 9). The 10.9 quality bolt taken on the gallery and the newly supplied 10.9 class nut were pulled together and this time no damage was observed on the nut. It has been observed that the connection (bolt - nut) has the strength values specified in the standard.

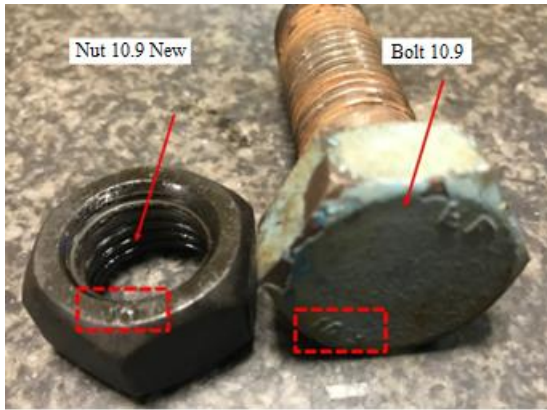
Figure 10. 10.9 Bolt and Nut match.

Accordingly, a nut whose quality class is known with certainty was obtained and the 10.9 quality bolt was subjected to the pull test again (Figure 10). The 10.9 quality bolt taken on the gallery and the newly supplied 10.9 quality nut were pulled together and this time no damage was observed on the nut. It has been observed that the connection (bolt - nut) has the strength values specified in the standard.

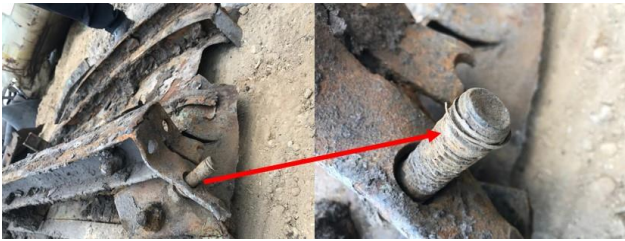
Figure 11. Nut stripped of its threads in damaged gallery lower segment.

According to the tensile test results, since both quality bolts are in M20 dimensions, it is thought that an 8.8 quality nut was attached to the 10.9 quality bolt that should be used in the lower segment. According to the video records, in the area that is thought to be the first broken gallery, parts of the damage type observed in the tensile tests were found in the 10.9 bolt-nut pair used as the fastener at the lower segment joint (Figure 11).

In order to determine the cause of unexpected damage to the nut threads, the damaged nut, the undamaged 10.9 quality nut removed from the gallery, and the newly supplied unused 10.9 quality nut thread regions, the microstructure of the completely stripped nut was coarse-grained and 170 HV hardness, as can be seen in Figure 12 (a). It has been determined that (b) sample is finer grained and has a hardness of 220 HV, and sample (c) has a “Martensitic Needle-like” structure and has a hardness of 300 HV. According to both hardness and microstructure images, some nuts used in the gallery should be 10.9 quality, but it strengthens the thesis that they are manufactured from 8.8 quality nuts.

Additionally, the corrosive effects of coal on the structural steel have been studied and detected that, the corrosion rate rises after %55 moisture [16]. The coal carried on related conveyor has a % 27 moisture. This is another reason why the corrosion effect remains on the steel surface. Similar surface corrosion effects were detected in bolts and nuts. The bolt strength was also detected in both the 8.8 and 10.9 class. But, due to disastrous mistake, the 8.8 nuts were attached to the 10.9 bolts.

Even if the designed safety factor for bolts is over 2.0, during the service life of thirty years, the vibration and dynamic loads could be responsible for the loosening. For that reason, the stress per bolt especially on the lower side has been increased and reach the critical level. During the inspections of collapsed construction, it is expected that the lower side of conveyor bridge was completely closed, and any manholes were not designed. This design insufficiency prevents the periodic control of bolt torques. Additionally, during the inspection of collapsed construction, the lower side of the conveyor bridge has a gap of 6 x 0.5 meter. Over the thirty years of service life, the coal dust takes place in this gap and keeps water in it (as seen in Figure 1). The coal dust accumulation reaches nearly half of the gallery and creates 116.000 kg additional load. This additional load is nearly one fourth of death weight of construction because bulk density of coal dust heavier than the coal grains that carried.

The manholes are the design criteria that should not be forgotten and must be used for periodic control. The bolt pre-tension and torque level must be checked and prevented to loosen.

Incorrect assembly and unpredictable loads can cause catastrophe. For this, a risk assessment should be made.
