Investigating the Material Deteriorations on the Facades of Stone Structures by Terrestrial Laser Scanning Method: Case Study of Mardin Mansion

Taş yapıların cephelerindeki malzeme bozulmalarının yersel lazer tarama yöntemiyle araştırılması: Mardin Konağı Örneği

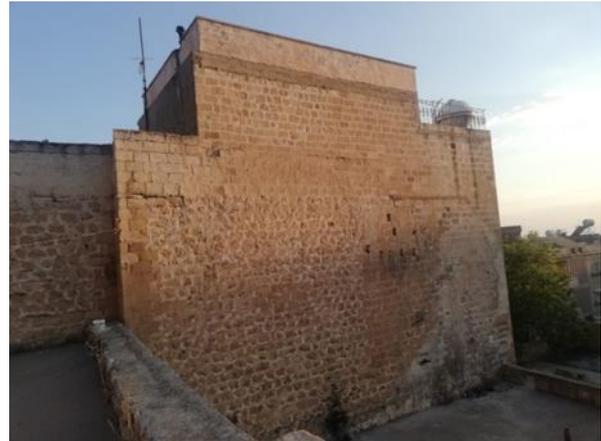
Figure 9. North façade

North facade: Rubble, freestone and briquette masonry are seen on the facade, there are facade beams of reinforced concrete attachment, which was made later ("Fig. 9").

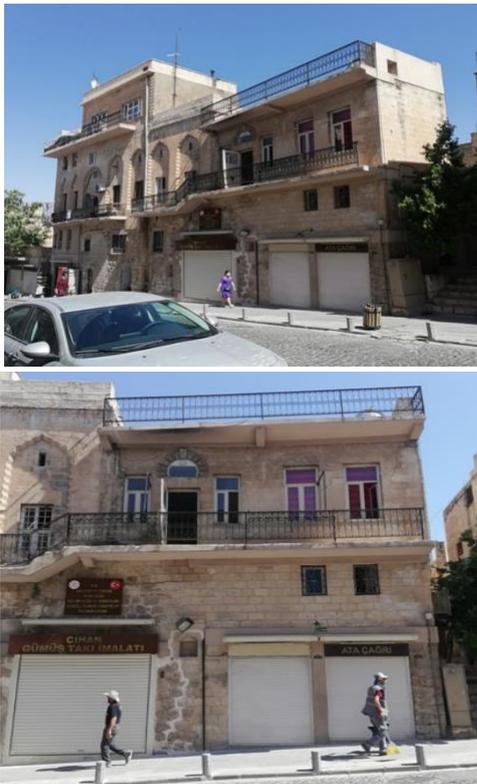
Figure 10. South Façade

South Facade: The south facade faces the main avenue. It is seen that the facade of the room, which is located on the west of the facade, was constructed in the same system with the adjacent building. The facades of two stores on the ground level, two windows of the upper mezzanine floor, balcony and the metal joinery of the building are seen. The building has been subjected to major changes during opening the Avenue 1 ("Fig. 10").

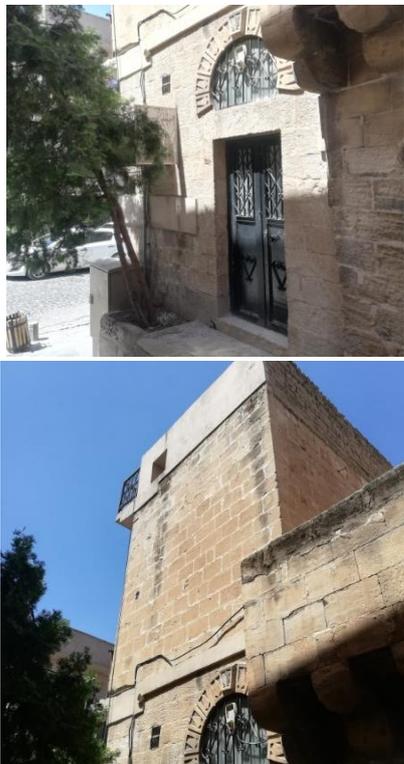
Figure 11. East Facade

East Facade: Double-wing metal entrance door, concrete beams of it, freestone masonry level and the plastered area are seen on the east facade (“Fig. 11”).

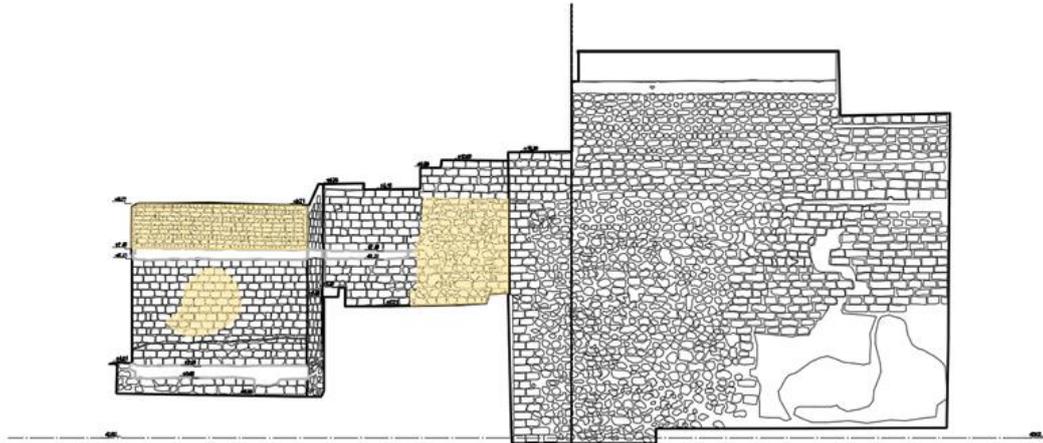
Figure 14. Material deterioration measured drawing of north façade

Blackening is present on **North facade** ("Fig. 14"). **South facade:** Major changes have been made on the building during opening. Blackening is present on the facade ("Fig. 15"). **East facade:** There are blackening and humidity-originated plant formation present on the facade ("Fig. 16").

As a result of the observations carried out on the historical building, the excessiveness discolouration on the facades that are caused by the air pollution, due to the fact that the building is located on the avenue called Avenue 1, where the vehicle traffic is the most intense, draws attention. This result support the finding determined in the studies conducted in different studies, regarding that the types of deteriorations seen in the form of discolouration and black crust on the facades of stone structures increase as a result of air pollution, specific to Mardin Province (Karataş *et al.* 2022, Karataş and Alptekin 2022, Karataş,2023).

In the study, it is recommended to remove the plant formations existing on and surrounding of the building, and to clean the places, where humidity, mould and blackening are seen, with pulp, during

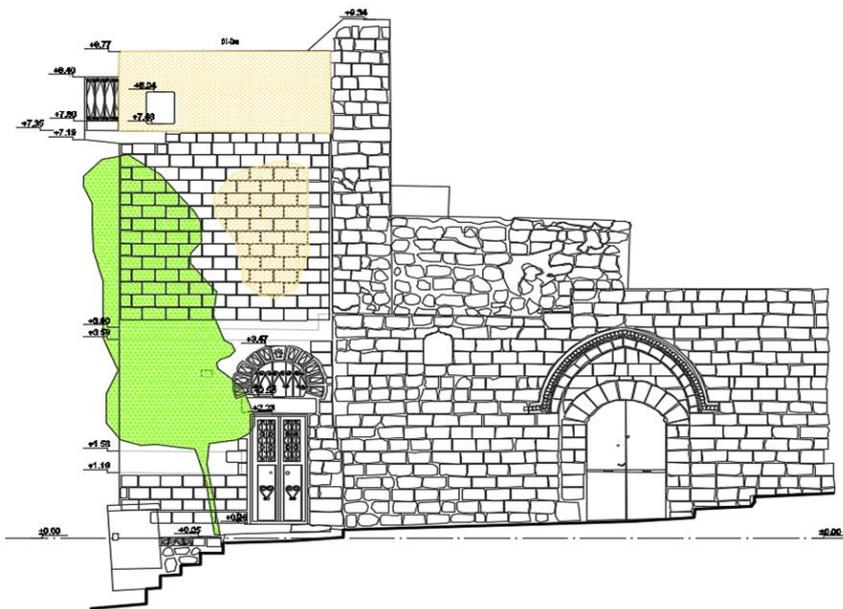
Figure 16. Material deterioration measured drawing of east façade

Another significant finding that must be emphasized is the intensity of plant formation seen on the east facade of the building. The reason of the intensity of this plant formation is the excessiveness of the factors such as wetness – drying process, which affects the stone due to having less hours of sunshine on east facade. This finding confirms the fact that factors such as sunshine hours and the wet-drying process in the building are effective in the deterioration of stone structures in the world (Robinson and Williams 1996, Paradise 1999, Martinho *et al.* 2014, O'Brien 1992, Kapsalas *et al.* 2007). For this reason, in order to interpret the causes of deterioration in the facades correctly, the factors that the facades are exposed to should be investigated specifically for the facade.
