Determination of Ground-Based Structural Problems in the Historical Four-Legged Minaret with Ground Penetration Radar

Süleyman İPEK^{1*}, Nursen IŞIK², Fatma Meral HALİFEOĞLU³

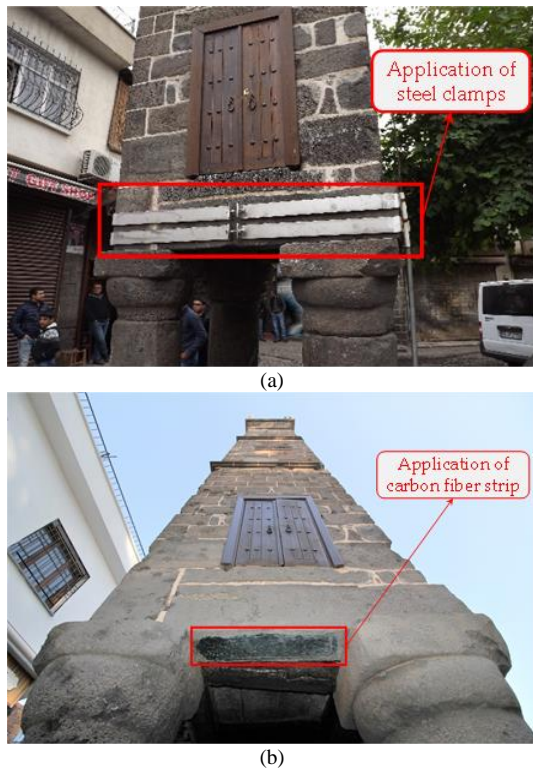
During the restoration work of the Four-Legged Minaret carried out between 2011-2012, the cracks in the north and east directions were reinforced by injection. In addition, steel clamps were added to the lintels as part of this restoration as shown in Figure 5a. However, in 2015, the clamp added around the minaret was removed. Besides, the lintels on the columns of the minaret were strengthened using carbon fiber strips as can be seen in Figure 5b.

Figure 5. Photographic view of strengthening work on the Four-Legged Minaret: (a) application of steel clamps (taken in 2015) and (b) application of carbon fiber strip (taken in 2021)

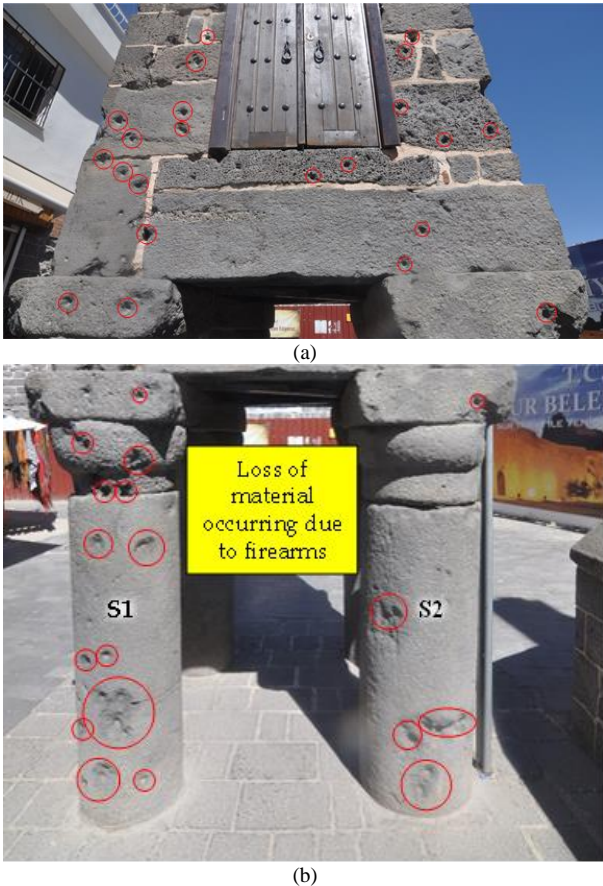
Due to the fact that the minaret was outside the courtyard of the mosque due to its location, partial material losses occurred due to vehicle hits. In addition, in 2015, damage such as fragmentation and abrasion due to firearms occurred on columns S1 and S2 in the northwest direction of the minaret, and bullet holes occurred in some places (see Figure 10).

Figure 10. Photographic views of damages caused by firearms on: (a) the body and (b) columns of the Four-Legged Minaret (taken in 2021)

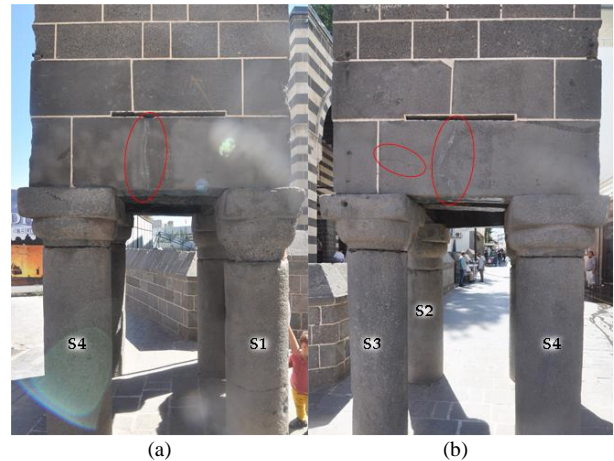
During the restoration work carried out between 2016-2017, no comprehensive repairs were made to the minaret, except for cleaning and removing mortar losses. Especially, there has not been any attempt to complete the material losses in the minaret during the period of vehicle traffic. The existing crack in the lintel of the minaret in the northwest direction was filled with injection during the repair works. In addition, macro-sized (visible) cracks were detected on the lintels on the

columns in the northeast and southeast directions (see Figure 11).

Figure 11. Photographic view of crack damage on lintels on: (a) S1-S4 columns in the northeast direction and (b) S3-S4 columns in the southeast direction (taken in 2021)

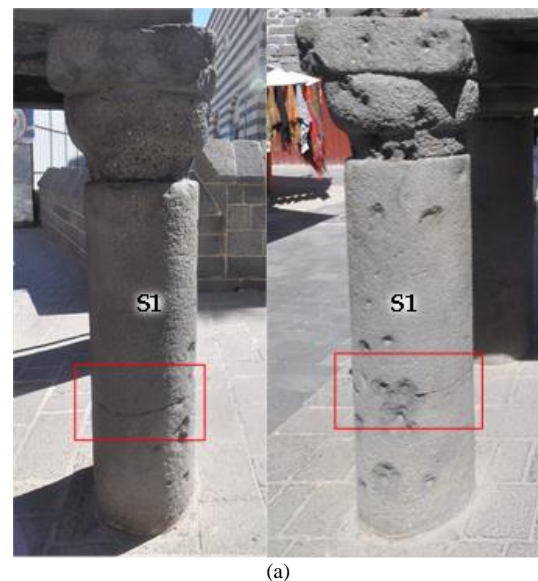
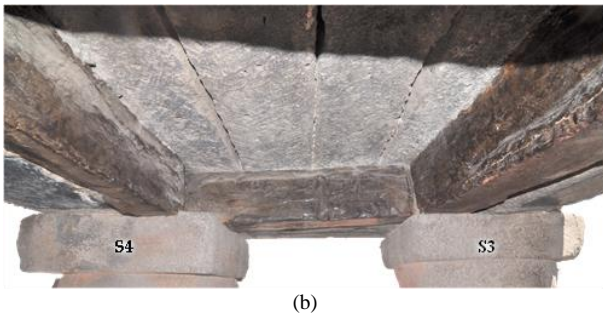
There are level irregularities on the street floor where the minaret is located. Although the street floor where the minaret is located was renewed with cut stone during the repair works, no detailed examination was done on the cause and correction of the level irregularities on the street floor. Besides, partial axis slippage due to vehicle hit, vibration, and level irregularity on the street floor has been observationally detected at the column heads. However, these irregularities and damages were not eliminated during the repairs. In addition, there is a horizontal crack in the middle part of the S1 column due to the loss of material because of the hit of a large number of bullets in that area and the impact of these bullets (see Figure 12). The wooden girders on the minaret columns are original but partially damaged. During the repair work, they were maintained by applying impregnation and protective paint for wood protection, and thereby, the current condition of the wooden girders was preserved.

Figure 12. Photographic view of: (a) the horizontal crack on column S1 and its location and (b) the current condition of wooden girders

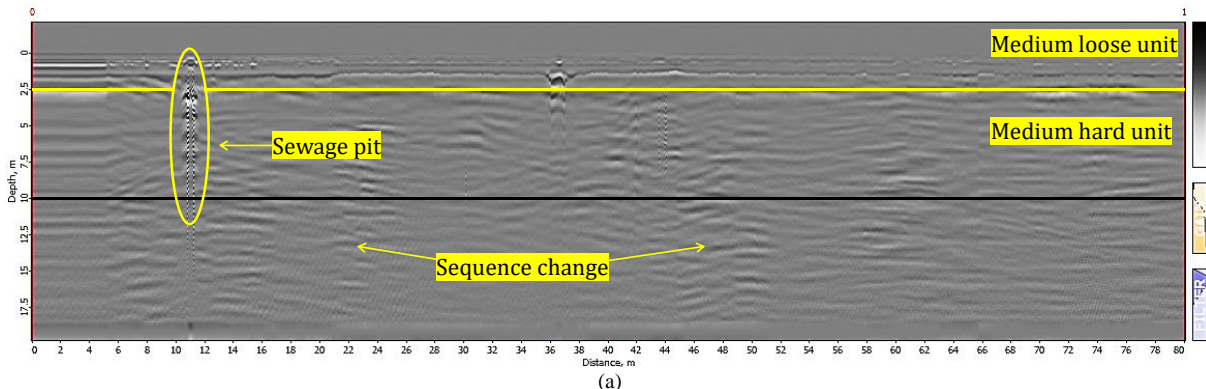
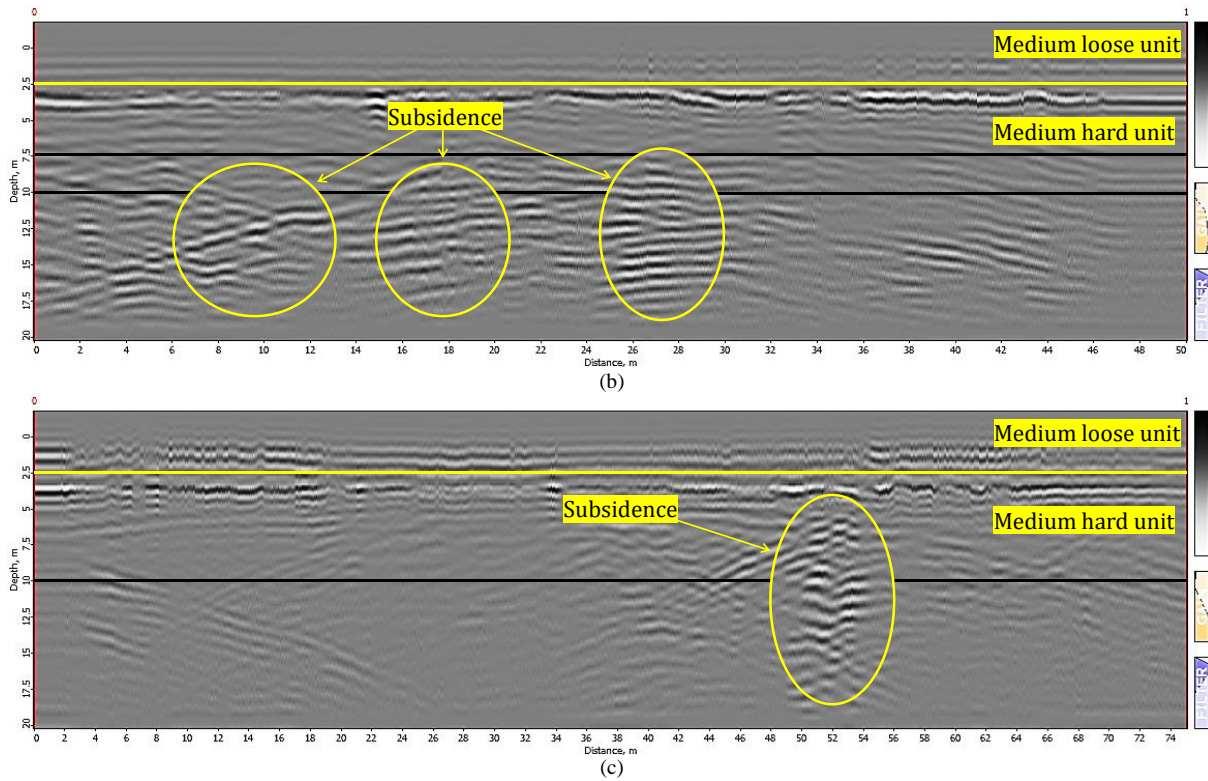
Figures 14a-c demonstrate the 2-dimensional GPR sections taken at zones 1, 2, and 3, respectively. As marked in these figures, 2 different levels were observed from the radargram section of each zone. It is considered to be a medium loose unit of about 2.50 m in the upper part, and a medium hard unit between 2.50 and 10.00 m. As indicated in Figure 14a, there is a sewer pit starting at a depth of 2.50 m and lasting about 10.00-12.00 m throughout the profiling of zone 1. Additionally, in this zone, there is no anomaly formation on the ground, except for the sequence changes. On the other hand, subsidence anomaly formations were identified in the profiling of zone 2. As can be seen in Figure 14b, the regions starting at a depth of 7.50 m lasting through 10.00 and 26.00 m took in water, thus collapsed. In the profiling of zone 3, only subsidence deformations caused by taking in water were detected, as pointed out in Figure 14c. These anomalies are starting at the depth of 5.00 m and lasting through the 50.00 and 52.00 m.

Figure 14. GPR sections: (a) taken at zone 1, (b) taken at zone 2, and (c) taken at zone 3

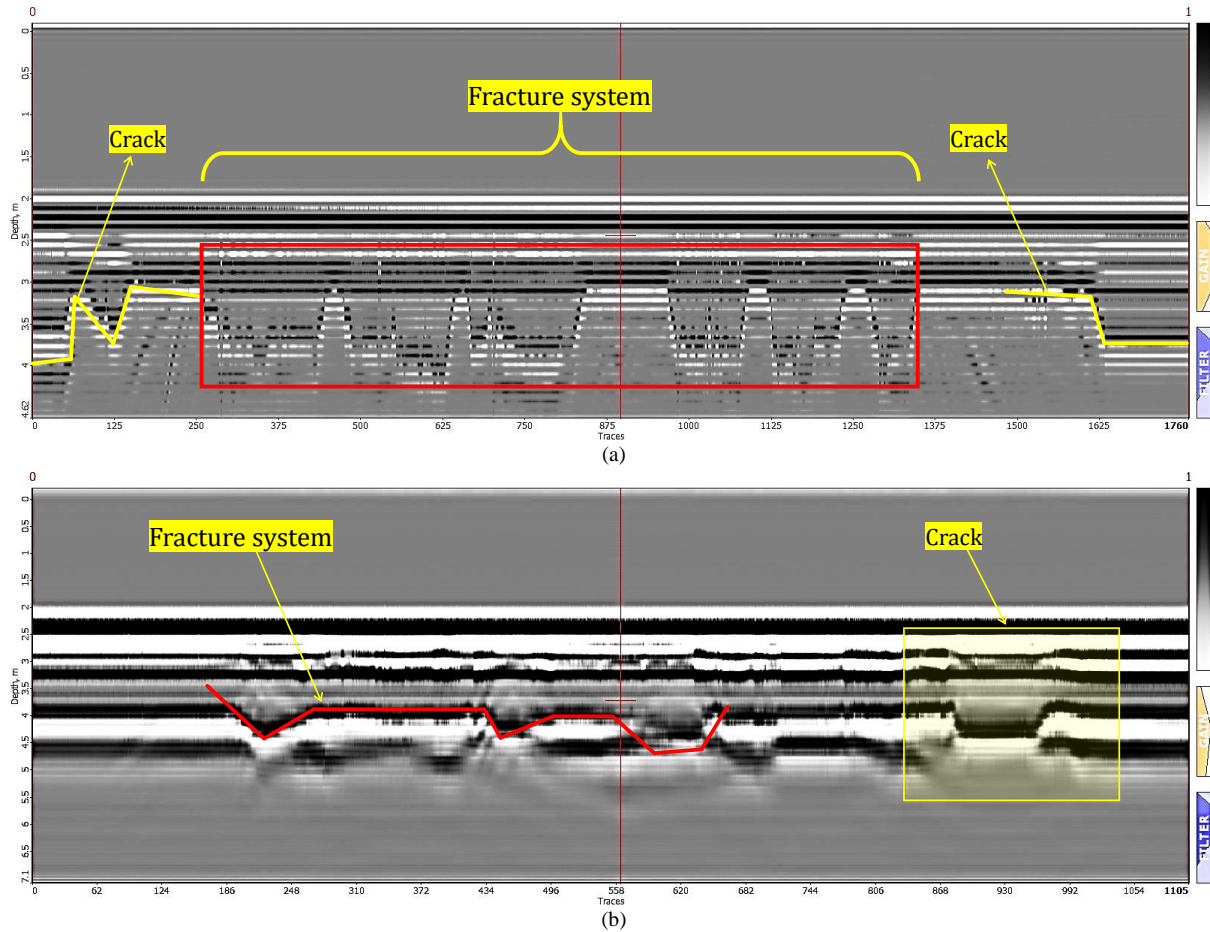
In regard to the radargram section obtained from region 1 (see Figure 16a), it can be stated that it has been observed that the cracks and fractures in the lintels are at a level that will affect the load-bearing system of the minarets. It is considered that cracks and fractures, the smallest 12.00 cm and the largest 20.00 cm, have been detected on the lintels in this area. On the other hand, broken V-type crack systems are at the maximum level in the lintels of region 2, as pointed out in Figure 16b. It is thought that the detected damages on the lintels may adversely influence the load-bearing system of the minaret.

Figure 16. GPR sections: (a) taken at Region 1 and (b) taken at Region 2

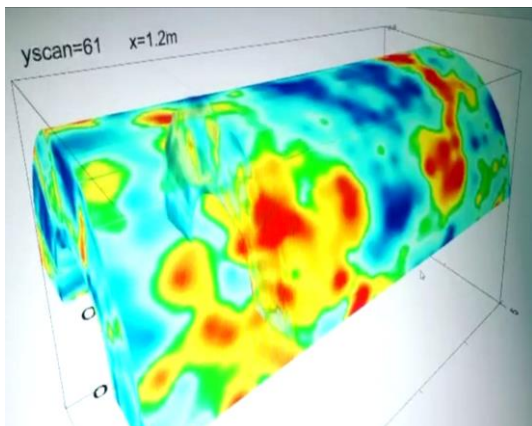
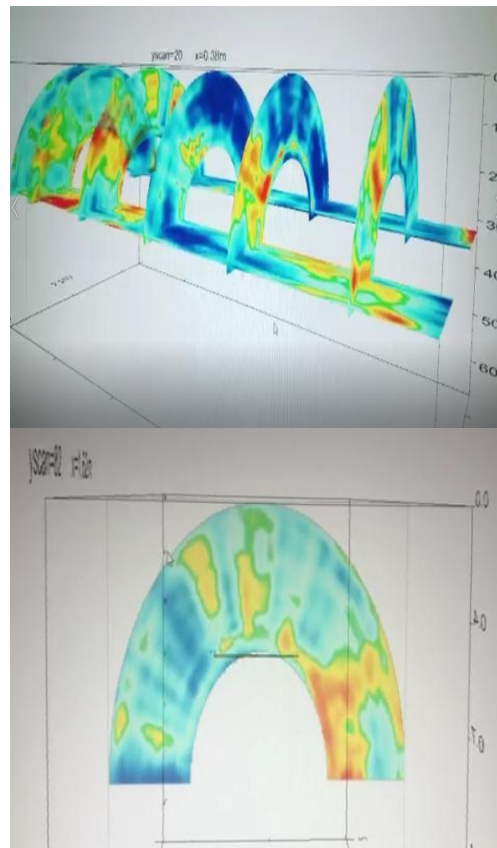
Unlike the GPR scanings carried out on the ground and lintels of the Four-Legged Minaret, 3-dimensional GPR scanning was performed on the S2 named column. Crack-, fracture-, and corrosion-dependent deformations were detected in this scanning. In order to simulate the crack and fracture formations, spectral color was appointed in the radargram section of column 2, as shown in Figure 17. In the scanning, the areas and locations involving cracks and fractures are demonstrated by red color. In regard to the radargram sections, it can be stated that the cracks and fractures accumulated in the lower regions of the scanned column.

Figure 17. 3D GPR sections of S2 named column of the Four-Legged Minaret

To repair the existing damages on the Four-Legged Minaret, comprehensive survey and restoration projects should be prepared under the leadership of the relevant experts, and reinforcement applications should be carried out immediately. In addition to the determination of the damages on the minaret with non-destructive methods, observation pits should be opened in the regions determined by the experts and the physical condition of the ground should be determined. Soil improvements should be carried out around the building, and also columns and walls having axis slippages should be suspended, and reinforcement work should be
