Failure of Gedikbulak K-12 School Building on October 23, 2011, in Van, Türkiye Earthquake

Halit Cenan MERTOL

Atılım University, Engineering Faculty, Civil Engineering Department, 06830, Ankara, Türkiye
Halit Cenan MERTOL, [ORCID No: 0000-0001-8058-5798](https://orcid.org/0000-0001-8058-5798)
Corresponding author e-mail: cenan.mertol@atilim.edu.tr

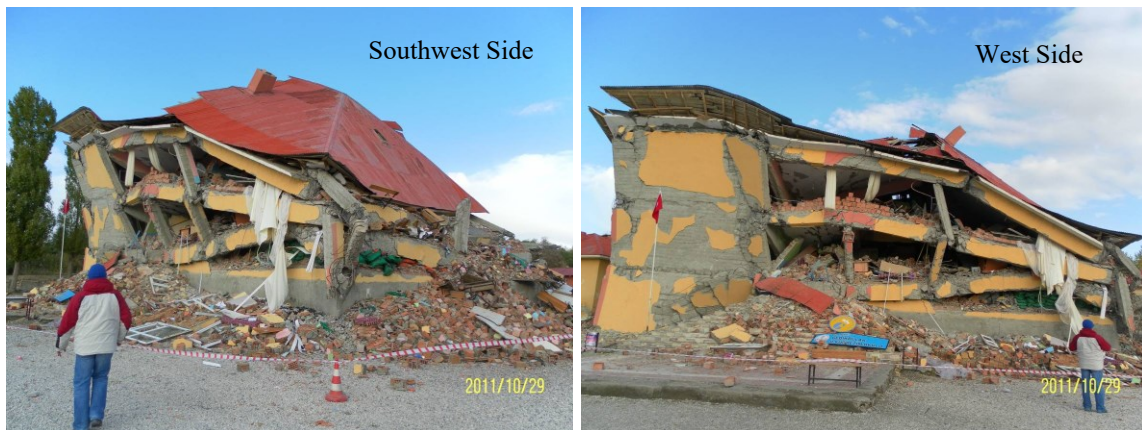
The side views of the building are shown in Figure 3 to Figure 5. The school building experienced total collapse. The locations between the 4 and 5 axes had collapsed, producing a sandwich-type failure of slabs on top of each other. The first floor had collapsed for the rest of the building, and the other floors were barely/partially standing with hefty damage. All the building has shifted towards the west direction, with fewer shear walls in the east-west direction compared to the north-south direction.

Figure 3. Southwest and west side views of the building.

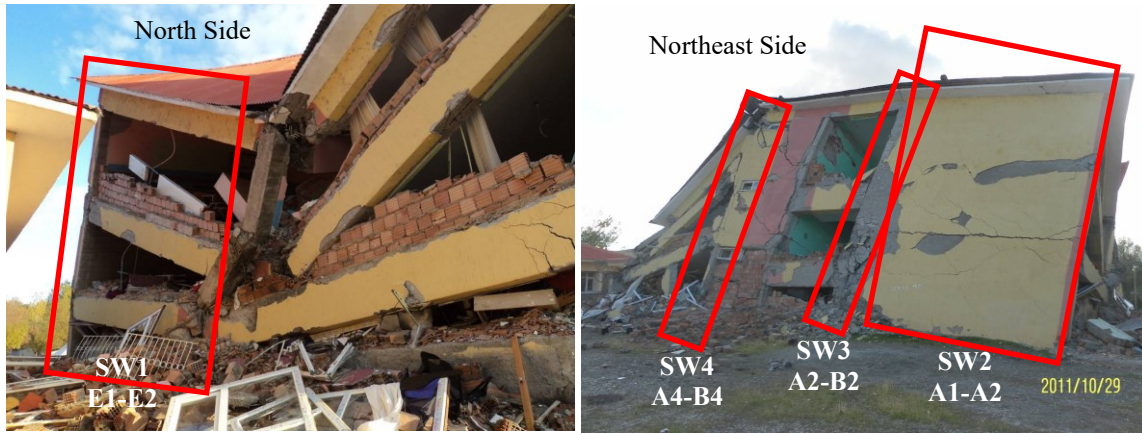
Figure 4. North and northeast side views of the building.

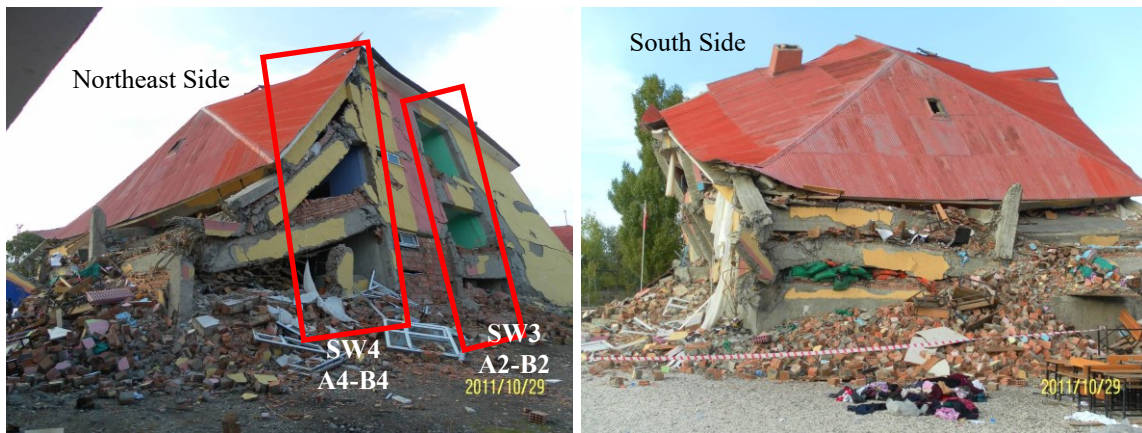
Figure 5. Southeast and south views of the building.

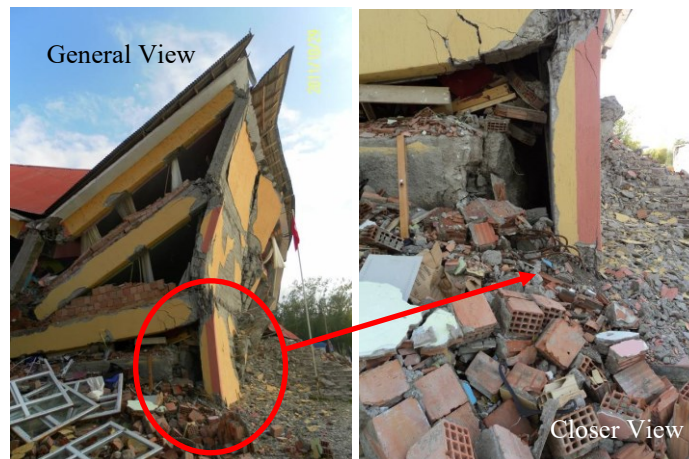
The base of the shear wall SW1 (SW1 E1-E2) had separated from the foundation due to the pull-out of the reinforcing bars and shifted approximately 1 m towards the west. This shear wall also experienced significant damage and bending in the weak direction towards the west, as shown in Figure 6. Shear wall SW2 (SW2 A1-A2) was significantly deformed in a weak direction. However, the base of this shear wall did not entirely separate from the foundation, as shown in Figure 4. However, a significant length of the longitudinal reinforcement was observed to pull-out, resulting in a detachment of approximately 100 mm between this shear wall SW2 and the foundation on one side. It was also observed that reinforcement bars were spliced at the base of the shear walls and columns (probable hinging locations) where the maximum load effects would occur.

Figure 6. Failure of shear wall SW1 (E1-E2 Axis).

For the existing school buildings with the same typical projects (No: 10370), the bottom parts of the shear walls shall be strengthened to prevent any pull-out of the reinforcing bars resulting in the separation of the shear walls from the foundation. Later, the insufficient members (both beams and columns) of Model 1 shall be strengthened to resist the design loads calculated based on the current code practices. Additional shear walls in the short direction may be constructed as a final touch to have similar ratios of the areas of shear walls in both directions.

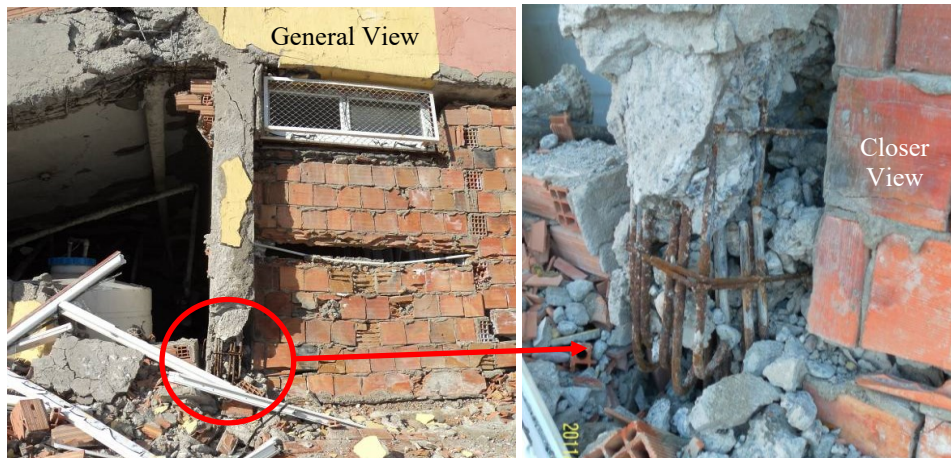
The base of shear walls SW3 (SW3 A2-B2) and SW4 (SW4 A4-B4) were also separated from the foundation for the same reason and shifted approximately 0.5 m towards the north and west directions. Photographs of the motion of the bottom side of the shear wall SW4 are shown in Figure 7 and Figure 8.

Figure 7. Failure of shear wall SW4 (A4-B4).

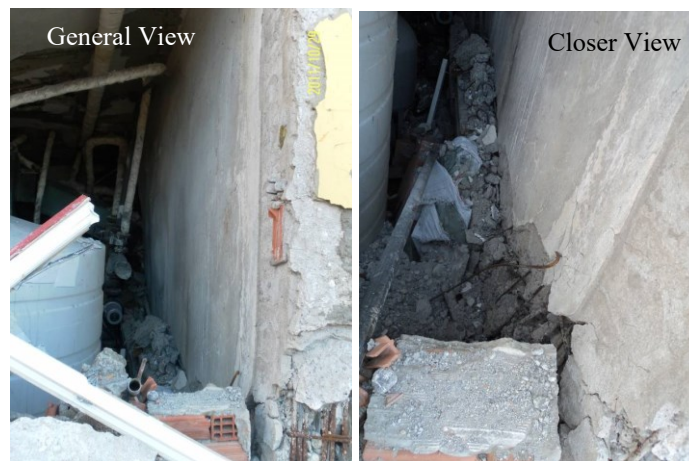
Figure 8. Separation of shear wall SW4 from the foundation (A4-B4).

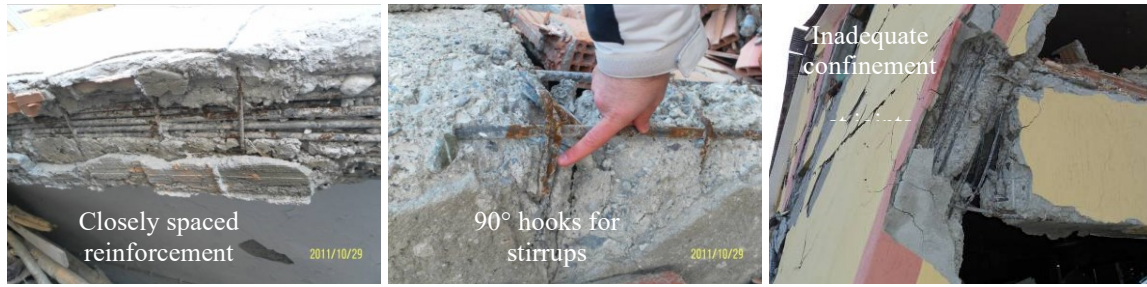
Plain bars were used as longitudinal and transverse reinforcing steel in the construction of the building. Using deformed bars prior to Specification for Buildings to be Constructed in Earthquake Areas (MPWS, 2007) was not required as longitudinal reinforcement in column and beam elements in Türkiye. The specified yield strength of reinforcing steel was 220 MPa in the drawings and calculations. Poor detailing and craft were observed throughout the building, such as closely placed longitudinal reinforcement for beams and columns. The ends of the stirrups were not bent 135° to keep core concrete in place after the cover concrete was lost. Observations related to these problems are shown in Figure 9. Also, no adequate confinement of the stirrups (large spacing of transverse reinforcement) was observed at the ends of beams, end of columns, and beam-column joints (potential plastic hinge regions), as shown in Figure 9.

Figure 9. Problems related to reinforcement.

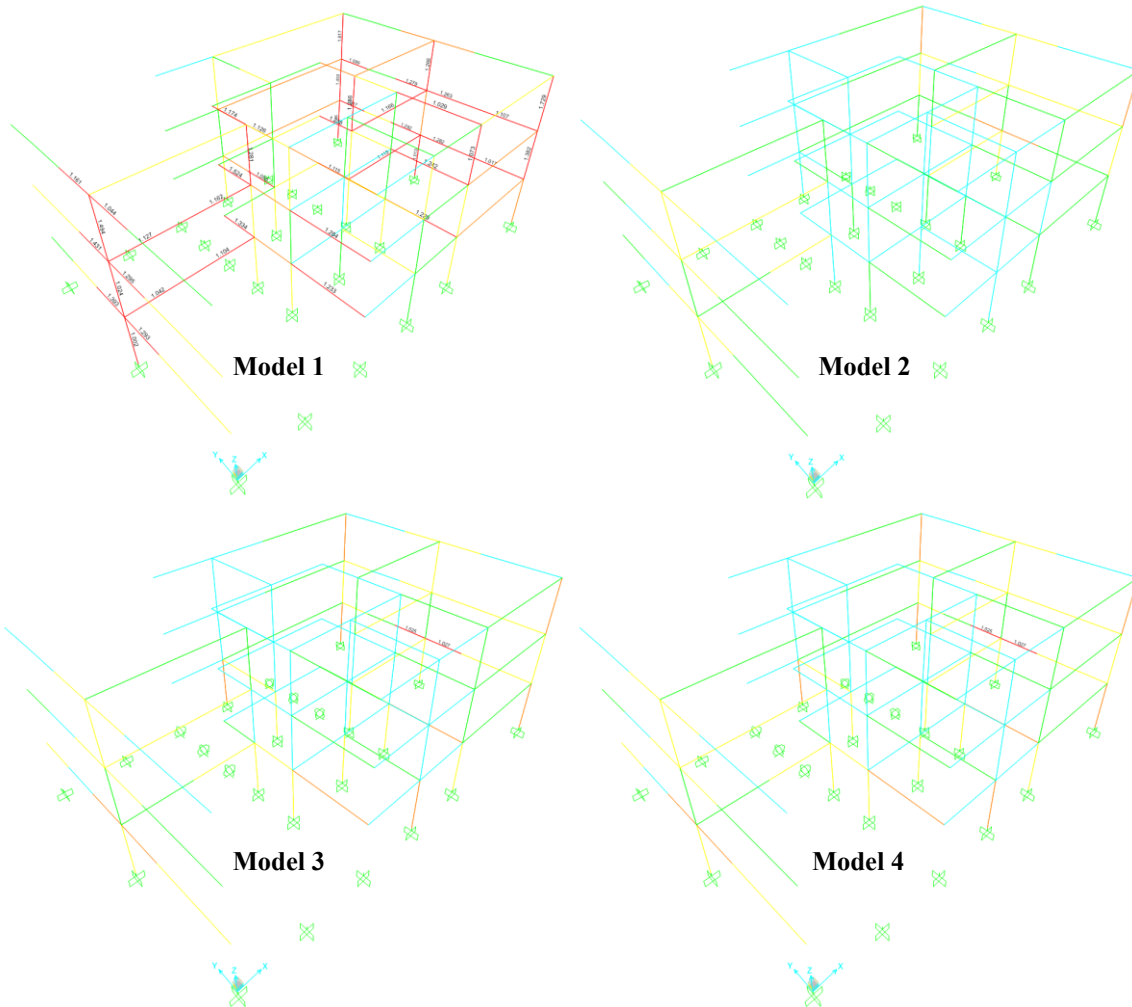
Figure 12. Results of capacity check of models (only the ratios more than 1.0 are shown).

The results of the elastic analysis of Model 1 indicate that the building would not resist the design loads specified by current codes since the capacity ratio of some of the members exceeded the

Results obtained from the elastic analysis of Model 2 indicate that the school building should have survived the earthquake that occurred on October 23, 2011. No beams or columns exceeded the capacity ratio of 1.0. In addition, the levels of load effects resisted by the shear walls were all under acceptable limits. However, the building collapsed totally. From the behavior of Model 2, it can be concluded that the failure of this building on the day of the earthquake was not related to the capacity exceedance (moment, shear, or axial load) of the structural members.

The reason for the collapse can be explained based on the results of the analysis of Models 3 and 4. Initially (as indicated by Model 3), the supports of the shear walls oriented in a short direction (SW3 and SW4) were separated from the foundation due to inadequate development and lap splice length of the reinforcing bars. Note that the reinforcing bars used in the building were all plain bars without any ribs. The poor bonding characteristics of plain reinforcing bars with low concrete quality resulted in pulling out of these reinforcing bars out of concrete elements. Later, this separation continued (as indicated by Model 4) with shear walls oriented in a long direction (SW1 and SW2). The loss of the connections of shear walls to the foundation resulted from excessive building motion in both directions. At this point, the moment capacity of 17 columns was exceeded with a maximum capacity ratio exceedance of more than three times, resulting in a total collapse of the building.

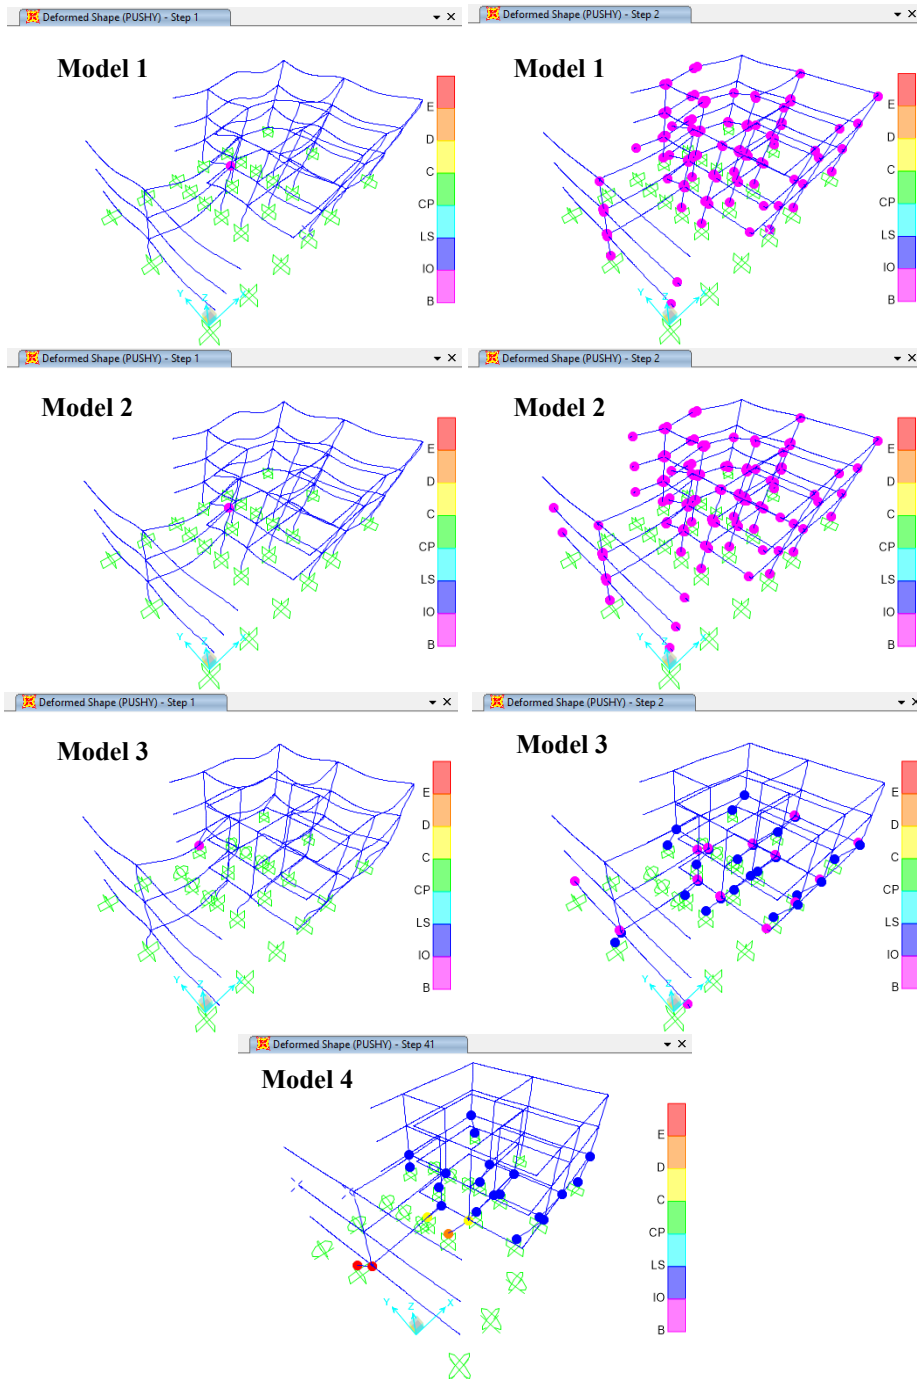
various steps of pushover analysis in y-direction are shown in Figure 16. Based on this figure, the hinges of Model 1 and 2 experienced deformations at the yielding level. This level was located before the IO level resulting in no or minimal damage to the structure at those levels of ground motions. Some hinges of Model 3 would reach the IO level, producing no failure at that level of ground motion. However, Model 4 had failed hinges at the maximum analyzable state (Step 41) using SAP2000 and still did not reach a performance point. This confirms the findings of the elastic analysis in which the failure of the structure is associated with the loss of the connections of shear walls to the foundation resulting in excessive motion of the building in both directions.

Figure 16. Performance levels of hinges at various steps of pushover analysis in y-direction.
