Increasing Risk of Silent Disaster in Uttarakhand Himalaya: An Example from Higher Himalaya

Sushil Khanduri¹, Rajendra Dutt Saklani², Bishnu Maya Chetry³

Abstract

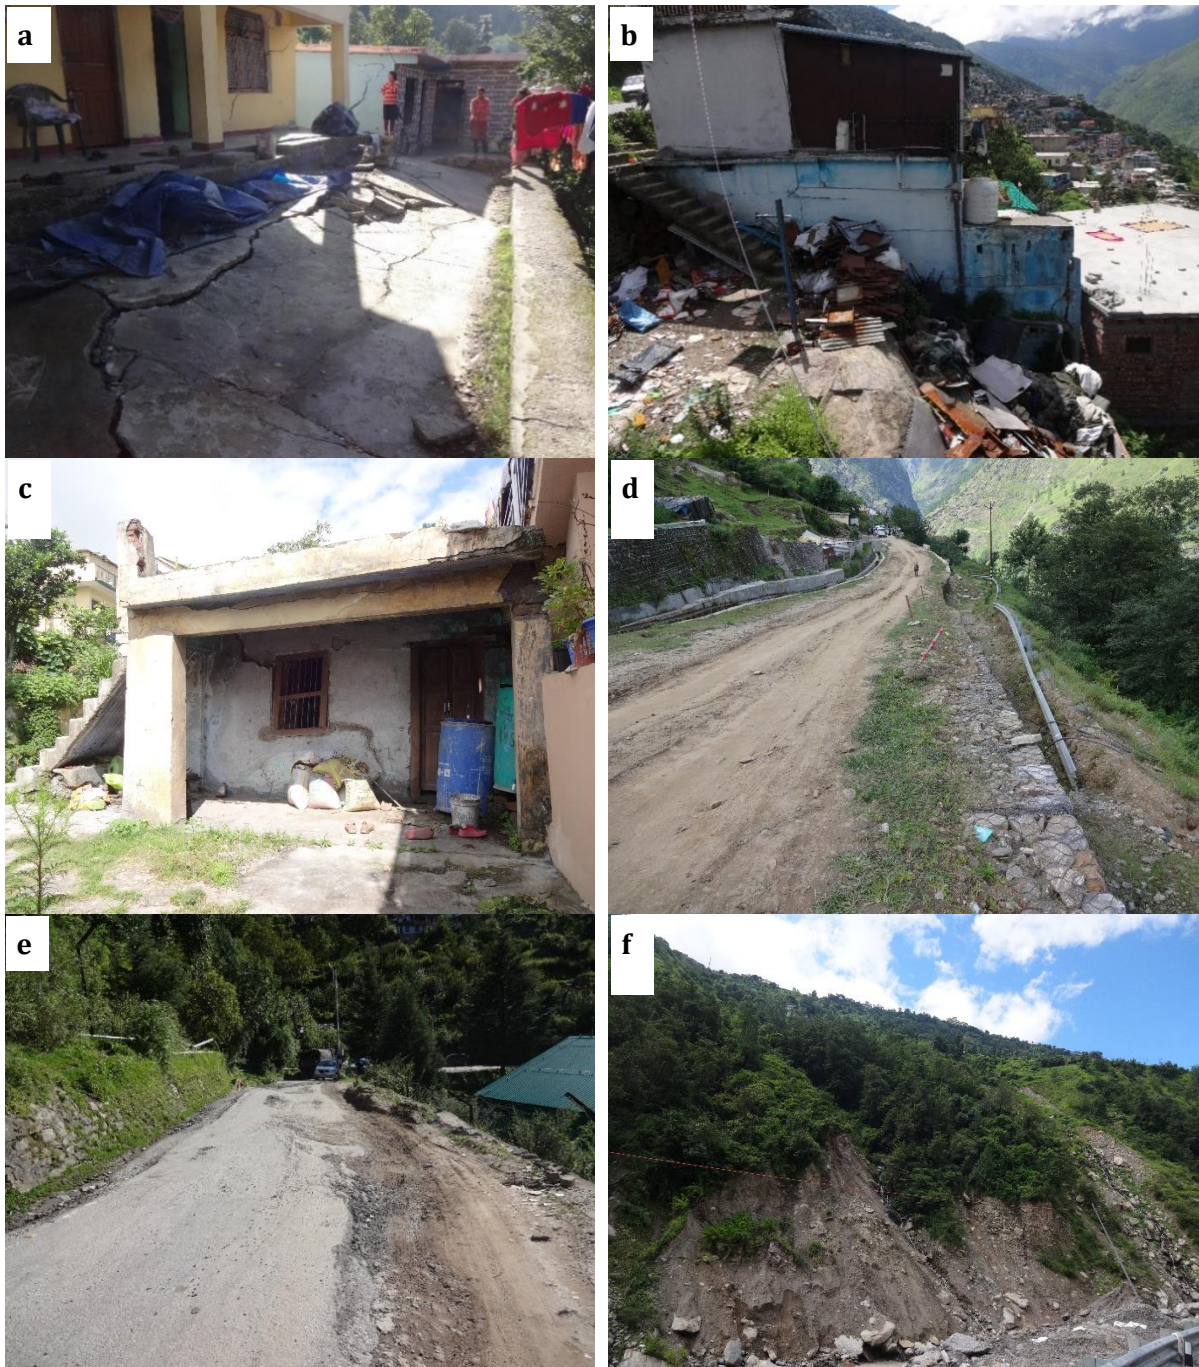
Figure 5. Damage to property and infrastructure due to land subsidence events; (a) Wider cracks in walls of houses and courtyard at Sunil village, (b) detached column of a house at Gandhinagar, (c) transverse cracks on the wall of a house at Ravigram village, (d) road subsided just below NTPC colony near Marwari area, (e) a water supply line was observed to be dislocated caused road subsided in the Sunil village, and (f) severe toe erosion by Alaknanda river on its left bank

During the field investigations, it was observed that cracks in houses, and water supply lines were damaged, and roads subsided in the different pockets of vulnerable localities of the town. Active land subsidence events are observed to have occurred mainly in Sema, Sunil, near NTPC colony, Gandhinagar and Ravigram localities. Cracks in the houses are to be observed in Sunil and Ravigram villages indicating active land subsidence (Figures 5a and 5c). Poor quality of civil construction works was also noticed, particularly in Gandhinagar during the site inspection (Figure 5b). Apart from, a part of a stretch of the approach road of the National Thermal Power Corporation (NTPC) colony near the Marwari was subsided whereas a water supply line was observed to be dislocated due to the road subsiding in the Sunil village (Figures 5d and 5e).

It was observed that the Ravigram village is undergoing serious land subsidence during the field investigations. Most of the houses of this village were subsided resulting in cracks in the houses whereas some of the houses of this village were on the verge of damage. The mass movement process in the area is mainly due to rapid erosion by the A T Nala located to the East of the Ravigram village. This Nala flows from the SW-NE direction and finally meets with the Dhauliganga river at a right angle in the area. On the other hand, toe erosion by the Dhauliganga river is also responsible for the active mass movement process in this area. Additionally, the aftermath of the Rishiganga-Dhauliganga flash flood of 2021 and rainfall on October 17-19, 2021 increased the problem of land subsidence in the area.

Based on ground observations and keeping in view of important geo-parameters like geomorphology, geology, and geo-environment conditions of the area, the following suggestive measures are recommended:

- Enforcing regulations for any type of construction activities in the area around the town.
- Managing seepages and leakages from natural and artificial means in this fragile mountainous slope.

- Relocating affected families who were residing in severely damaged houses while the same houses should be dismantled immediately and debris of these houses be removed helping with the guidance and advice of respective expertise agencies.
