## Geotechnical and Structural Investigations in Malatya Province after Kahramanmaraş Earthquakes on February 6, 2023

Özgür YILDIZ<sup>1</sup>, Ceren KINA<sup>1\*</sup>

<sup>1</sup>Malatya Turgut Ozal University, Faculty of Engineering and Natural Sciences, Department of Civil Engineering, Malatya, Türkiye  
(ORCID: [0000-0002-3684-3750](https://orcid.org/0000-0002-3684-3750)) (ORCID: [0000-0002-2054-3323](https://orcid.org/0000-0002-2054-3323))

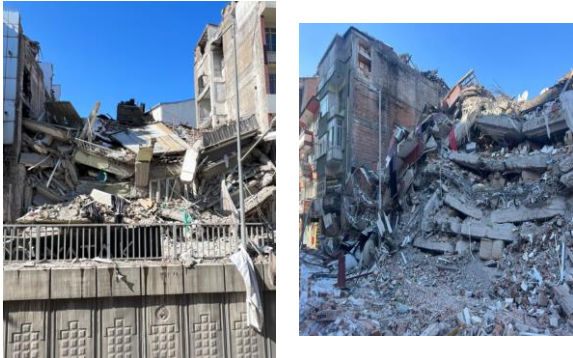
The building stock in the very center of the city, especially in the region where commercial enterprises are concentrated, is commonly old and adjacent structures with no or not enough dilatation. These buildings, which were generally built prior to 2000, are mid-rise with infill walls. A modern reinforced concrete design guide (TS 500) [22] was issued on October 12, 2000, and it mandated the use of ready-mixed concrete and ductile low-carbon steel. Besides, this guide improved the detailing of the steel bars and banned the use of non-deformed bars. It was observed that most of the buildings built prior to 2000 were collapsed, immediately demolished, or heavily damaged (Fig. 10). The main defects in these buildings were the use of non-deformed bars, the inadequacy of stirrups, and the low strength properties of concrete due to the use of hand-mixed concrete.

**Figure 10.** Totally collapsed buildings in Malatya

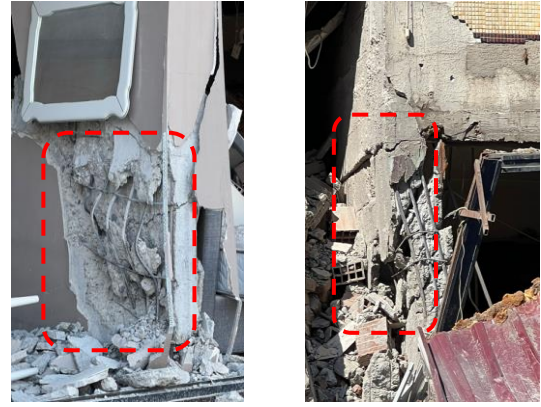
**Figure 11.** The observed damages in the old buildings in the city center, caused by the insufficiency in stirrups and the use of non-deformed steel bars

Observing Fig. 11, the longitudinal bars buckled due to the wide stirrup spacing, so the bond strength of the concrete-steel bar could not be achieved and the concrete was crushed. Besides, it is also striking that the bond strength of concrete-steel bars was not provided due to the use of non-deformed steel bars.

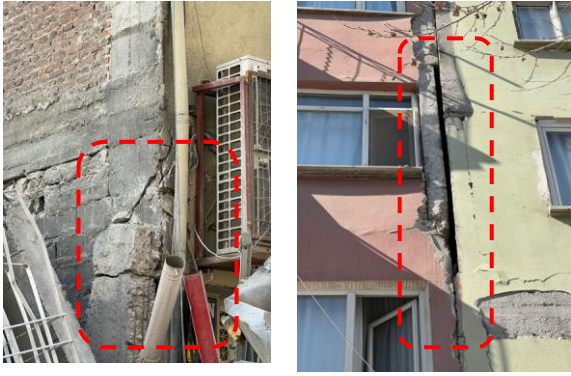
As mentioned above, the old building stock in the city center was commonly built as adjacent structures with no or not enough seismic gaps. For these kinds of structures, in order to exhibit the least damage caused by the earthquake motion, a sufficient seismic gap element should be placed or a seismic gap should be left between the buildings. Based on the code, the minimum seismic gap should be 30 mm up to 6 m in height. Moreover, a minimum of 10 mm should be added for every 3 m of height increase. In the opposite case, a pounding effect can cause harm to the structural elements of buildings. Another defect observed in the collapsed or damaged reinforced concrete buildings can be explained by the fact that they were built at different times as adjacent buildings, and they damaged each other's load-bearing elements due to the lack of or insufficient seismic gap. Considering Fig. 12, the pounding of the adjacent structural elements of two buildings induced damages due to an insufficient seismic gap or element.

**Figure 12.** Pounding effect in adjacent reinforced concrete buildings caused by the lack of seismic gap

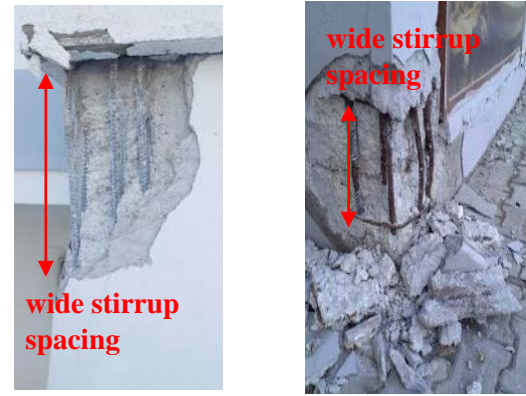
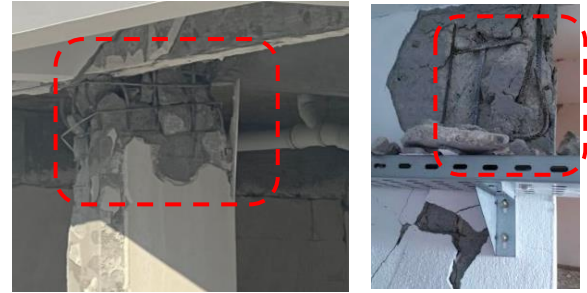
The load-bearing capacity of the elements and their connection zones in the structures must have the required ductility and strength to provide the structural safety of the buildings built in the earthquake zones. Within this scope, in the structural system, the most vital and critical areas are the column-beam connections during an earthquake. Turkish Building Earthquake Code-2018 [22] includes some rules and restrictions on structural element design. For example, the spacing of stirrups must be reduced in the confinement area, and at their ends, the ties must have hooks with a bent of 135 degrees. It can minimize the damage in the connection areas during the earthquake caused by the use of insufficient stirrups. According to the present code [22], for columns, the minimum transverse reinforcement spacing is 5 cm and the maximum spacing is 1/3 of the smaller cross-section dimensions. Besides, it shall not be higher than 1/4 of the beam depth and eight times of the minimum diameter of longitudinal reinforcement for beams. In Fig. 13, the defects in the structural elements caused by the lack of stirrups in the columns and column-beam connections were depicted. As shown, sufficient stirrup spacing was not applied in the columns, and the distance between the stirrups was also widened due to insufficient anchoring. Therefore, the longitudinal bars were buckled by the effect of both vertical load and moment, and thus, severe damage occurred in the core of the concrete.

**Figure 13.** Improper stirrup spacing and 90-degree hook bends

During observations, some mistakes were also detected due to straight hooks bent 90 degrees at their ends. Considering Fig. 13, the improper 90-degree hook bends could not provide a sufficient confinement effect. In some cases, ruptures in the stirrups were also observed due to the insufficient detailing of the transverse reinforcements, as shown in Fig. 14. It was seen that in some buildings, especially in the lower parts of the columns, the stirrup spacing was so high that there was no stirrup in those parts. Besides, when the columns were subjected to a high axial load, the longitudinal reinforcements buckled, resulting in the spalling of the cover concrete (Fig. 14). This fact can also be attributed to the use of wide stirrup spacing, insufficient concrete strength, and column-cross section dimensions.

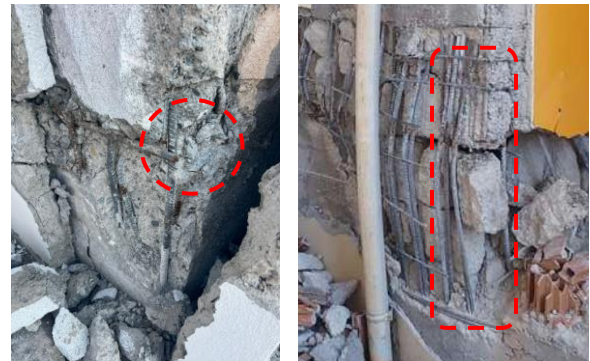
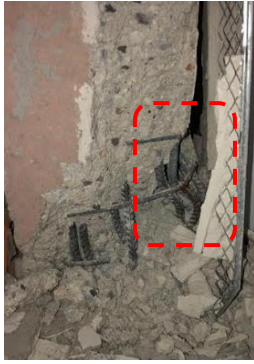
**Figure 14.** Rupture in stirrup and buckling of longitudinal reinforcement

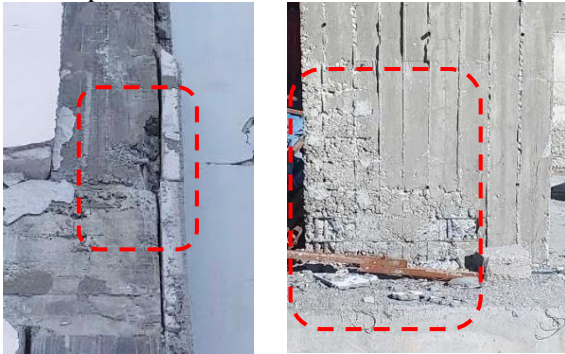
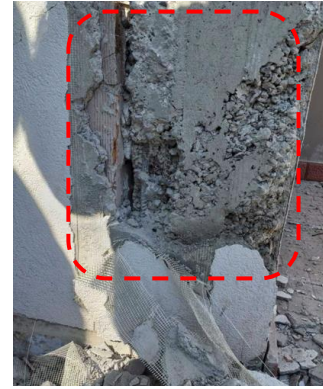
The workmanship defects can also cause tragic damage to the buildings during an earthquake. One of the main defects is the poor placement of concrete in the buildings. In some columns, coarse aggregates were observed and a homogeneous distribution was not achieved, so segregation took place. In these load-bearing structural elements, the reinforcement bars were also seen on the surface of the members, which can be due to the use of insufficient concrete cover around the longitudinal reinforcement (Fig. 15). Therefore, the bond strength between the reinforcement and concrete could not be achieved. Besides, it was seen that, in one of the beam elements, wood and large stone pieces mixed with the concrete during concrete pouring prevented the concrete from entering the mold, resulting in gaps between the reinforcements (Fig 16). The voids in the column and beam elements where concrete was not well placed showed faults in workmanship.

**Figure 15.** Insufficient concrete cover, concrete settlement problems and segregation

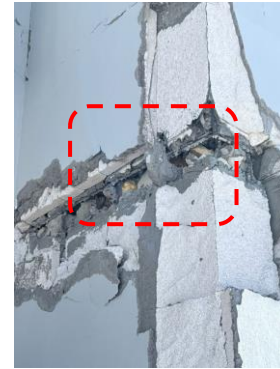
**Figure 16.** Foreign materials in concrete

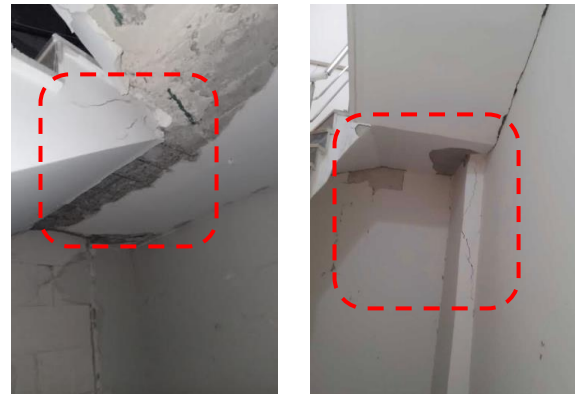
Staircases are one of the most important load-bearing structural elements and should not be damaged during an earthquake in order to ensure the safe evacuation of people from the buildings. The seismic damages in the joints of the staircase and landing were observed, as shown in Fig. 17. The spalling of the concrete cover occurred both on the landing and staircase-landing joint parts. Besides, on some staircases of buildings, splitting cracks were also observed on the concrete elements.

**Figure 17.** Damages in staircase

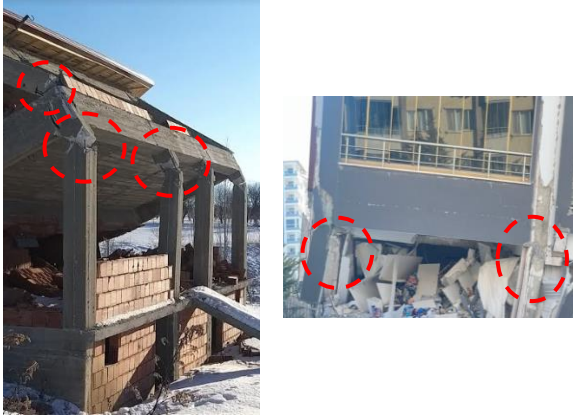
According to the earthquake regulations, it is aimed at absorbing the energy caused by the earthquake in the buildings by the beam elements and keeping the columns undamaged. Therefore, columns must be designed to be stronger than beams. A design implemented in this way will allow plastic hinges to form on the beam elements so that most of the energy will be absorbed in the damaged areas that will occur on the beams. The fact that the columns remain undamaged under the effects of an earthquake also prevents the structure from experiencing stability problems. However, from the observations, it was seen that there were structures that did not comply with this design principle. Observing Fig. 18, in some structures, the beams remained undamaged, and plastic hinges were formed at the lower and upper ends of the column elements. This situation led to the deterioration of the building's stability.

**Figure 18.** Stability problem due to weak column-strong beam situation

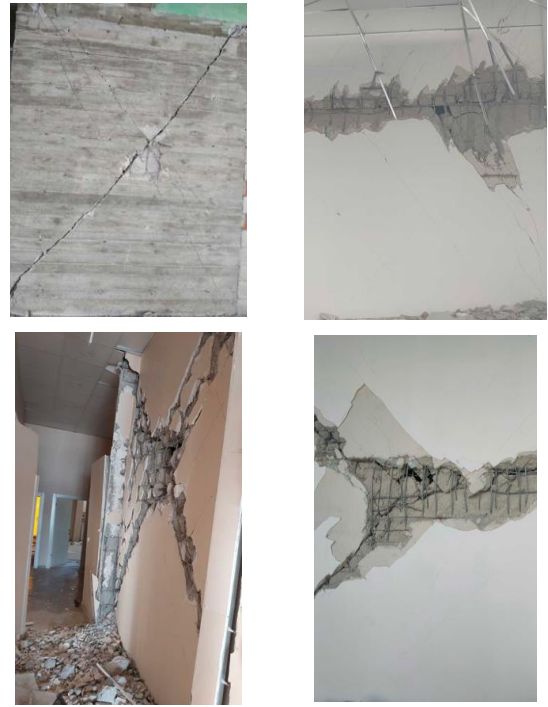
Shear damages caused by insufficient shear strength were observed in columns and shearwalls. Observing Fig. 19, cracks with a slope of 45 degrees were formed. This brittle type of damage can be considered heavy damage. The shearwalls were damaged due to the inability of the lateral reinforcement in the web of the element to meet the shear force caused by the earthquake. It caused the spalling of the concrete cover and crushed the concrete.

**Figure 19.** Shear damages in the shearwalls and columns

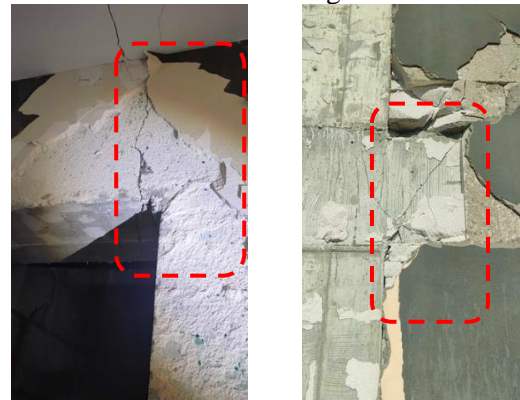
In the Turkish Building Earthquake Code, there are some restrictions that must be obeyed in the design of the end sections of the structural elements. According to this code, the reduction in the spacing of stirrups in the confinement area causes an increase in the energy consumption of this region. The shear cracks in the beam elements shown in Fig. 20 formed due to the increase in shear stress near the beam-column joint section. This type of damage can be due to the use of wide spacing between the stirrups in the beam-column joint section and inadequate transverse reinforcement. It was seen that the lack of reinforcement in the beam and beam-column joint sections caused critical damage.

**Figure 20.** Shear cracks at the beams

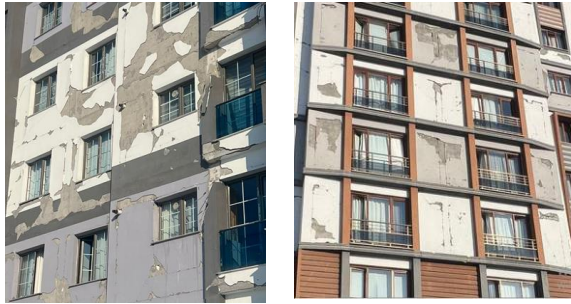
The non-structural elements are the components such as curtain walls, chimneys, walls, cladding, etc. that are not in the load-bearing system of the building. Such damages can cause interruptions in the use of buildings after the earthquake. As seen in Fig. 21, cracks have formed on the outer surface of almost all buildings, and plaster and paint spills have been observed.

**Figure 21.** Cracks and plaster spills observed on the exterior of the buildings

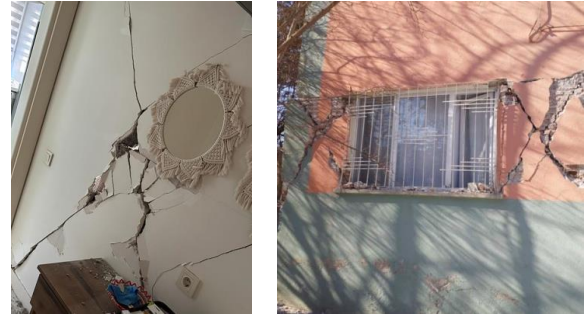
Although the load-bearing capacities of the infill walls are ignored, they contribute to the lateral strength of the structure. The damages in the brick wall show the insufficiency of the lateral stiffness of the structure. The shear cracks were observed because of the inadequate rigidity of the structural system and as a result of the reversed cyclic lateral loading during an earthquake. Lots of shear cracks in the form of X were observed on both the interior and exterior walls of the buildings, as seen in Fig. 22.

**Figure 22.** Shear cracks in walls

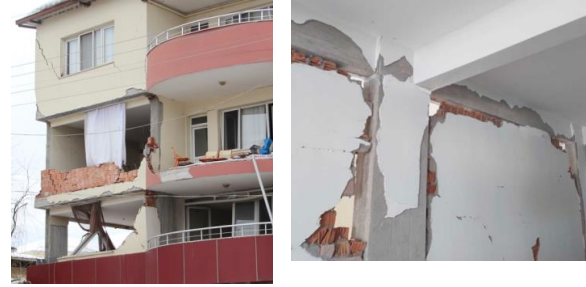
In some buildings, the damages caused by the deflection of the walls in an out-of-plane direction due to the strong ground motion were observed. This type of damage can be due to inadequate adhesion between the walls and structural elements. Besides, it was observed that during lateral motion, the frame with no adequate lateral stiffness caused shear damage in the infill walls (Fig 23). In order to reduce this type of damage, in Turkish Building Earthquake Code-2018 [22], the use of elastic materials between the infill walls and structural system has been advised.

**Figure 23.** Out-of-plane toppling of walls and frame-wall separations

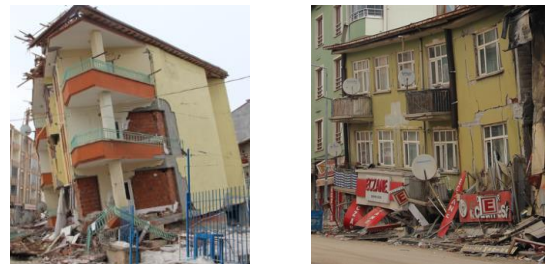
As the brick infill walls used on the upper floors of the buildings are not continued on the ground floors due to the presence of shops or stores, a sudden decrease in rigidity occurs on these floors. This causes the formation of ‘soft storey’ irregularities. The presence of mezzanines on the ground floors of the buildings, which makes the floor height higher than the other floors, also causes a sudden decrease in rigidity. In this case, the lateral displacements between the ground and first floors of the buildings reach relatively high levels, and the stability of the building deteriorates. Especially in the district of Doğanşehir, many buildings were heavily damaged due to the formation of soft storey irregularities, and the ground floors were completely demolished (Fig. 24).

**Figure 24.** Collapsed structures due to sudden stiffness changes on the ground floor.

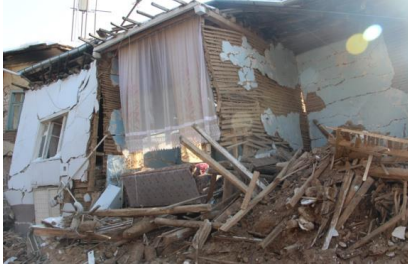
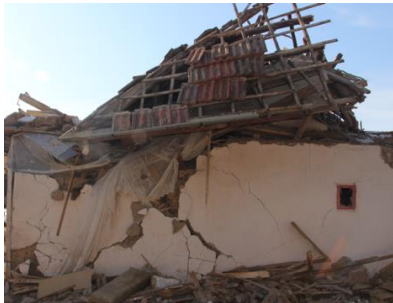
The rural buildings in the countryside of Doğanşehir, Akçadağ, and Darende villages of Malatya have been heavily damaged, and it was observed that many masonry buildings constructed by their users without any engineering services collapsed (Fig. 25). These rural buildings in the villages were built with local materials found in the close vicinity, such as stone and adobe. In general, they are in the form of a one or two storey masonry structure.

In the villages of Doğanşehir, Akçadağ, and Darende, it was observed that the bearing walls were built using mud mortar as a binder. However, according to Turkish Building Earthquake Code-2007 [25], the use of lime mortar supported with cement or cement mortar was suggested as a binder in load-bearing walls. The minimum compressive strength of mortar for masonry buildings should be higher than 5 MPa, so the use of mud mortar as a binder could cause deficiencies. Besides, their flooring includes beams made of wood and plank decking. The wooden logs were placed in one direction, parallel to the walls. No mechanical connection between the wall sections was observed, so during the earthquake motion, the walls separated. The out-of-plane failures were observed in some buildings, as shown in Fig. 26. The quality of the workmanship of these buildings was so poor such that there were no horizontal bonding timber beams inside the bearing walls.

**Figure 25.** Collapsed structures in the rural areas

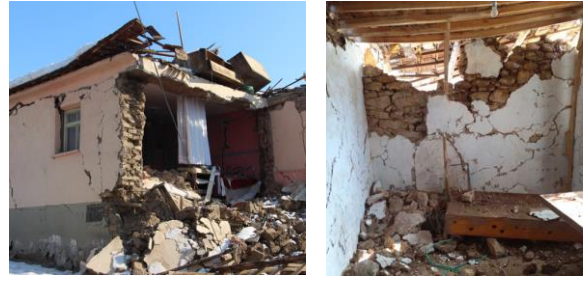
**Figure 26.** Wall damages in Gündüzbey and Akçadağ

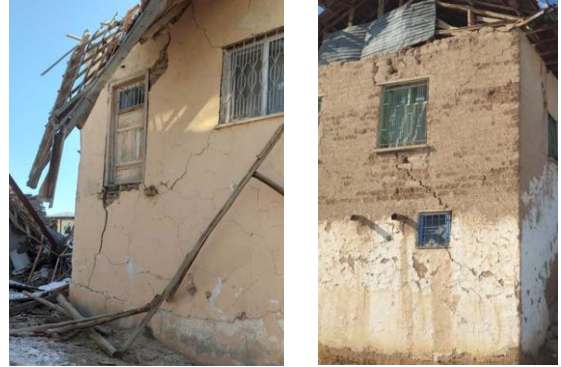
It was observed that the loads formed during the earthquake caused the formation of shear cracks on the walls of the masonry structure (Fig. 27). In order to prevent this type of damage, during the construction of the building, continuous beams should be placed at certain heights that surround the structure.

**Figure 27.** Shear cracks in masonry buildings

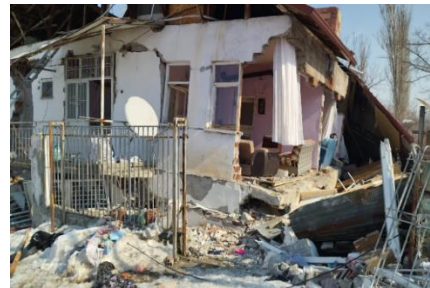
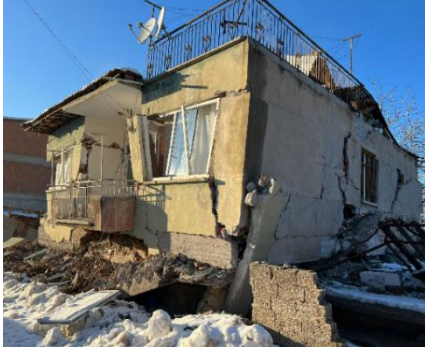
Vertical cracks have occurred in the corners of the masonry buildings due to the effect of ground movement. With the growth of these cracks, the walls separated from the building were partially demolished, as seen in Fig. 28. This damage can be avoided by installing corner joints during the construction of the masonry structure.

**Figure 28.** Corner collapses due to vertical cracks in Akçadağ

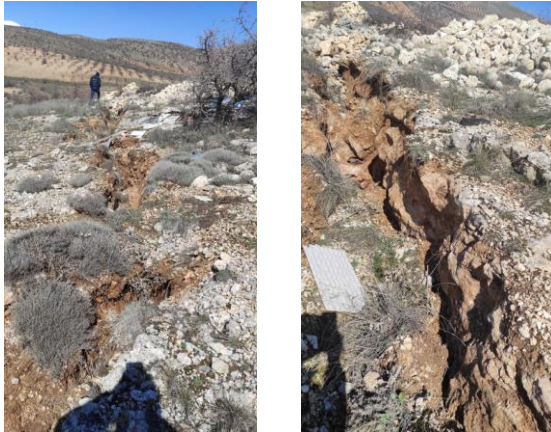
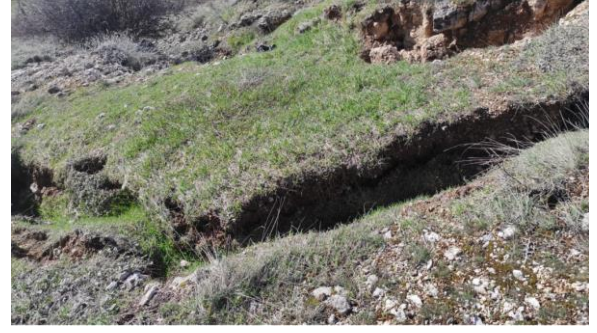
The dense construction in Malatya's city center makes it difficult to observe the surface traces created by the earthquake. However, in rural areas, data that allow observational evaluation, such as surface fractures, ground traces, and slope movements, can be encountered. Surface ruptures (i.e., ground rupture or ground displacement) occur as the apparent slip of the ground surface when an earthquake rupture affects the ground surface along a fault. Those ruptures, which pose a great risk for structures built along a fault belt that may be active, were observed in Akçadağ, the district of Malatya on the western border. The slit width reaches 1.5 m, and the height reaches 80 cm. The observed surface crevices were formed in a rural area with no settlement. Therefore, no structural effects were noticed (Fig. 29).

**Figure 29** View of surface ruptures in Akçadağ district

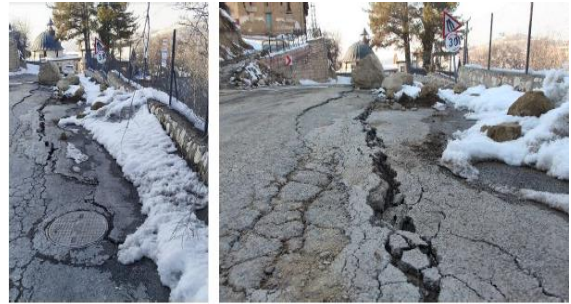
Significant asphalt pavement damages were observed on the roads between Yeşilyurt and Gündüzbey districts, on the border of the city of Adıyaman in the south. It was observed that the deformation and cracks on the surface are deduced by the movement in the earth retaining structures supporting the road, which have an approximate height of 4 m. The lateral movement of the retaining structure supporting the road and the ground structure has also caused the movement of the abutment structure on the upper side. Rock masses broken off from the backfill caused significant deformations on the asphalt pavement (Fig. 30). Again, in this region, where the superstructure damage density is quite high, displacements and settlements have occurred on the highways supported by the retaining walls. Due to the lateral movement of the bearing structure, fractures and displacements of up to 40 cm occurred at the asphalt pavement level (Fig. 31).

**Figure 30.** The asphalt pavement cracks due to the lateral movement of retaining wall in Yeşilyurt district

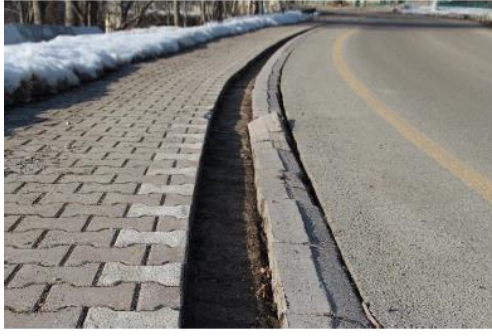
**Figure 31.** The slid pavement due to lateral movement of retaining wall

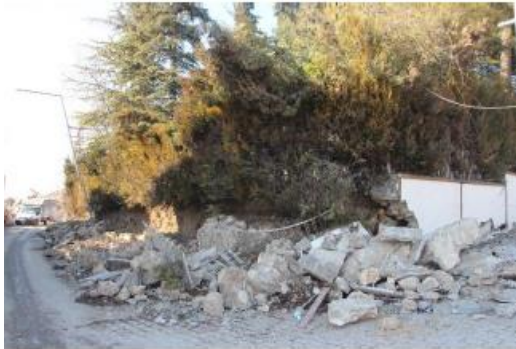
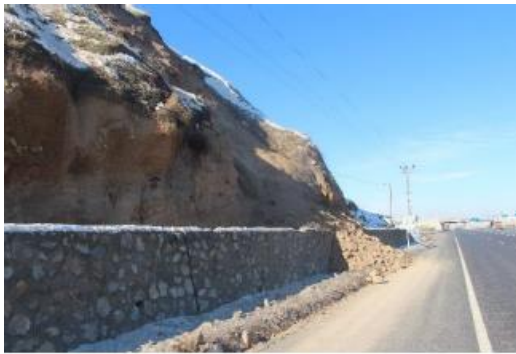
**Figure 32.** Retaining wall failures and flow of backfill material

Even in small magnitude earthquakes, lateral displacement of retaining walls can be expected within certain limits. The movements of massive, weighted walls built on rock are more limited. The performance of the reinforced earth structures against these earthquakes has been observed to be quite successful. It has been concluded that this is largely due to the flexibility provided by the strip reinforcements used. Local and global failures were observed in the load-bearing structures built, especially in regions where soil amplification effects are observed. It is also considered that wall height is an important parameter of structural performance. Vegetation and afforestation, which correspond to significant surcharge loads in the abutment structures at the

border of the public parcels, especially in the backfills, triggered the effects on wholesale collapses (Fig. 32).
