Damage Assessment of Masonry Structures in Adıyaman Province After Kahramanmaraş Earthquakes (February 6, 2023)

Ertuğrul ÇAMBAY^{1*}

doi: 10.5505/fujece.2023.47955
Research Article

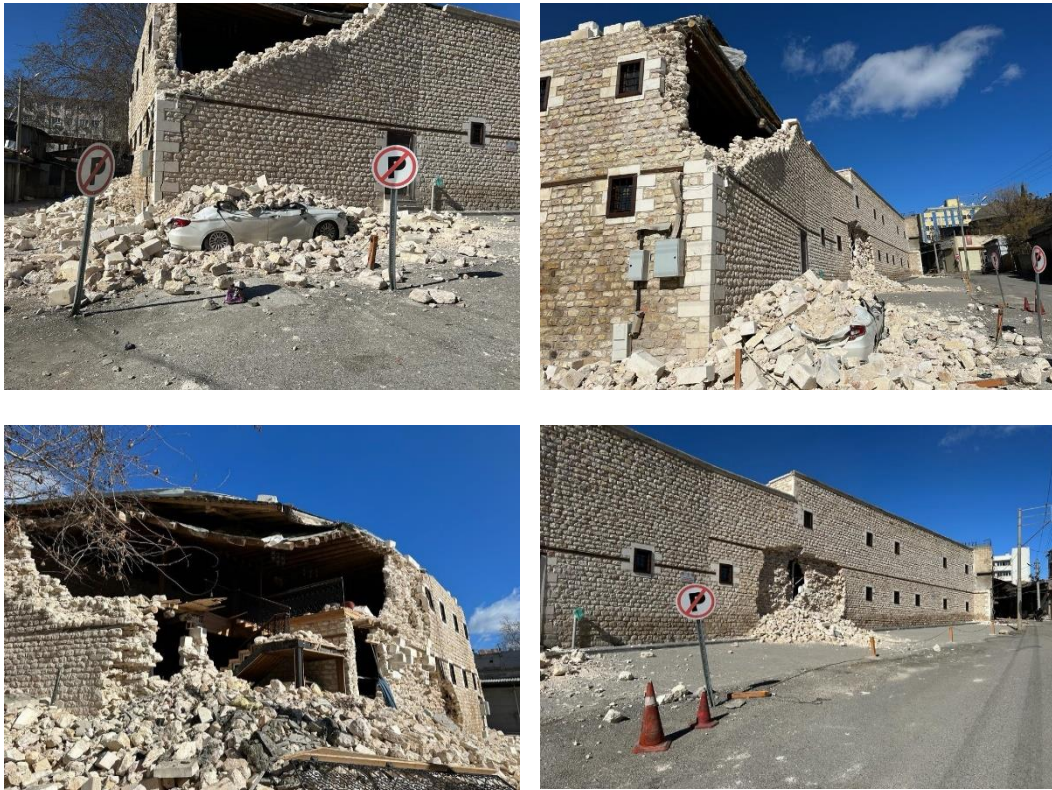
After the restoration process in 2021, the Adıyaman Tuz Hanı, built in the 1800s, was observed to have suffered major damage as a result of the 6 February Pazarcık earthquake. As a result of on-site inspections, damage occurred due to out-of-plane behavior. In particular, it has been determined that the masonry units were built using randomly placed stones with irregular shapes. The lack of sufficient connections between stones has resulted in poor earthquake performance of such structures. TDY [10], to increase the lateral resistance of masonry structures against earthquakes, it is mandatory to use reinforced beam systems called both horizontal and vertical beams. However, no reinforced concrete beams were seen on the exterior of this building (Fig. 4). As a result of the restoration, careless workmanship and random placement of stones were also determined as a result of the examinations.

Figure 4. Tuz Hami in the center of Adiyaman

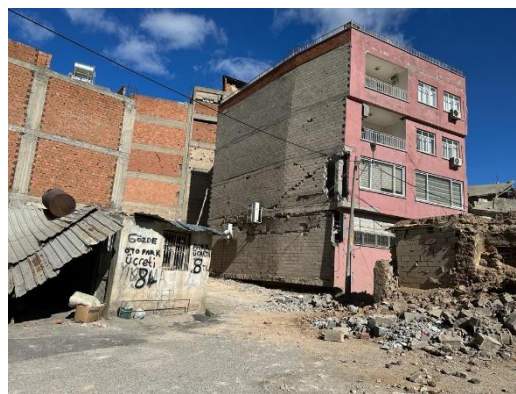
As a result of field studies carried out in the region, it was observed that most of the masonry structures were built using a mixture of natural stone and perforated clay bricks. Due to the weakness and brittleness of the perforated clay brick material, it has been concluded that the seismic behavior of masonry structures built using this type of material is weak. In many cases, it has been found that under the influence of earthquakes, clay elements lose their strength before mortar. Generally, it has been found that clay bricks are crushed as soon as masonry walls begin to lose their strength due to shearing. This loss in the connection between masonry materials can lead to collapse following the initiation of cracks. The fact that the infill wall of the reinforced concrete building was manufactured without being compressed between columns caused both in-plane and out-of-plane behavior (Fig 5).

Figure 5. Damaged masonry walls in Adiyaman city center

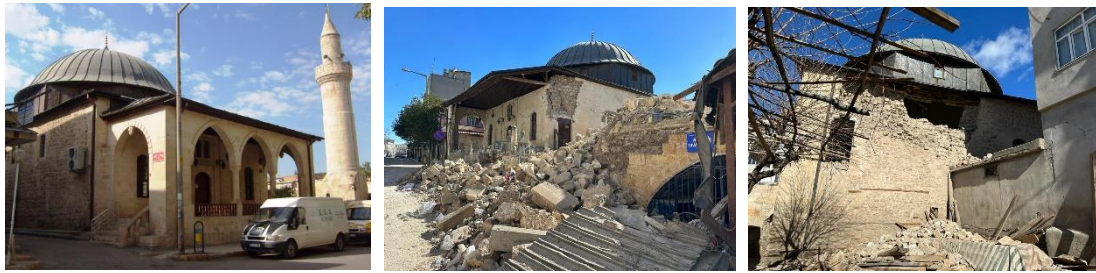
Figure 6. Kap mosque in the center of Adiyaman

It was observed that the lack of connection between the roof and walls in the mosque under investigation increased the earthquake damage. In many historical buildings in the region, the roofs are made of wooden beams and are supported directly on the load-bearing walls. Failure to install beam systems at the roof level disrupts the box behavior of the masonry structure, causing masonry walls to collapse in out-of-plane directions. Fig-6 shows the earthquake damages observed as a result of the roof system not being supported correctly to the walls.

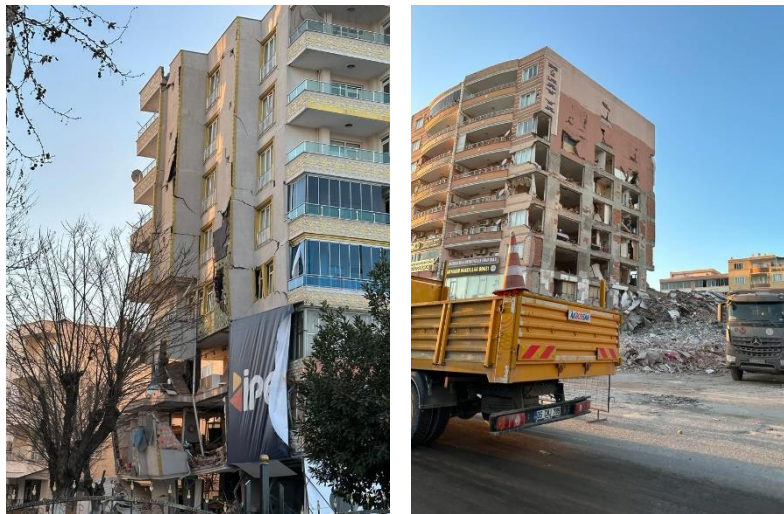
In addition, corner joint damages were frequently encountered in studies carried out in the earthquake zone. It has been shown in the literature that lateral stresses caused by the roof increase the damage. Improper wall-to-wall and wall-to-floor connections reduce the strength of corners under earthquake effects. In particular, incorrect support of corner joints causes them to become unstable. In case of roof damage, non-deformed walls usually topple over, causing major damage. The quality of the wall is determined by the effectiveness of the keystones used. Fig. 7 shows the corner joint damages observed in the region.

Figure 7. Damaged masonry walls in Adiyaman city center
