Finite Element Analysis of a Historic Masonry Building with Unique Architectural Features: A Case of KLP Building at İÜC Cerrahpaşa Campus

Keywords: Masonry buildings, Seismic performance analysis, Structural safety

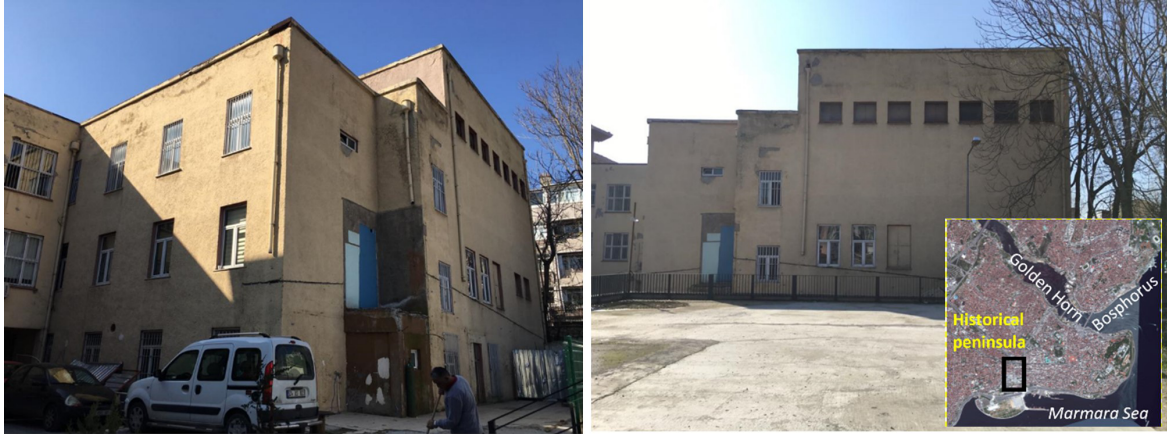
The current building is a masonry style building with brick walls, consisting of two floors, has a closed area of 447 sqm (Figure 1). It is located within the campus of Istanbul University-Cerrahpaşa Faculty of Medicine in Fatih district, Cerrahpaşa neighborhood, Block 1138, and Plot 1. While still standing, the building has suffered the loss of many of its original and distinctive architectural element. The building has been utilized as the faculty of medicine for a considerable period. While the building was initially constructed to meet the faculty's classroom needs, it was used for various other purposes over time. The building was used as an amphitheater, pathological anatomy institute, x-ray unit building, and finally Consultation Liaison Psychiatry Department in the past. Recently, the building was closed down and abandoned.

Figure 1. The current condition of the examined building

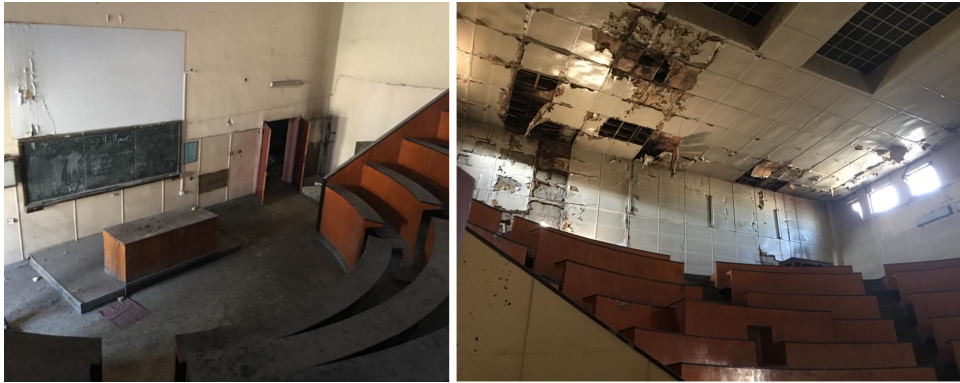
Figure 4.The current status of the amphitheater

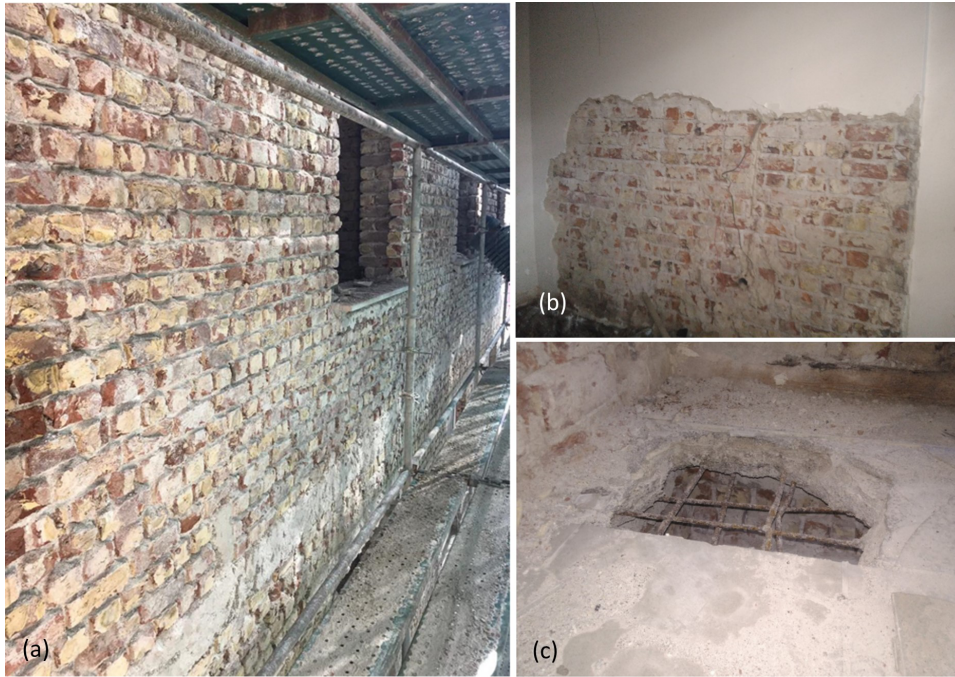
During the restoration process, the wall plasters were removed to partially uncover the connections between the structural elements, revealing the presence of horizontal and vertical RC peripheral ties in some of the walls. It should be noted that not all walls had horizontal and vertical RC peripheral ties. As shown in Figure 8, in some sections wall-slab joints were through horizontal RC peripheral ties, while in other sections, RC slabs were directly connected to the masonry walls.

Figure 5.(a, b) Masonry walls, (c) RC Slab

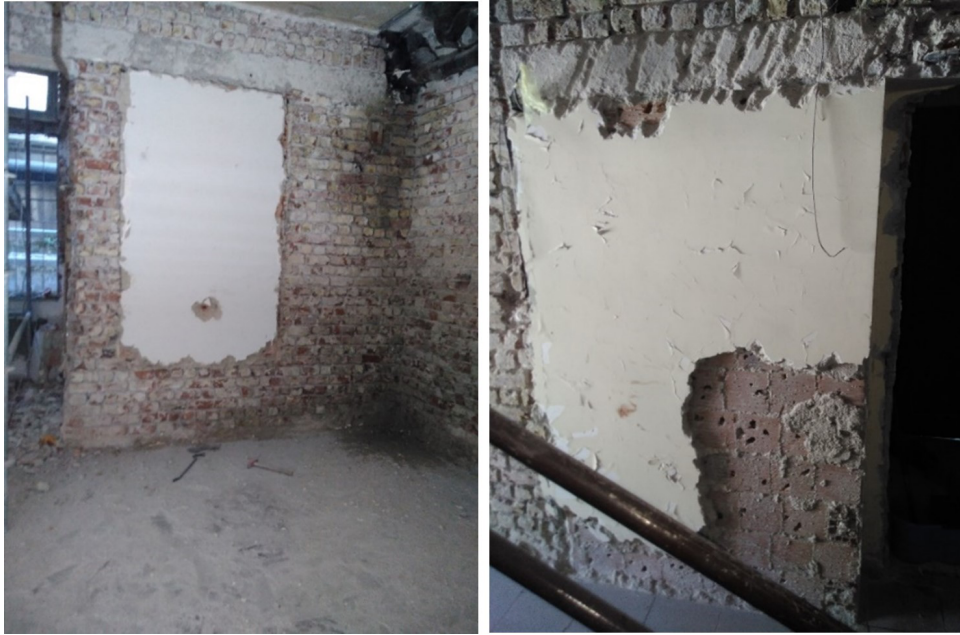
The interventions carried out on the building aimed to adapt it for a change of use or to repair and strengthen it following damages caused by seismic events. Examples of revisions to the building’s architectural plan due to changes in use include the cutting of window and door openings in the load-bearing walls (Figure 9). After scraping the wall plasters, some openings were discovered which had negative effect on the load-bearing capacity of the walls. To fill these openings, new perforated bricks were used. On the other hand, steel columns and beams shown in Figure 10 are examples of the strengthening interventions performed in the past.

Figure 9.An opening cut in the masonry wall (later closed)

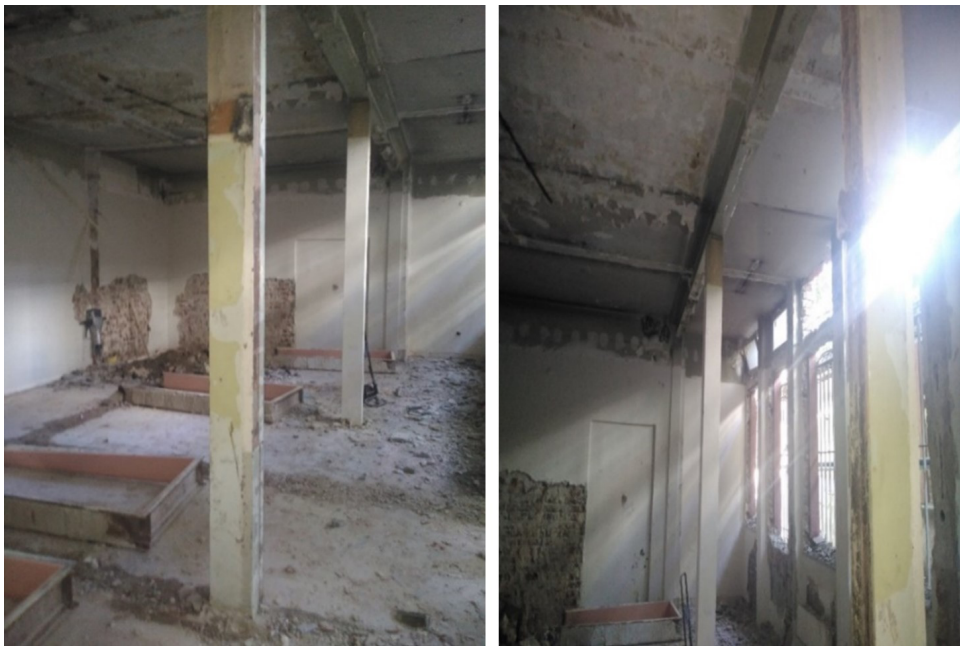
Figure 10.Steel columns and beams added to the building

These steel columns and beams were discovered after removing suspended ceilings and demolishing later-added walls. The most significant interventions made to the building involved the addition of connections on both side facades, which were designed to provide access to adjacent buildings. The original plan of the building includes only one access to the Dean Building from the 1st floor. However, as seen in Figure 11, additional connections were later made to the ground and 2nd floors to connect with the Dean Building.

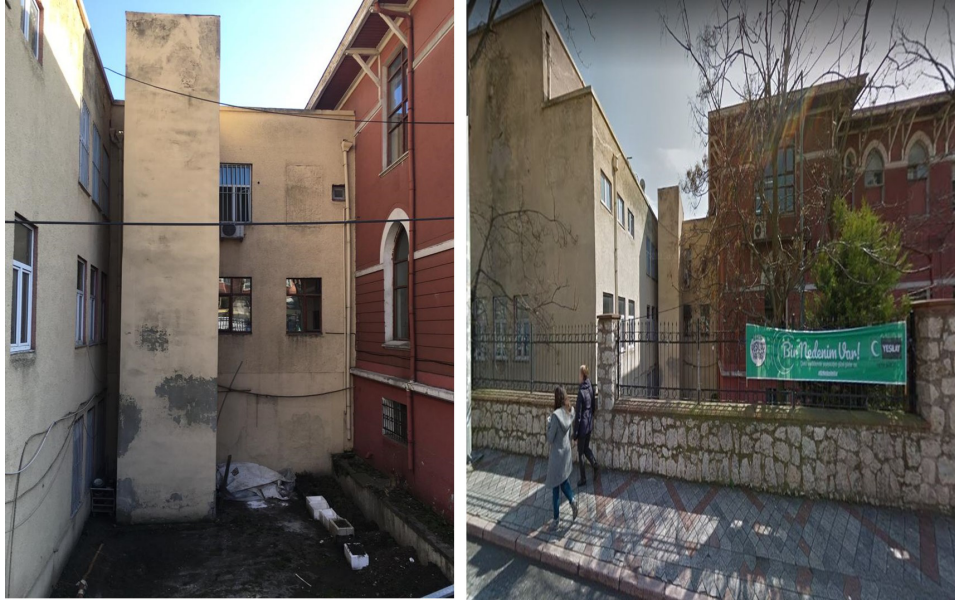
Figure 11.Current connection of the building to the Dean Building

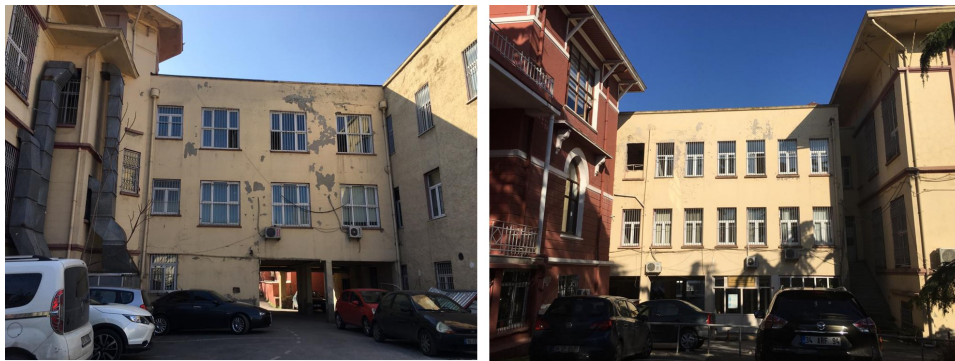
The original plan did not include a connection to the Psychiatry Clinic from the south façade. However, an RC structure was constructed in 1951 to connection the buildings as seen in Figure 12. This building was later used as the Department of Pediatric Mental Health and Diseases.

Figure 12.Connection of the building to the Psychiatry Clinic

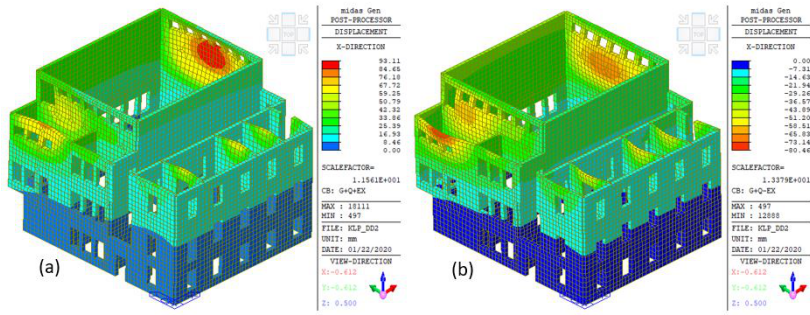
Under this loading, the wall of the amphitheater on the north façade of the building exhibited the maximum displacement of 93.1 mm. The displacement distribution in the x direction was observed to increase from the lower part of the 1st floor to the top of the building. The displacements observed under combined load effects in the negative x direction are given in Figure 18b.

Figure 18. Lateral displacements under earthquake effects in the x direction (a) G+Q+Exp, (b) (G+Q-Exn) (G:dead load, Q: Live load, Exp: Earthquake load in the positive x direction)

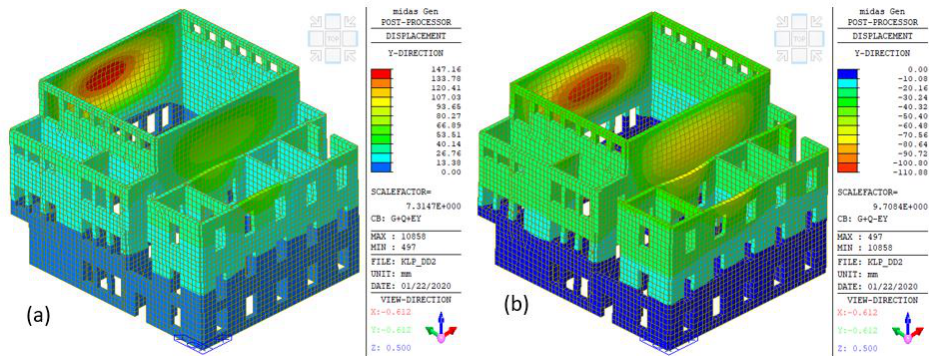
Under this loading, a maximum displacement of 80.5 mm was observed on the 2nd floor, exterior wall of stair hall no 202 on the west façade. Additionally, displacement values up to 73 mm were observed on the west façade. The amphitheater walls on the east façade also experienced significant displacements. The displacements observed under earthquake combined load effects in the positive y direction is shown in Figure 19a, a maximum displacement of 147.2 mm was observed in the amphitheater wall on the north façade of the building. Since the first dominant mode of the building was in this direction, the maximum displacement was observed in this direction. The displacements observed under earthquake combined load effects in the negative y direction are shown in Figure 19b. Under this loading, a maximum displacement of 110.9 mm was observed in the amphitheater wall on the north façade of the building. Since the first dominant mode of the building was in this direction, significant displacements were observed in this direction.

Figure 19. Lateral displacements under earthquake effects in the y direction (a) G+Q+Eyp, (b) (G+Q-Eyn) (Eyp: Earthquake load in the positive y direction, Eyn: Earthquake load in the negative y direction)

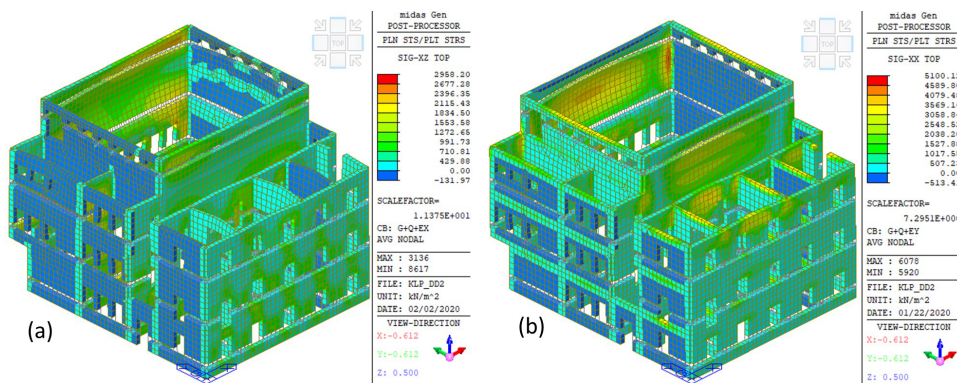
represent shear stresses on the x-z plane. Based on the obtained results, the highest stress value of 2958 kN/m² was observed on the exterior walls of the north façade at the 2nd floor. The shear stresses on the window and door lintels of the walls in the x-axis reached a maximum of 1500 kN/m². Stresses observed under earthquake combined load effects in the positive y direction are shown in Figure 22b. Upon examining the stresses, it was found that the joints of the exterior walls on the north façade experienced the highest stress, with a maximum value of 5100 kN/m². The walls on the y-axis generally experienced compressive stresses, while those on the x-axis experienced tensile stresses.

Figure 22. Stresses occurred under (a) G+Q+Exp loading, (b) G+Q+Eyp loading

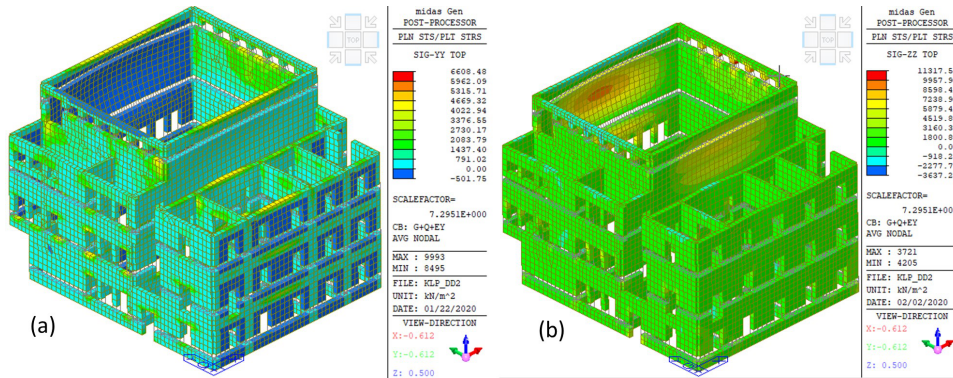
Figure 23a shows axial stresses observed under earthquake combined load effects in the positive x direction. The analysis revealed that the highest stress was 6608 kN/m², which occurred on the east façade between the window openings of the 2nd floor exterior walls. Figure 23b shows axial stresses in the positive y direction. An examination of the stresses showed that a maximum

stress of 11318 kN/m^2 was observed on the north façade, on the amphitheater wall and between the window openings and the door lintels of the 2nd floor.

Figure 23. Stresses occurred under (a) G+Q+Exp loading, (b) G+Q+Eyp loading

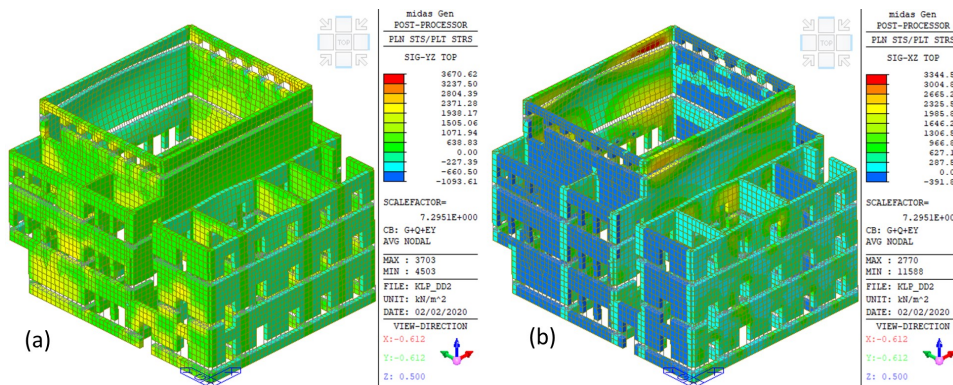
Shear stresses observed under earthquake combined load effects in the positive x direction are shown in Figure 24a. The obtained results revealed that the upper window lintels of the amphitheater walls on both the east and north façades experienced a maximum stress of a maximum stress of 3671 kN/m^2 . Figure 24b shows shear stresses observed in the positive y direction. The obtained stresses revealed that the maximum stress of 3345 kN/m^2 was observed on the upper parts of the exterior walls on the northeast façade. Moreover, shear stresses of 1600 kN/m^2 were observed on the window and door lintels of the x-axis walls.

Figure 24. Stresses occurred under (a) G+Q+Exp loading, (b) G+Q+Eyp loading
