## THE EFFECTS OF 23.10.2011 VAN EARTHQUAKE ON NEAR-FIELD AND DAMAGED ON STRUCTURES

Ercan Işık<sup>1</sup>

### ABSTRACT

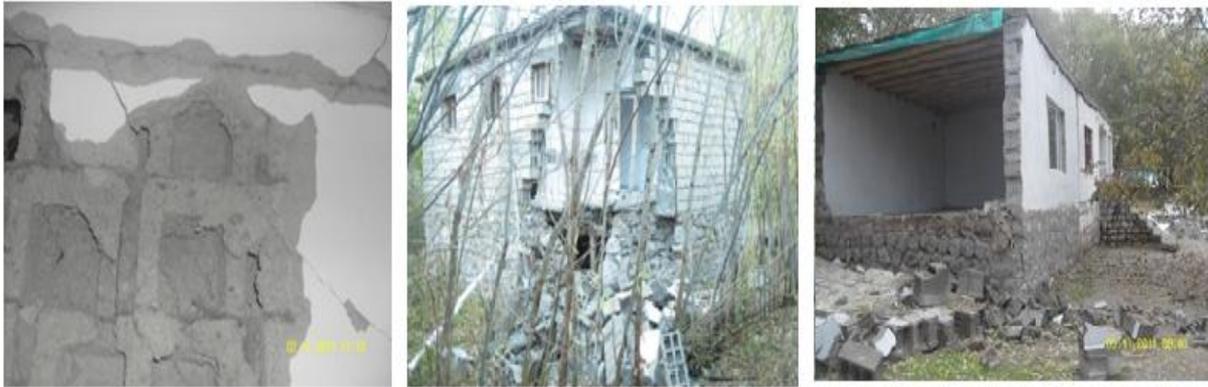
Cement mortar has been used in bearing walls in the region commonly constructed by concrete briquettes. The reason of choosing such construction materials is that they are easily available in this region. The raw material of these briquettes is pumice. The production of pumice is in quite a bit in Lake Van Basin also. It was observed that low-strength concrete briquettes used in the region broken completely or consisted cracks at walls under earthquake (Fig. 9).

**Fig.9.** Low-strength wall material (briquette) and its damage

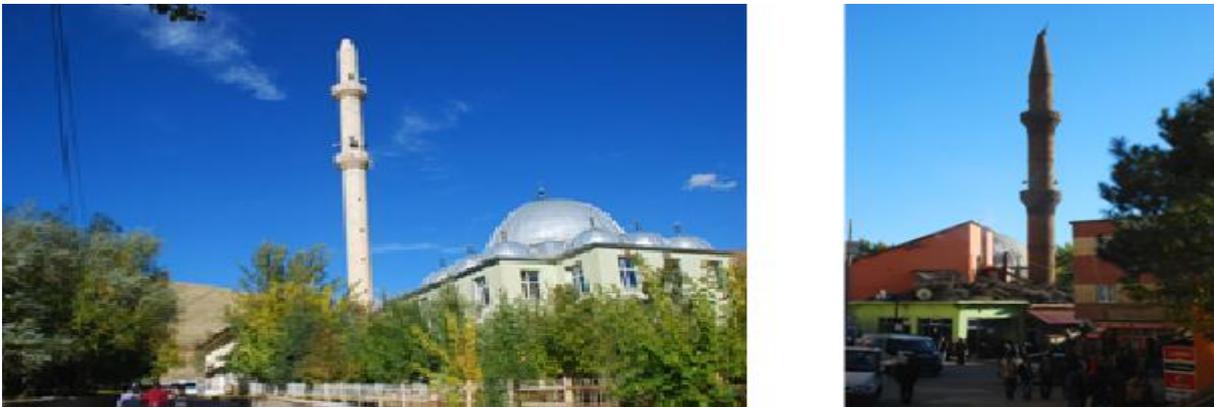
Mosques and minarets were also damaged during the earthquake. The damages were generally observed on the top of minarets (Fig.10).

**Fig. 10.** Minarets damages in Bitlis Centre

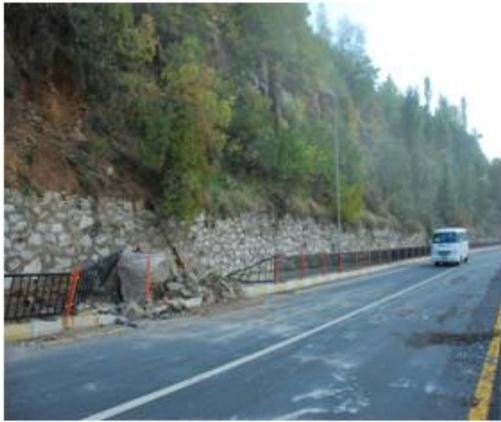
Rockfall is a kind of geotechnical damage that could be observed after earthquake. Rockfall incidents occurred Bitlis - Diyarbakır highway and nearby slopes (Fig.11). Careless of selection, design and construction of structural systems in many buildings that have not taken enough or any engineering services was caused negatively to the damage amount. It was observed that beam and column's size was not provided the minimum sizes that given Turkish Earthquakes Codes (Fig.12.).

**Fig.11.** Rockfall damage

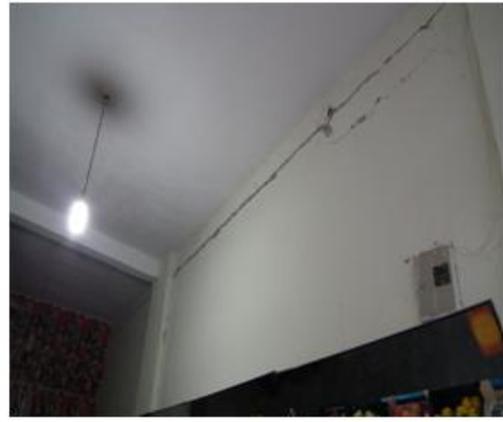
**Fig.12.** Insufficient size of beam and column

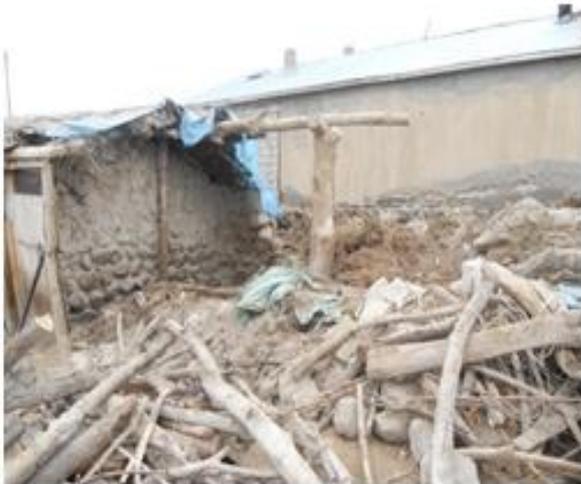
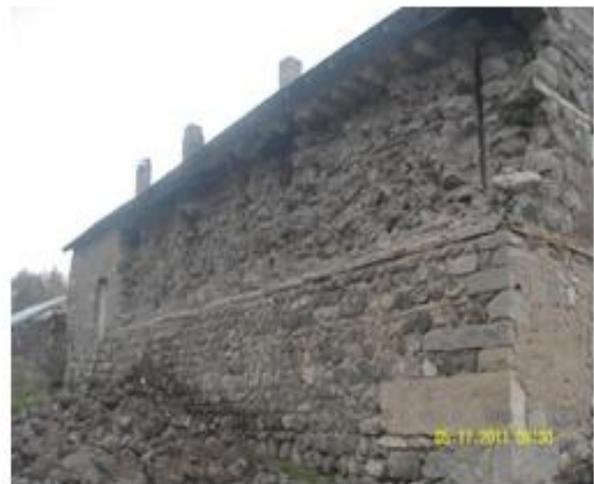
The history of masonry structures built especially in rural region was lied till to resident life of mankind. Most of these structures have not taken engineering services. These structures have not provided the principles of design that were given in Codes also. The %40 of existing buildings is masonry structures in Bitlis (TUIK, 2000). The masonry structures were built with regional stone and soil roof. The roof is heavy condensed soil laid over a wooden slab. The thickness of the condensed soil at the roof is between 30 and 50 cm. Such heavy roofs induce large inertial forces during earthquakes, which result in high stresses on low-strength walls (Akkar et al 2011). These buildings that were built with soil mortar have been collapsed partially or completely during the earthquake (Fig. 13).

**Fig. 13.** Damages of masonry structures

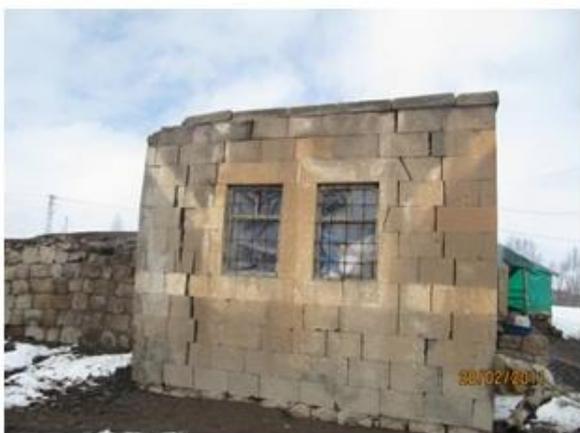
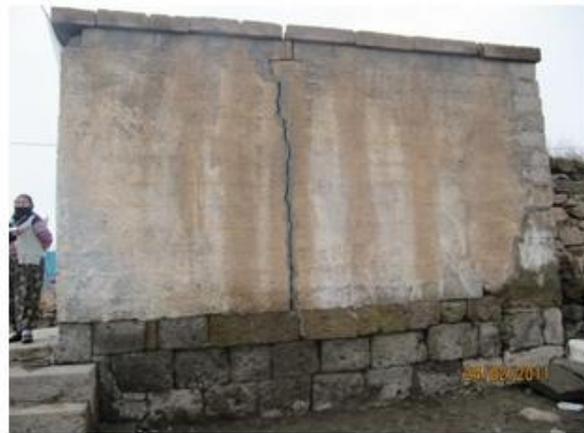
Another widely used material in masonry structure is regional stone. The binder used in such structures is low-strength cement mortar or clay. Poor quality of this binder is one of the reasons for the structural damages in rural regions (Fig. 14).

**Fig. 14.** Damages to the poor quality of mortar in Stone structures

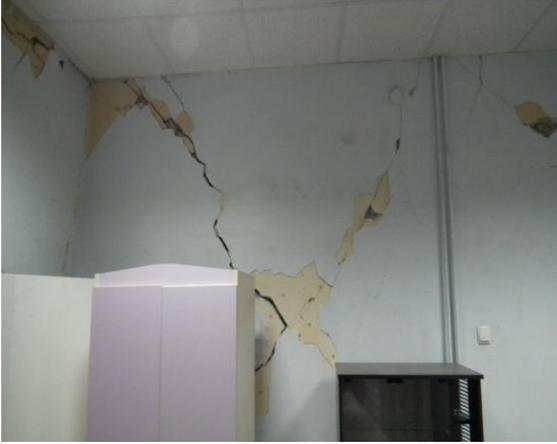
Another kind of earthquake damage is X-shaped cracks in the structural walls. These cracks have been continued to the inner of these structural walls (Bayülke, 1995). This typical damage due to earthquake has been observed also in Bitlis (Fig. 15). The most common earthquake damage observed in the roofs is the collapse of the gable walls (Fig. 16). The reason of the vast majority of the collapse of the gable walls is their inadequate connection to the structure and their construction with missing lintels.

**Fig.15.** Typical structural wall damage

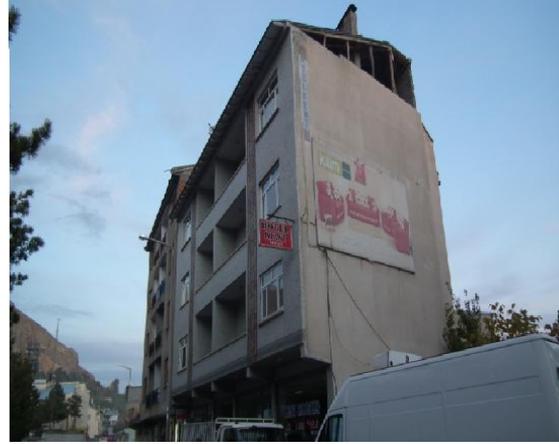
**Fig.16.** Damaged gable wall

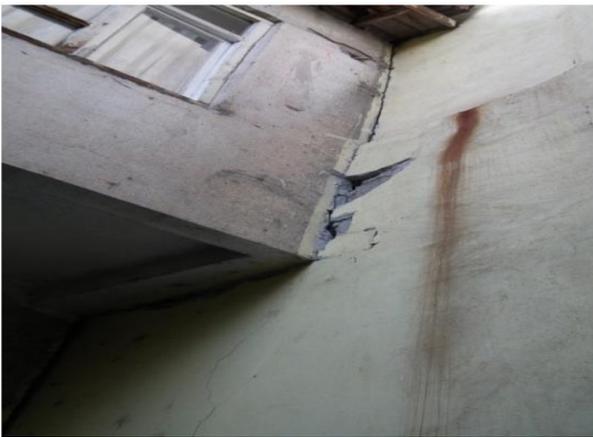
The problem of pounding is unavoidable in many large cities located in seismically active regions where, due to land usage requirements, buildings are constructed adjacent to each other. The buildings which are adjacent to each other carry a high risk because of different periods because of their different heights and weights of buildings due to the principle of conservation of energy as seen as in past earthquakes (Bal, 2005; Bal et al 2007). Pounding damage in two adjacent buildings in Adilcevaz district is given in Fig.17.

**Fig.17.** Pounding of two adjacent buildings

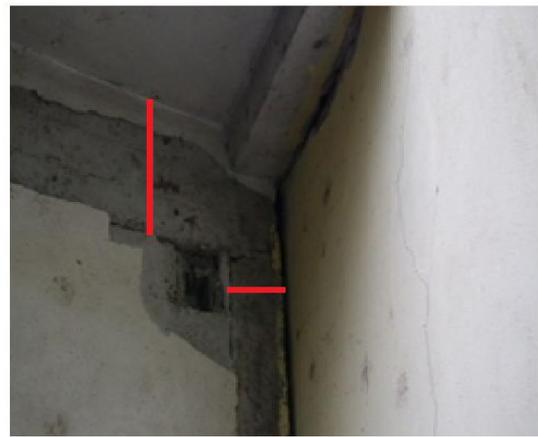
In earthquake-resisting structure design, one of the important point is to avoid the strong beam-weak column behaviour. The main purpose of this approach is to enable the weak element, that is, beams, to lose their bearing capacity initially and contrary to enable the columns to stand for a while to provide living space for people. To achieve this behaviour, Turkish Earthquake Code section 3.3.5 requires the sum of bearing capacity moments of columns should be at least 20 % more than the sum of bearing capacity moments of beams at the same joint for structures which resist the earthquake effects by frames or frame-wall combination (Celebi et al, 2013). The damage was observed because of strong beam and weak column type (Fig.18).

**Fig. 18.** Strong beam-weak column

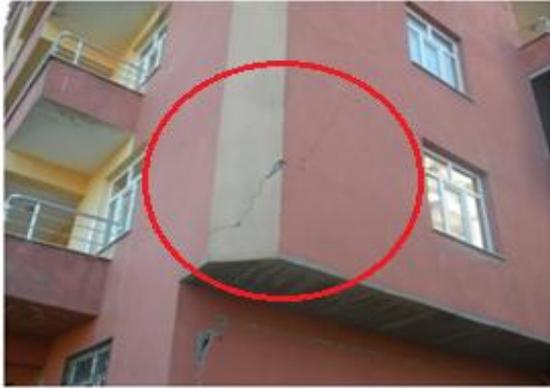
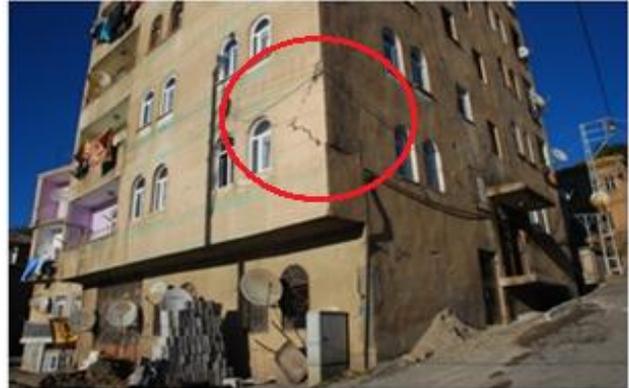
Large and heavy overhangs that built over the reinforced-concrete frame systems created irregularities in the multi-story buildings under the seismic loads. Damages related to the existence of large and heavy overhangs are given in Fig. 19.

**Fig. 19.** Damages on the large and heavy overhangs

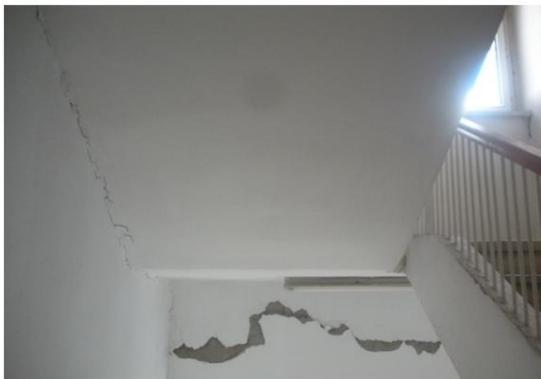
The staircase system damage is also a kind of damage under earthquake structural system. Damage observed in staircase system is due to insufficient connection between staircase and structural frame system (Fig.20). Fig. 21 is shows how to prevent the damage on the wooden beam by supported wooden log.

**Fig.20.** Staircase system damage

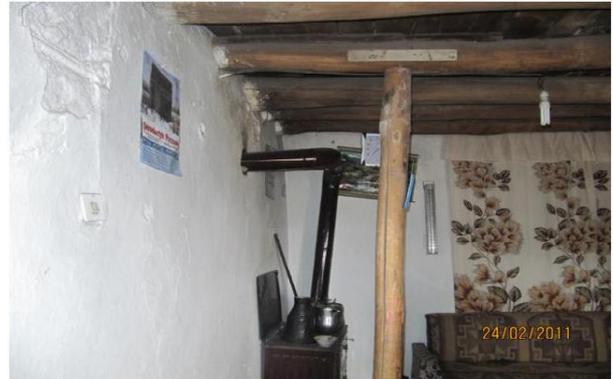
**Fig.21.** Wooden beam damage

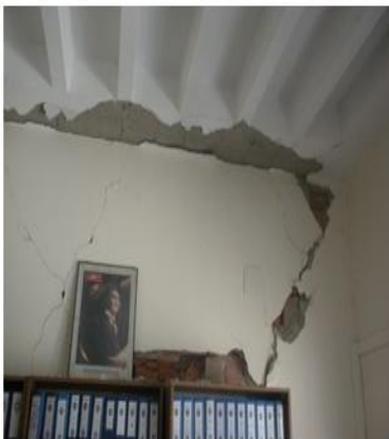
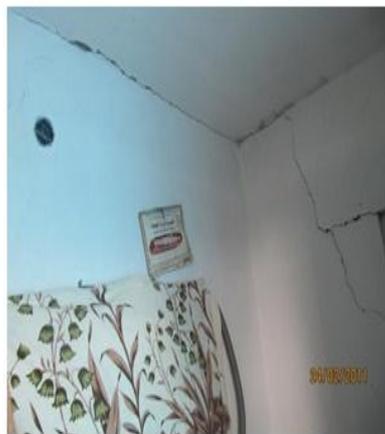
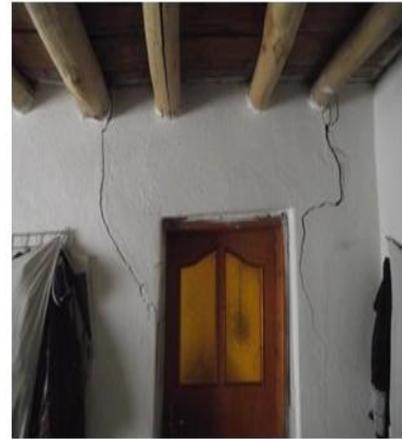
Separation damages between wall and frame system and structural wall damages caused by door or windows openings were observed in masonry and RC buildings commonly in Bitlis also (Fig.22.).

**Fig. 22.** Wall damages in masonry and RC buildings

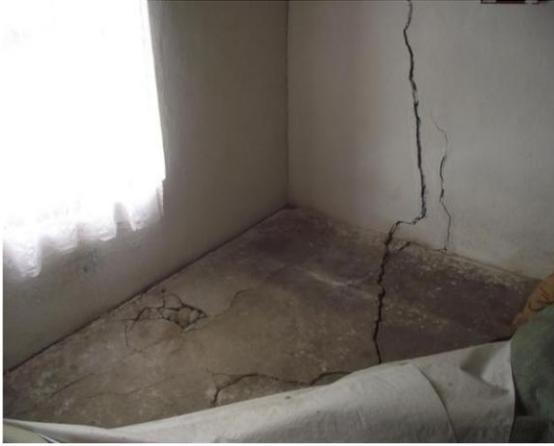
Wall's damages could be continued to the floor. Damage was observed on the floor in the ground story related to the wall damage in masonry structures (Fig. 23). Insufficient longitudinal reinforcing bars and insufficient adherence between concrete and reinforcement caused to damage in RC beams (Fig. 24).

**Fig.23.** Floor and wall damage in ground story

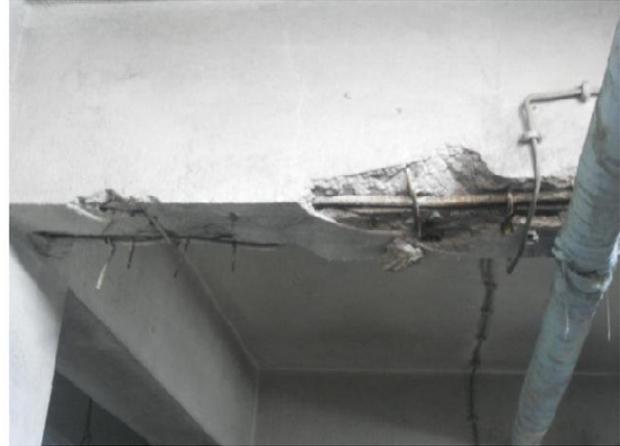
**Fig.24.** Beam damage

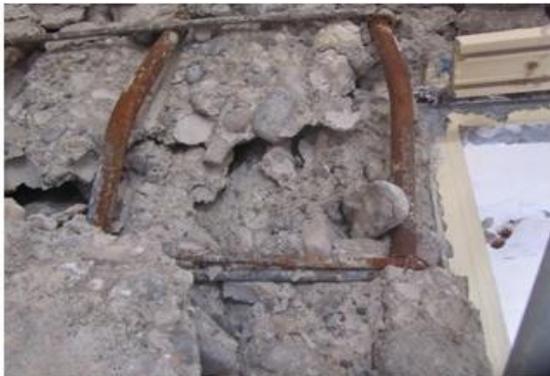
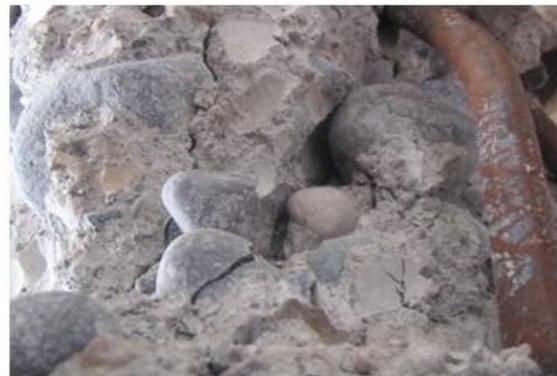
The quality of concrete that used in the region was very poor. It is observed that the aggregate gradation that used in damaged RC buildings did not provide a particle size distribution. In the damaged buildings, excessive large pieces of stones were observed. The other reason of concrete damage is insufficient thickness of concrete cover that used in structural system elements. Insufficient thickness of concrete caused to corrosion of reinforcement. It is observed from field observations that some of the concretes are easily broken into small pieces by hand (Fig.25). In the Turkish Earthquake Code, it is clearly expressed in section 3.2.5 of that the minimum characteristic strength of concrete must be at least 20 MPa for reinforced concrete structures to be built in earthquake active zones (TEC 2007). This value must be at least 14 MPa in the code that used till 1975 and 16 MPa in the code that used till 1998. The concrete samples were taken from

RC buildings during and after earthquake did not provide any conditions in any Codes that given above. For example the characteristic strength of concrete that used in Adilcevaz High School varied with the average value of 7.6 MPa (Comlekcioglu, 2011). This value is 5.55 MPa for apartment of Central Court (Uzun, 2011). This showed that the characteristic strength of concrete is well below that values that given in all National Codes.

**Fig.25.** Examples of poor concrete quality

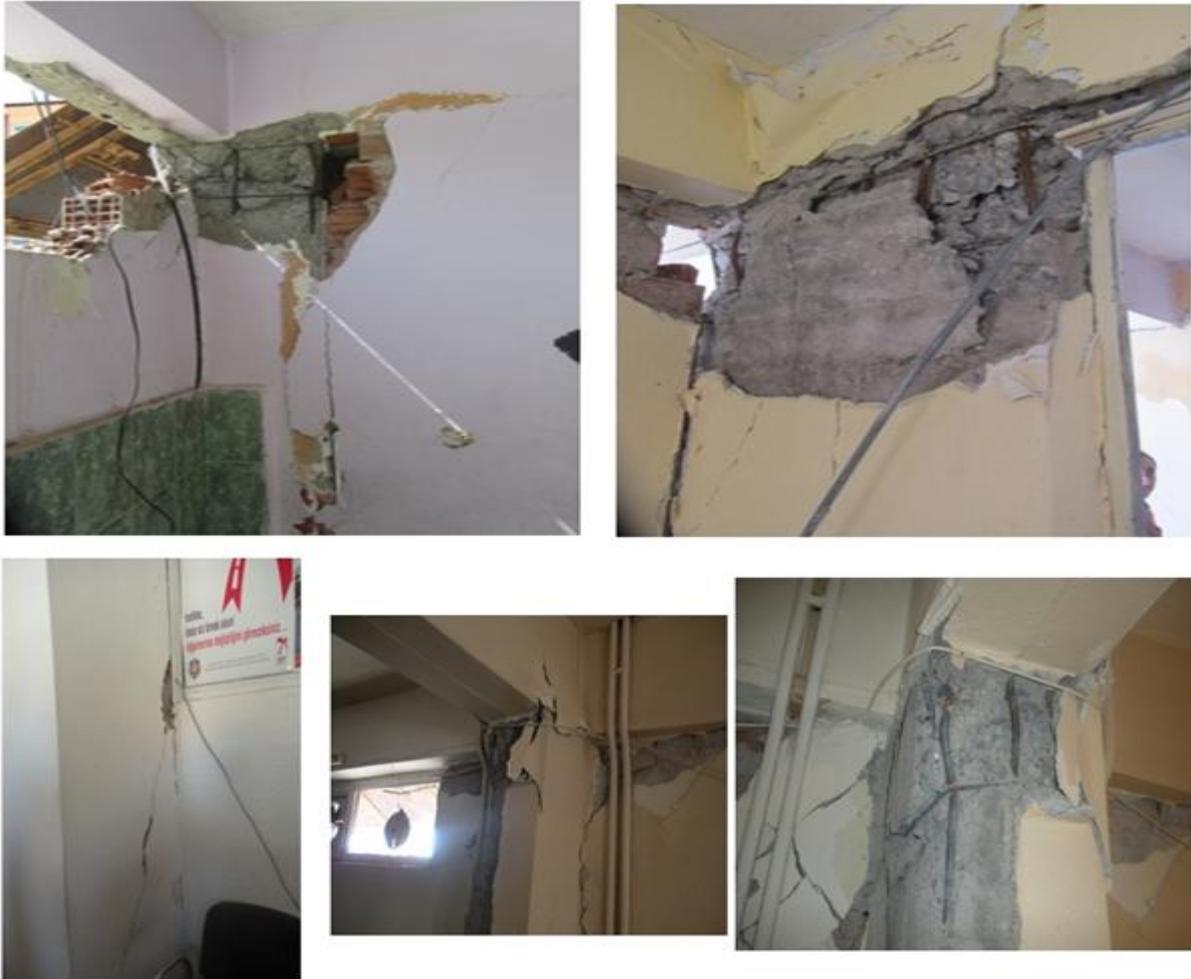
Frame damages are observed in columns more than the other elements of frame system in RC buildings because of columns were built weaker than beams or result of high load bearing then designated load of beam by behaving beam and floor together. Not insufficient shear force bearing capacity of column but also insufficient adherence between concrete and reinforcement was caused to increase damage amount in columns (Bayulke, 1995). Damaged columns showed that reinforcements that were used in structural systems elements are not provided principles of regulatory of reinforcement that given in National Codes. Especially wide spacing of the cross-ties related to buckling of longitudinal reinforcement. The concrete that was in the core region was diffused because of this buckling. Columns damages observed in Bitlis are given in Fig. 26.

**Fig.26.** Columns damages
