## Comparison of Structural Damages Observed in Kahramanmaraş Earthquakes with the Damage Types in The Regulations

It is reported that a significant number of buildings were damaged in two major earthquakes with a magnitude of  $M_w=7,7$  in Pazarcık, Kahramanmaraş, Turkey on 06.02.2023 and with a magnitude of  $M_w=7,6$  in Elbistan, Kahramanmaraş, Turkey on the same day. It has been stated that the effects of the earthquakes were felt in 10 provinces (Kahramanmaraş, Hatay, Gaziantep, Diyarbakır, Şanlıurfa, Elazığ, Malatya, Adana, Osmaniye and Kilis), and there were many casualties in these 10 provinces where more than 20,000 buildings collapsed. It is reported that in the earthquakes that took place on 06.02.2023, structures built according to the 2018 Earthquake Regulation rules in force for Turkey also suffered significant damage and even collapsed. Although the current investigations are focused on buildings, bridges, prefabricated structures, water structures that provide transportation in this earthquake should also be examined and reported. Based on the rough observations made, many structures were knocked down without any damage due to soil liquefaction due to the ground

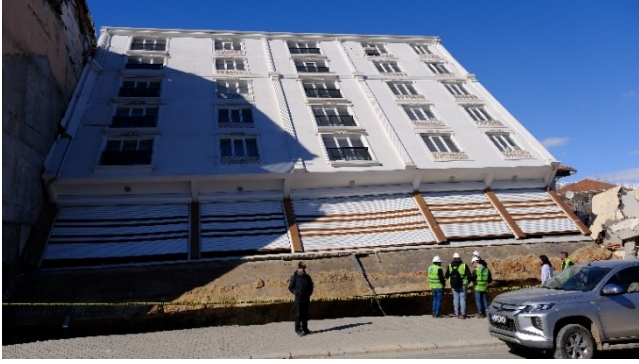
We did not look at the number of floors of the buildings. We mostly looked at how buildings collapsed and their durability. As seen in Figure 1, there was no need for structural examination of the buildings that were tilted due to liquefied soil. because there was no structural break or collapse other than

**Figure 1.** A building that collapsed due to soil liquefaction but remained intact based on its elements.

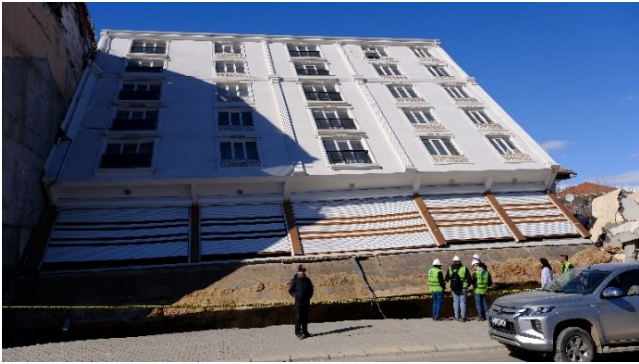
the collapse and overthrow of the structure (Figure 2).

**Figure 2.** A building that moves vertically due to soil liquefaction - sand boiling but remains intact with its elements.

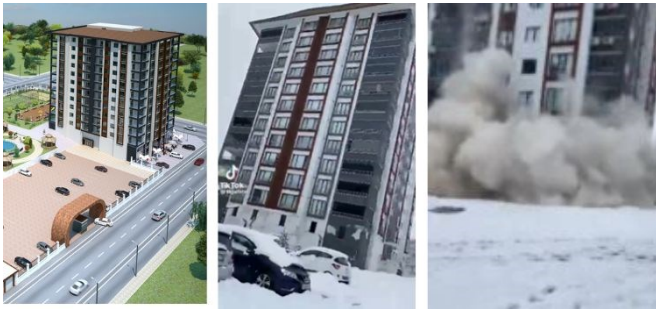
**Figure 3.** The building built in 2022 in Malatya's Bostanbaşı Neighborhood.

Figure 3 The structure, which was built in 2022 in Malatya's Bostanbaşı Neighborhood, but collapsed due to the soft floor in two major earthquakes of 7.7 and 7.6 magnitudes that occurred in Kahramanmaraş on February 6, 2023. It is seen that the lower part of the collapsed structure in Malatya, which is widely seen on social media, has collapsed. However, the top of the building remains obliquely standing on a pile of dust and rubble. This structure was built last year, and advertisements seen on social media say that the building was "built under the latest

earthquake regulations". All materials and workmanship were claimed to be of "first-class quality". The fact that the building is newly constructed requires that it be constructed under the 2018 earthquake regulations. In this regulation, it is stated that high-quality concrete reinforced with steel reinforcements should be used in buildings in areas with earthquake risk.

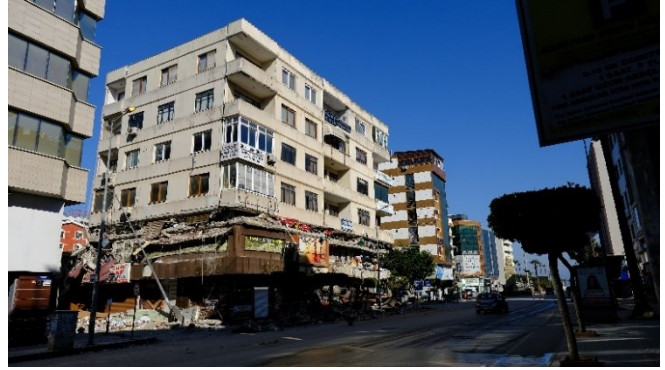
**Figure 4.** A soft floor incident that occurred in the city center of Iskenderun

In Figure 4. soft floor incident that occurred in the city center of Iskenderun. It is envisaged that the columns and beams will be effectively distributed and arranged with shear concrete in both directions to meet the horizontal loads to meet the impact of the earthquake. However, we do not have information about the materials and workmanship that determine the construction standards used in this building.

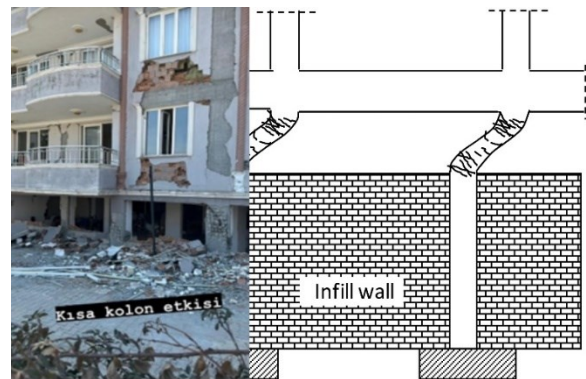
Illustrated figure 4, since the ground floors are raised more than necessary to sell them at a better price, band windows should be opened in the curtains of the basements surrounded by curtains to provide adequate illumination of the basement. As a result of examining the building photographs above, it was seen that the basement floor was surrounded by curtains and windows were opened from these curtains. It was understood that due to the opening of these windows, a short column effect occurred, and the building collapsed. Figure 5. Despite the warnings made two years ago in Malatya, the building where the columns were cut for the market collapsed in the earthquake.

**Figure 5.** Despite the warnings made two years ago in Malatya, the building where the columns were cut for the market collapsed in the earthquake.

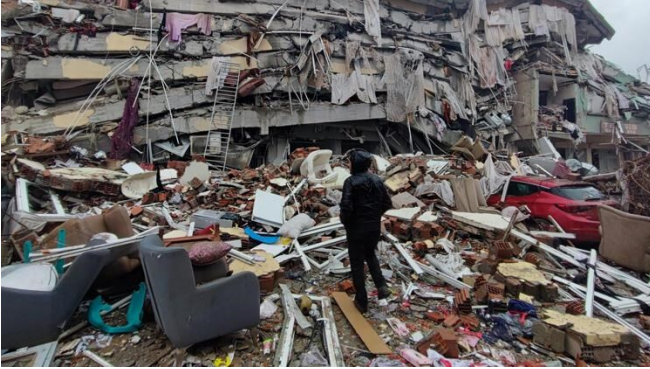
If the beams are stronger than the columns, the beams are solid, like a layered sandwich, but there is no sign of the columns. Figure 6. A collapsed building in the Malatya Özalper Neighborhood collapsed due to a weak column-strong beam.

**Figure 6.** A collapsed building in the Malatya Özalper Neighborhood collapsed due to a weak column-strong beam.

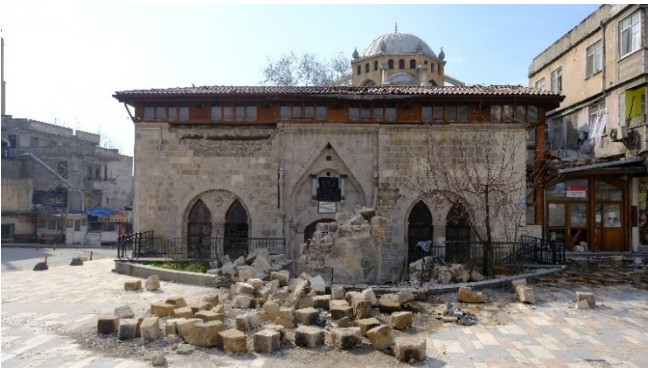
**Figure 7.** The Historical Arasa Mosque in the Kahramanmaraş earthquakes

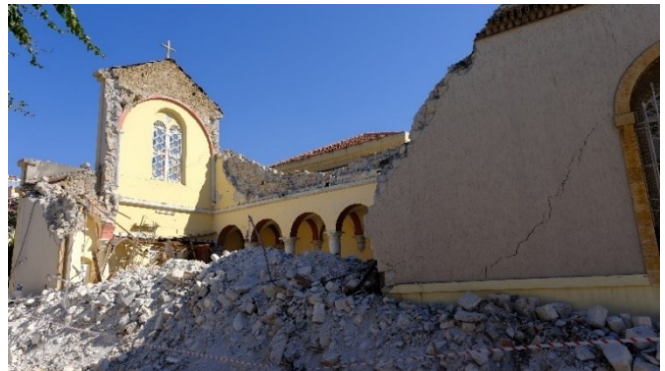
**Figure 8.** The Historical Church of Saints Peter and Paul, Hatay-Antakya

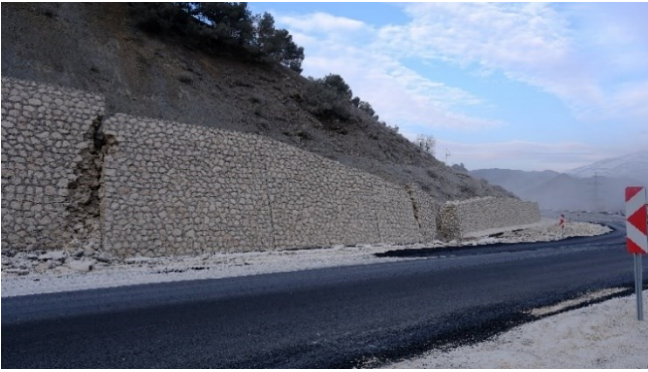
The main load-bearing elements of masonry structures are walls obtained using different materials. These walls, which are used both to carry loads and to separate spaces, can be thick because they generally have low-strength properties. Masonry structures commonly found in rural areas are sensitive to earthquake effects and can receive damage at different levels. These masonry structures, which were generally built without any engineering services, suffered serious damage due to the impact of the Kahramanmaraş earthquake couple that occurred on February 6, 2023.

**Figure 9.** Examples of damage to the structural stone walls

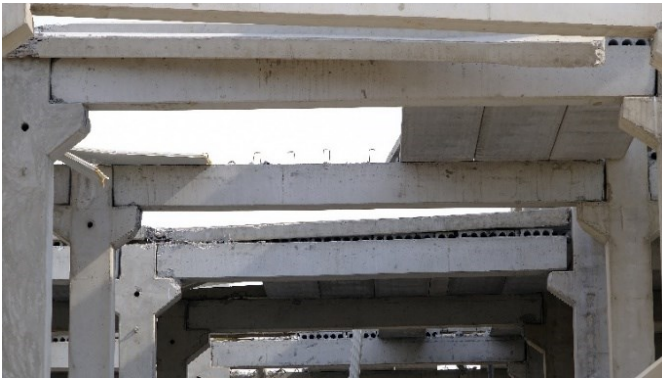
**Figure 10.** Damage occurring at the connection points of the prefabricated structure

During this earthquake, field observations were made on precast structures in industrial zones, grain warehouses, farms and textile workshops, and the damage to these structures was examined. The most common type of damage is the horizontal beams sitting on the column falling apart from their connection points. In buildings where solar energy panels are widely used on roofs, disintegration has occurred in the elements of the buildings due to damage to the structure during the installation of the panels and the use of non-standard aggregate (flat aggregate). Due to the additional loads of these panels, they overloaded the roof trusses and caused them to topple sideways. Floor damage occurred due to the prefabricated concrete structure with weak columns and heavy roof beams. Another common situation is that purlins that are not sufficiently connected to the beams as third members are stripped.

The structures designed as a displacement-based design method could not meet the horizontal displacement and rotation demands because sufficient displacement and rotation distances were not given at the element joints. The necessary pin

connections were not made at the joints. Due to the lack of cement mortar at the connection points of the floors and purlins to the beams, the floors did not work as a diaphragm structure. Some buildings with mezzanine floors appear as design errors. Mezzanines and other floors of the building are exposed to different piping effects.

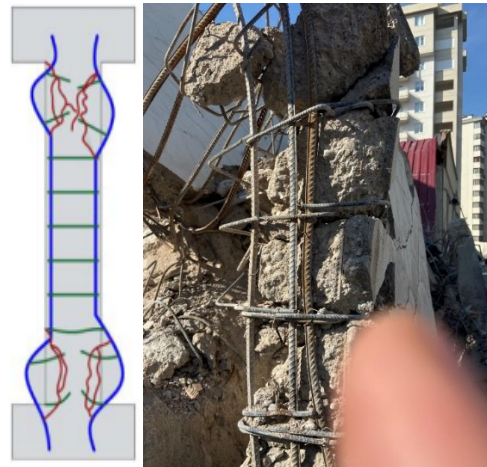
To prevent brittle fractures, the reinforcement must be wrapped in detail and its connections must be made well. Therefore, pre-stressed structures have been recommended recently. Therefore, the structures strengthened using coiled material survived the earthquake normally. However, even though this event can't occur during construction, this situation can be overcome by using sufficient equipment and proper workmanship. Figure 11. Insufficient Shear Reinforcement Detail.

**Figure 11.** Insufficient Shear reinforcement detail.

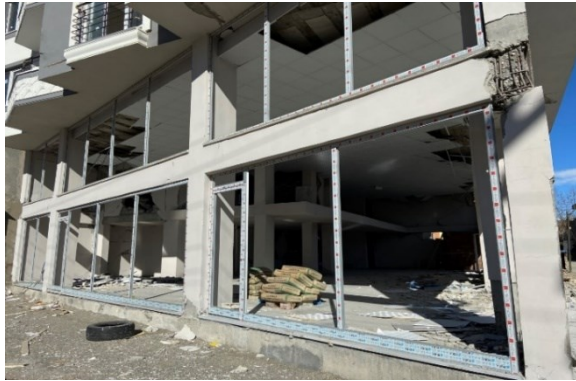
A typical column beam combination is given in Figure 4. in other words, throat stirrups are shown. The application of this column beam area requires expertise in terms of mastery and workmanship. If this part is not processed carefully and by an

expert, the iron hooks will not be tied well. For this reason, these parts are the first places of destruction to occur in structures with defective connections [12].

**Figure 12.** Column beam connection detail.

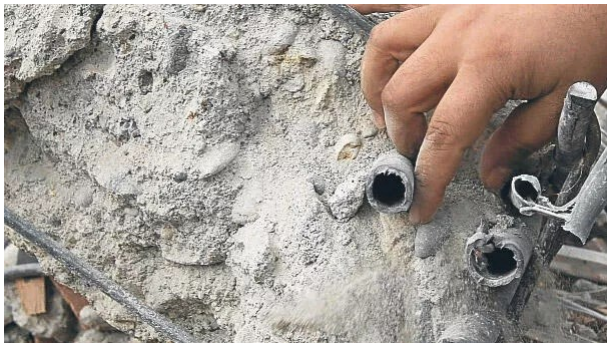
The common view in field investigations after the earthquake is that the damage occurring in the column-beam junction areas is due to low-quality concrete, unskilled workmanship, incomplete engineering service, segregation in concrete, and accordingly the column-beam junction. In Figure 14. Shows manual crushing of concrete to indicate poor concrete quality.

**Figure 13.** Shows manual crushing of concrete to indicate poor concrete quality.

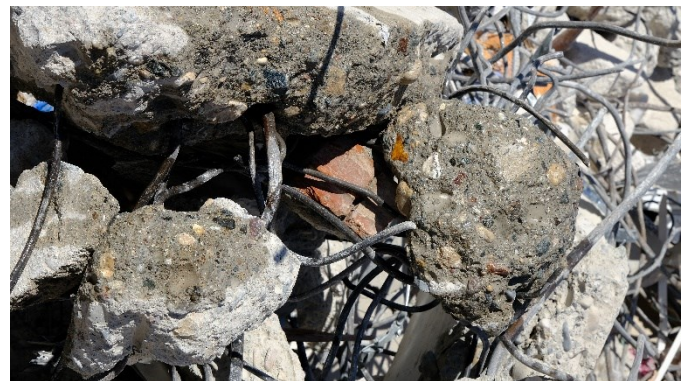
Contrarily, plain reinforcement was used instead of ribbed reinforcement with high interlocking with concrete (Figure 5). In non-collapsed buildings, total collapse did not occur because the infill walls increased structural rigidity and in non-collapsed buildings, the infill walls increased the building performance. However, since such structures are brittle, there is a high probability of collapse [14].

**Figure 15.** Column beam connection detail for low iron and concrete.

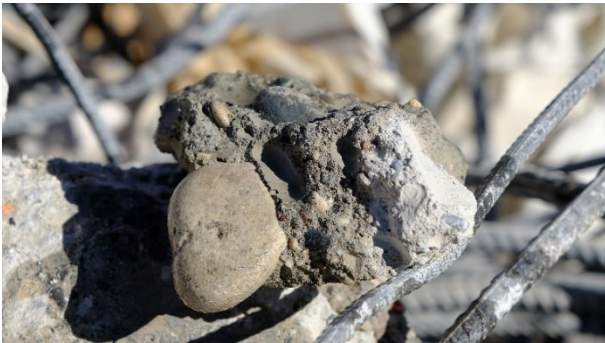
**Figure 16.** Aggregate that is not suitable in size and shape.

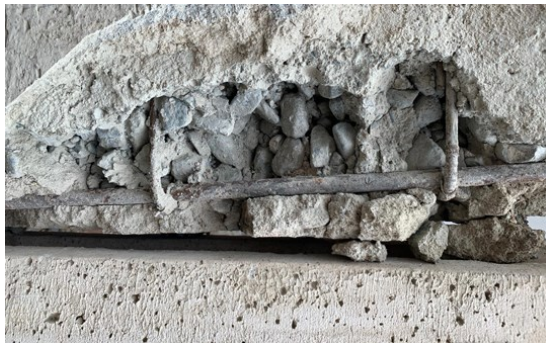
Among the most common defects seen in the field is segregation, which significantly determines the strength of concrete. Figure 17- 18. It is seen that the concrete was placed with segregation and without a vibrator. The investigations have shown that, especially in narrow and deep molded structures, concrete begins to collapse due to excessive segregation and corrosion occurs due to voids. Crusting and corrosion have occurred due to excessive water intake in the unwashed parts of the concrete poured without considering the water permeability of the concrete or without using a compaction machine. It was observed that in a few columns, pressure buckling occurred due to insufficient pressure zone formed due to aggregation and insufficient wrapping.

**Figure 17.** It is seen that the concrete was placed with segregation and without a vibrator.

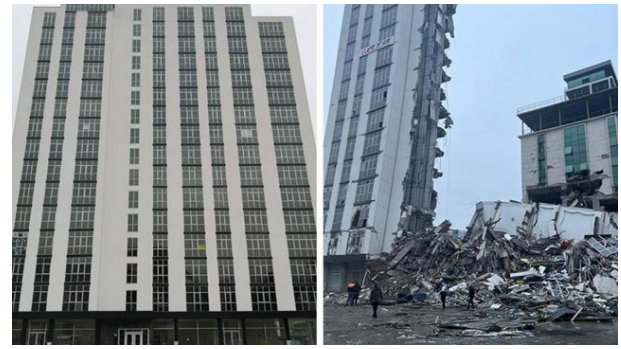
**Figure 18.** We conclude that the structure, completed in 2019, should be built to the latest standards.

The possible collapse of this structure is seen as ground conditions. The number of buildings destroyed in these ten provinces should not be surprising. Current construction regulations ensure that structures can withstand earthquakes of this magnitude. However, the collapse of even the buildings built according to the new earthquake regulations brought up the problems related to building safety standards in the country.

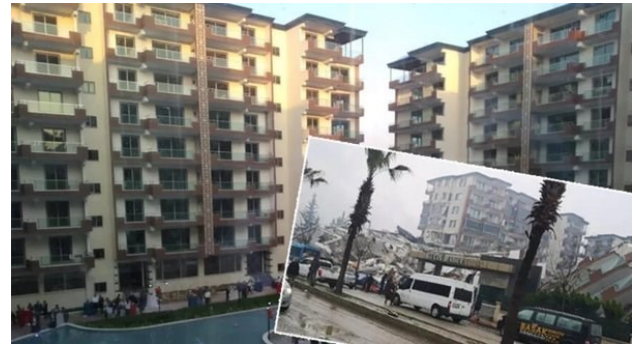
**Figure 19.** A nine-storey building in Antakya

Another structure, a nine-story building in Antakya, seems to have collapsed. We know that the construction was finished in November 2019. Of the 10 blocks built together, only two are demolished. After so many buildings collapsed in the earthquake-affected area, scientists and researchers began to question building regulations. Although earthquakes are severe, experts, scientists and researchers need properly constructed buildings to survive. Illustrated Figure 20. Kahraman Maraş onikişubat haydar bey mah. The building collapsed due to column cutting.

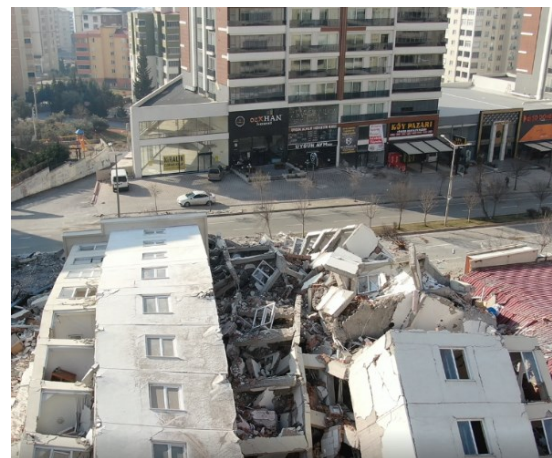
**Figure 20.** Kahraman Maraş onikişubat haydar bey mah. The building collapsed due to column cutting.
