## COLLAPSE OF BASE SOIL AND ITS CONSEQUENCES DURING A CEMENT PLANT CONSTRUCTION

**ABSTRACT:** Collapsible soils are subjected to rapid changes in their volume when inundated with water. Collapse of such a soil deposit during construction of a cement plant in north Azerbaijan resulted in significant settlement and tilting of structures causing a 2 years delay in the construction. The investor had to bear the huge costs of delay and remediation works. The collapse susceptibility of the soil could not be identified during initial site investigations. After first indications of the collapse problem (tilting, cracking of structures) the settlements were measured at different locations for a long time and a new site investigation was executed. The results of these studies were utilized to determine the collapse potential of the soil. Interestingly, some of the indirect methods were not capable of determining the collapse potential. It was seen that, indirect methods may mislead the engineers in such soils and it is more reliable to perform direct tests to determine collapse potential in similar soil deposits. In this study, it is aimed to discuss the experience gained in this project a

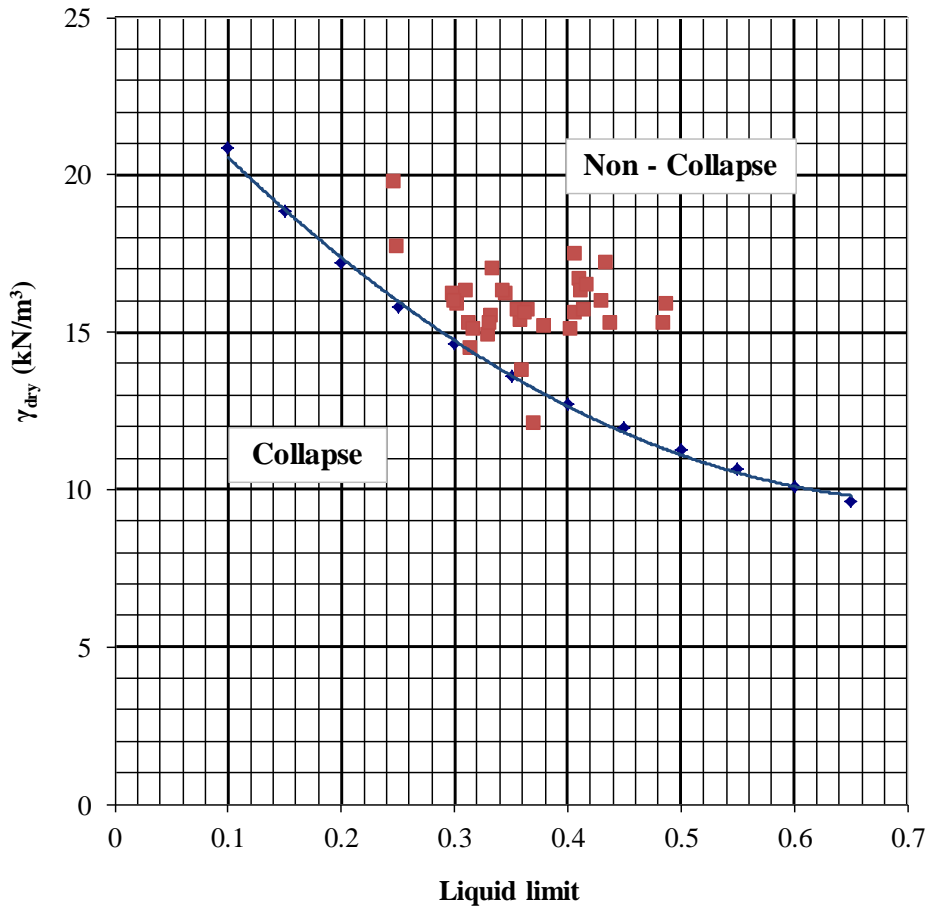
According to the site observations, the soil which was evaluated as a loose soil deposit according to the SPT test results was seen to be stiff enough and cemented in dry condition. The method suggested by Das (2015) was used initially to evaluate the collapse susceptibility of the soil based on the data obtained from the tested soil samples. In this method, a line representing the equation given in Eq.1 separates the collapsing and non-collapsing soils. The obtained dry unit weight and liquid limit is plotted on the graph for each sample and if the point is above the line, the sample is classified as non-collapsible while it is classified as collapsible if it falls below this line. When dry unit weight was plotted against the liquid limit for the tested samples, only two out of thirty samples were located on this line while only one sample fell below this line. All of the other points (90% of the tested samples) fell to the non-collapsing region (Fig.4). Also, many other methods suitable to be utilized with the available data, to estimate the collapse potential (CP) of the soil have been investigated. The soil was evaluated as collapsible by some of the methods while other methods were classifying the soil as non-collapsible or in the transition zone. Only the method suggested by Ayadat and Hanna (2007) indicated the collapse potential clearly. All of these evaluations are summarized in Table 2.

Figure 4. Collapse susceptibility of soil samples of the construction area (Das, 2015)

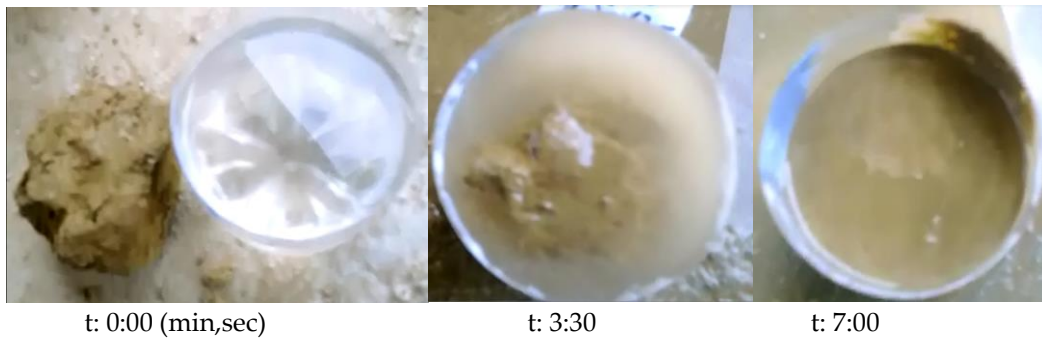
of the soil completely changes when it is subjected to water. As it can be seen in Fig.5, a stiff soil block starts to disintegrate rapidly when inundated with water and turns in to mud just in a few minutes. The complete disintegration of an approximately 10x10cm sample took around seven minutes during this observational experiment.

Figure 5. Change of soil state when subjected to water

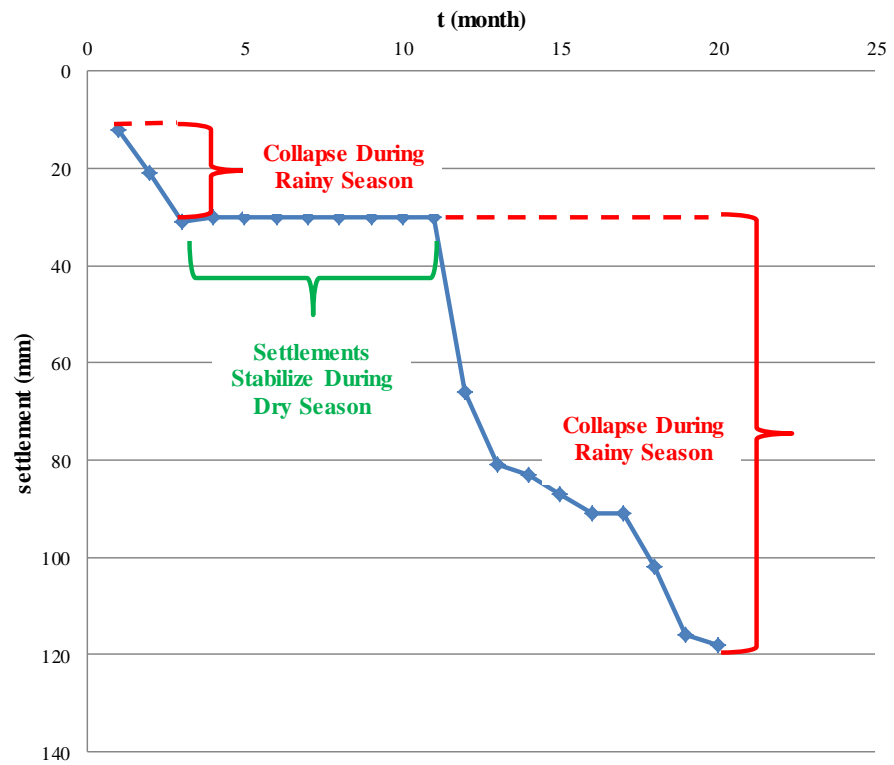
The collapse of the subsoil was most clearly observed under clinker silo. As it can be seen from settlement measurements under clinker silo (Fig.6), the rate of settlements increased during rainy seasons while they almost stabilized during dry seasons. The total collapse at this location was on the order of 120 mm which resulted in significant tilting of the structure (Fig.7).

Figure 6. Time-Settlement plot for clinker silo

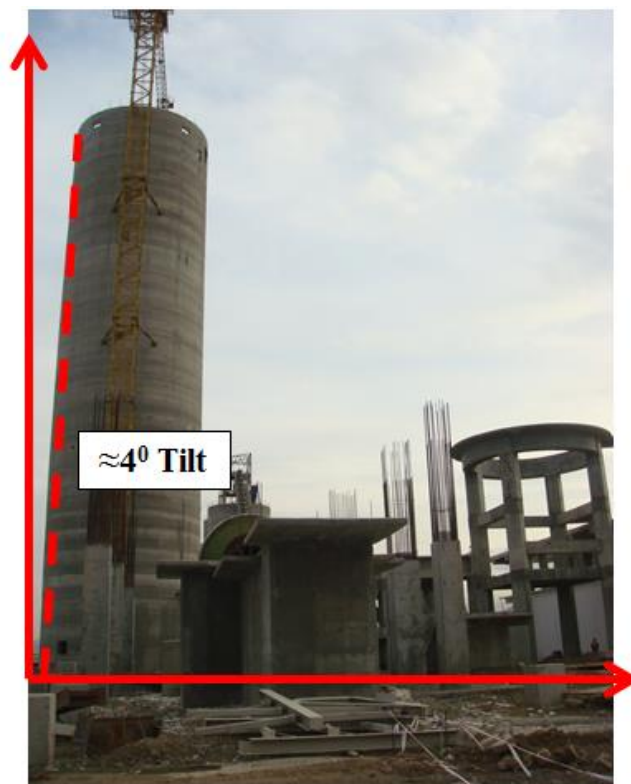
Figure 7. Tilting of clinker silo

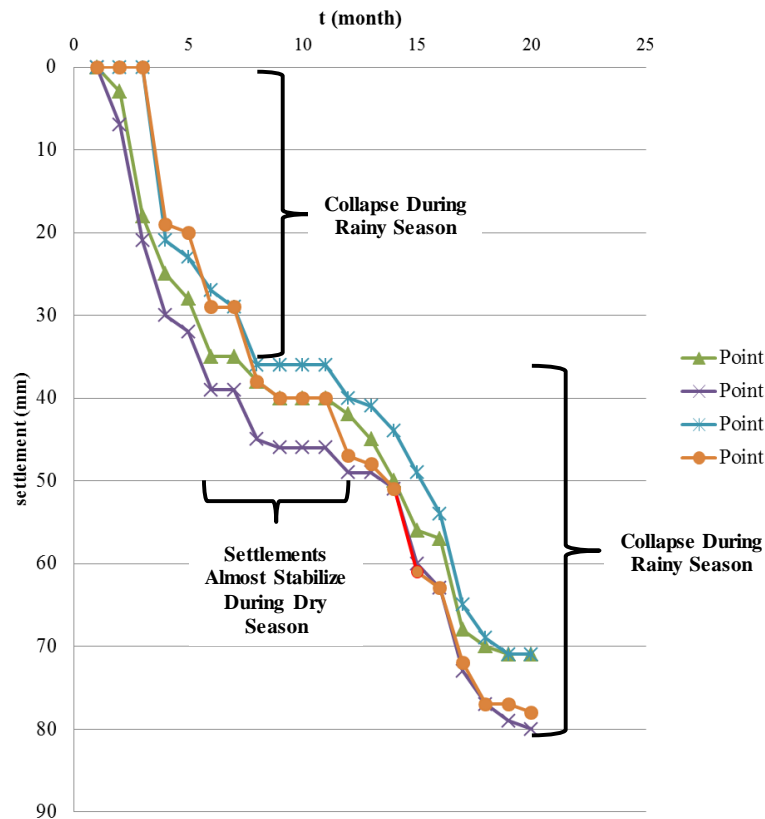
of the raw mill fan of the cement plant were measured at four corners and it was seen that the foundation had collapsed on the order of 80 mm (Fig. 8) which led to cracking of the foundation at different points (Fig. 9). Similar behavior and extensive settlements were measured at almost all important parts of the cement plant construction. The construction had been stopped for almost 2 years during which extensive site investigations were executed. The cost of underestimating the collapse probability of the base soil was tremendous since the opening of the plant was delayed for 2 years and some of the constructed facilities had to be demolished and reconstructed after soil improvement. Also 1400 piles constructed at the beginning of the project were completely sunk in to the soil and could not be used to support the structures any more resulting in another significant financial loss.

Figure 8. Settlement measurement beneath raw mill fan foundation

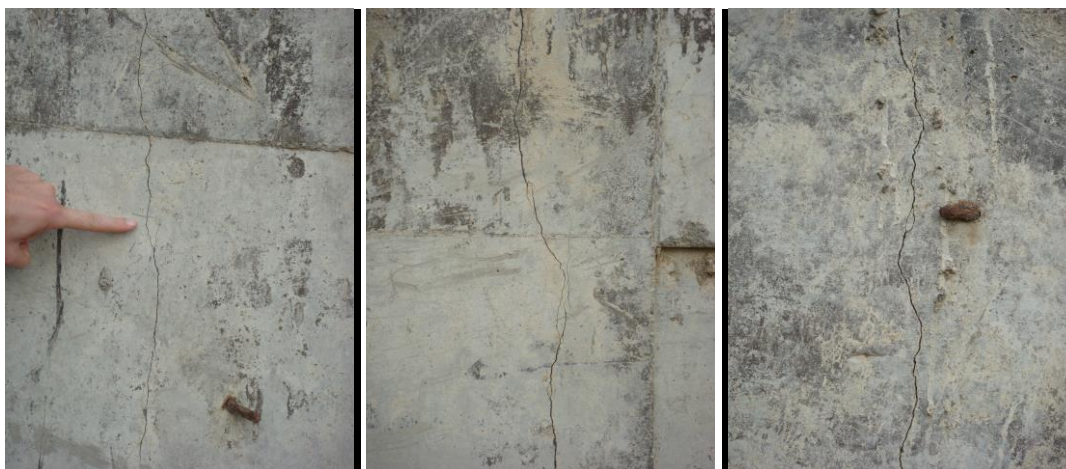
The reinforced concrete foundations were cracked due to collapse of base soil even before the construction of the structures which they were planned to carry. The settlements beneath the foundation

Figure 9. Concrete cracking in foundations due to collapse settlements
