Geotechnical Investigation for A Damaged Light Building Erected on A Fill Material-Rich in Expansive Soil

Adil Ozdemir^{1*}, Ekrem Kalkan^{1,2,3}, Duygu Turhan¹

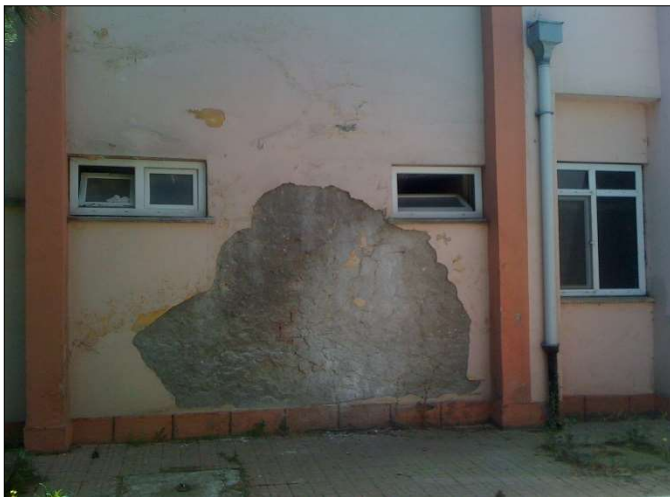
There is no damage to the walls or floors of the two-storey building. On the east side of the later single-storey annex building, there is significant plaster blistering, plaster flaking and plaster cracks on the exterior wall of the WC (Fig. 3).

Fig. 3. Plaster spills on the east side of the building

As a result of the investigations, it was understood that the plaster spills and blistering on the north and east sides of the building were not caused by the soil. The fact that the places where these damages are seen intensively are wet rooms such as WC, washbasin and shower indicate that these damages are caused by water leakages or leaks in the installations.

In addition, the fact that the building is an old building suggests that old type cast iron pipes were used in the plumbing. Old type cast iron pipes are oxidized over time and their cross-sections become thinner and a condition called “sweating” occurs. This idea is strengthened by the fact that the plaster blistering in the horizontal direction seen on the exterior of the building almost coincides with the level where the plumbing pipes pass. Lack of perimeter drainage around the building, rain gutters discharging directly into the foundation soil, and the presence of many trees around the building at frequent intervals are important factors that cause an increase in the water content of the soil and thus trigger swelling of the soil.

In order to prevent plaster blistering and flaking caused by defects in the plumbing system, it may be recommended to

renew the water pipes, and if cast iron pipes are used, these pipes should be replaced with PVC based water pipes that do not sweat.

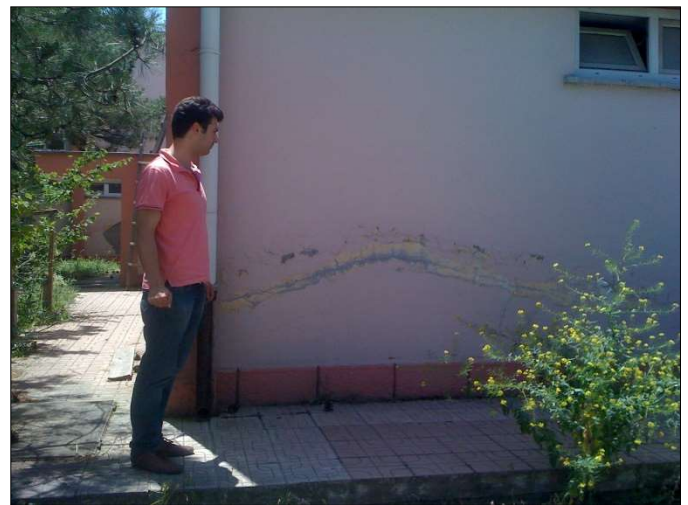
On the north side of the same building, there are similar plaster damages (blistering, flaking and cracking) on the exterior walls of wet rooms such as shower, washbasin and WC (Fig. 4).

Fig. 4. Stucco blistering on the north side of the building

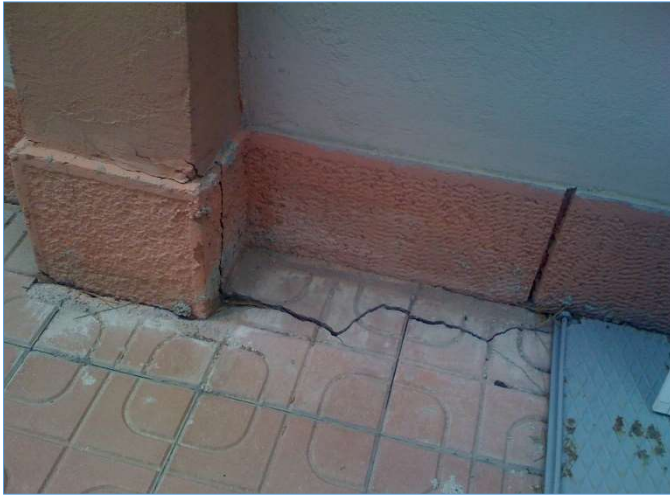
On the west and south sides of this building, there are large and small wall and floor cracks, especially on the exterior walls and floors of the spaces used as dining and recreation halls (Figs. 5 and 6). Since the cracks in the walls go beyond the plaster and penetrate into the wall, it is thought that the cracks in these sides are not simple plaster cracks but originate from the soil.

Fig. 5. Floor and wall cracks on the west side of the building

According to these results, it is understood that the swelling pressure of the ground is higher than the base pressure applied by the building to the ground. In this case, it is concluded that the cracks observed in the interior and exterior walls and floor slabs of the single-storey building are caused by the swelling of the ground. The absence of any

In order to prevent and/or mitigate damage to the structure caused by swelling of the soil, it may be recommended to (1) provide effective perimeter drainage down to below the foundation level, (2) discharge rain gutters into manholes, and (3) avoid excessive irrigation of lawns or trees around/near the building.

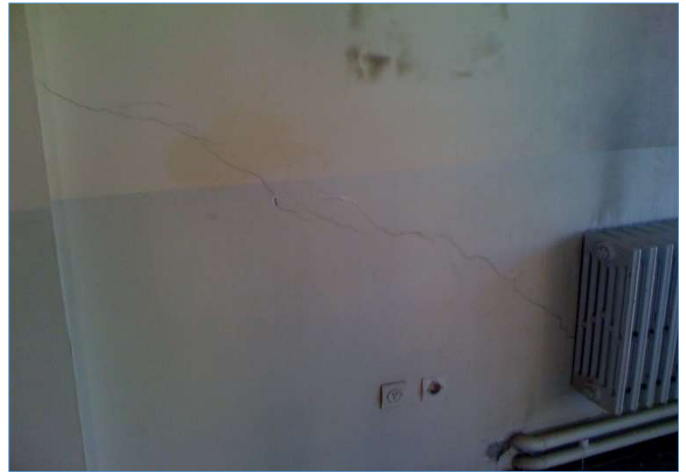
Fig. 6. Wall crack inside the building

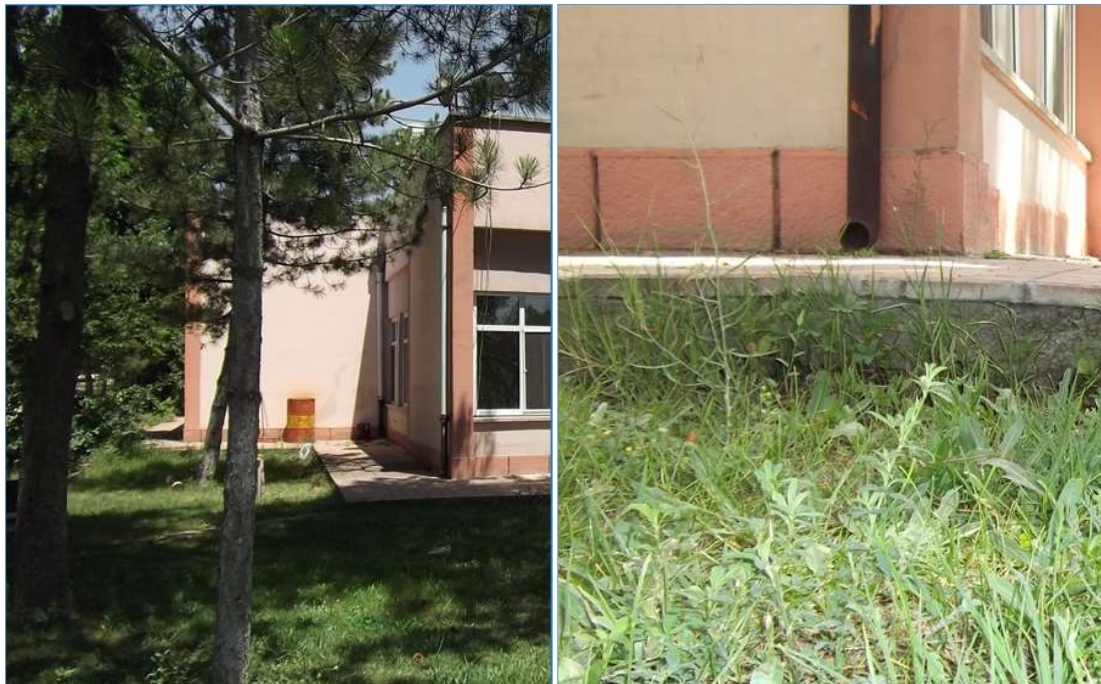
The vertical rain gutters used to collect and remove the rainwater accumulated on the roof of the building discharge the collected water directly onto the pavement and indirectly into the soil of the foundation (Fig. 7). There are also 28 trees on the west side of the building, approximately 2.5-3.0 m away from the wall, spaced 2.5-3.0 m apart and ranging in height from 3-4 m. There are also many trees on other sides.

Fig. 7. Photographs showing rain gutters discharging into the pavement

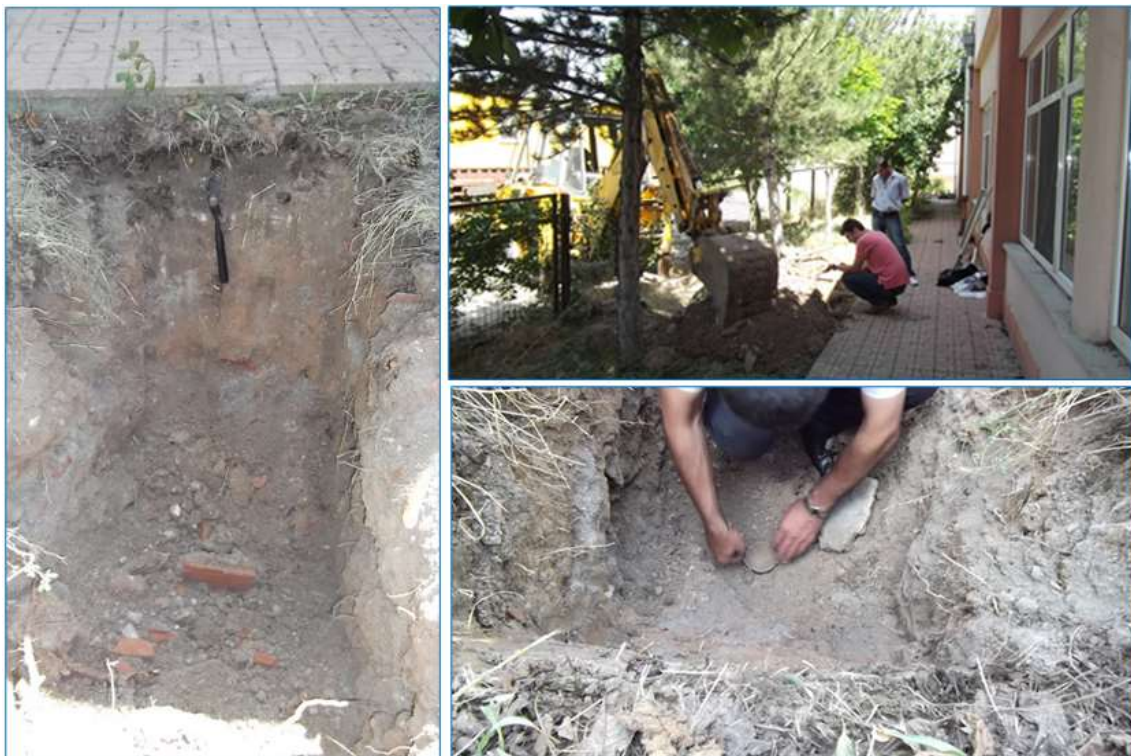
Trial pit-1 was excavated on the west side of the building, near the wall where the cracks were observed. In the first stage, after the pit was excavated to a depth of approximately 0.8 m, undisturbed samples were taken with cylindrical samplers. From the region where the undisturbed samples were taken, the disturbed samples were also taken and placed in nylon bags and labeled and preserved to be sent to the laboratory. After the sampling was completed, the pit was deepened to approximately 2.5 m in order to observe and log the soil profile with the naked eye. As a result of the observations, a light brown colored, very soft topsoil containing tree roots was observed between 0.00-0.30 m, and a sandy, gravelly, clayey, silty, medium solid to solid fill material containing large andesite blocks and brick fragments were observed between 0.30-2.50 m (Fig. 10).

Fig. 10. View of the fill material from Trial pit-1 and undisturbed sampling

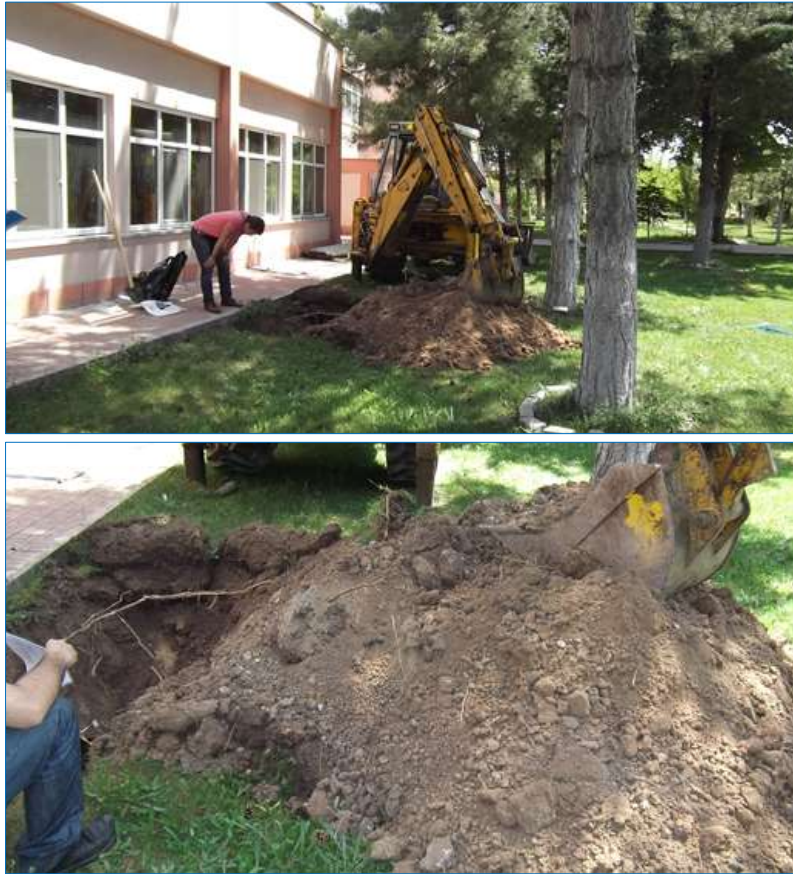
Fig. 11. Condition of the fill material from Trial pit-2

As a result of the observations, a light brown colored, very soft topsoil containing tree roots was observed between 0.00-0.30 m. Between 0.30-1.00 m, a silt and clay-dominated, medium-solid to solid fill material containing large concrete blocks was observed, and between 1.00-2.50 m, a brown-black colored, very solid clay-silt mixture was observed (Figs. 11 and 12).

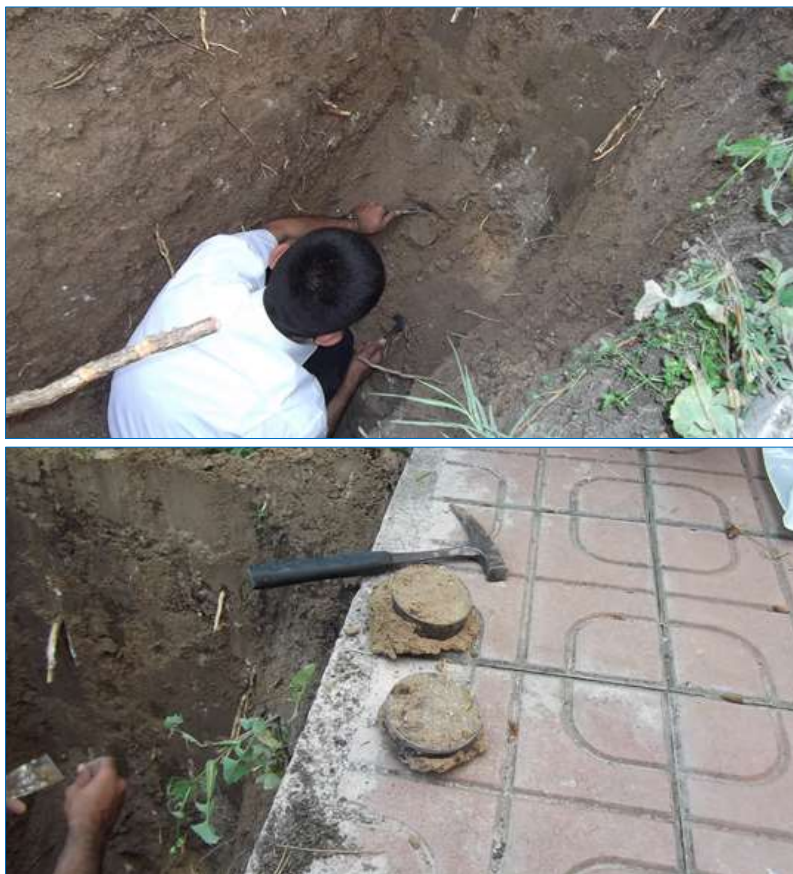
Fig. 12. Taking undisturbed samples from Trial pit-2

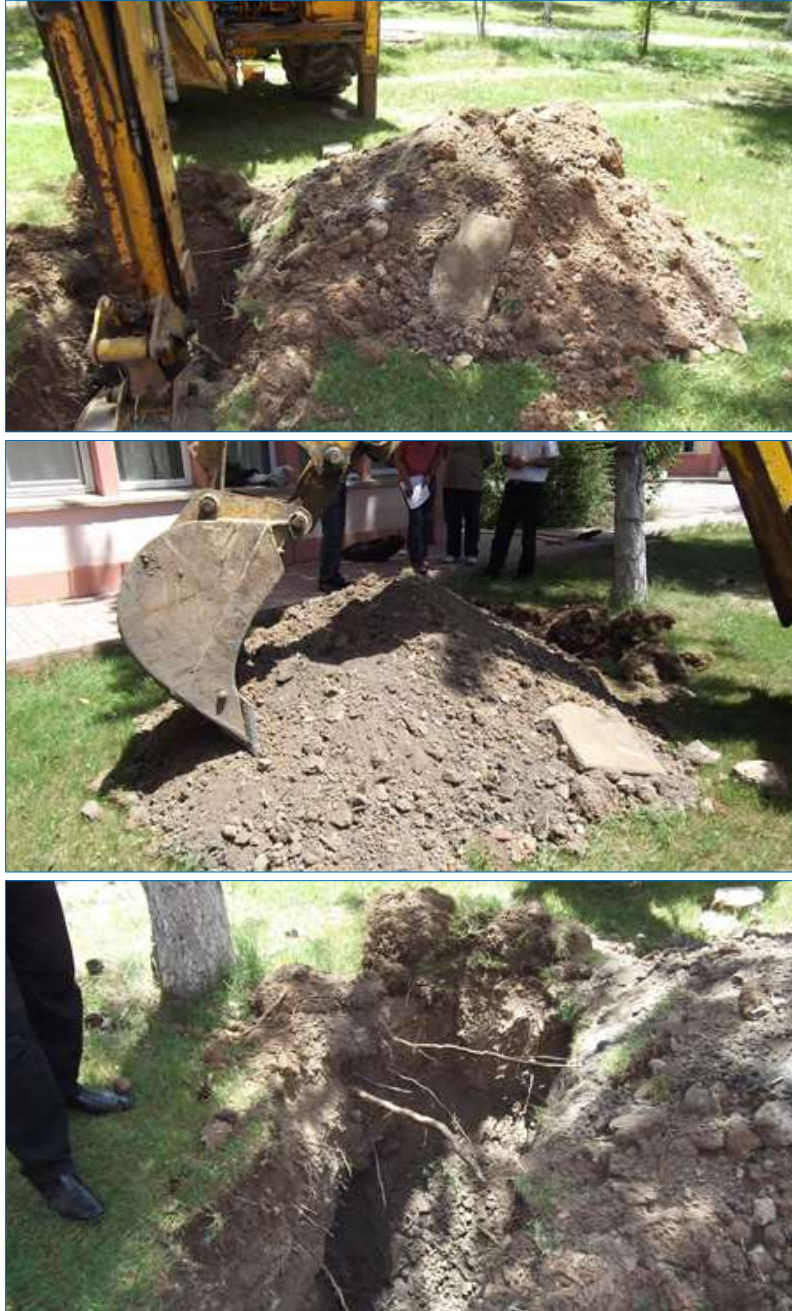
Between 0.30-1.00 m, a sandy, gravelly, sandy, gravelly, medium solid-solid fill material with little clay and little silt, containing very large concrete blocks, and between 1.00-2.50 m, a brown-black colored, very solid clay-silt mixture was observed (Fig. 13).

Fig. 13. Condition of the fill material from Trial pit-3

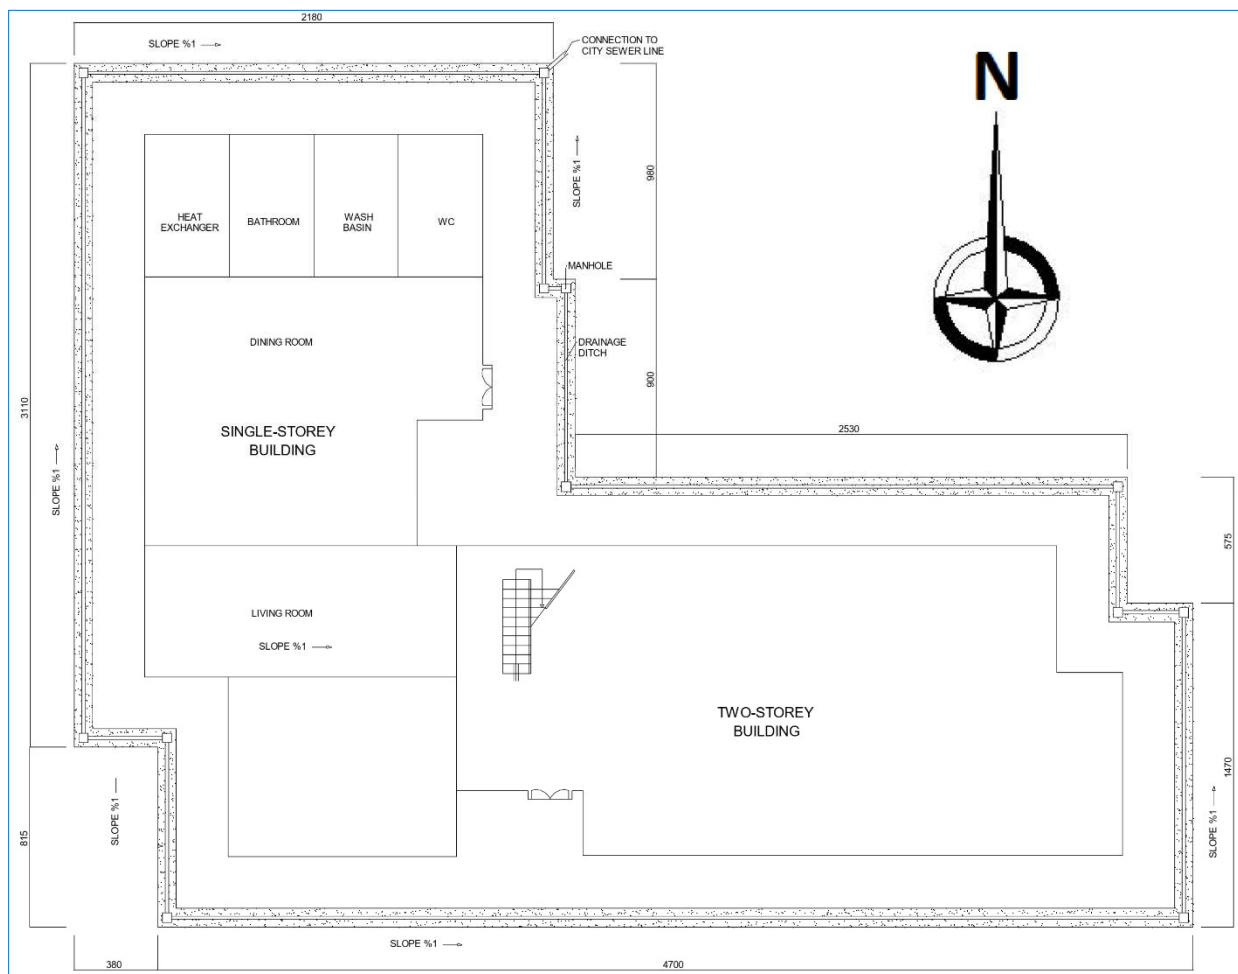
Fig. 17. Suggested perimeter drainage project (length of total drainage line: 180 m)

In order to prevent soil swelling, it is necessary to prevent or minimize the change in water content. Therefore, the measures that can be taken to prevent or minimize the swelling problem in the investigated building can be summarized as; (1) an effective perimeter drainage that goes down to below the foundation level (2) emptying rain gutters into manholes and (3) avoiding excessive irrigation for the purpose of watering the grass or trees around/near the building.

The depth of the perimeter drainage should be designed to be at least 30 cm lower than the foundation depth. However, since the exact foundation depth of the building is not known, it is thought that the depth of the drainage should be planned as 2.0 m (Figs. 17 and 18).

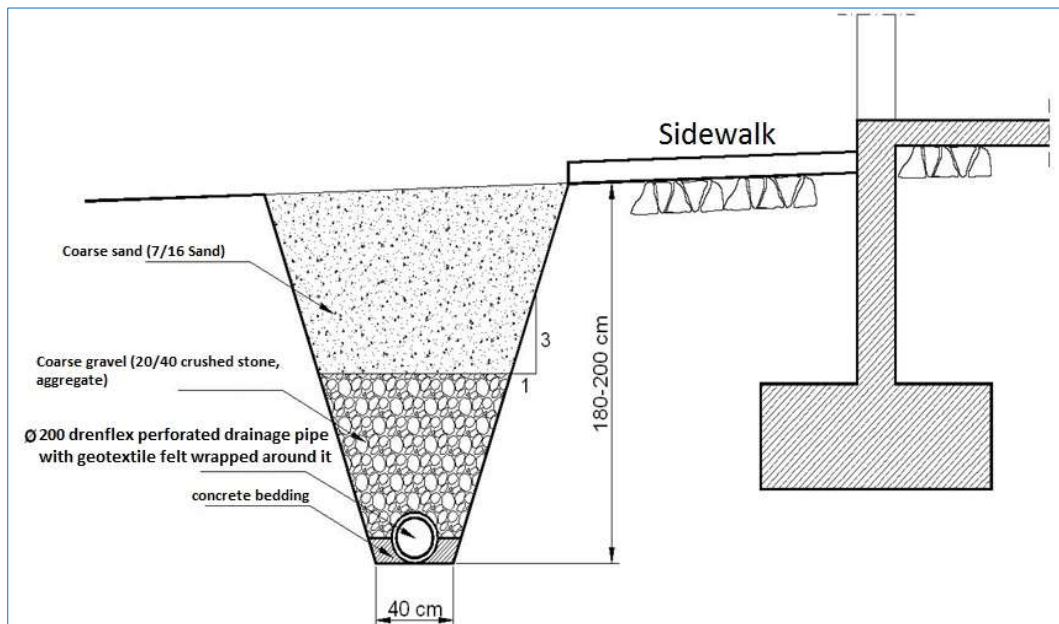
Fig. 18. Detail of the drainage trench (cross-sectional area of the trench is approximately 1.85 m²)
