Architectural Heritage After the February 6th Kahramanmaraş Earthquakes: Preliminary Observations on Historical Masonry Structures

6 Şubat Kahramanmaraş Depremleri Sonrası Mimari Miras: Tarihi Yiğma Yapılar Üzerine Ön Gözlemler

Sedef KOCAKAPLAN SEZGIN^{1*}

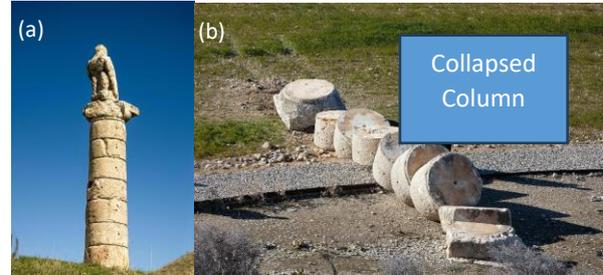
Figure 2. Karakuş Tumulus (a) Eagle column (ArkeolojiSanat, 2023) (b) collapsed column.

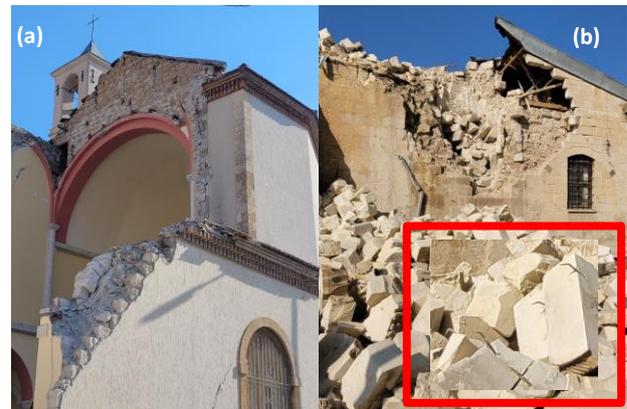
The construction materials that were used for the historical structures in the earthquake affected region mostly consist of rubble stone and cut stone. The substandard quality of both the stones and mortar, compounded by degradation over time, has led to poor seismic performance. An illustration of stone disintegration is evident in Figure 7a, representing the Latin Catholic Church of Iskenderun constructed around

The use of cut stones is another widely utilized construction method and material. The stones forming the cut stone wall are generally quarry stones. In the production of cut stone walls, just like alongside traditional structures, stones that are most abundant in their regions and naturally more economical were used in construction. The depth of the stones to be used is arranged to provide the wall thickness. The construction of cut stone walls can be with the use of mortar in between or without any joints. In the construction of jointless cut stone walls, the stones should be connected to each other using connectors of metal (iron or copper). Figure 7b demonstrates the failure of the minaret of the Şirvani Mosque in the city centre of Gaziantep, which was constructed using cut stone (Tayla, 2007). In addition to the slenderness of the minaret, the opened metal connectors in between the stones observed during the field reconnaissance.

Figure 7. (a) Rubble stone masonry disintegration due to poor quality of materials, (b) cut stone disintegration due to opened metal connector equipment in between.

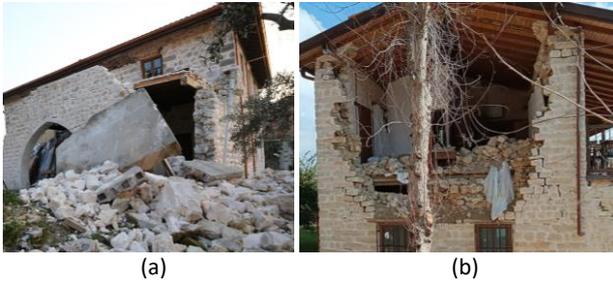
Unreinforced masonry (URM) refers to structures lacking reinforcement (mainly timber elements) or possessing insufficient reinforcement. Analyses conducted on the damage sustained by buildings in the aftermath of various earthquakes have exposed the seismic vulnerability inherent in URMs (Cetin et al. 2020, Oyguc and Oyguc 2017, Vlachakis et al. 2020, Karatas and Bayhan 2023, Nasery et al. 2024). URM buildings can be built with two- or three-leaf rubble stone masonry (Vlachakis et al. 2020). Figure 8a depicts the Church of Mary in Samandağ, Hatay, which suffered damage due to the absence of transversal interlocking stones, resulting in masonry delamination. It

is noteworthy that the Church of Mary sustained minor damage after the earthquakes on February 6th but experienced severe damage following the Samandağ aftershock on February 20, 2023, with a magnitude of 5.8.(Anadolu Ajansı, 2023).

Figure 8. Poor quality, multi-leaves stone masonry buildings (a) Church of Mary, Samandağ, Hatay (Anadolu Ajansı, 2023), (b) English Protestant School, Samandağ, Hatay (Haber Global, 2023).

Figure 8b illustrates another example of the damage to a two-leaf stone masonry building corresponding to English Protestant School in Samandağ, Hatay. An important detail in the construction of URM structures is the corners. Typically, corners are constructed using quoin

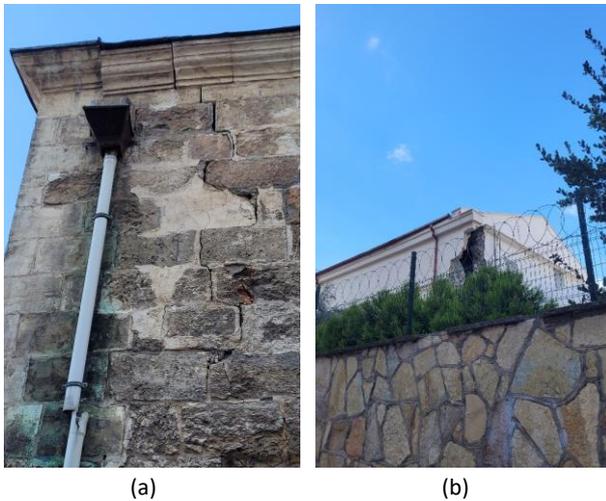
Figure 9. (a) Proper connection of quoin stones, Karagöz Mosque, Gaziantep. (b) Insufficient connection of quoin stones, St. Nicholas Orthodox Church of Iskenderun, Hatay.

stones, facilitating the connection of transversal walls, and mitigating the risk of local or global failures (Vlachakis et al. 2020). Figure 9a provides a tangible example of the implementation of quoin stones at the Karagöz Mosque in the city centre of Gaziantep, while Figure 9b illustrates the lack of quoin stones in the corner of the St. Nicholas Orthodox Church of Iskenderun in Hatay. The corners of URM buildings during the restoration process should be provided with rigid corner connections to prevent separations or cracks. In timber-laced masonry, vertical and horizontal reinforcing timber bars enhance the strength and ductility of the walls (Oyguc and Oyguc 2017). Figure 10a and 10b exemplify a timber-laced masonry structure, the Kahramanmaraş Saraçhane Mosque, constructed in the 18th century.

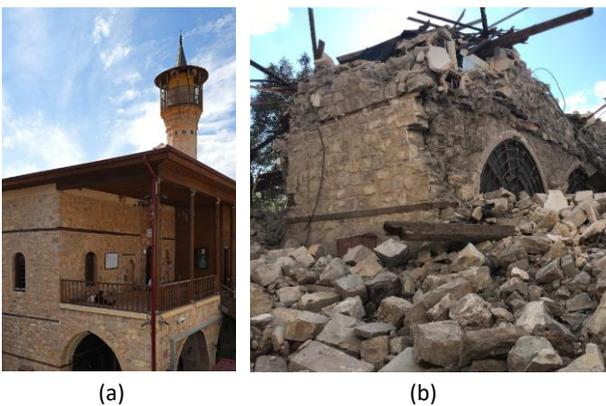
Figure 10. (a) Kahramanmaraş Saraçhane Mosque before the earthquakes (Go Türkiye, 2020). (b) Damage after the Kahramanmaraş earthquakes.

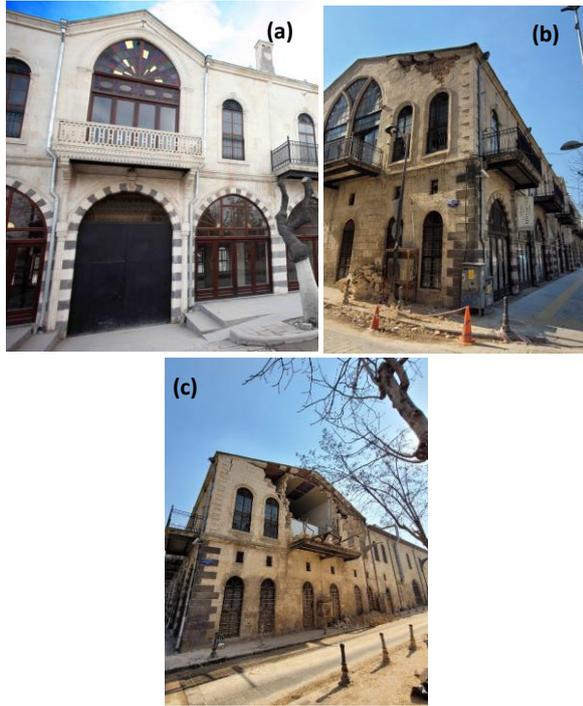
The distance of Bayazhan to the fault rupture line for the first earthquake is around 58 km. According to Figure 12b, the disintegration, mainly delamination of the external leaf, of masonry was observed during the site investigation conducted by the authors. In literature, this

behaviour is also described as the "zero" mechanism, occurring when a masonry portion is incapable of resisting nearly any horizontal force and disintegrates into pieces (Indirli et al. 2013, Vlachakis et al. 2020). Figure 12c illustrates the overturning of gable end walls known as local failure mechanism which is due to the inadequate connection with the roofing system and the walls. Similar failure mechanism is also reported by Güleç (2023) in which the author observed failures due to inadequate connection between roof system and the walls.

Figure 12. Bayazhan in Gaziantep, (a) Bayazhan before Kahramanmaraş earthquakes (Photo Credit: Gaziantep Provincial Directorate of Culture and Tourism). (b) Damage at the walls of the east side of Bayazhan. (c) Damage at walls the west side of Bayazhan.

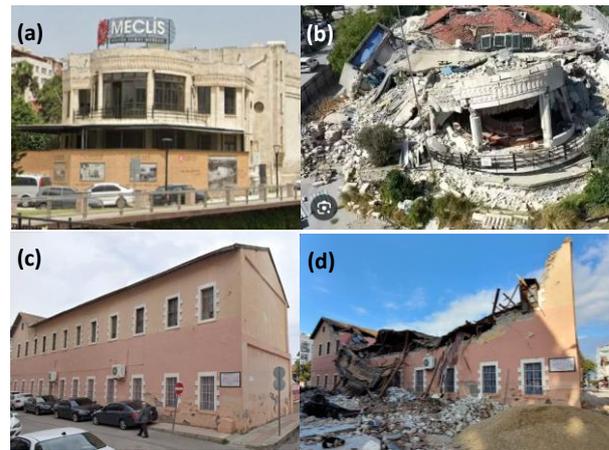
building was completed in 1928, and the building consist of cut stone load-bearing walls and reinforced concrete column forming the core around the courtyard. As depicted in Figure 13b, the load-bearing system constructed with cut-stone completely collapsed, and the reinforced concrete columns failed, exhibiting weak column behaviour at the connections. Figure 13c and 13d depict Mithatpaşa Primary School, built in 1926 by the French, located in Iskenderun Province in Hatay. The school, constructed with rubble stone featuring long walls and a timber roof, experienced complete collapse of the roof and the second floor during the Kahramanmaraş earthquake sequence.

Figure 13. (a) Hatay Council Building before Kahramanmaraş earthquakes (Google Earth, 2022). (b) Hatay Council Building, damage after the earthquakes (CNN TURK, 2023). (c) Mithatpaşa Primary School, Kahramanmaraş earthquakes (Google Earth, 2022). (d) Mithatpaşa Primary School, damage after the earthquakes.

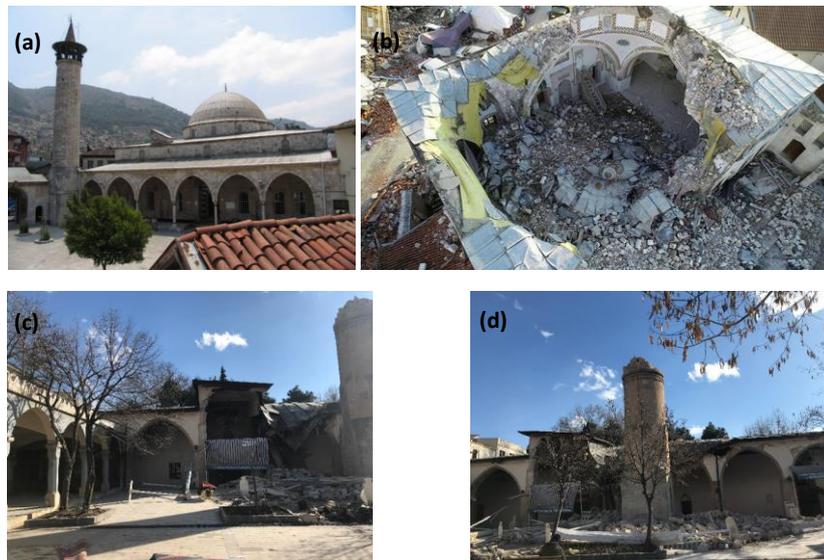
Figures 14a and 14b represent the complete collapse of The Habibi Neccar Mosque, situated in Antakya Province, where high PGA values were documented (AFAD, 2023; Erdik et al., 2023). The Habibi Neccar Mosque, initially constructed around the 7th century and recognized as the first mosque in Anatolia, underwent reconstruction around the 11th century and has undergone multiple repairs over time (Hatay Governorship, 2024). The Habibi Neccar Mosque is a masonry structure that was constructed with cut stone. The collapse of the masonry dome was followed by the out-of-plane behaviour of the masonry walls. URM walls are most vulnerable to flexural out-of-plane behaviour (Oyguc and Oyguc, 2017). The partial collapse of the Grand Mosque of Kahramanmaraş is depicted in Figures 14c and 14d, with the partial collapse of its minaret. The Grand Mosque of

Figure 14. (a) Habib-I Neccar Mosque before the Kahramanmaraş Earthquakes (Google Earth, 2022). (b) Damage in Habib-I Neccar Mosque the after the earthquakes (DHA, 2023). (c) Damage in The Grand Mosque of Kahramanmaraş after the earthquakes, (d) Damage in The Grand Mosque of Kahramanmaraş after the earthquakes.

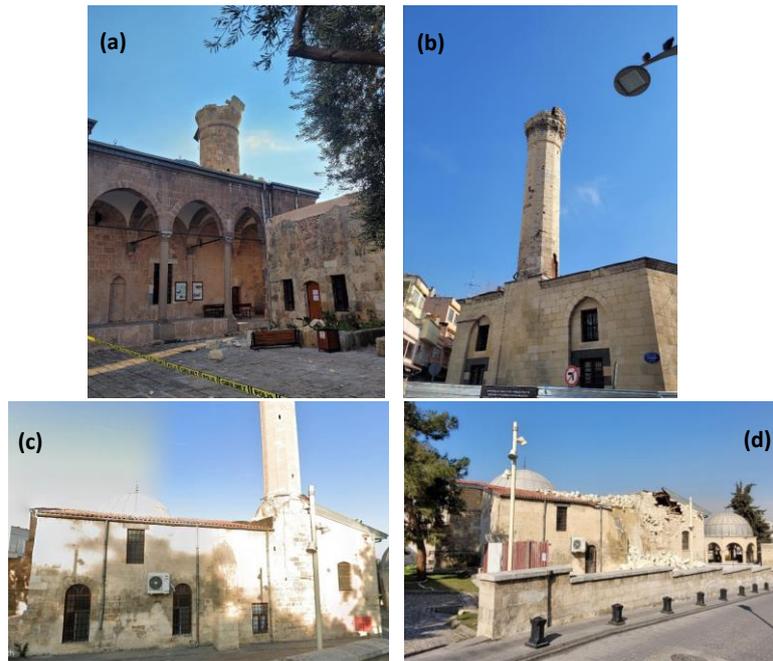
photographs offer a detailed illustration of the damage incurred by the minarets, showcasing the diverse structural alterations resulting from the seismic events. By presenting these images, the objective is to offer a more holistic insight into the effects of earthquakes on historic masonry structures, particularly minarets. Through this presentation, the aim is to contribute to the advancement of more effective measures for earthquake-resistant design and construction practices in the future. As an example, Figure 16a shows the minaret of Sarı Selim Mosque in Iskenderun, constructed in the 16th century, while Figure 16b illustrates the minaret of Karagöz Mosque in Gaziantep, built in the 18th century, both

constructed using masonry techniques. According to both figures, damage is evident in the balcony section of the minarets. As reported by Doğangün et al. (2007), minarets are more susceptible to damage in areas such as the hood, upper part, balcony, and transition sections during seismic events. The region above the balcony experiences maximum displacement, and the lack of stairs in the upper body contributes to reduced rigidity, leading to a rapid increase in the displacement. Figure 16c and 16d shows the Şirvani Mosque in Gaziantep constructed in 17th century as masonry structure. The collapse of the minaret lead to extensive damage also at the mosque.

Figure 16. (a) Damage in the minarets at Sarı Selim Mosque in Iskenderun, Hatay. (b) Damage in Karagöz Mosque in Gaziantep city centre. (c) Şirvani Mosque in Gaziantep before the Kahramanmaraş Earthquakes (Google Earth, 2022). (d) Collapse of the Minaret of Şirvani Mosque after the earthquakes.

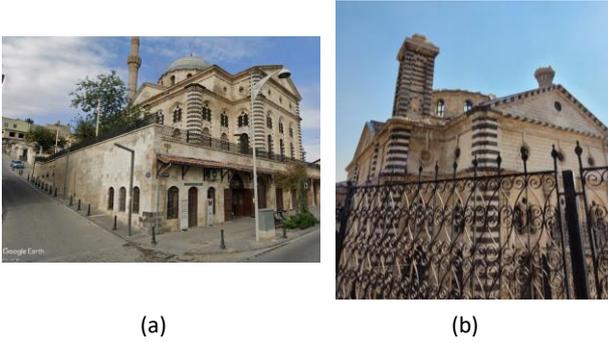
Figure 17a and 17b illustrates the Gaziantep Kurtuluş Mosque prior and after the Kahramanmaraş earthquake sequences. The Gaziantep Kurtuluş Mosque, formerly known as the Virgin Mary Church, is a 125-year-old structure constructed with cut stone. Originally built as a church in 1892, this historic building, situated in Gaziantep, served as a prison after its church function until 1980. Subsequently, it underwent conversion into a mosque (Güllü and Karabekmez, 2016). The central dome, spanning approximately 12 meters in diameter, has a height of 30 meters above the ground (Güllü and Karabekmez, 2016). The collapse of the dome occurred in the mosque, which is mainly due to significant diameter of the dome and due to the insufficient connection to the

body of the main structure. The typical damage at the balcony of the minaret also occurred in the mosque.

Figure 17. Kurtuluş Mosque in Gaziantep before the Kahramanmaraş Earthquakes (Google Earth, 2022). (b) Dome and minaret damage in Kurtuluş Mosque after the earthquake.

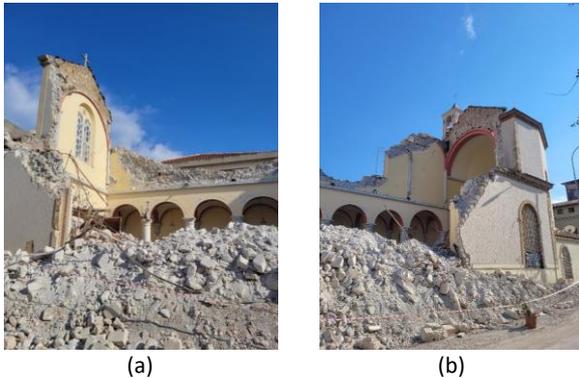
Churches are the significant historical structures of the region with their architectural features. Out-of-plane failure mechanism were observed in the churches. In the absence of a ‘box like behaviour’ of structures, the internal forces of the walls perpendicular to the seismic action give rise to out-of-plane bending. Long walls or walls with insufficient transversal support suffers vertical, one-way bending as seen in Figure 18 in Iskenderun Catholic Church. The walls experienced out-of-plane failure, also due to the top part of the façades might inadequately connected with the roof, and the wall behaves as a cantilever about their base (rocking type of failure) (Vlachakis et al., 2020).

Figure 18. Iskenderun Catholic Church (a, b) Out-of-plane damage in the Iskenderun Catholic Church after the earthquake.

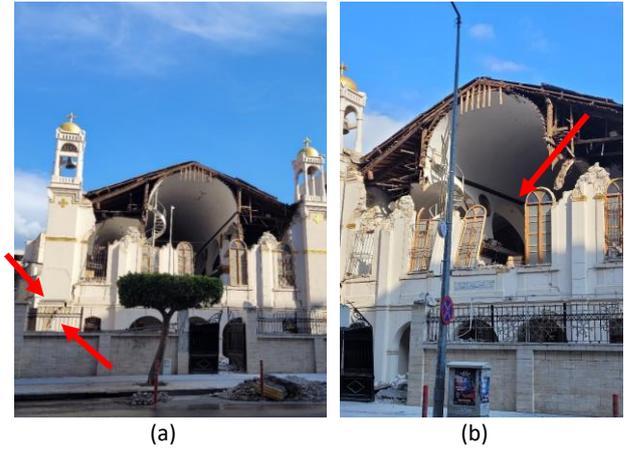
Multiple failure mechanisms observed during the field studies in St. Nicholas Orthodox Church in Iskenderun, Hatay (see Figure 19). The distance of the church to fault rupture is around 18 kilometres. The church’s construction was initiated in the 1870s and features masonry construction, with load-bearing walls composed of brick or stone. The church experienced damage during the Amik earthquake of 1872 and reopened after 1876. Out-of-plane mechanism of the front wall at the entrance of the Church were examined as reported in Figure 19a and 19b.

Figure 19. St. Nicholas Orthodox Church in Iskenderun, (a, b) Observed combined in-plane and out-of-plane mechanisms in the St. Nicholas Orthodox Church after the earthquake.
