Damage Assessment of Rock-Cut Ortahisar Castle in Cappadocia Region

Şerife ÖZATA^{1,*}, Emine Görün ARUN²

Abstract

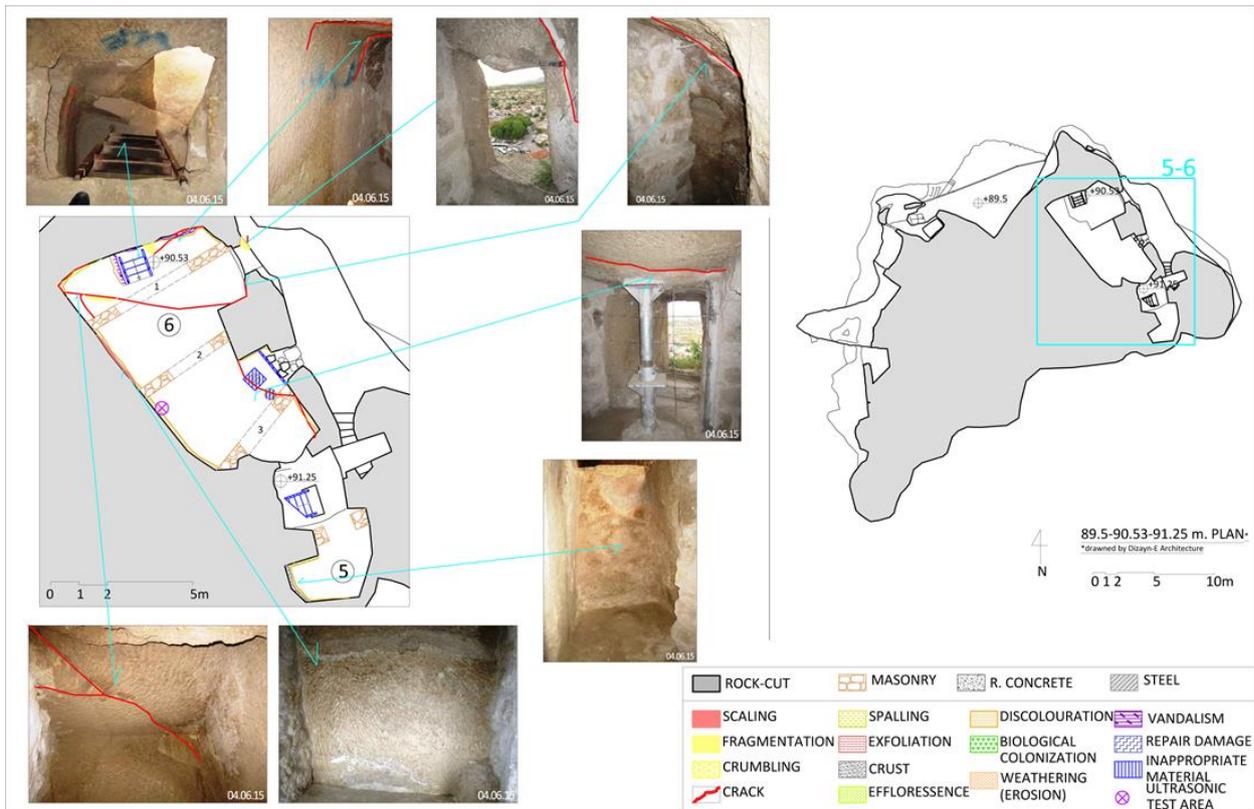
Figure 4. Damages and deteriorations in the space 5 and 6

There are nine spaces in the castle, which is accessible for analyzing the inner and outer deteriorations and damages. All masonry arched walls and steel columns in the space 5, at the +91, 25 m. level, and in the space 6, at the +90, 53 m. level, were constructed during restoration (Figs. 4-5). Deterioration and damages in the space 5 is as follow. On its north wall there is spalling. On its west wall, crust exists. There are discolorations on the north, west and east walls (Fig. 4).

There are damages originating from Vandalism and discoloration on the west wall of tunnel in space 6. There are fragmentation and crack on the tunnel's east wall (Fig. 4). Masonry arched walls in the space 6 was numbered for defining the place of deteriorations apparently.

Damages and deterioration in the space 6 are as follow. There are various cracks, efflorescence, discoloration and vandalism effects on the north wall of the area until the first masonry wall. There are scaling and discoloration on the west wall of the area between the 1st and 2nd masonry walls. The fracture on the ceiling of this area continues along the border of the window of this area. The window has fragmentation, too. There is discoloration on the west and north walls of the area between 2nd and 3rd masonry walls and cracks exist on the ceiling. Window in the area is closed with inappropriate iron chains. There are inappropriate steel columns in front of the window. Discoloration on the east wall and cracks on the ceiling of the area between 3rd masonry wall and space 5 are seen (Fig. 4).

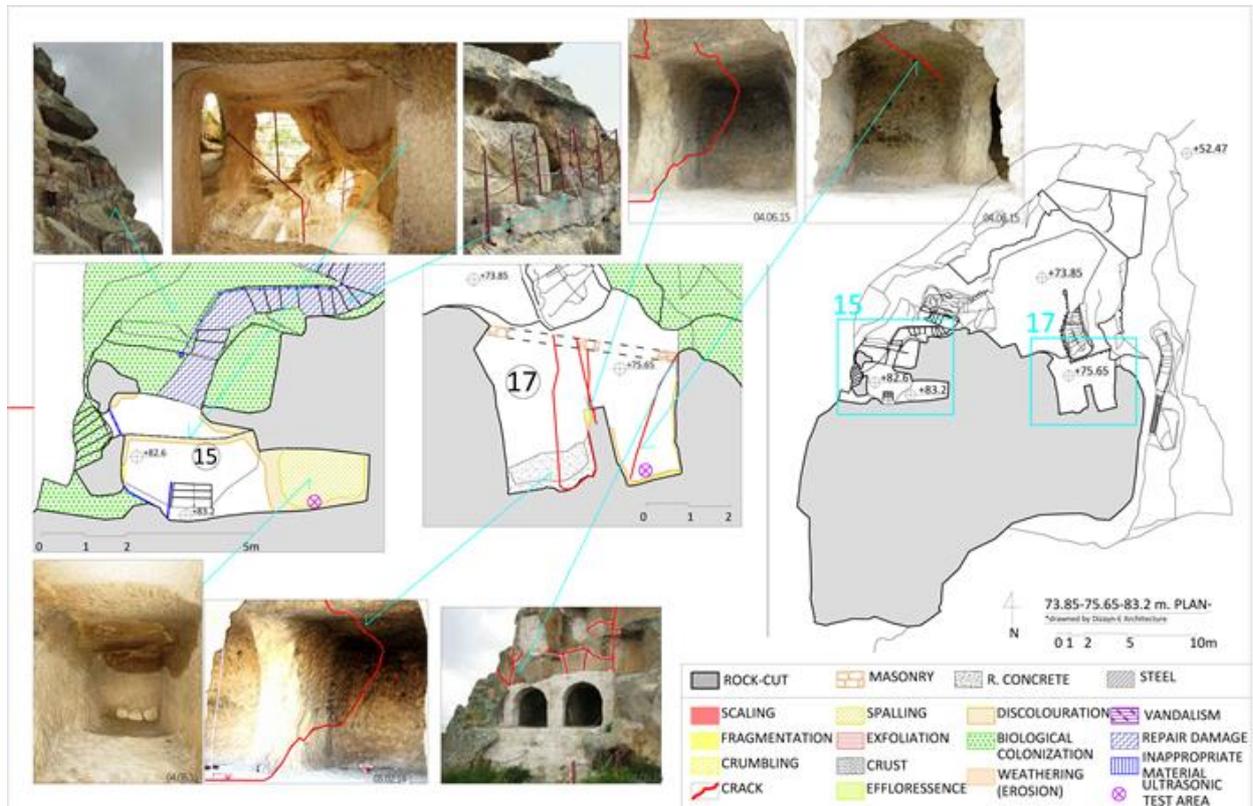
Figure 5. Damages and deteriorations in the space 15 and 17

There are repair damages resulting from cement mortar on the staircase, which gets people to space 15. In addition, the pipe railings on the staircases are inappropriate. There is biological colonization on the outer surface of the space 15. Algae, lichens, mosses and plants are main colony types on the surface. There are

inappropriate attachments like iron chains out of the window and pipe railings. Other damages, degradations and deteriorations in space 15 are as follow (Fig. 5).

There are two different levels in the space 15. At the level +82, 6 m, north wall has discoloration; west wall has fragmentation and discoloration. At the level +83, 2 m, there are spalling and discoloration on the ceiling. There are two different area in the space 17, at the +75, 65 m level. Cracks in these areas sometimes convert into fractures and continue on the outer surface of the space. A masonry-arched wall was constructed during restoration to avoid rock falling due to fractures and fractures filled with mortar (Fig. 5).

The space 17 is divided into east and west parts based upon the rock wall in the middle of the space. At the west area, there are crusts on the ceiling and south wall of it and fragmentation on the east wall. Fractures exist on the ceiling and floor. At the east area, all walls have discoloration. There are spalling on the south wall and fractures on the ceiling (Fig. 5).

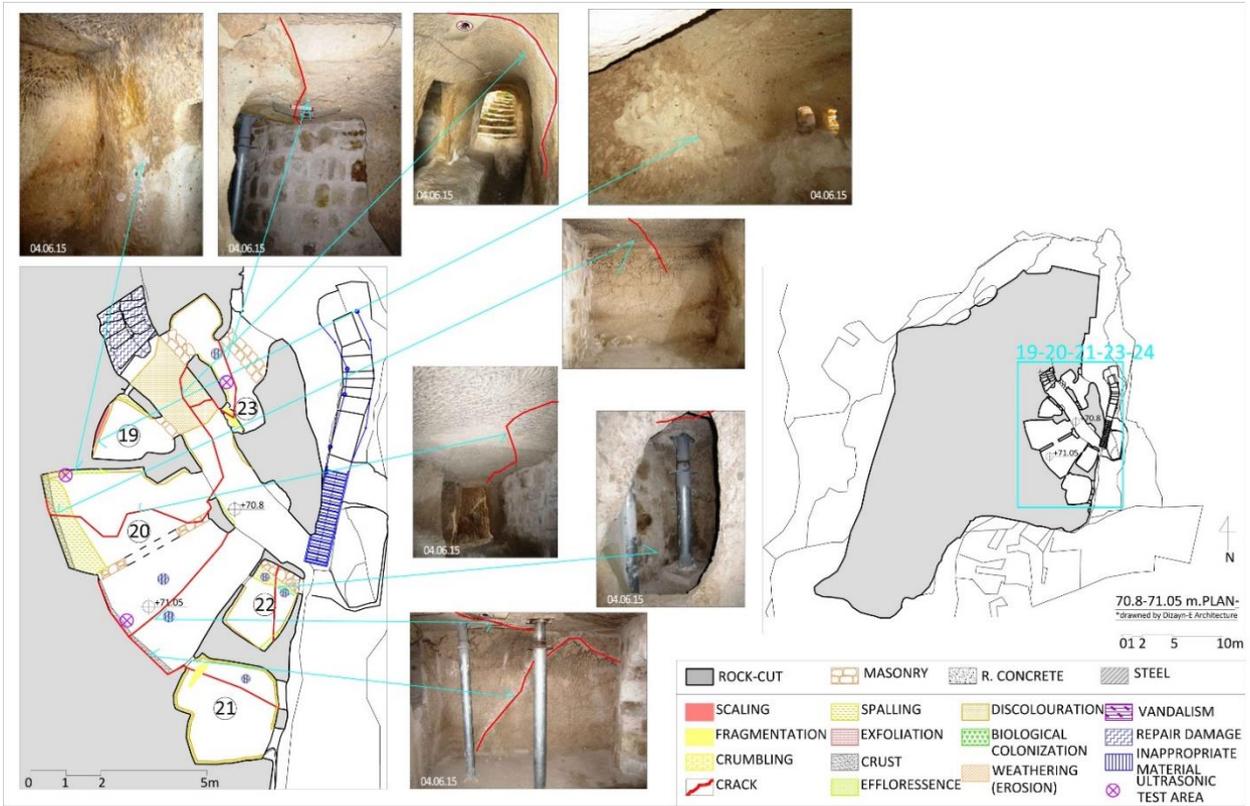
Figure 6. Damages and deteriorations in the space 19-20-21-22 and 23

In the space 19, at the +71, 05 m level, discoloration and the scaling are seen on the west wall; spalling and discoloration exist on the north wall (Fig. 6). The space 20, at the +71, 05 m level, is divided into north and south parts based upon masonry-arched wall in the middle of the space. At the north area, cracks on the ceiling continue on the ceiling of the corridor, which is at the +70, 8 m level. There are crusts on the west wall, spalling on the ceiling, efflorescence and discoloration on the north wall of this area. At the north area of the space 20, there are cracks on the ceiling, south and west walls. Crusts exist on the west wall, too. All walls have discoloration and spalling in the space 21. There are fragmentation and cracks on the ceiling (Fig. 6).

Spalling and crack exist on the ceiling of the space 22. A masonry wall was constructed in front of the northeast wall of this space. Southeast wall has discoloration and efflorescence. There is discoloration on the southwest and northwest walls (Fig. 6).

Two gaps in the space 23 were closed with masonry walls. Fragmentation exists on the entrance gap. There are spalling on the west wall and discoloration on the north and east walls. Discolorations exist on

the ceiling, west and east walls of the corridor, at the +70, 8 m level. There is spalling on the east wall, too. Staircase that gets people to upper parts of the corridor has repair damage due to using cement (Fig. 6).

In addition, ladder gets people from lower parts to corridor and railings are inappropriate due to its material and style. Inappropriate steel columns exist in the space 21, 21, 22 and 23 to avoid rock fall by reason of cracks (Fig. 6).

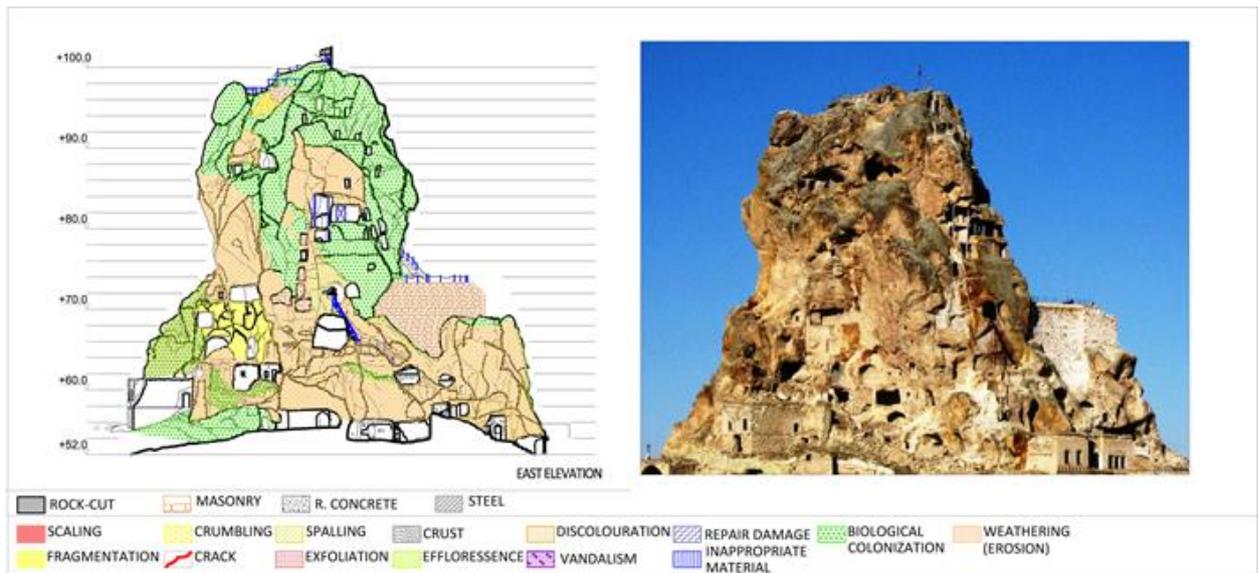
Figure 7. Damages and deteriorations on the east elevation

On the east elevation of the castle, biological colonization like algae, lichens, mosses and plants, weathering (erosion) and spalling exist between the +52, 0-60, 0 m levels. Between the +60, 0-90, 0 m

levels there are biological colonization, discoloration, fragmentation, spalling, weathering and inappropriate steel columns (Fig. 7).

Some windows on the elevation were closed with masonry walls. Crumbling, weathering, spalling, biological colonization and inappropriate annexes are seen between the +90,0-100,0 m levels. Walls of the terrace between +64, 0-74, 0 m levels were renewed during restoration (Fig. 7). Other elevations have similar deterioration and damages on.

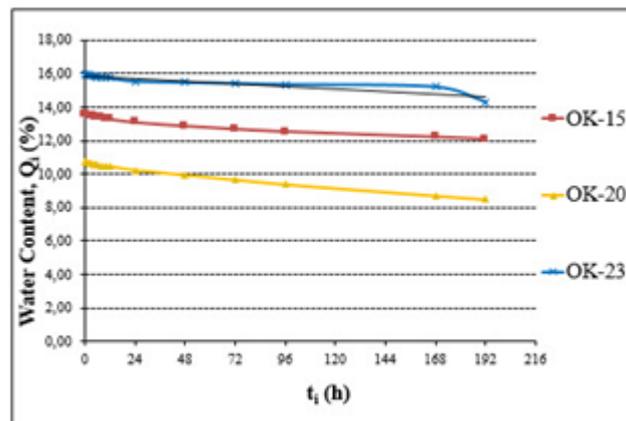
Figure 8. Water desorption of OK-15, OK-20 and OK-23

The changing percentage of water desorption of each sample in unit of time is shown on the Fig. 8. According to Fig.8, quickest water desorption ratio belongs to OK-20 and OK-23 has slowest desorption. If the sample has low open porosity, its water desorption is high.

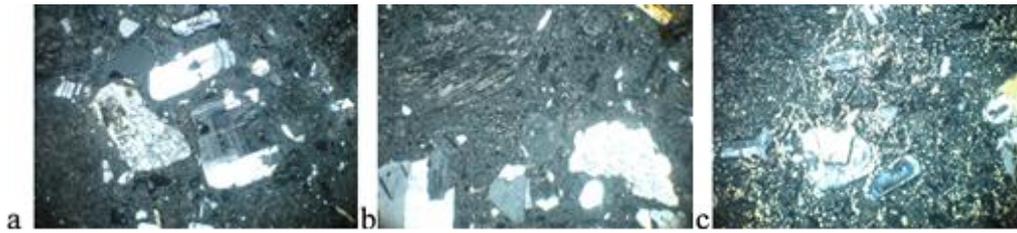
Figure 9. Photomicrograph of OK-15 (a) OK-20 (b) and OK-23 (c) sample (double Nicol, width 4mm) [4]

OK-15 microscopic analysis: Sample has a volcanic porphyritic-glassy tuff texture, contains slight amount (30-35 %) of mineral and rock spall (aggregates), more of it is matrix (binder). Aggregates consist of plagioclase, amphibole, quartz low and sanidine (a type of K- feldspar) and biotite. Most of the matrix possesses a similar characteristic with volcanic glass. Volcanic glass has secondary conversions (Silica-Mika- Chlorite conversion) (Fig. 9)[4].

OK-20 microscopic analysis: Sample has a characteristic of tuff. It contains approximately 30 percent of mineral-crystal spall and 70 percent of matrix. There are secondary conversions in matrix. It consists of microlites of plagioclase and volcanic glass. Aggregates consist of quartz low, quartz, plagioclase, sanidine, mica, and opaque (nontransparent) minerals. All aggregates are eroded and lost lose their original shapes (Fig. 9) [4].

OK-23 microscopic analysis: Sample has a volcanic porphyritic texture. The proportion of matrix is around 75-80 percent and comprises microlites and volcanic glass. Aggregates consist of quartz, quartz low, plagioclase, biotite, amphibole and sanidine (Fig 9) [4].
