Assist. Prof. Dr., Süleyman Demirel University, Faculty of Architecture, Department of Architecture, Isparta, Türkiye, aysegokarslan@sdu.edu.tr

Gökarslan, A. B. (2024). An Example of Conservation and Documentation of Traditional Houses: Isparta Nurten Terlikçi House. *Akademik Tarih ve Düşünce Dergisi*, 11 (6), 4190-4223.

An Example of Conservation and Documentation of Traditional Houses: Isparta Nurten Terlikçi House

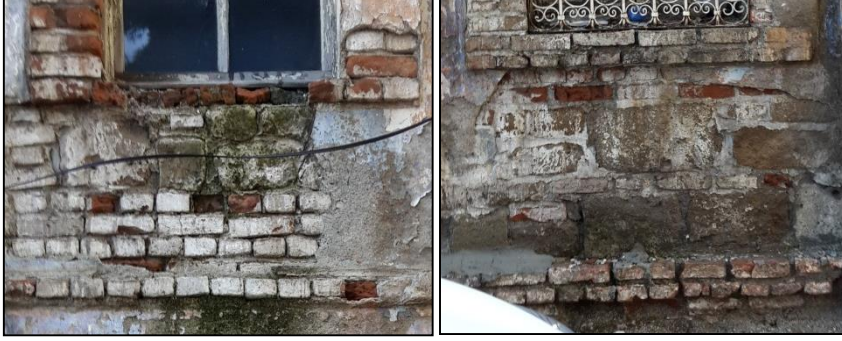
Between the inappropriate accretion eaves and the floor, which was added later on the entrance door, there are brick moldings about 15 cm wide on the eaves and at the water basement level. The facade suffers from plaster flaking, mossing and corrosion due to the installation of various tools. The facade has significant plaster spills and losses on the jambs. Rising damp and moisture transmission from the ground are noticeable up to a height of 150-200 cm. Decay is observed in some of the wooden frames on the façade. Particularly on the entrance door, physical deformation and decay have occurred due to ground moisture (Figure 6). The south (rear) facade of the building facing the courtyard has lost its original appearance. On this facade, which reaches 5.80 m in height, inappropriate accretion walls were constructed to disrupt the original plan organization. The wall of the inappropriate accretion section is covered with metal sheets. It is known that this section was originally covered with wood. On this facade; there is a door and window belonging to the Z-05 sofa on the ground floor and a three-pane guillotine window belonging to the Z-04 room. On the upper floor there are two rectangular guillotine windows belonging to room M-05, a guillotine window belonging to kitchen M-06 and a door leading to the terrace. The rear facade wall connecting the ground floor with the courtyard was completely reconstructed. Wooden joinery incompatible with the original joinery was added. An outbuilding was added to the south facade at a later date. Room Z-04 coincided with this section, partially blocking the guillotine window in this room facing the courtyard. Even if the outbuilding is compatible in terms of material and facade character, the fact that it covers the window suggests that this section is inappropriate accretion.

Figure 7. Materials used in the front facade walls of the building (Created by the author)

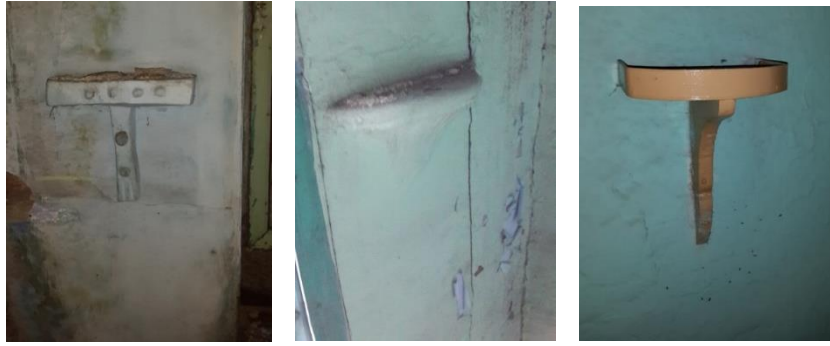
walls and between 15 and 18 cm on the interior walls. Usually the interior walls are 15 cm. In the brick parts of the walls of the building, wooden beams were laid for the window door gaps. The house is plastered inside and outside. However, there are spills on the plaster in places. The exterior of the house was painted blue in a later period, while the interior was painted light green. All doors, windows and cabinet joinery of the building are made of wood. Wood was also used in the original ceiling and floor coverings. Some ceilings are clad in plywood. Plaster and metal materials were used for the ceilings of some rooms and for the “çırappa” (niches for lamps) in some rooms. The front facade ground floor windows have iron railings with craftsmanship. It is seen that cement and screed materials were used during the repairs and additions to the house. On the east wall of the courtyard, a briquette wall was added over the original rubble stone wall (Figure 8).

Figure 8. Original plaster and inappropriate accretion metal ırappas (niches for lamps) from rooms M-02, M-04 and Z-01 (Created by the author)

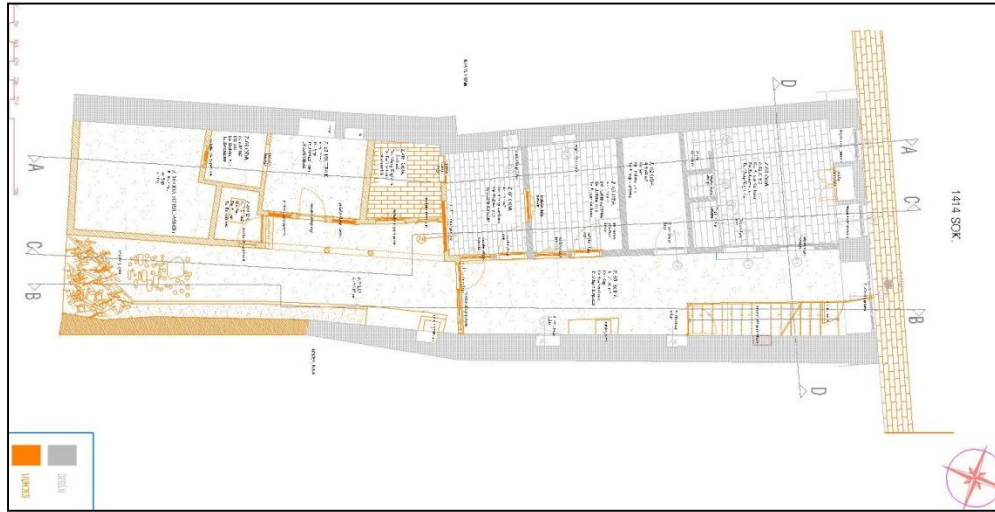
There is no information on the restoration of the Nurten Terlikçi house. However, when the building is examined, it is seen that it has been subjected to many faulty interventions. During these interventions, an outbuilding was added to the building, a concrete terrace was added to this outbuilding, and many original joinery such as stairs and doors and windows were changed within the main mass of the building. On the upper floor, two rooms were created within the sofa (Figures

*Figure 10. Distinction between the original and inappropriate accretion (orange:inappropriate accretion)
(Created by author)*

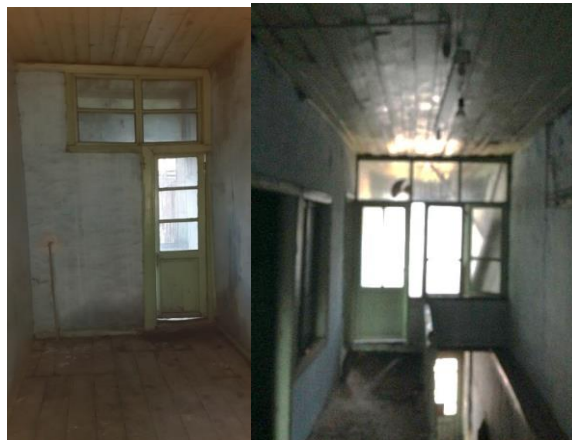
Figure 11. Inappropriate accretion spaces (spaces M-01 and M-06) in the upper floor sofa (Created by the author)

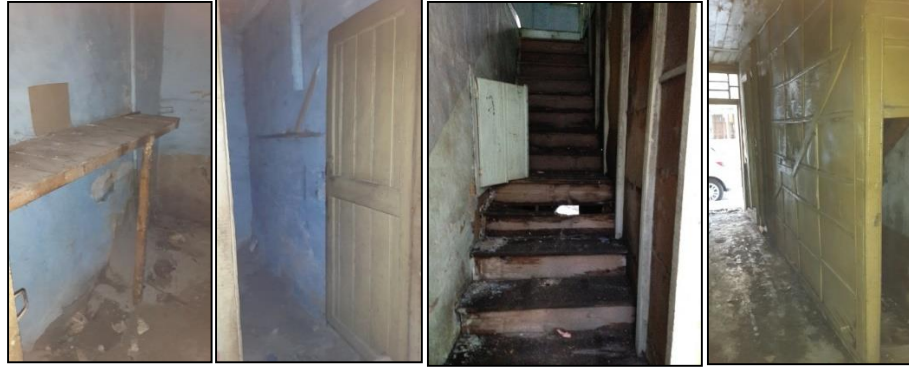
The upper floor is accessed by a wooden staircase on the east wall of the Sofa Z-05. The house owners have stated that this staircase is an inappropriate accretion. However, it is certain that it belongs to a specific period. This staircase was later turned into a closed space with a wooden joinery incompatible with the original joinery. The house owners stated that the original staircase is located in the area where rooms Z-02 and M03 are located today. It is known that the staircase is a wooden, double-armed staircase, but there is no data on its style (Figure 4).

Figure 12. The location of the staircase according to the original plan of the building and the location of the staircase today (Created by the author)

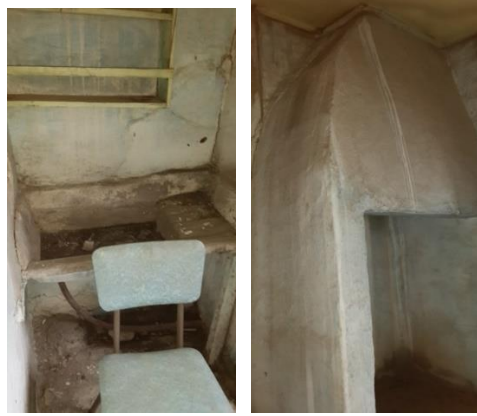
10, 11, 12). A sink and stove were added to the M-06 kitchen space. These addenda both overloaded this section and disrupted the material and formal integrity of the space (Figure 13).

Figure 13. Addenda in section M-06 (Created by the author)

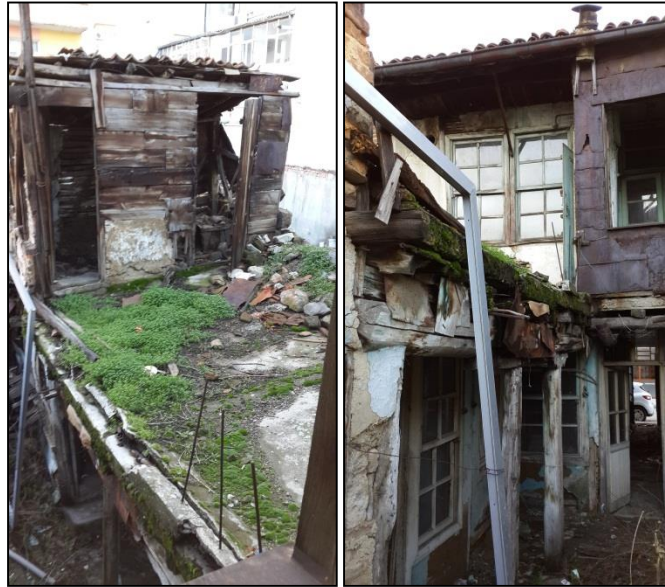
These interventions have damaged the house visually and physically. Especially the outbuilding section has moved away from the building materials and appearance of a traditional Isparta houses. The use of the outbuilding section outside its traditional spatial and functional characteristics and the interventions made to the spaces belonging to this section have created visual pollution (Figure 14). Briquettes were added to a section of the courtyard wall of the building, thus disrupting the form, statics and visual integrity of the original wall. Many unnecessary materials and equipment were thrown into this part of the courtyard, causing visual pollution in the courtyard.

Figure 14. The outbuilding and the roof over the outbuilding (Created by the author)

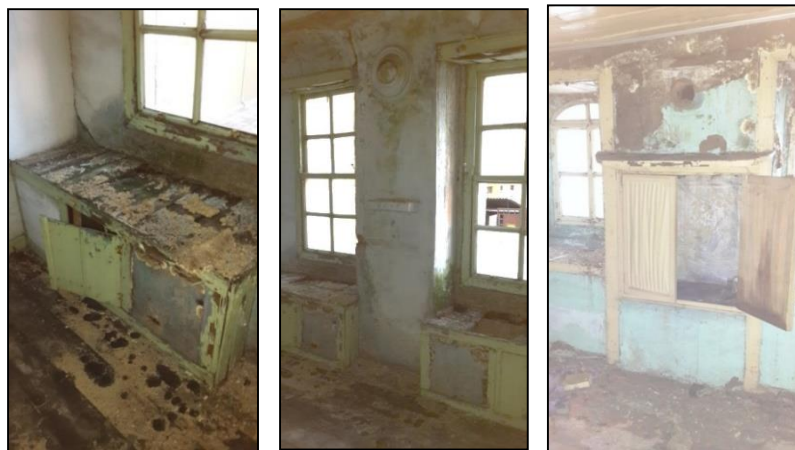
Many material deteriorations were detected both in the interior and exterior of the building. On the exterior, especially on the north facade and on the interior walls facing this façade, there is a lot of plaster loss, dampness, moss, blackening, and corrosion problems. As a result, rotting of wooden elements has occurred. Decay and collapse can be seen in both window and cabinet joinery as well as floor and ceiling coverings (Figures 15, 16, 17).

Figure 15. Dampness, moss and rot problems (Created by the author)

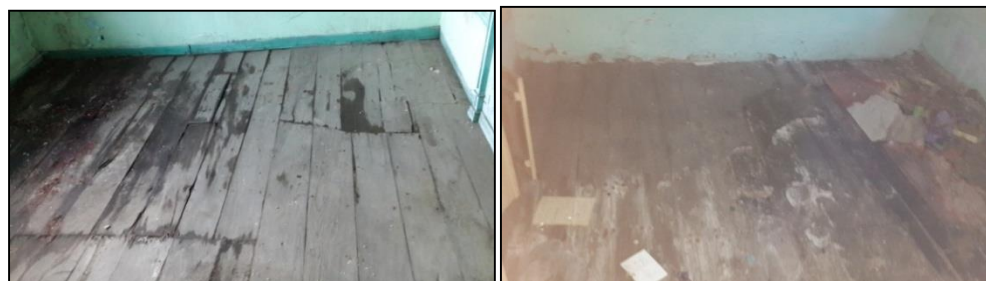
Figure 16. Dampness and rotting problems in the flooring (M-04 and Z-01 floors) (Created by the author)

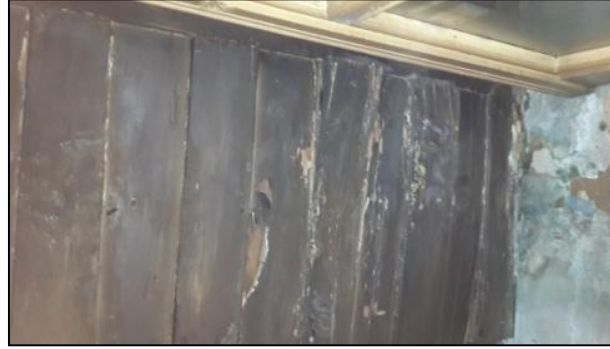
Figure 17. Dampness, rotting and collapse problems on the ceiling (Z-05 living room) (Created by the author)

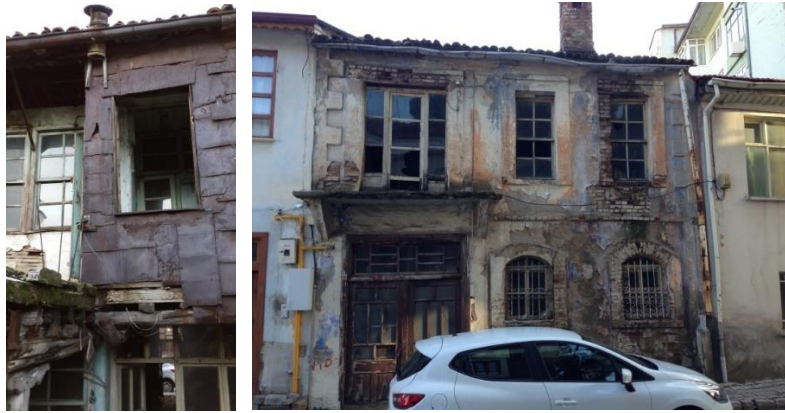
The outbuilding on the south facade of the building is incompatible with the original architecture of the building. On the same facade, there are door and window joinery added later. Elements related to electricity, water (stormwater), natural gas installations on both façades and

chimneys, sheet metal plates, etc. added later disrupt the facade both physically and aesthetically. It causes corrosion (Figure 18).

Figure 18. Sheet metal plates on the south facade of the building and the installation seen on the north facade (Created by the author)

Due to the building's attached configuration, it has both a north and south facade. Both facades show signs of deterioration, including material loss, dampness, moss growth, and other damages. The entrance facade (north facade), which is significant for the building's architectural character, shows more damage due to harsh weather conditions, while the rear facade (south facade) has structural issues due to the displacement of the walls. Elements related to electricity, water (stormwater), natural gas installations on both facades and chimneys, etc. added later disrupt the facade both physically and aesthetically. It causes corrosion. These addenda should be removed immediately. Pipes to drain rainwater should be renewed together with the roof repair. The outbuilding on the south facade of the building is incompatible with the original architecture of the building and should be removed immediately. On the same facade, there are door and window

joinery added later. The upper floor closed exit on this facade is also inappropriate accretion. Therefore, the debris on the south facade should be cleared, the vegetation on the closed overhang should be removed, and the south walls of the M-06 and Z-04 spaces should be repositioned according to the original floor plan. During this process, a suspend operation must be performed. The south facade should be a wooden facade built entirely with the lath-and-plaster technique in accordance with the original facade character. Windows of unknown original character should be replaced with guillotine windows. The outbuilding located in the courtyard of the building and adjacent to the south facade should be removed and replaced with a new outbuilding compatible with the architecture of the building. In this way, the need for a kitchen and roof should be eliminated and a healthier and more harmonious outbuilding should be obtained with the architectural character of the building. The concrete entrance canopy added later on the north facade, which is the entrance facade of the building, is incompatible with the architecture of the building and has caused loss of parts due to material incompatibility. It needs to be removed urgently. This removed addenda should be replaced with the original material and plastered with a plaster suitable for the original plaster. The entrance door on this facade has fallen into decay. However, this door is a period addenda and should be protected by sanding with the appropriate technique. The jambs, moldings and brackets on this facade should be completed with appropriate materials where there is material loss, and the facade should be completely re-plastered. Rotting wooden beams between the jambs should be replaced with suitable wooden material. The original window railings of the ground floor windows on the south facade are rusted. These railings should therefore be cleaned. Rust and paint layers on the original interlocking iron railings should be removed with the help of paint remover and scalpel. After the preservative is applied, matt black acrylic paint should be applied. It should be plastered with plaster mortar containing hydraulic lime reinforced slaked lime mortar.

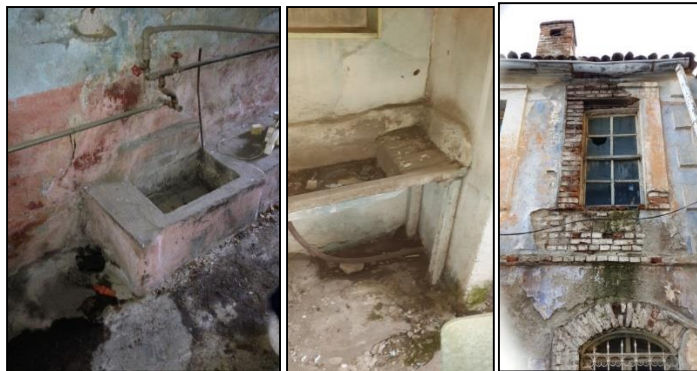
The clean water, waste water and lighting installations of the building were both damaged and destroyed. Rust and corrosion have occurred in the rainwater drainage system in the building, and the pipes and gutters of this system present a bad appearance. In addition, the plumbing added to the sofa section of both floors also damages the structure (Figure 19).

Figure 19. Plumbing problems in the building (Created by the author)

The clean water, waste water and lighting installations of the building were both damaged and destroyed. Rust and corrosion have occurred in the rainwater drainage system in the building, and the pipes and gutters of this system present a bad appearance. In addition, the plumbing added to the sofa section of both floors also damages the structure. The inappropriate accretion plumbing in the building should be removed, and only the rain gutters and water pipes from the roof and the newly created kitchen and bathroom sections should be plumbed. The original bathing cubicles should never be used as bathing cubicles. These sections can be used as cabinets with a light glazing system. The sewage drains of the toilet and bathtub in the M-02 space, which was later converted into a bathroom in the building, should be connected to the manhole system outside the building and removed from the building. Discharge of waste water should be done with slightly inclined pipes. In order to remove water from the ground of the structure, it should be excavated up to the foundations of the structure. A drainage system should be installed in the excavated part of the

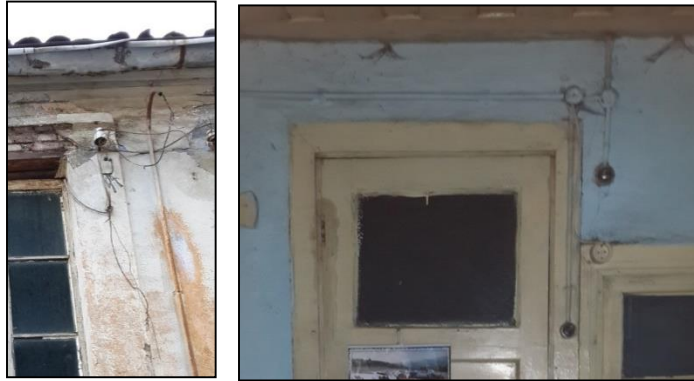
Another important installation problem of the building is lighting. Since there was no electrical installation in its original state, it was necessary to bring electrical installation to the building. However, the introduction of electrical wiring resulted in the installation of a large number of electrical cables and switches in the building, which caused various deterioration in the structure. In addition, these cables and switches passing through wooden joinery pose a fire risk (Figure 20). In addition, it was observed that holes were drilled for stove chimneys in some walls due to the heating problem in the building (Figure 21).

Figure 20. Electrical cables in the building (Created by the author)

building in the outdoor area by utilizing the slope and the foundations of the building should be sheathed. Another important installation problem of the building is lighting. Since there was no electrical installation in its original state, it was necessary to bring electrical installation to the building. However, the introduction of electrical wiring resulted in the installation of a large number of electrical cables and switches in the building, which caused various deterioration in the structure. These cables and switches passing through wooden joinery pose a fire risk. These cables should be removed and electrical wiring should be installed with a nano-technology cable system that does not pose a fire risk. Besides, these cables should be concealed as much as possible and should be brought over the shortest distance. In addition, it was observed that holes were drilled for stove chimneys in some walls due to the heating problem in the building. There is no original heating system in the building. However, due to today's comfort conditions, the heating system should be built in a way that should not damage the original walls and floors of the building. Thus, the facade and structural system of the building should not be disrupted by the stove chimneys to be added later. It is proposed to install the heating system using panel radiators in simple and small sizes. The building should be heated with natural gas, so an additional boiler room should not be required. Finally, a small marble plaque should be placed on the eastern wall of the ground floor hall section of the building, indicating the construction date, the owner, the restoration date, the restoring institution, and the restoring architect. Nurten Terlikçi house, which is estimated to be a Greek structure, is one of the important and rare buildings in the traditional Isparta urban fabric. The building, which has reached the present day in a very worn-out state, continues to deteriorate rapidly due to factors such as neglect, abandonment, vandalism, faulty repairs and faces the risk of extinction. The idle structure needs to be preserved and transferred to future generations in a sound manner. For these reasons, the deterioration process of the building should be stopped urgently, and conservation and restoration practices should be started in the light of the necessary documentation for its repair. It was also decided that the original function of the building should continue in order to transfer it to the future with confidence. Within this scope, the building survey, restitution and restoration works of Nurten Terlikçi house were documented and the project was designed for restoration applications.

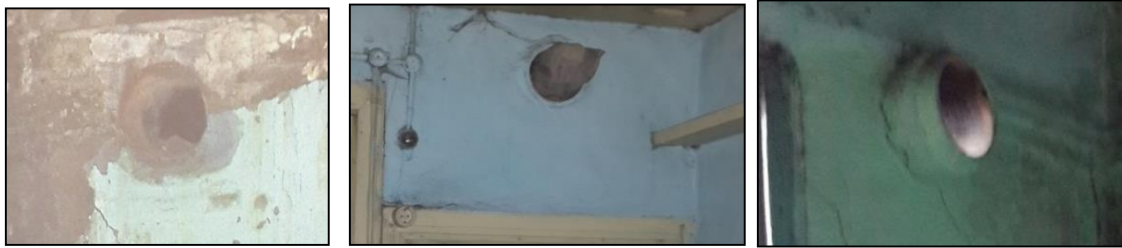
Figure 21. Stove chimney holes drilled later in the building (Created by the author)
Figure 21. Stove chimney holes drilled later in the building (Created by the author)
