THE METHODOLOGY OF PHOTO INTERPRETATION OF MASS MOVEMENTS WITH SPECIAL REFERENCE TO THE SPANISH PYRENEES, TREMP, NORTHERN SPAIN*

Murat AVCI

University of IFE, ILE-IFE, Department of Geology, Nigeria

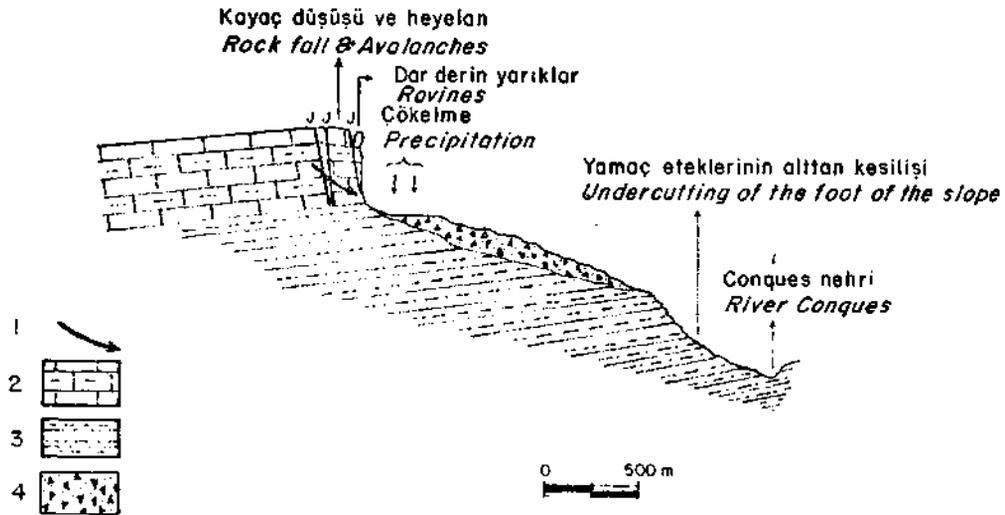
Fig. 2 - Factors affecting the instability conditions prevailing between the Eocene limestone-marl and Paleocene Red Marls.

The Eocene limestones are compact, intensely jointed and also marl intercalated rocks (Photo 4). The infiltration of water, through the joints, during the heavy rainfalls expands the intercalated plastic marls and disturbs the stability of the unit. The underlying formation consists of the Paleocene Red Marls which are easily eroded and removed. As a result the blocks of jointed Eocene limestone fall down and/or, if the zone of instability is large, rock avalanches occur along the Eocene-Paleocene contact (Photo 5). This fragmentation from Eocene limestone escarpment overloads the Paleocene Red Marls and produces a colluvial slope by accumulating a variable thickness (approximately 2-4 m) of colluvial material. These are light gray, clayey silt with angular gravels and blocks, and boulders of the Eocene limestones. The laboratory analysis of a representative sample from the matrix of this materials yielded a high moisture content (43 %) and a high plasticity (39 %).

At the foot of the slope the lateral river erosion and the other erosional processes such as gulleying, badlands and rills are rather active. This situation leads to increased shearing stress by overloading and undercutting by which in turn the strength of the materials is reduced, especially when saturated. Consequently, the colluvial material moves downwards in the different forms of mass movements. For instance, the creep is a constant phenomenon on this slope which does not exceed the thickness of the colluvial material (Photo 6 and 7).

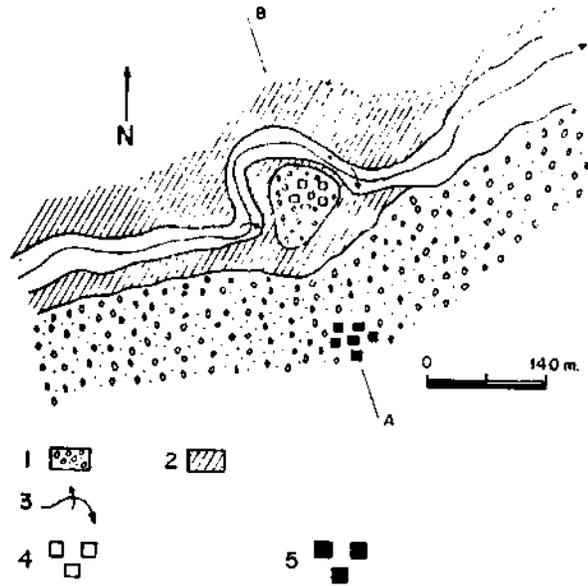
Fig. 3 - Plan view of Tendruy situation.
 1 - Gravel; 2 - Marls; 3 - Lateral river erosion;
 4 - Old village; 5 - New village.

Geotechnical explanation. — The former village of Tendruy was erected on a hill near the river side edge of a shallow fossil river channel which overlies the Paleocene Red Marls. The material of the fossil channel is unconsolidated sandy gravel which crumbles when touched by hand. At the lowest part of the gravel - deposit a new stream is formed which cut approximately 30 m into the surface of the fossil channel. To the west of the village a moderately deep abandoned valley occurs, as can be seen on the plan and section. The village with its gravelly base over the marls is thus completely isolated (Fig. 3 and 4).

The contact between the gravel and underlying marls has an inclination of approximately 7 degrees east. This situation creates instabilities due to lateral sapping and vertical cutting of the existing stream which prevail all along the east side of this gravel formation and the underlying marls. It is also a well known fact that infiltration of water through the overlying permeable layer may produce a slip surface in the lower impermeable formation. As a result of these combined unstable conditions the hill and the village started to move (creep) slowly eastward, towards the river.

The old village still exist. It has an irregular surface and many fissured and undulated walls can be seen. Although it is not ruined yet, it is dangerous to stroll in it. The village may completely slide down within a few years. The new village has been erected on a stable place further to the south.

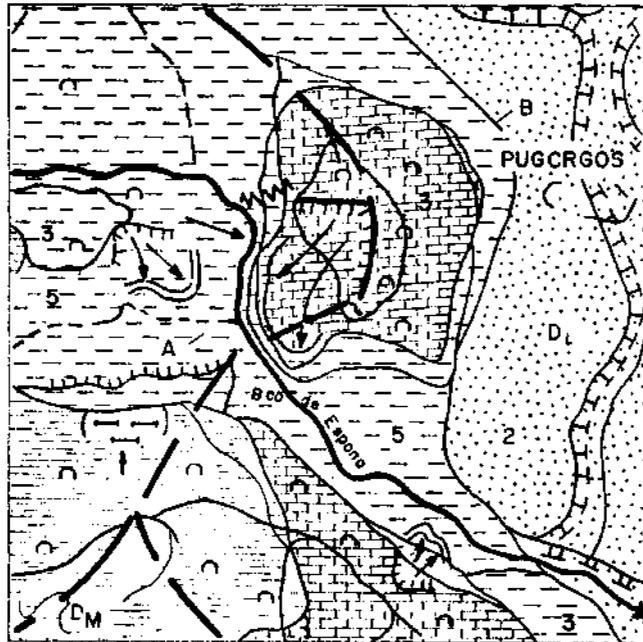
Fig. 5 - Plan view of the Puigcergos slump initiated by lateral river erosion.

The relative height of the hill is approximately 100 m and the B^{co}. de Espona, which is flowing at its southwest side, carved the final form of the hill and separated it from the hills which occur further to the south. Lithologically the hill is the extension of the Eocene limestones in the south (Fig. 5). The vertical cutting of the B^{co}. de Espona is negligible, since it has reached the mature stage and is characterized by a gentle gradient. Lateral sapping on the other hand is of great importance especially in the rainy periods when great discharges are observed as a result of its fairly large catchment area (apprx. 7 km²).

The flow direction of B^{co}. de Espona is straight and almost eastward until it reaches the hill which forces the river to make a southward bend. At this point of the channel the lateral erosion is evidently maximum and the current actively erodes the foot of the hill. With progressing lateral cutting the first sign of disequilibrium was the appearance of a number of cracks on top of the hill. Warned by these clear indications of imminent danger the villagers

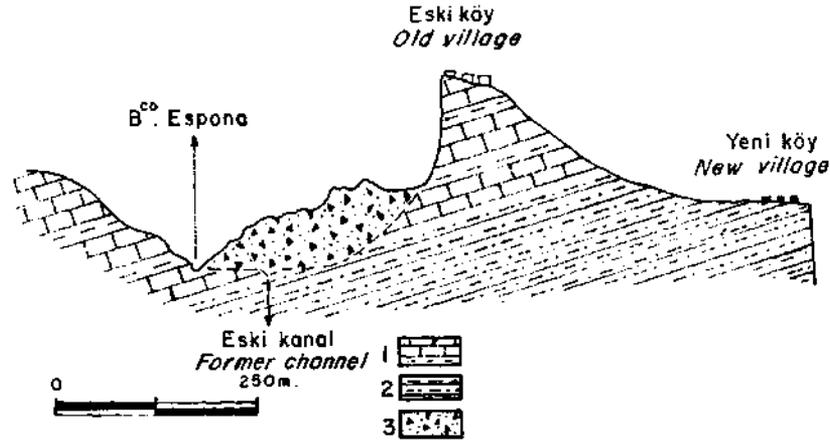
Fig. 6 - The cross section along A-B on the plan view of Figure 5.
 1 - Limestone & marls (Eocene); 2 - Red marls (Paleocene);
 3 - Debris.

removed the settlement to a flat and stable place further to the east. Infiltration of rain water through the cracks and into the susceptible Paleocene marls below (Fig. 6). increased the instability and finally caused the slump (Photo 15). The resulting anomaly of the detached mass is great and well visible in the stereovision (Photo 2).

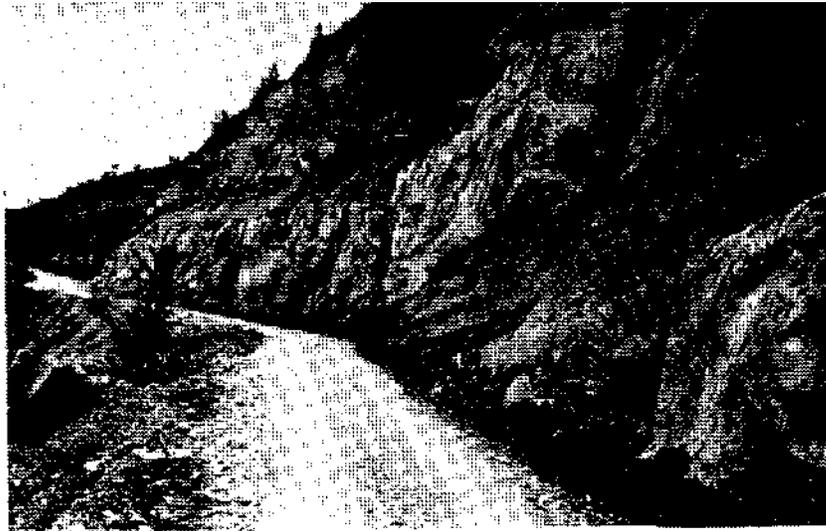
Photo 4 - Photograph of the Eocene limestone-marl intercalated formation. The road reconstructed after the rock avalanche of figure 5.

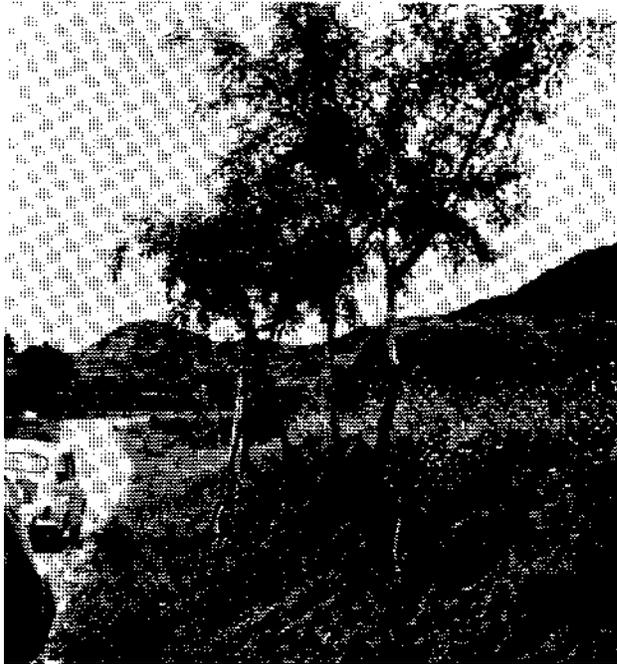
Photo 6 - Photograph showing the roots of the trees which indicate the creep of soil in the colluvial material over the Paleocene Red Marls.

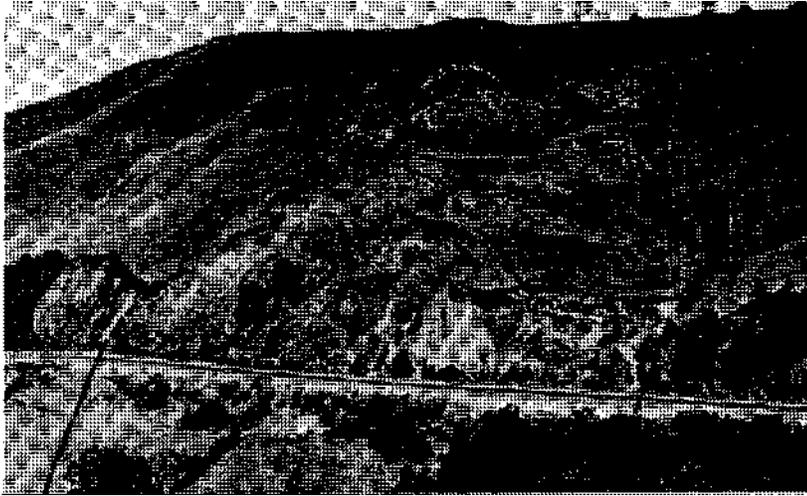
Photo 10 - Photograph showing a superficial slide which tends to be deep-seated rotational slide along the dashed lines.

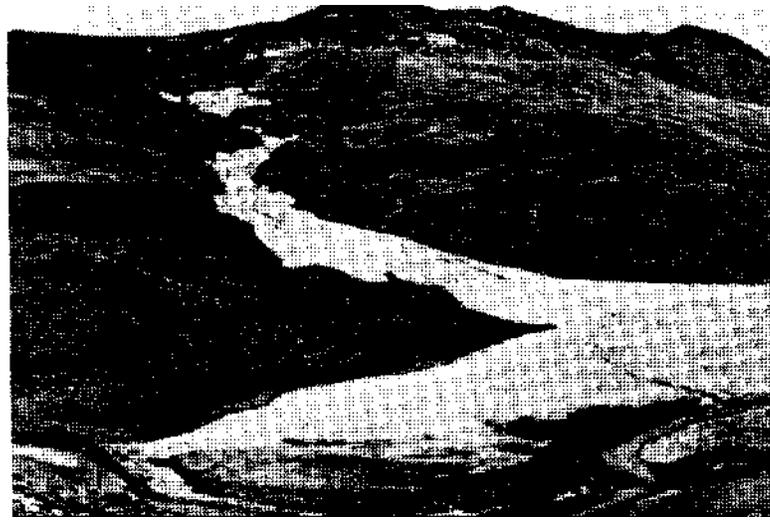
Photo 13 - Photograph showing the mudflow which resulted from the retransportation of the slide material detached from the scar at the top of the flow.

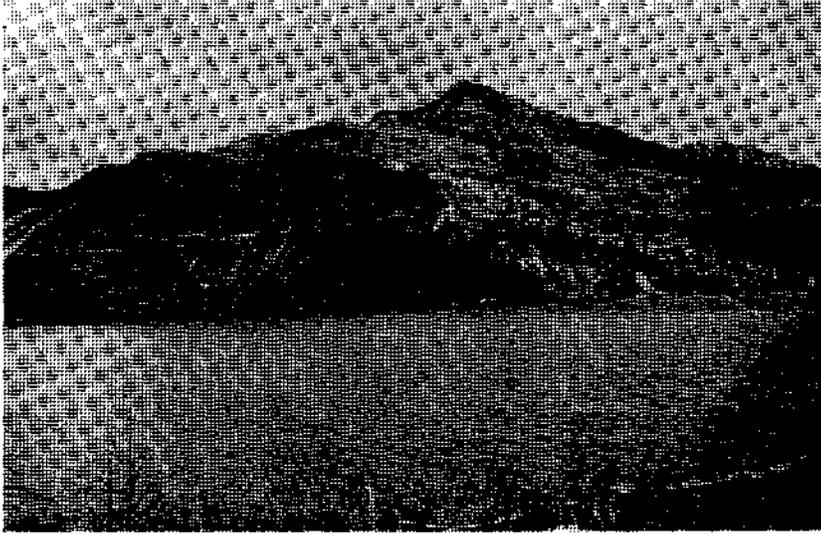
The mass movements which occurred in the Upper Cretaceous Sandstone-Limestone-Marl intercalated formation falls in the fourth instability group. An example of this type, is seen in Photo 14, which slipped into the Tresp reservoir lake. The movement has taken place with a slip surface parallel to the bedding plane between the calcareous sandstone (above) and marl layers (below) of Cretaceous series. The slide might have been due to the penetration of water through the permeable sandstone layer into the expansive plastic marl layer. Thus a slide surface developed between the marl and sandstone inducing the movement. Probably the sliding was also provoked by the undermining of the lake waves. Furthermore, Two villages (Tendruy and Puigcergos) have been destroyed by mass movements and sections of several roads had to be reconstructed after each wet season in the area.

Photo 14 - A slide parallel to bedding plane in the Cretaceous series.

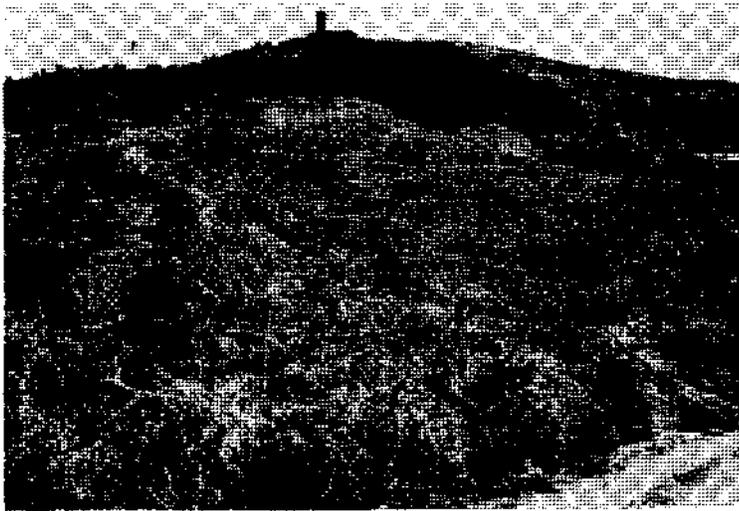
A slump affecting the Eocene limestone-marl formation is the cause of this disaster. The former village of Puigcergos was located on a residual hill.

Photo 15 - Photograph showing the Pulgergos slump affecting the Eocene limestone-marl intercalated formation.
