Investigation of the lifetime of the coating applied on the steam turbine blade in terms of corrosion and erosion

Investigation of The Lifetime of the Coating Applied on The Steam Turbine Blade in Terms of Corrosion and Erosion

In this unprecedented study, the amount of corrosion and wear that occurred during the durability/operational life of a turbine blade and its coating, which had been used for 25 years in a Thermal Power Plant, was comparatively examined with an original turbine blade made of the same material that had never been used.

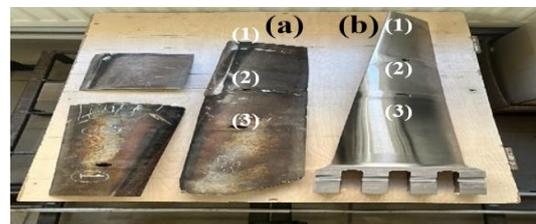
Figure 2. Used (a) and unused (b) steam turbine blades [icmatse2024]

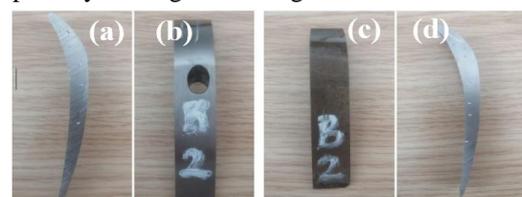
Figure 3. Images of unused (a and b) and used (c and d) turbine blade hardness test samples

On the other hand, when the coating hardness was measured, it was determined that the hardness of the unused material was higher than that of the used one. The coating of the used blade weakens over time due to the effects of wear and corrosion, and it completely disappears at the end of its service life. These results explain the process of the coating first weakening (decrease in hardness) and then completely disappearing due to the effects of corrosion and/or other wear mechanisms during the use of the blade material [37]. A study observed that corrosion and erosion on turbine blades caused a severe decrease and deterioration in the material's mechanical properties [43]. Detailed examination images of the abrasion damage of the used turbine blade are given in Figure 6. When the photos are examined, it is seen that the coating in the upper part of the blade (A and B) decreases until the transition coating

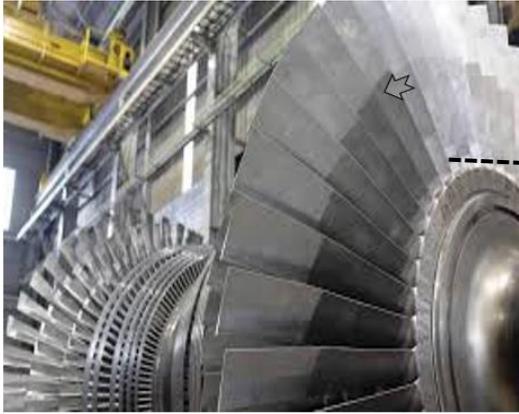
Figure 4. The turbine blade that has completed its working life, and the areas from which samples are taken

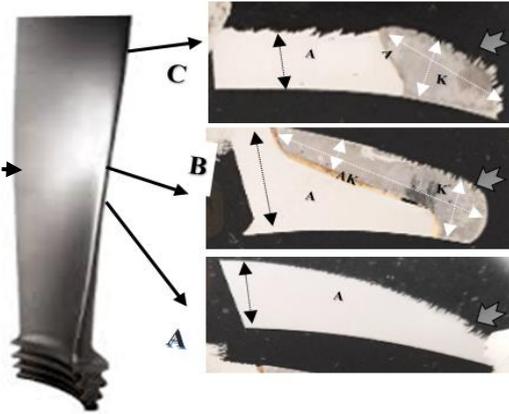
Figure 5. Sectional images of the samples taken (K: Coating, A: Base, AK: Intermediate coating)

Defects in the form of irregularities and gaps in the thickness were detected in the intermediate coating. It is seen that the intermediate layer is 0.3-0.4 mm thick on average. The coating thickness is 2-4 mm on the back in region B, 4-5 mm on the tip, and 15-16 mm wide, 4-5 mm thick on the tip, and 7-8 mm wide on the tip in region C. Since sample A is an uncoated area, the shoulder tip of the blade has been primarily worn, and the thickness has decreased by 25%. Since the steam intensity is higher in region B, the coating tip has been worn by 10%.

In region C, where the most severe steam effect is seen, 20-30% wear has occurred both on the shoulder tip and back of the coating and on the uncoated parts [37].

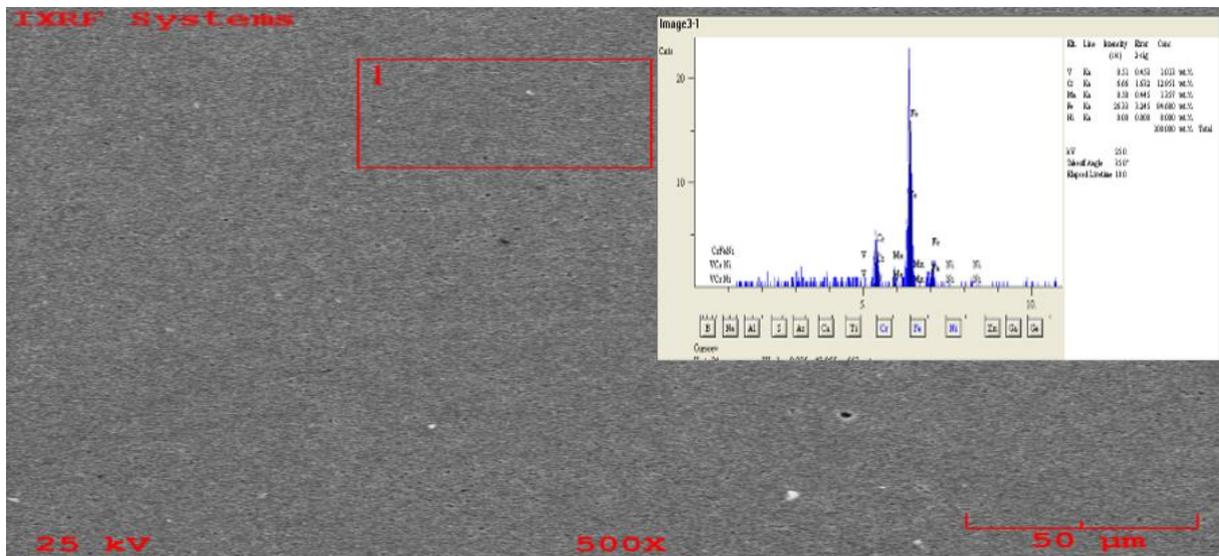
The blade used for the microstructures, SEM images, and EDS analysis of sample A is given in Figure 7. The photos and Analyses show a turbine blade structure with a three-layer (base, bond coating, and top coating) structure consisting of three different materials (420 stainless steel, hard solder, and Co-based). When looking at sample A (Figure 5), it is seen that there is no coating on the surface since this area has never been coated before; only the resistance of the substrate material to the working conditions is seen; a high rate of wear occurs during the working process; and chemical changes occur on the surfaces during the working process. The results of the chemical analysis show that the substrate material is AISI 420 stainless steel, various unstable oxides occur on the uppermost parts of the worn surfaces, and the wear occurs much more severely inward in the form of a line parallel to the steam direction along the grain boundaries. The particles that emerge due to the wear cause more severe wear of the general system and the turbine blades by causing a particle effect [38].

Figure 7. SEM-EDS analysis of the transition regions of sample A

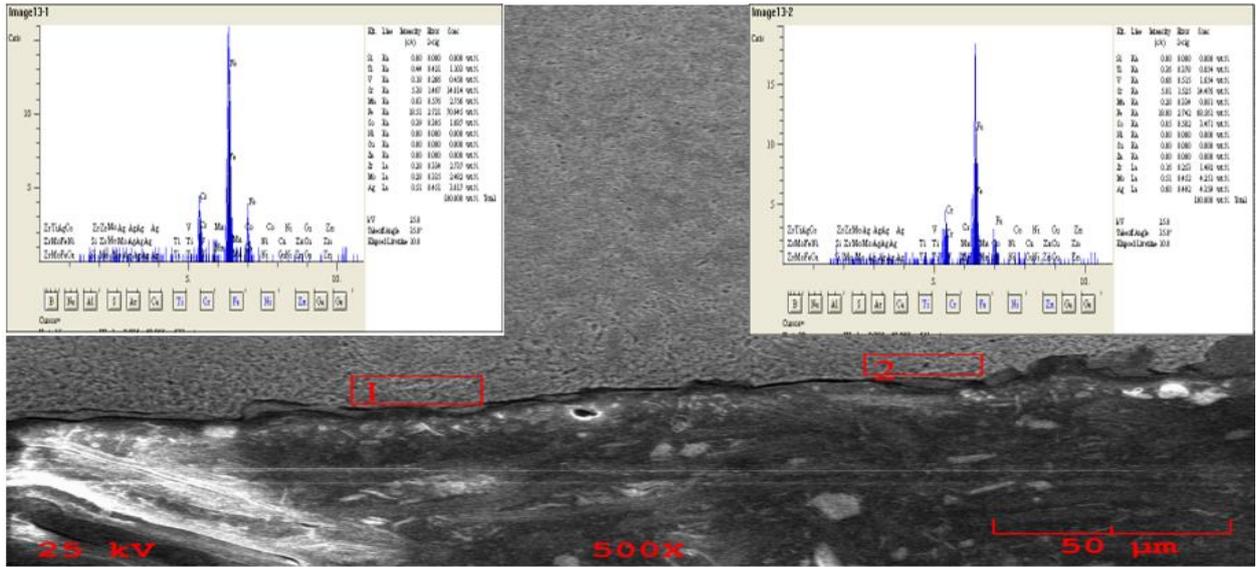
Figures 8-10 show that macro- and microstructural analysis, SEM images, and EDS analysis of sample B were used. The pictures and studies show that the turbine blade structure has a three-layer (substrate, bond coating, and coating) structure consisting of three different materials (AISI 420 stainless steel, hard solder, and Co-based) (Figure 9-10). Bond coating application is common for a better fit and adhesion/bonding resistance during coating processes. In this blade, Cu-based

Figure 8. Macrostructure images of sample B

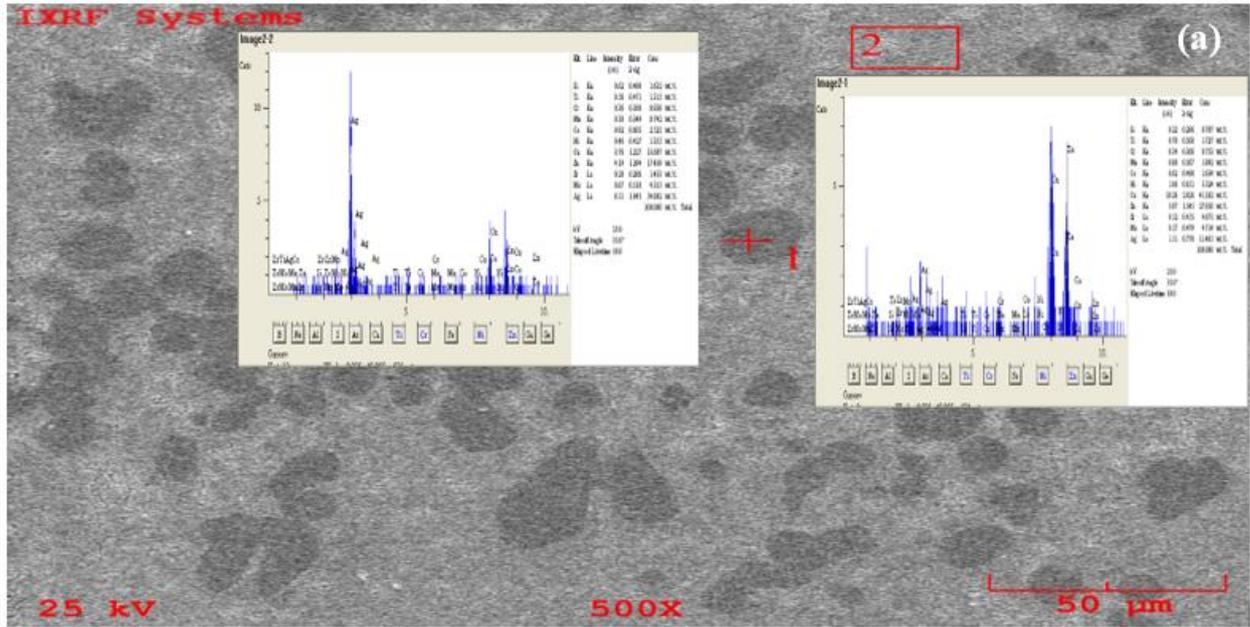
Figures 11-13 show the macro and microstructure images and chemical analysis data obtained from sample C. It was observed that very severe wear occurred both on the blade shoulder tip coating and on the back of the substrate (Figure 11-12). Irregularity and void-shaped defects were detected in the bond coating thickness. The coating has a dendritic structure, and much segregation was observed (Figure 13). Segregation is a point and/or regional composition difference. Thus, the corrosion potential increases in a structure with segregation. In sample C, the most severe wear occurred due to the steam's chemical and mechanical effects (Figure 13.a-c). Figure 12 shows the linear elemental EDS analysis to determine the chemical transition and bonding properties between the bond coating and the coating. When the analysis results are examined, it is understood that there are partial transitions between the bond coating and the coating regions. Therefore, the bond between both coatings is strong, and there will be no separation/breakage/shedding while using the blades [39].

Figure 11. Macrostructure images of sample C

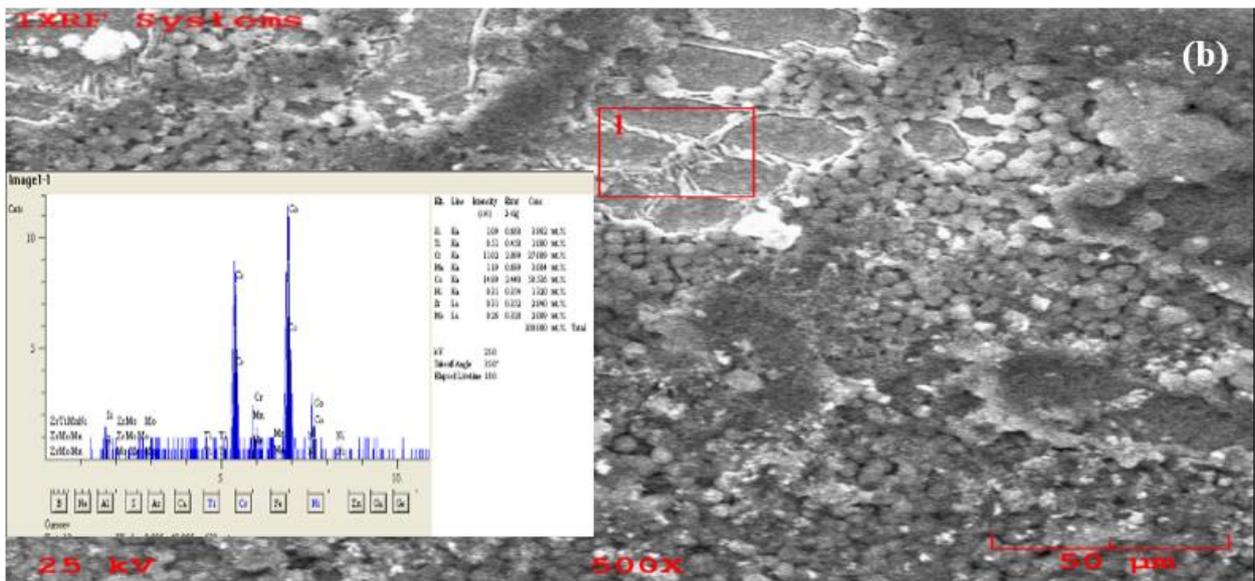
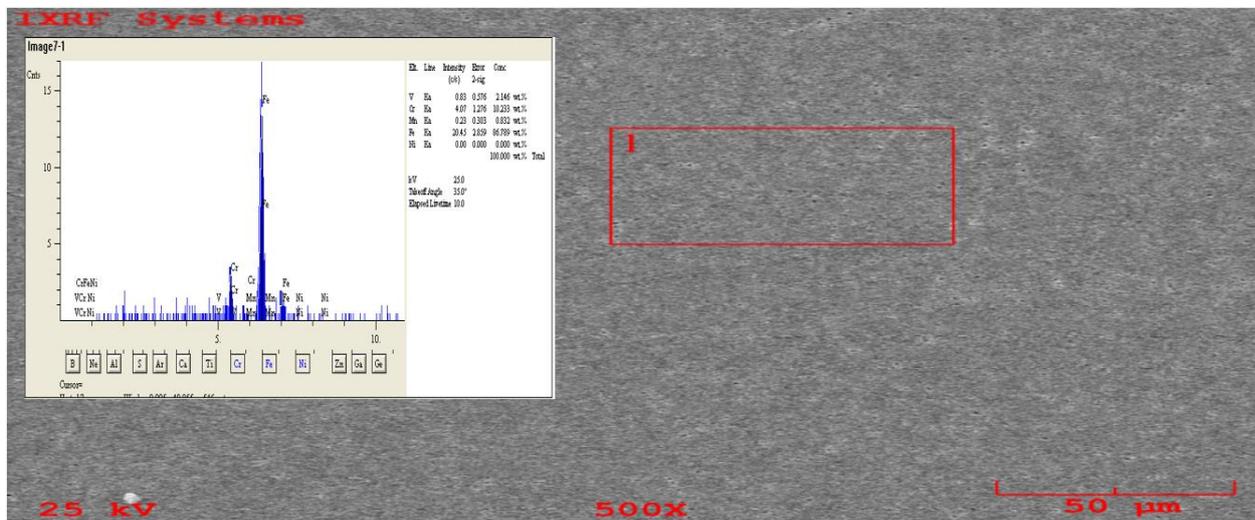
Figure 12. SEM image and EDS analysis of the substrate of sample C.

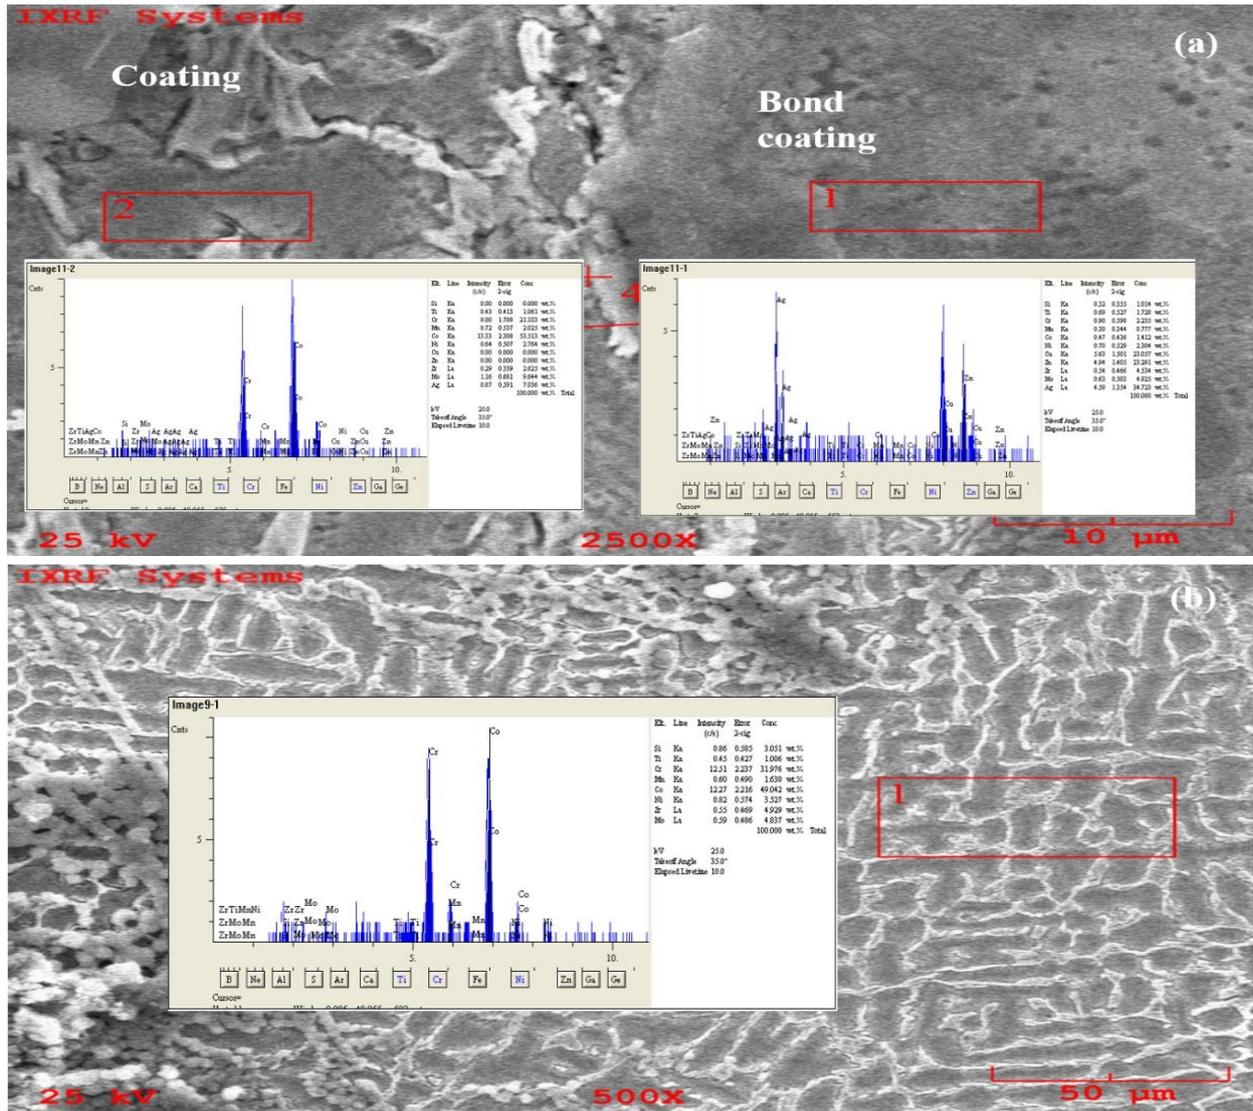
Figure 13. SEM image and EDS analysis of bond coating (a) and coating (b) of sample C.

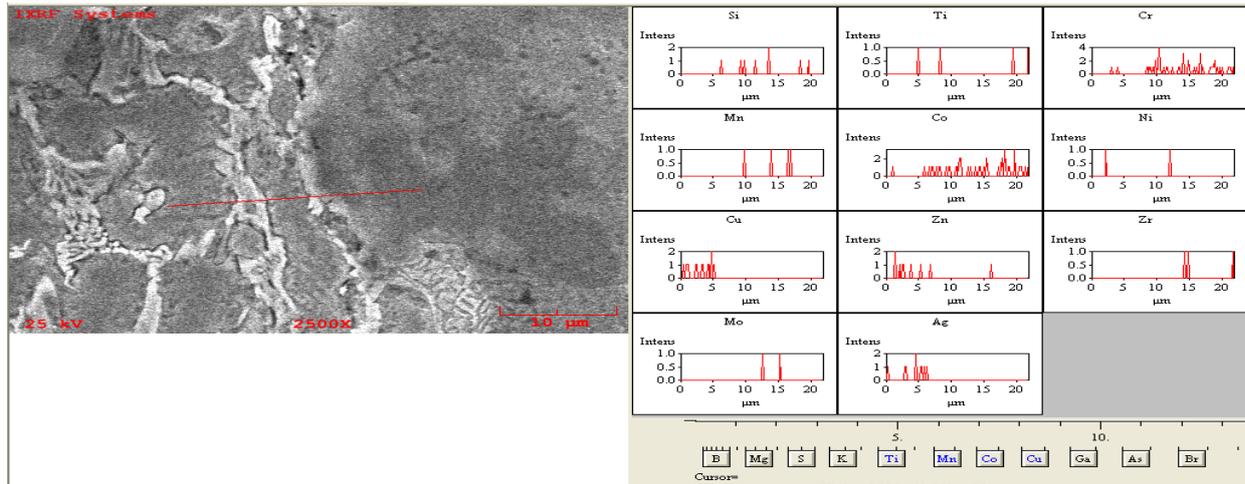
Figure 14. Sample C bond coating and coating SEM image and transition region linear EDS analysis

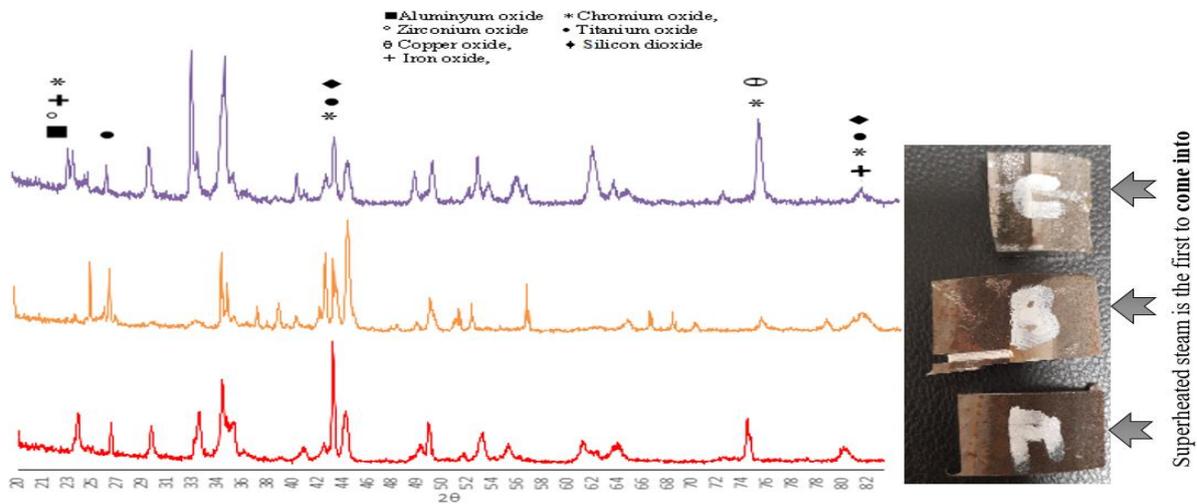
They are preferred due to both high-temperature wear and corrosion resistance. The corrosion products formed were determined by XRD analysis of A, B, and C surface samples (Figure 15). It was determined that oxides of the elements comprising the substrate were formed in sample A, and the coating material in samples B and C. The formation of chemically and mechanically stable oxides at high temperatures in the coating and substrate surface will provide surface passivation and protection. However, the corrosion + abrasive wear process continued since very mixed oxides were formed here and there was a continuous mechanical abrasion effect, the corrosion + abrasive wear process continued. All three region examinations showed that the substrate/blade material has a classic AISI 420-quality stainless steel composition and coaxial grain structure. The coating is applied mainly in areas where abrasion is severe. The bond coating is applied first, and then the main coating is applied. It has been determined that the bond coating and main coating structures are suitable, and the interface between them is sufficient. This is a standard application

Figure 15. XRD results obtained from sample surfaces and the resulting products (A, B, and C).

in such fins [36]. This application is necessary to improve the wear and corrosion properties at high temperatures. However, as can be seen from this study, although the Co-Cr coating materials are very resistant to corrosion, it is clearly understood from the oxidized compounds that the coating material reacts with the oxygen in the environment after a specific period of time, primarily due to the catalytic effect of high temperatures, and therefore corrodes (Figure 15). When the difference between the A, B, and C samples is evaluated, the components belonging to the coating material are dominant in sample A, while the oxides of the elements belonging to the bond coating material and the components belonging to the base (fin) material are dominant in samples B and C. This situation is critical in revealing the lower parts with the wear of the corroded surfaces and showing how the process progresses in the progressive corrosion and wear processes. This study shows that using more stable materials (oxide, carbide, and nitride) in blade coatings would be appropriate for these blades [42,45].
