# Investigation of the lifetime of the coating applied on the steam turbine blade in terms of corrosion and erosion

# Investigation of The Lifetime of the Coating Applied on The Steam Turbine Blade in Terms of Corrosion and Erosion

(Bu çalışma ICMATSE 2024 konferansında sunulmuştur. / This study was presented at ICMATSE 2024 conference.)

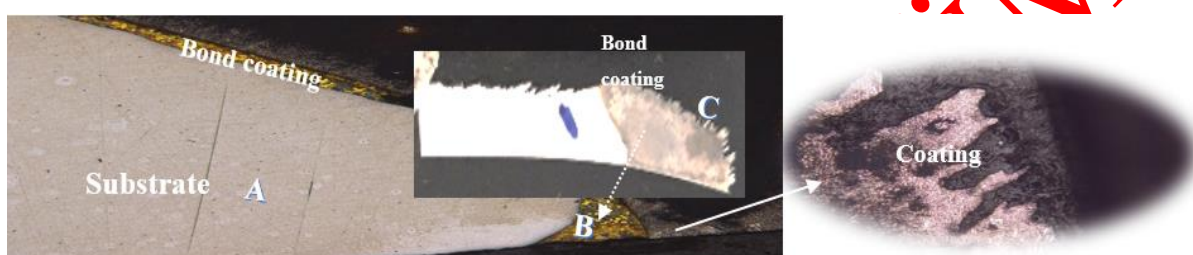
Detailed examination images of the abrasion damage of the used turbine blade are given in Figure X. When the photos are examined, it is seen that the coating in the upper part of the blade (A and B) decreases until the transition coating almost disappears; on the other hand, it is more present in the blade tip part (C). This situation shows that corrosion and wear have a more severe effect on the blade surface (upper) parts.

**Figure 1.** Images of the cross-sectional macrostructure and microstructure of the used sample

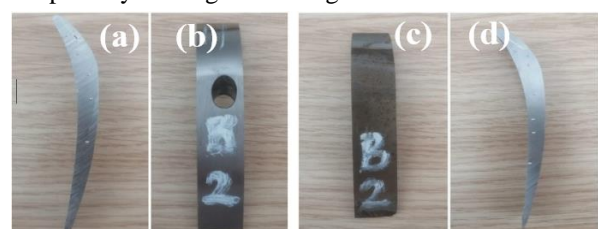
**Figure 3.** Images of unused (a and b) and used (c and d) turbine blade hardness test samples

On the other hand, when the coating hardness was measured, it was determined that the hardness of the unused material was higher than that of the used one. The coating of the used blade weakens over time due to the effects of wear and corrosion, and it completely disappears at the end of its service life. These results explain the process of the coating first weakening (decrease in hardness) and then completely disappearing due to the effects of corrosion and/or other wear mechanisms during the use of the blade material [37]. A study observed that corrosion and erosion on turbine blades caused a severe decrease and deterioration in the material's mechanical properties [43]. Detailed examination images of the abrasion damage of the used turbine blade are given in Figure 6. When the photos are examined, it is seen that the coating in the upper part of the blade (A and B) decreases until the transition coating

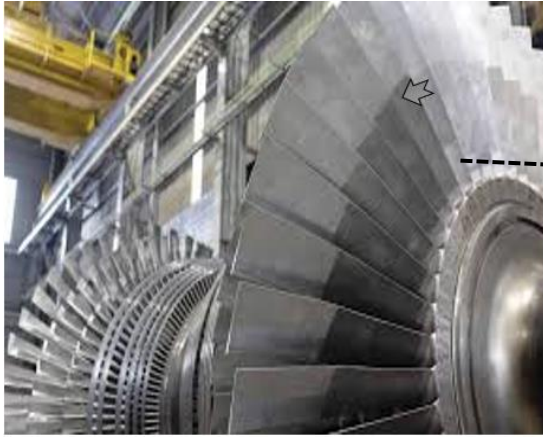
**Figure 4.** The turbine blade that has completed its working life, and the areas from which samples are taken

It is seen that the intermediate coating is 0.3-0.4 mm thick on average. The coating is: 2-4 mm on the back in region B, 4-5 mm on the tip, and 15-16 mm wide, 4-5 mm thick on the tip, and 7-8 mm wide on the tip in region C. Since sample A is an uncoated area, the shoulder tip of the wing has been primarily worn, and the thickness has decreased by 25%. Since the steam intensity is higher in region B, the coating tip has been worn by 10%. In region C, where the most severe steam effect is seen, 20-30% wear has occurred both on the shoulder tip and back

of the coating and on the uncoated parts (Figure 4,5). Since the hardness was measured from the area where the coating remained on the used blade, measurements were made from the exact location on the other side. The results showed that ASTM A276 values should be in annealed AISI 420-quality stainless steel used as the blade material [36]. This study was conducted as a comparative analysis of turbine blades used and unused for comparison purposes. When the chemical analysis results were evaluated, it was determined that the primary materials of the turbine blade were very much the same. This approach is essential for the reliability of other data obtained in the study. On the other hand, the transition and primary coating data also gave similar results.

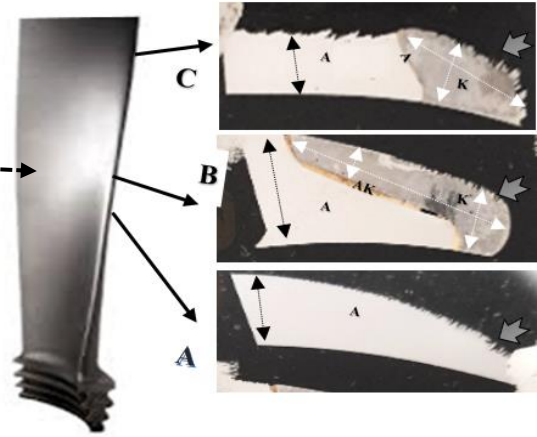
**Figure 5.** Sectional images of the samples taken (K: Coating, A: Base, AK: Intermediate coating)

Defects in the form of irregularities and gaps in the thickness were detected in the intermediate coating. It is seen that the intermediate layer is 0.3-0.4 mm thick on average. The coating thickness is 2-4 mm on the back in region B, 4-5 mm on the tip, and 15-16 mm wide, 4-5 mm thick on the tip, and 7-8 mm wide on the tip in region C. Since sample A is an uncoated area, the shoulder tip of the blade has been primarily worn, and the thickness has decreased by 25%. Since the steam intensity is higher in region B, the coating tip has been worn by 10%.

In region C, where the most severe steam effect is seen, 20-30% wear has occurred both on the shoulder tip and back of the coating and on the uncoated parts [37].

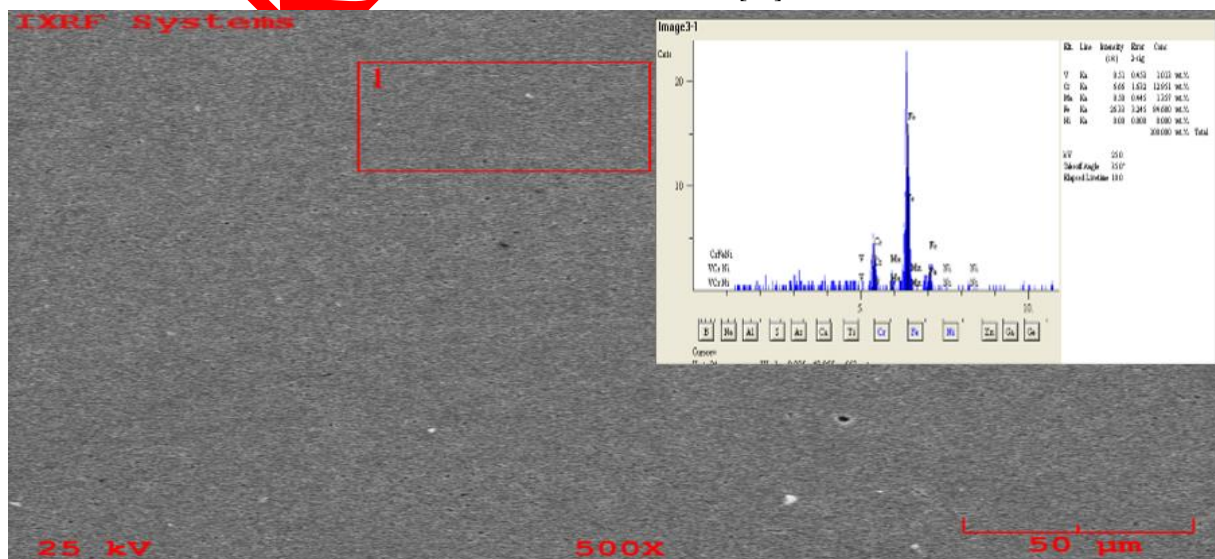
The blade used for the microstructures, SEM images, and EDS analysis of sample A is given in Figure 7. The photos and Analyses show a turbine blade structure with a three-layer (base, bond coating, and top coating) structure consisting of three different materials (420 stainless steel, hard solder, and Co-based). When looking at sample A (Figure 5), it is seen that there is no coating on the surface since this area has never been coated before; only the resistance of the substrate material to the working conditions is seen; a high rate of wear occurs during the working process; and chemical changes occur on the surfaces during the working process. The results of the chemical analysis show that the substrate material is AISI 420 stainless steel, various unstable oxides occur on the uppermost parts of the worn surfaces, and the wear occurs much more severely inward in the form of a line parallel to the steam direction along the grain boundaries. The particles that emerge due to the wear cause more severe wear of the general system and the turbine blades by causing a particle effect [38].

**Figure 7.** SEM-EDS analysis of the transition regions of sample A

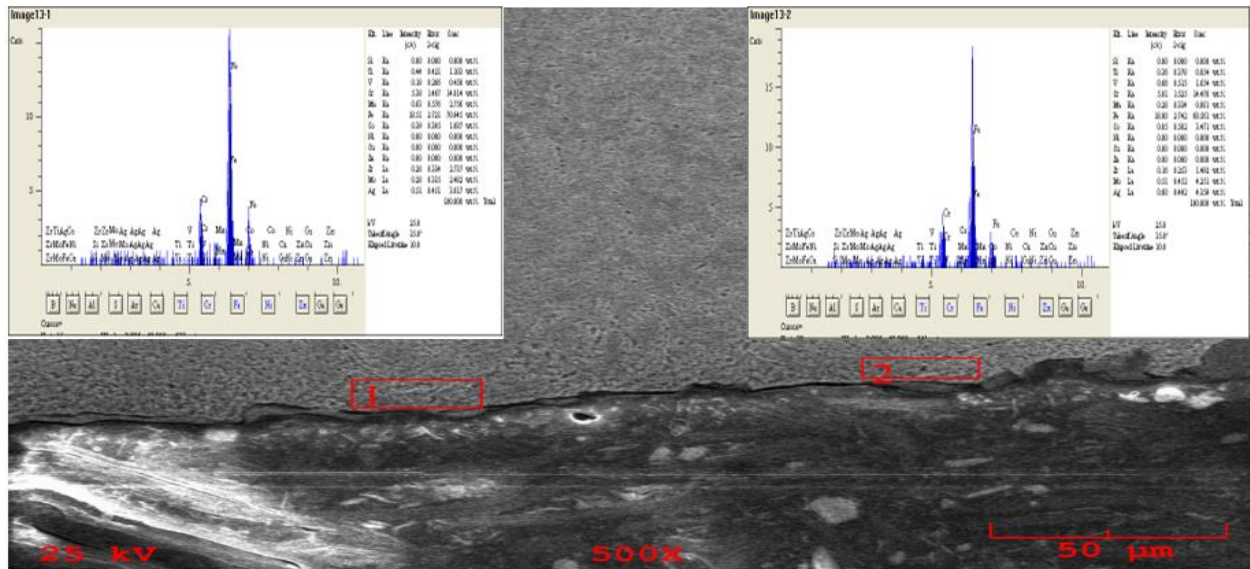
Figures 8-10 show that macro- and microstructural analysis, SEM images, and EDS analysis of sample B were used. The pictures and studies show that the turbine blade structure has a three-layer (substrate, bond coating, and coating) structure consisting of three different materials (AISI 420 stainless steel, hard solder, and Co-based) (Figure 9-10). Bond coating application is common for a better fit and adhesion/bonding resistance during coating processes. In this blade, Cu-based

Figure 8. Macrostructure images of sample B

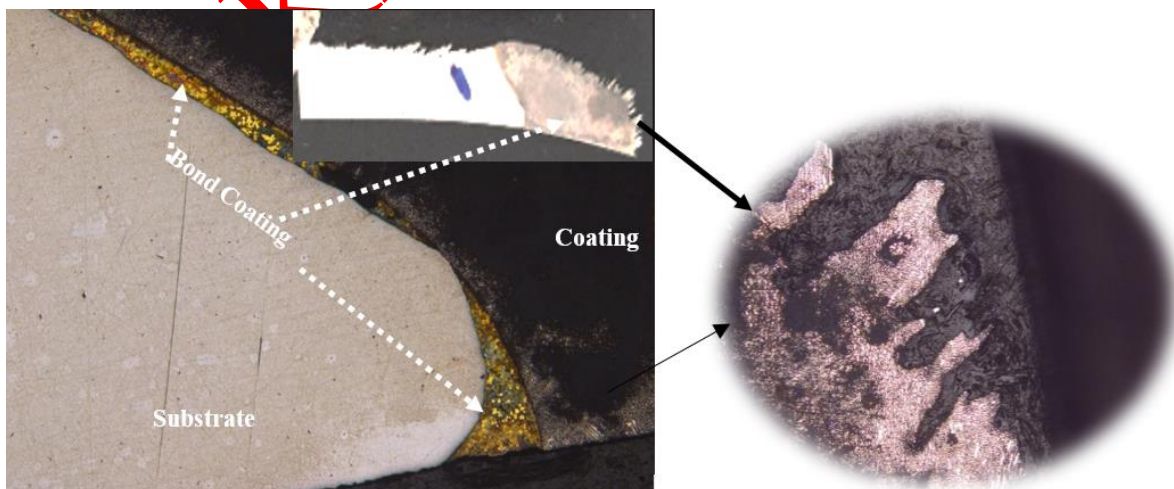
intermediate bond coating is applied, and it is seen that it is coated with Co-based superalloy material [38].

Figure 10. SEM image and EDS analysis of bond coating (a) and substrate (b) of sample B.

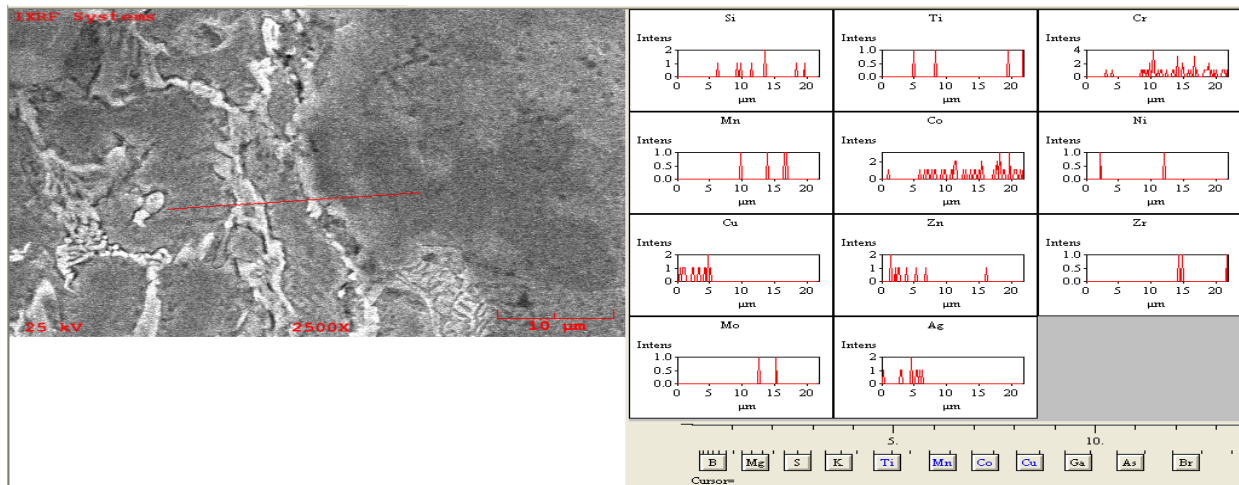
Figure 14. Sample C bond coating and coating SEM image and transition region linear EDS analysis

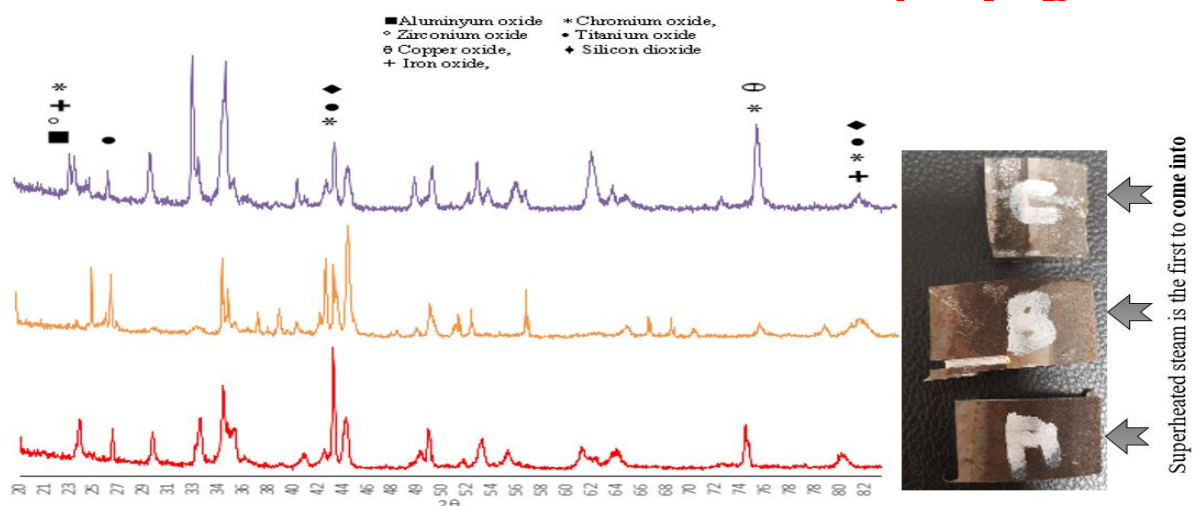
They are preferred due to both high-temperature wear and corrosion resistance. The corrosion products formed were determined by XRD analysis of A, B, and C surface samples (Figure 15). It was determined that oxides of the elements comprising the substrate were formed in sample A, and the coating material in samples B and C. The formation of chemically and mechanically stable oxides at high temperatures in the coating and substrate surface will provide surface passivation and protection. However, the corrosion + abrasive wear process continued since very mixed oxides were formed here and there was a continuous mechanical abrasion effect, the corrosion + abrasive wear process continued. All three region examinations showed that the substrate/blade material has a classic AISI 420-quality stainless steel composition and coaxial grain structure. The coating is applied mainly in areas where abrasion is severe. The bond coating is applied first, and then the main coating is applied. It has been determined that the bond coating and main coating structures are suitable, and the interface between them is sufficient. This is a standard application

Figure 15. XRD results obtained from sample surfaces and the resulting products (A, B, and C).

in such fins [36]. This application is necessary to improve the wear and corrosion properties at high temperatures. However, as can be seen from this study, although the Co-Cr coating materials are very resistant to corrosion, it is clearly understood from the oxidized compounds that the coating material reacts with the oxygen in the environment after a specific period of time, primarily due to the catalytic effect of high temperatures, and therefore corrodes (Figure 15). When the difference between the A, B, and C samples is evaluated, the components belonging to the coating material are dominant in sample A, while the oxides of the elements belonging to the base (fin) material are dominant in samples B and C. This situation is critical in revealing the lower parts with the wear of the corroded surfaces and showing how the process progresses in the progressive corrosion and wear processes. This study shows that using more stable materials (oxide, carbide, and nitride) in blade coatings would be appropriate for these blades [42,45].
