Seismic Risk Prioritization of Stone Masonry Building Stock in Urla Peninsula Based on Rapid Assessment Techniques

ABSTRACT

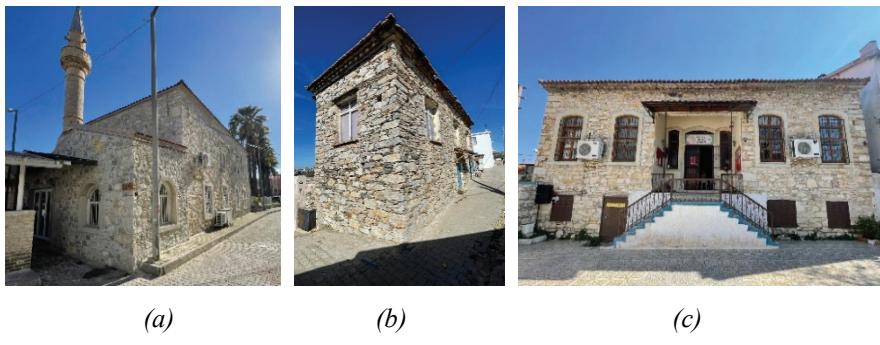
Figure 2 - Typical examples of examined SMBs with different occupancy classes: a) religious, b) residential, c) educational.

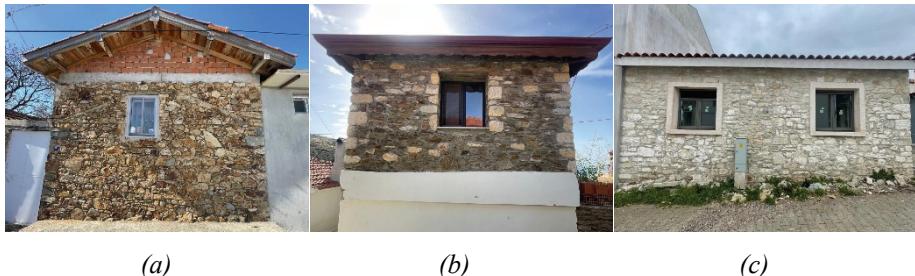
Figure 3 - Examples of stone and roof types from: a) Küçükkaya, b) Sarpincik, c) Urla
