2011 Van Earthquakes: Design vs Construction

Barış Erdil*

ABSTRACT

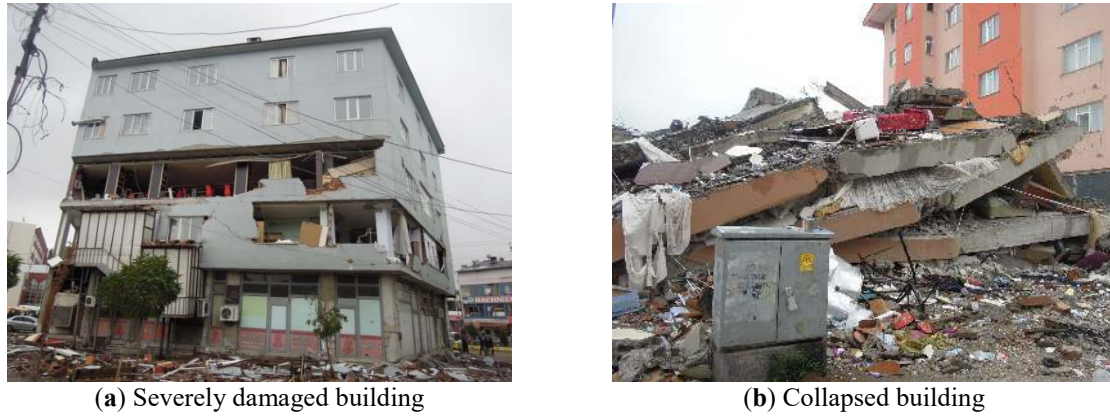
146 buildings are taken into account to compare the important parameters of their design projects with construction practices in the light of Turkish Earthquake Resistant Codes (TERC) published in 1975, 1997 and 2007. Buildings were located in Erciş Town and Van City and experienced 2011 Van Earthquakes. From the 114 buildings in Van City, 59 of them undamaged or had light damage, 6 buildings had moderate damage, 41 buildings experienced severe damage and 8 of them collapsed during earthquakes. As for the 32 buildings in Erciş Town, 3 buildings remained undamaged or had light damage, one building was damaged moderately, 2 buildings experienced severe damage and 26 buildings collapsed. Overall, 47.3% of the investigated buildings can be occupied after proper repair and strengthening, whereas 52.7% cannot be utilized due to severe damage or collapse [10]. Figure 1 depicts the severely damaged and collapsed buildings in Erciş Town.

Figure 1. Severely damaged and collapsed buildings in Erciş Town.

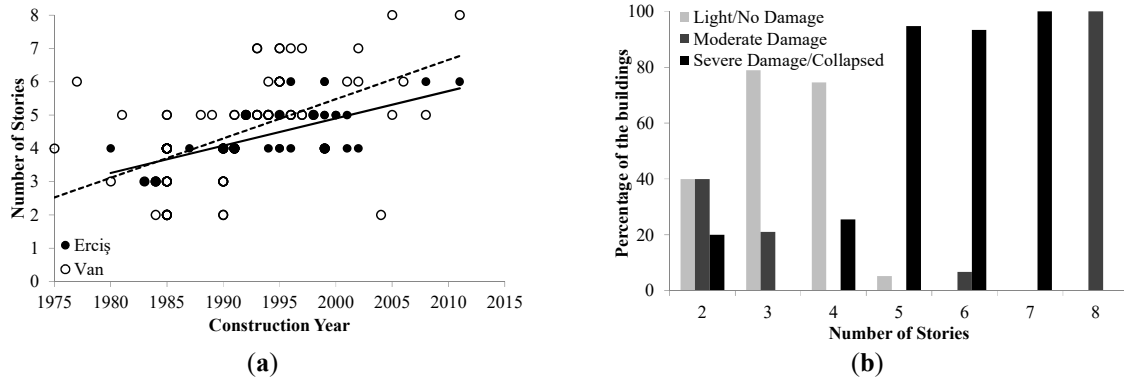
Several reports written after earthquakes state that number of stories may have negative effect on the seismic performance of buildings. The reason can be attributed to the fact that, mass and the related base shear increases with the number of stories and also increased base shear results in increase in base moments. The building should have adequate and quality load carrying members to withstand those increased demands. Otherwise, demands being greater than the capacities will force the members to damage either locally or globally. The relationship between the number of stories with the construction year and the damage state is given in Figure 2 for the investigated 146 buildings. Figure 2.a. illustrates the number of stories with the construction year. It is seen from the figure that there is an increasing trend in the number of stories of the buildings in Van City and Erciş Town. From Figure 2.b., which indicates the number of stories with the damage states, it is observed that there is no direct relation between number of stories and damage state. Any buildings with any number of stories may damage severely or collapse. However, having high percentages of the severely damaged or collapsed buildings in 5, 6 and 7 story-buildings, it will not be wrong to say that increase in number of stories may increase the damage state in the building.

Figure 2. Relationship between N and a) construction year, b) damage

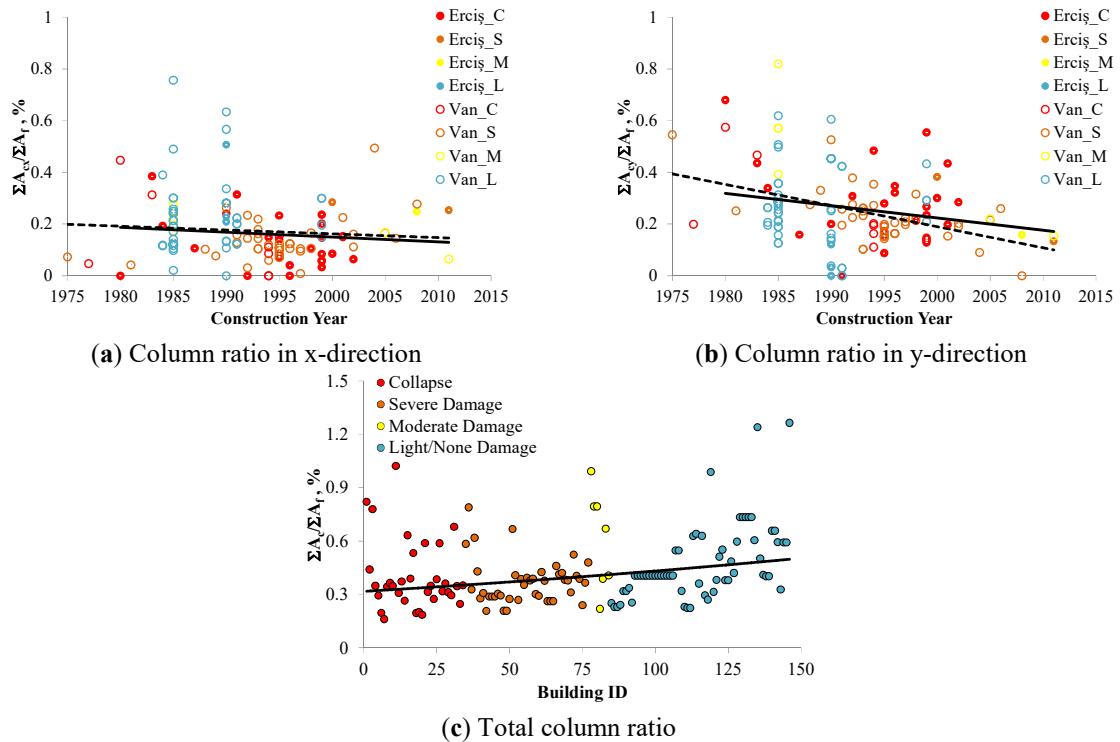
ratio less than 0.3% in x-direction and 0.4% in y-direction. As regards to the general trends of column ratios w.r.t. construction years (the lines in the figures, solid line is for Erciş Town and dashed line is for Van City), it is seen that buildings had decreasing tendency in column ratio, the rate of decrease being higher for y-direction. Erciş Town and Van City had similar tendencies. It can be inferred from those figures that engineers reduce column ratios by time. It should be kept in mind that only column ratio is discussed in here and the trend may change with shear wall ratio, in other words, engineers may use shear walls instead of the eliminated columns. Similar properties can be seen from the total column ratio given in Figure 3.c. In Van and Erciş most of the investigated buildings had column ratio less than 0.5% and the ratio has a decreasing tendency over year.

Figure 3.c. presents the relations between column ratio and damage. In the figures red color represents collapsed buildings, orange used for severely damaged buildings, yellow is for moderate damage and blue represents light/none damage. It is seen from the figure that, as column ratio increases, damage seems to decrease. In other words, collapsed and severely damaged buildings had column ratio less than the buildings with light or no damage

Figure 3. Column ratio vs construction year and damage state

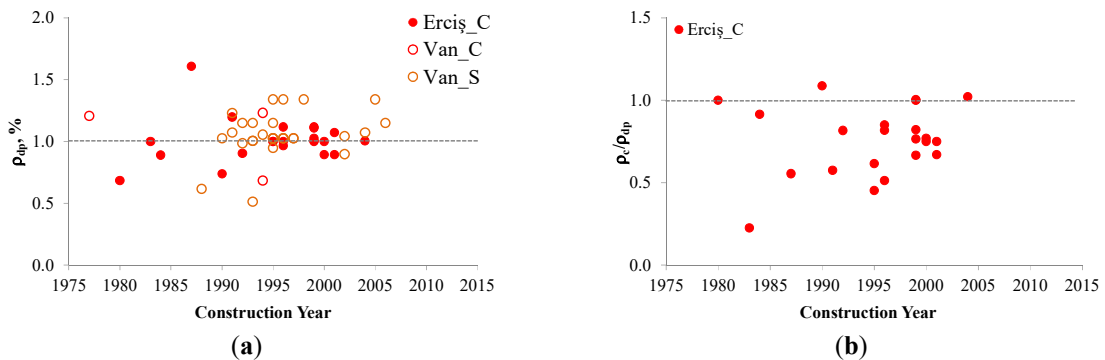
Figure 4.a illustrates the minimum longitudinal reinforcement ratios specified in the design projects (ρ_{dp}) and Figure 4.b. presents the ratio of the longitudinal reinforcement at the site (ρ_c) to the one given in the design projects. All the information belongs to the severely damaged and collapsed 54 buildings. It is seen from Figure 4.a. that most of the design projects obeyed the rule for minimum reinforcement ratio ($\rho_{min} = 1\%$) given in the codes. However, 12 design projects (22% of the buildings) had ρ_{dp} less than ρ_{min} . Although ρ_{dp} is much less than ρ_{min} for the design projects before TEC1997, it starts to increase around 1% after the publication of TEC1997. It seems as if this improvement is because of the improvement in TEC1997 however same ρ_{min} is also specified in TEC1975 indicating that this code is mainly disregarded in design projects because of the lack of supervision. The other possible reason may be attributed to the computer software which became capable of obeying the rules given in the codes

and eliminates the mistakes and errors in the design projects. Unfortunately, improvement in the design projects was not seen at the site as shown in Figure 4.b. Only 22 buildings were able to be investigated after the earthquakes and their reinforcement ratio could be calculated. From these data it is seen that only 4 buildings had the same longitudinal reinforcement ratio (ρ_c) specified in their design projects. 18 buildings had ρ_c/ρ_{dp} less than 1, the average being around 0.75. One building constructed in 1983 had $\rho_c/\rho_{dp}=0.23$ stating that design project is not taken into account in the construction phase. The situation for ρ_c is not improved with the codes because buildings still had less ρ_c after TEC1997.

Figure 4. a) Minimum longitudinal reinforcement ratios specified in design projects (ρ_{dp}) (Erdil 2016), b) ρ_c/ρ_{dp}

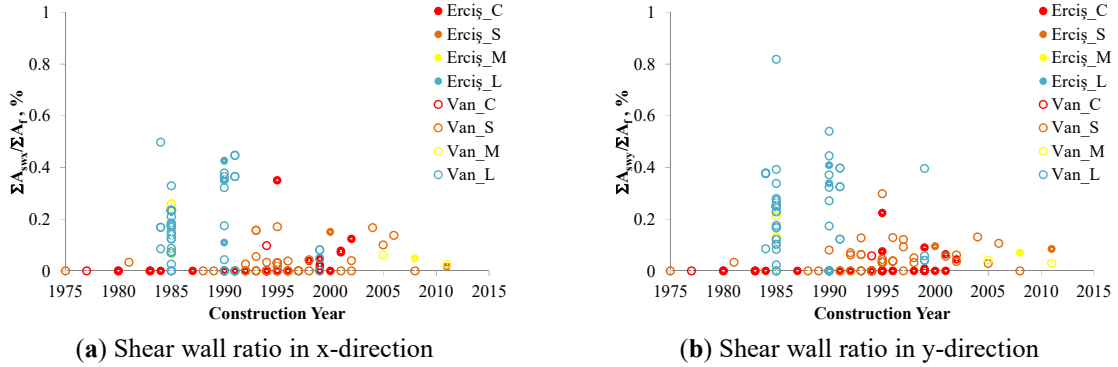
In this study total shear wall areas in x and y-directions are divided to the total floor area and the results are presented in Figure 5. Disregarding the blue buildings (buildings with light or no damage) in the figure, it is seen that shear wall areas increase with time in both directions. Although column ratios

decrease with time, shear walls seem to take place of the eliminated columns. Figure 5 does not give apparent relationship between shear wall ratio and damage. Even buildings with more than 0.2% shear wall ratio collapsed and the one having no shear walls survived

Figure 5. Shear wall ratio vs damage and construction year

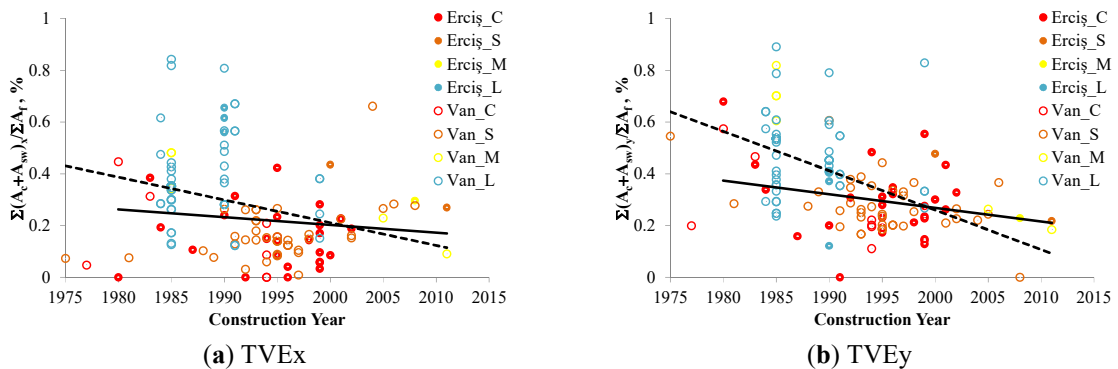
Figure 6 shows the ratio of the total vertical load carrying members in x-direction (TVEx) and y-direction (TVEy). It is seen from the figures that there was a slight decrease in TVEx and TVEy for Erciş and considerable decrease for Van. The rate of decrease for Van can be attributed to the lightly damaged buildings having great TVEx and TVEy and being built before 1990. Most of the severely damaged and collapsed buildings are observed to have TVEx and TVEy less than 0.4% and TVEx and TVEy are higher in y-direction. Even those buildings have no columns and shear wall placed parallel to x-direction, which makes those buildings vulnerable to the seismic actions.

Figure 6. Column ratio vs construction year and damage state

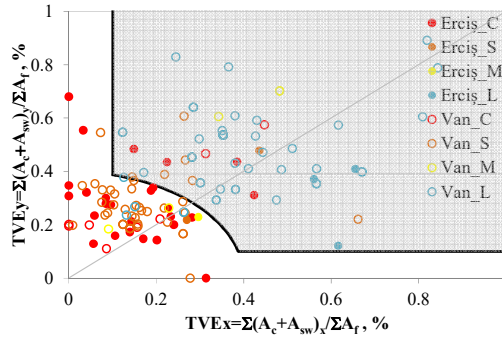
In order to understand the critical ratio for TVEx and TVEy, Figure 7 was prepared. From the figure it is seen that most of the collapsed and severely damaged buildings accumulated below 0.4%. Defining a curved boundary between 0.4%, it is possible to separate severely damaged and collapsed buildings from the others. Although some buildings had TVEx and TVEy beyond that curved line collapsed or severely damaged, they are not too much and can be ignored. In addition to that curved line, two other boundaries are defined: one specifying the minimum TVEx and the other one determining the minimum TVEy. The final boundaries and the required equations for the boundaries are given in Equation 1 and 3. In the figure, safe region is painted in gray. The equations are derived considering the 146 buildings data presented in Figure 7 and they may not be representative for all buildings. However, they may give some information about the seismic vulnerability of reinforced concrete buildings

Figure 7. TVEx vs. TVEy

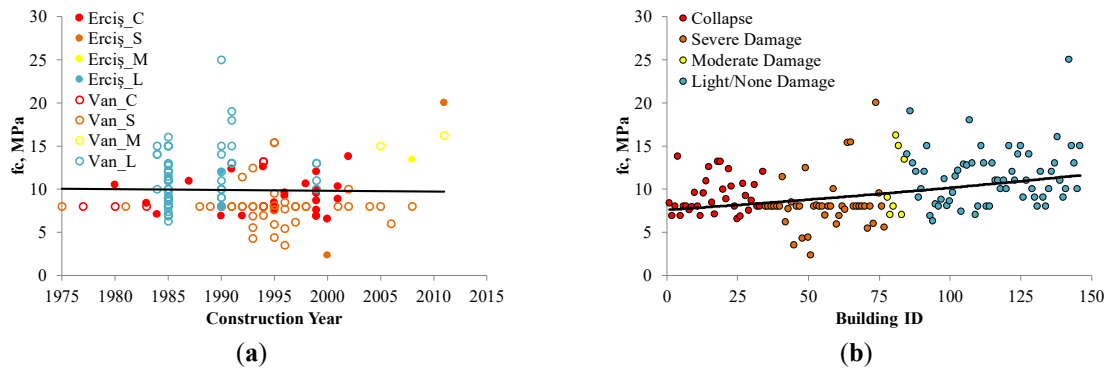
Strength of concrete core samples of the investigated buildings is given in Figure 8 w.r.t. construction year and damage state. Figure 8.a. verifies the findings available in the literature and shows that the average concrete strength is about 10 MPa for the 146 buildings considered in this study. It has no improvement by time. It is known that ready mixed concrete is not available in Van region before 2000 [9] and the low strength concrete can be connected with inadequate mixing, placing, compacting and non-standard aggregates. The introduction of ready mixed concrete goes back to early 2000s in the region and the aim of this implementation was to improve the concrete quality. Concrete strength is expected to increase after 2000, but that improvement is not seen in reality. Except three buildings before TEC1997 ($f_{c,min}=18$ MPa) and one building after TEC2007 ($f_{c,min}=20$ MPa), all of the buildings had concrete strength lower than the ones specified in the codes. The average is around 10 MPa indicating that although concrete technology improved rapidly, concrete quality at the site has slow or no improvement. The reason can also be attributed to the human power. Well designed and prepared concrete may result in low quality if treated wrongly. For example, although the laboratory result of a concrete gives 32 MPa it may be only 13 MPa at the site due to the improper compaction and curing [10].

Figure 8.b. illustrates the concrete strength w.r.t. the damage state. In the figure, first 34 buildings collapsed during 2011 Van Earthquakes, following 43 buildings severely damaged, 7 buildings experienced moderate damage and the last 62 buildings had light damage or remained undamaged. It is interesting to note that as damage increases concrete strength reduces, in other words, lightly damaged buildings had higher concrete strength as compared to the collapsed ones. However, concrete strength in the lightly damaged buildings were not code compliant either

Figure 8. Concrete strength vs. a) construction year, b) damage state
